ATSB TRANSPORT SAFETY INVESTIGATION REPORT
Marine Occurrence Investigation No. 204
Final

Independent investigation into the knockdown of the
Australian sail training vessel

Windeward Bound

3 June 2004

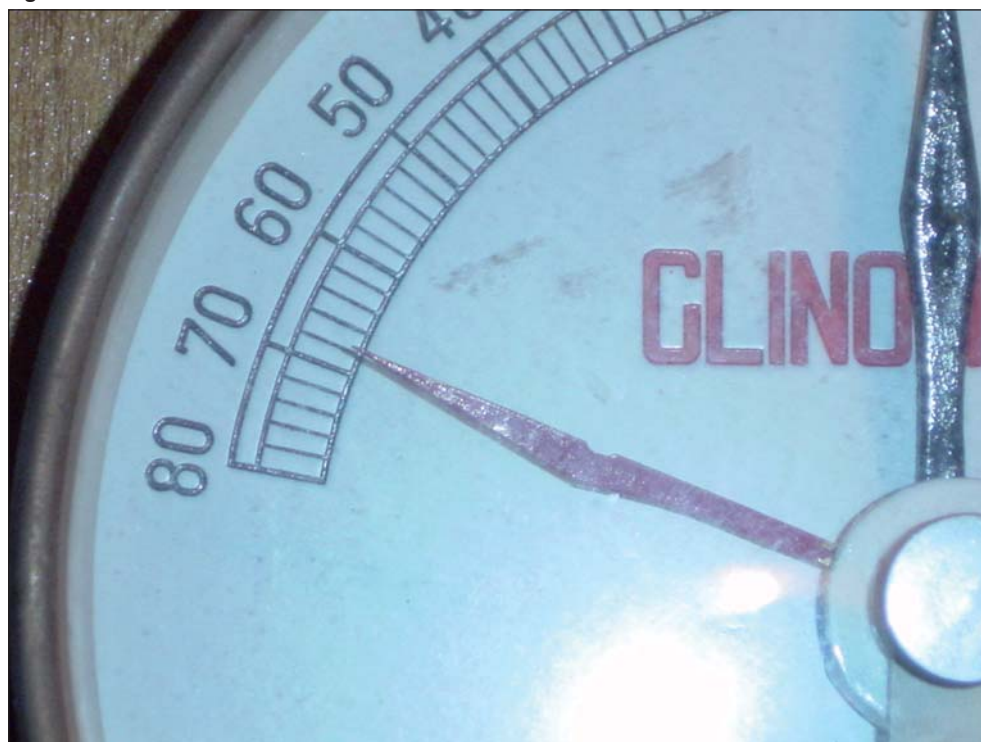
Figure 4: Inclinometer mounted on the aft bulkhead of the master's cabin

the vessel and caused it to be 'knocked down'¹⁰. The vessel heeled to an angle of about 68 degrees (Figure 4), with the starboard side of its main deck submerged.

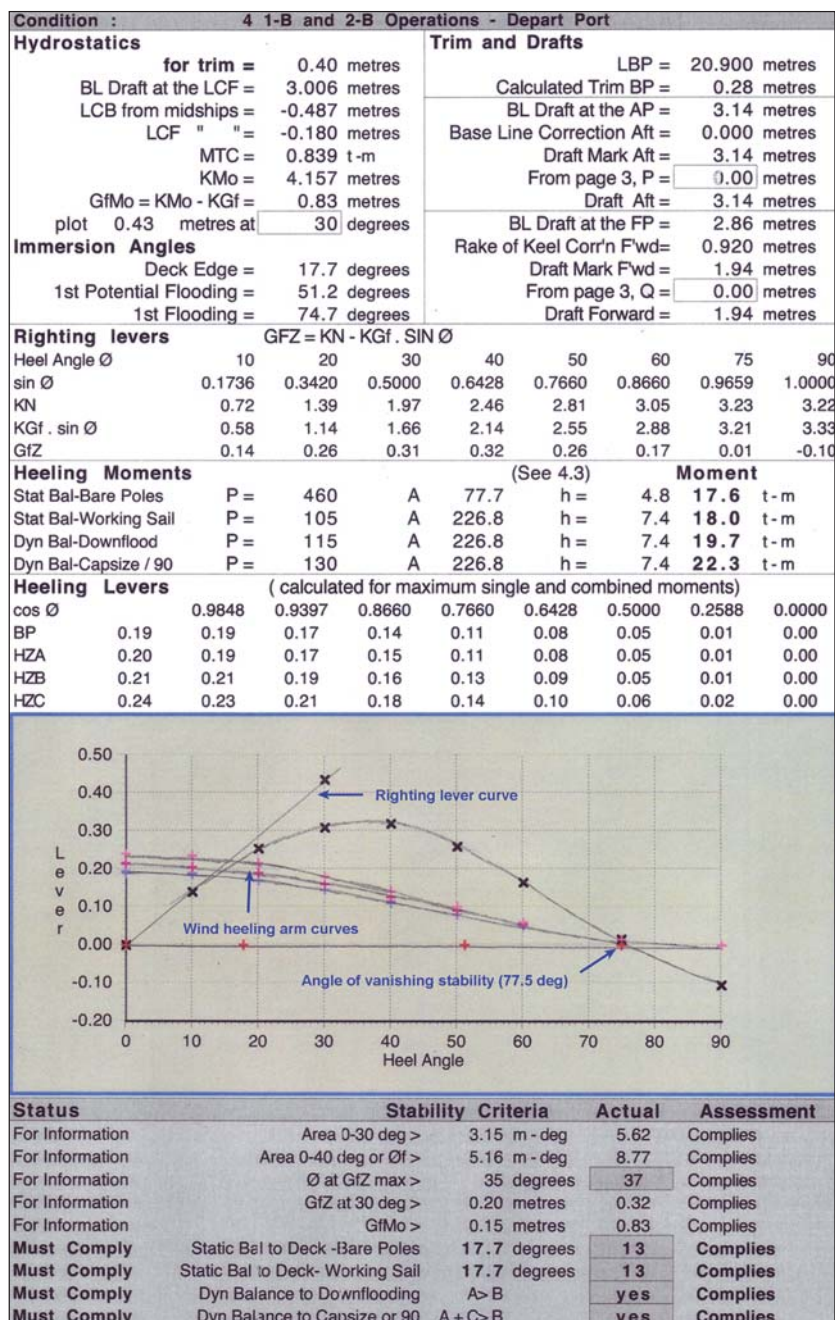
Figure 7: *Windeward Bound's* approved stability data

The information presented in *Windeward Bound's* stability book for various loaded conditions shows calculations and wind heeling arm curves for the limiting wind strengths of 105, 115 and 130 Pascals. The curves are labelled $HZ_{A, B \text{ and } C}$. However, the analysis as depicted in *Windeward Bound's* approved stability booklet is not

It is also worth noting that the wind heeling arm calculations in *Windeward Bound's* stability book are based on a defined set of 'working sails' and not on the vessel's full set of sails. Using the full sail area of 402 m² and the lever arm of 9.87 m, it is found that the wind force for down flooding is only 75 Pascals (21 knots), well below the limit of 115 Pascals.

After this incident Marine and Safety Tasmania (MAST) reviewed the stability information for *Windeward Bound*. The lightship displacement was found to have changed by more than 2 per cent since initial measurement and therefore the vessel was re-inclined. The vessel's Class 2B certificate was withdrawn pending results of the revised stability data.

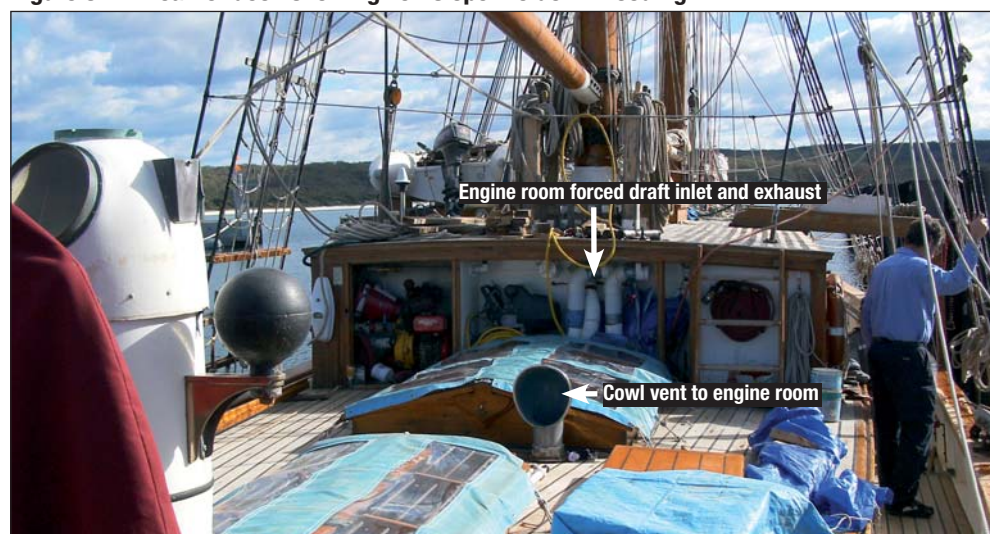
Figure 8: Weather deck showing vents open to down flooding

The engine room cowl ventilator should have been fitted with a closing device where it terminated, i.e. at deck level. A similar situation existed with the cowl ventilator forward for the crew accommodation.

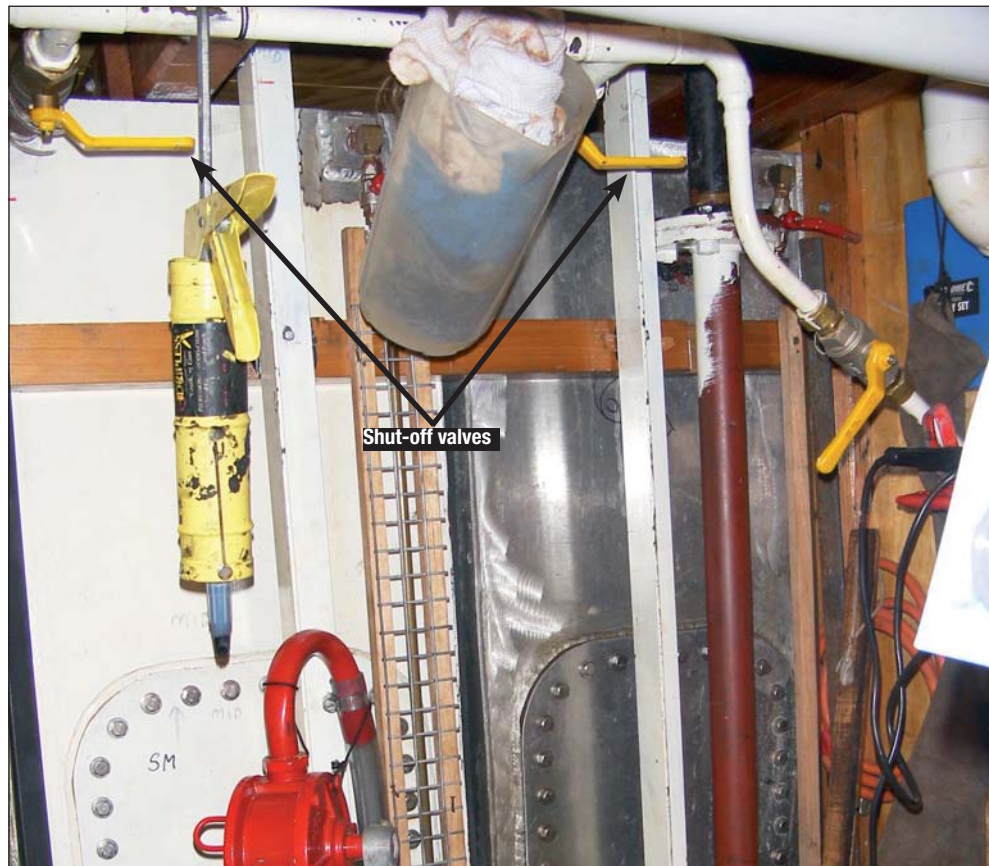
Figure 9: Shut off valves for air pipes

When *Windeward Bound* was knocked down, water entered the in-service fuel tank through the open air pipe. The water ingress into the fuel tank resulted in main engine and generator damage.

Windeward Bound's fuel tank air pipes were fitted with closing devices but, like the engine room cowl vent, they were ineffective because they were inside the accommodation spaces and were not easily operated by the crew (Figure 9). Furthermore, the arrangement was such that seawater could accumulate in the air pipe above the closed valve. Since there was no means of draining the air pipes into the bilge, the accumulated water would be dumped into the fuel tank when the valves were re-opened.

Windeward Bound's fuel tank air pipes were less than 30 mm in diameter and they terminated in a 'gooseneck' to inhibit sea water from entering the pipes. However, their location on the weather deck made them prone to total submersion. Therefore, it would have been appropriate for the air pipes to be fitted with automatic closing devices.

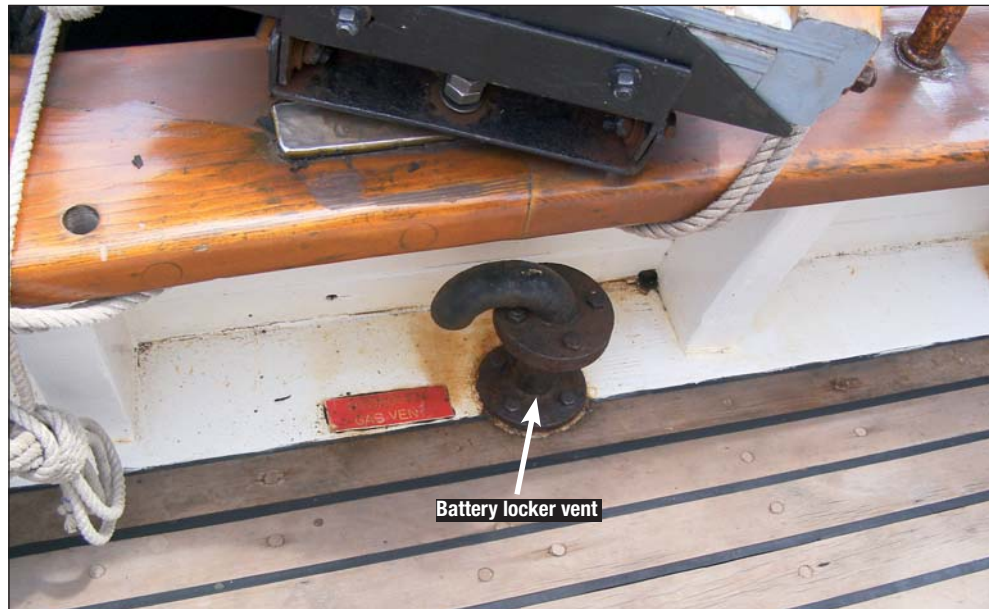
Figure 10: Battery locker vent

A similar situation existed with the battery locker ventilator (Figure 10). The pipe terminated in a gooseneck but it was located outboard on the weather deck and was thus prone to total submersion. Given the hazards associated with the possible generation of chlorine gas when lead-acid batteries are submerged in seawater, it would have been highly desirable to terminate the vent pipe with a closing device.
