MARINE SAFETY INVESTIGATION
No. 205

Independent investigation into the grounding
of the passenger vessel

True North

in the approach passage to
St. George Basin, Western Australia
7 August 2004

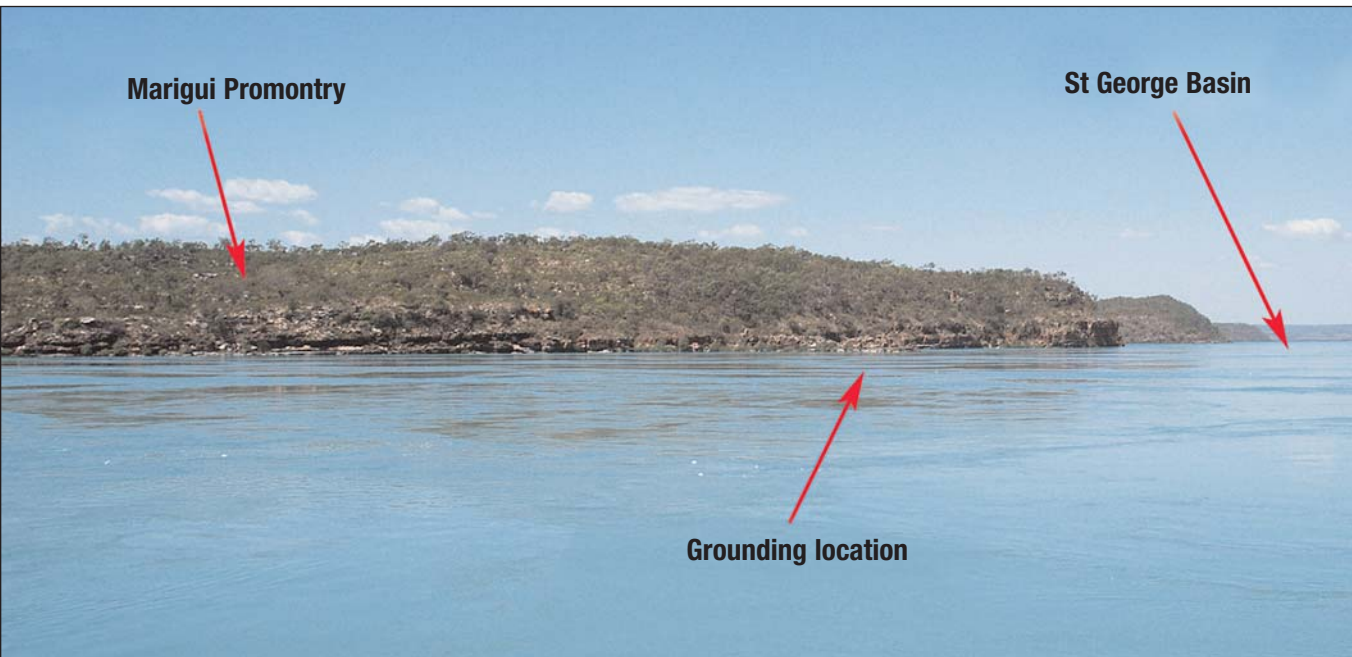
FIGURE 7: Strong Tide Point – location of grounding

There are no soundings in the area around Strong Tide Point, so very little is known of the underwater topography and contours. It is not known how close the vessel has to be to the point to run aground. Therefore, by maintaining a CMG of 121°(T), passing 0.7 cables off Strong Tide Point may have been close enough to cause the vessel to ground on an unknown underwater obstruction.

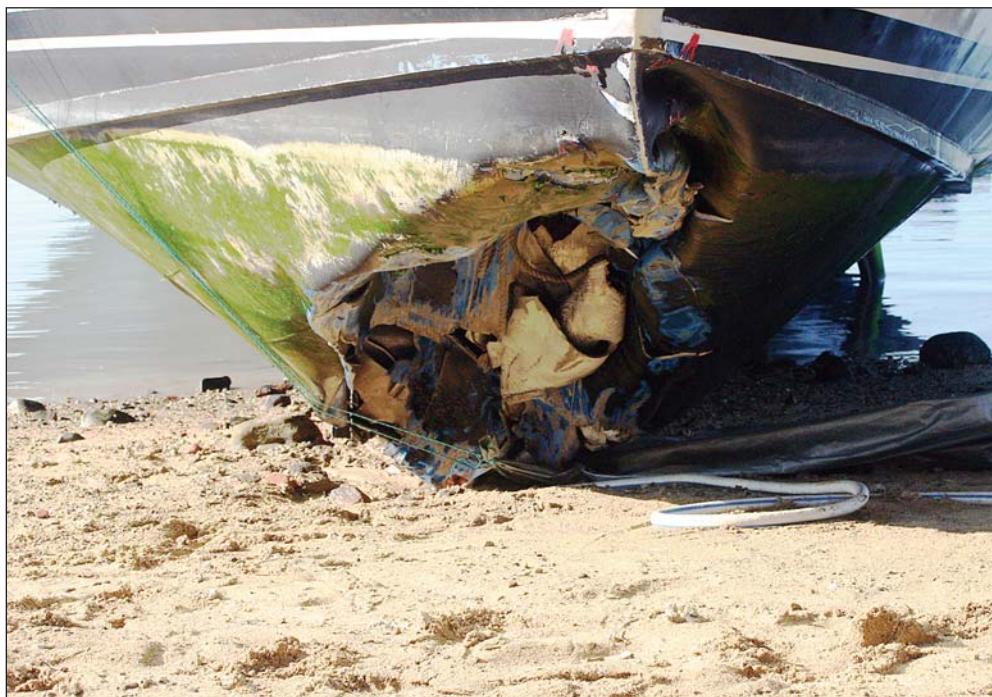
FIGURE 8: Grounding damage

On entering the water, with the aid of torchlight, the master could see that a large, sharp rock had penetrated the hull forward of the collision bulkhead. The impact had forced the forward part of the vessel's shell plating up and into the forward void space. The collision bulkhead was also damaged to the extent that water was entering the forward accommodation bilge space, just aft of the void space. He then returned to the vessel. While the master was in the water, the first mate had removed the access hatch in the lower deck, to assess the extent of damage to the collision bulkhead and forward accommodation bilge plating could be assessed. The bilge pumps were started.

At about 0700 on 8 August, the master beached *True North* on Saint Patrick Island. The extent of the damage was readily apparent and this was reported back to the owners and managers in Broome. With this knowledge, the decision was made to fly a repair team, equipment and materials to St George Basin and to fly the passengers and non-essential crew to Broome. The master advised AMSA of the incident on the morning of 8 August.

Between 9 and 11 August, aluminium plates were welded over the area of damage in the fore part of the vessel. This was done while the vessel was beached in between the periods of high water. Internal bracing was welded in place and cement was poured into the temporary structure to provide additional rigidity. The temporary repair work was completed by mid afternoon of 11 August. At 1510 that afternoon, the floatplane departed St. George Basin with the repair team and four non-essential crew members on board.

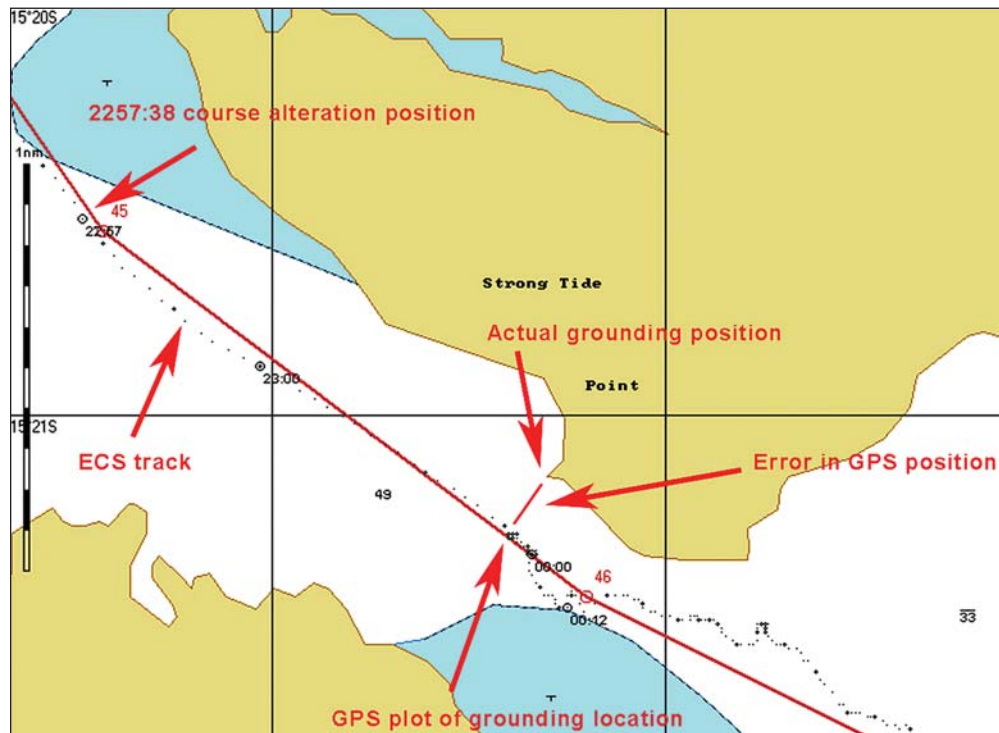
FIGURE 9: ECS plot of vessel track leading up to grounding

There is no evidence of a substantial course or heading alteration to port prior to the grounding.

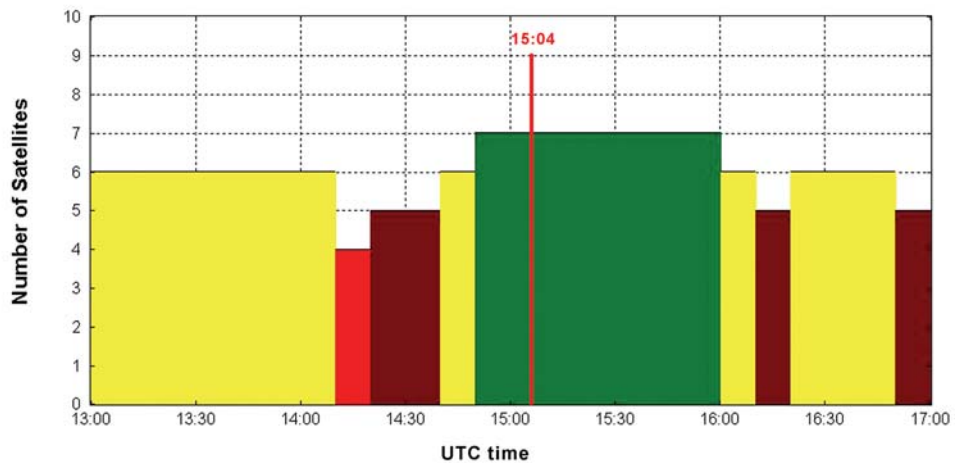
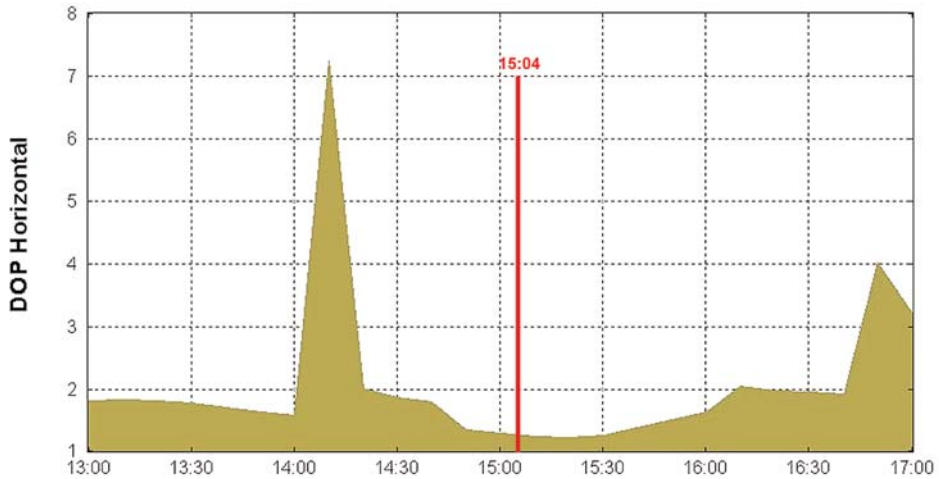
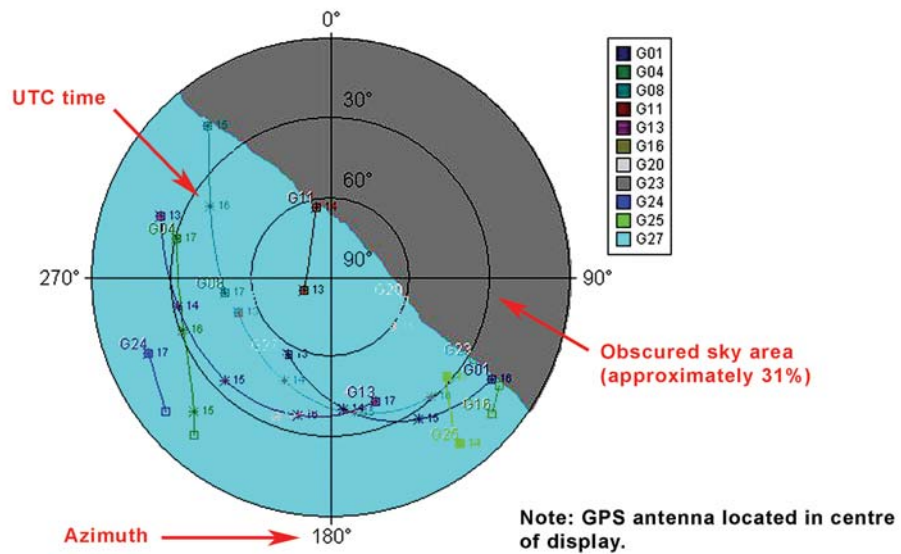
Expert advice requested by the ATSB on the integrity of the GPS system indicates that there were no satellite outages at the time of the grounding. The close proximity of the land, combined with the low elevation of *True North*’s GPS antenna, means that possibly 31% (worse case scenario) of the sky to the north east of the vessel was not visible to the GPS antenna (Fig. 10c). This is a large portion of sky and it contained a number of GPS satellites. However, there were still seven satellites, with a sufficient HDOP, visible to the GPS antenna in the remainder of the sky able to provide a reliable position fix (Fig. 10a) (Data sourced from Trimble Navigation, USA).

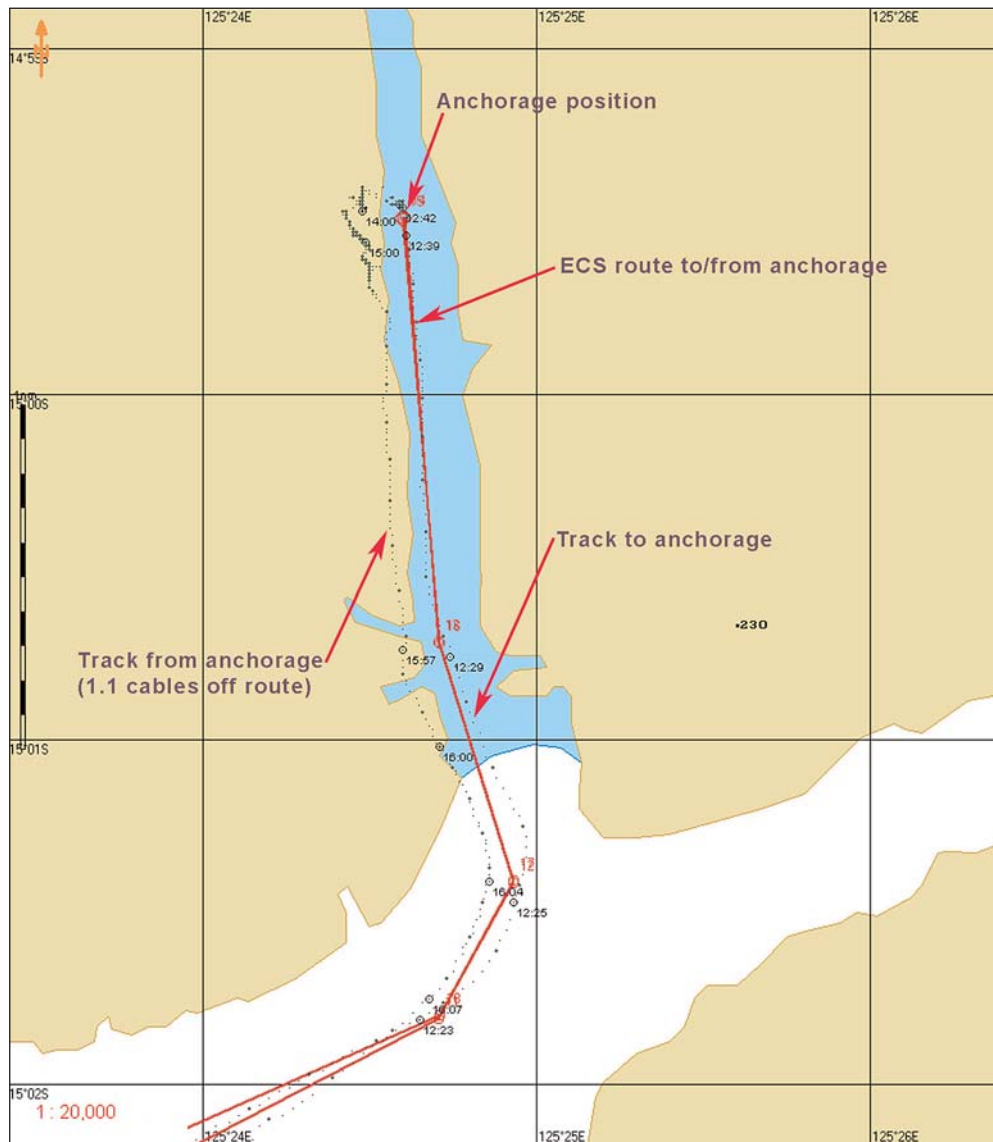
FIGURE 11: Plot of vessel's track into and out of Porosous Creek on 7 August

As the plotted positions in figure 11 show, the track up to the anchorage was in the creek, on the route programmed in the ECS. However the track from the anchorage to the river was displaced over the western bank, a distance of 1.1 cables (203 m) off the route to be followed.

The location of the grounding was the closest point that the vessel passed land on the passage from Porosous Creek to St. George Basin. If the position error apparent leaving Porosous Creek is applied to the approach to St. George Basin, then *True North* would have been 1.1 cables to the north of the pre-programmed track, which could explain the grounding.

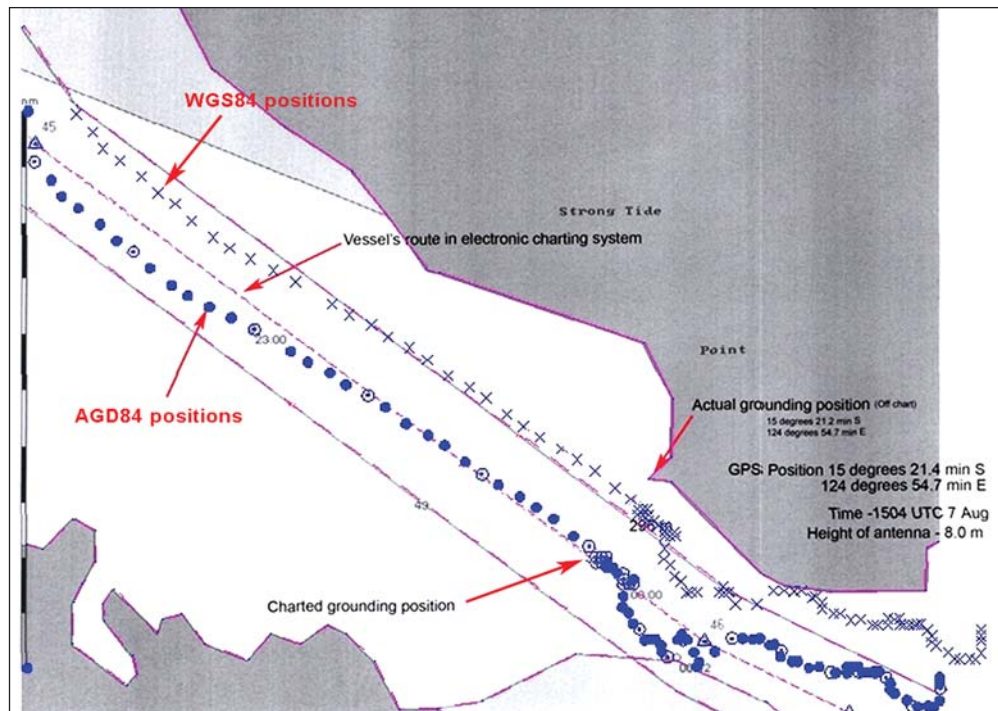
FIGURE 12: Comparison of datum position plots

To apply the theory that incorrect datum information was being used on board *True North*, its track information was provided to the School of Mathematical and Geospatial Sciences, RMIT University, Melbourne. The data was imported into a surveying software package (LISCAD) and then registered with the nautical mile scale bar, as seen below in figure 12.

The plot compares the ECS display using two datums, AGD84 and WGS84. The effect of this is that if *True North* was running its 'auto-nav' system on WGS84, with the GPS receiver inadvertently logging ADG84, the plotted position would have been in error by 1.1 cables (203 m) south of the true position relative to land. This happens to be the distance the track was displaced when *True North* departed its anchorage in Porosous Creek.

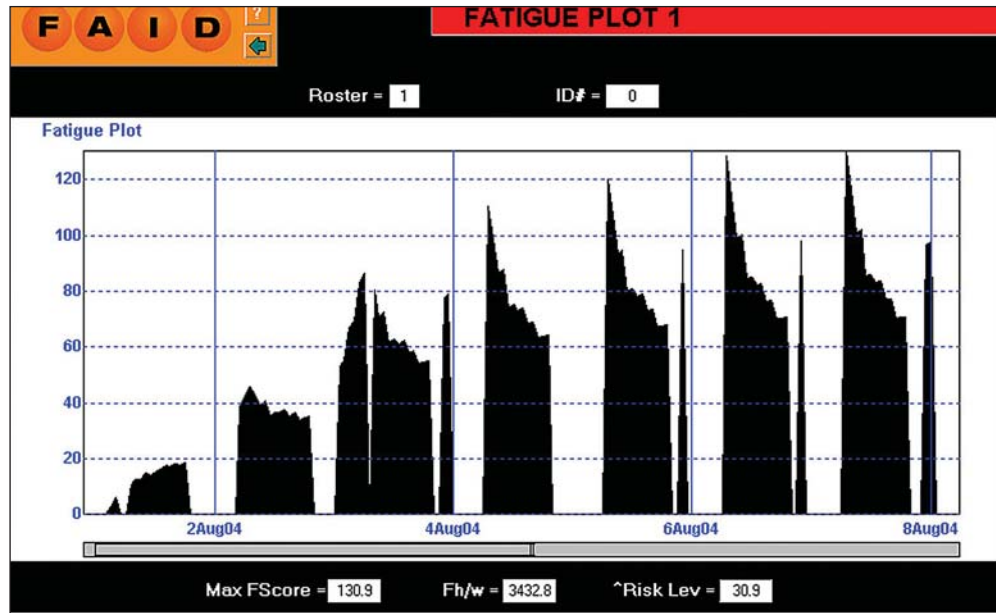
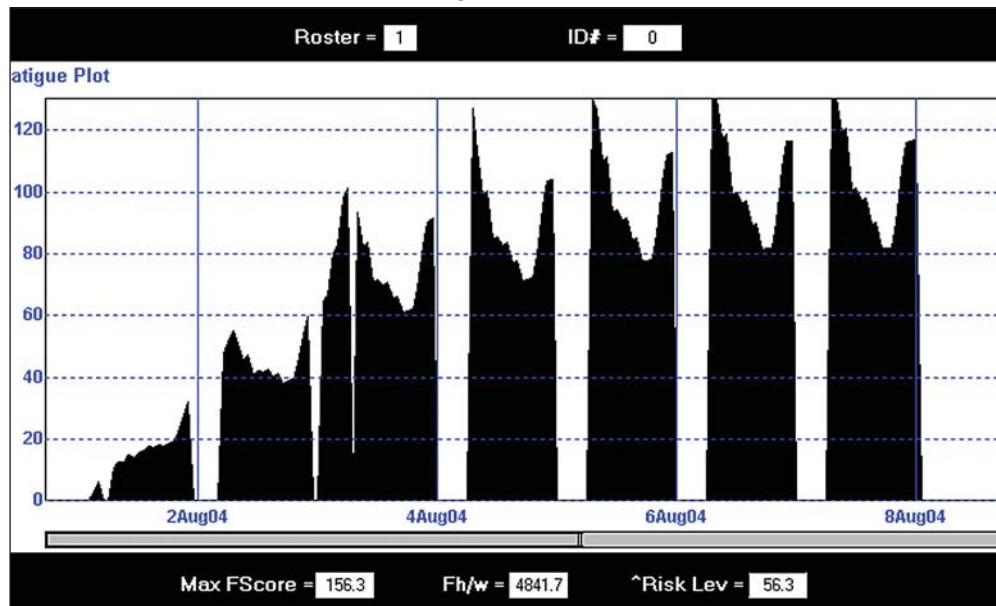
The first FAID scenario shows an index score of 97, immediately prior to the grounding. The second scenario score was 117. These fatigue scores are considered to be in the high to very high range.

Based on the master's working routine and his time awake, it is reasonable to conclude that the master was, to some degree, affected by fatigue. As such, it is likely that he was operating below a level of awareness necessary to properly carry out his duties as a sole watchkeeper in charge of the vessel.
