ATSB TRANSPORT SAFETY INVESTIGATION REPORT
Marine Occurrence Investigation No. 209
Final

Independent investigation into the man overboard fatality
and subsequent lifeboat accident on board the
French registered Antarctic support vessel

L'Astrolabe

27 January 2005

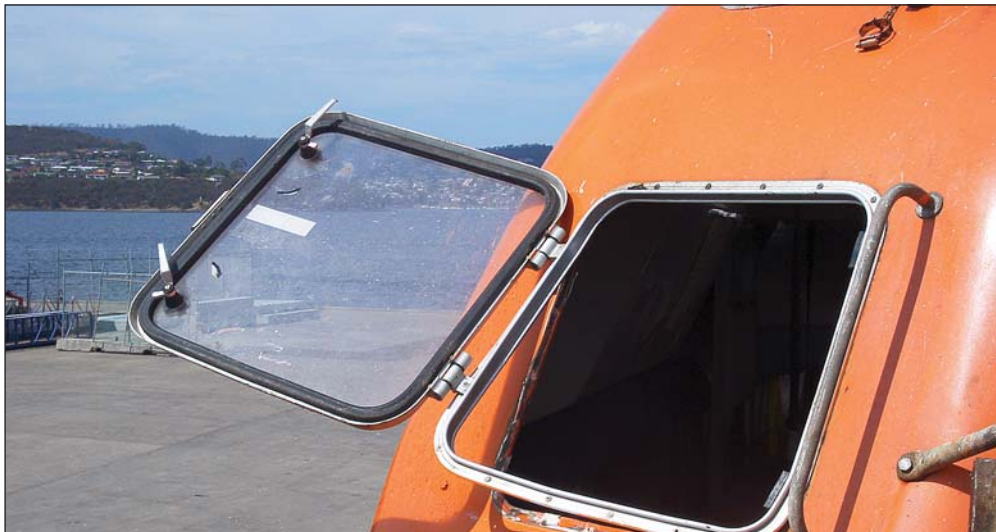
Figure 5: Port lifeboat's rear hatch damage

During the recovery operation, the lifeboat suffered a significant amount of damage from both the swinging fall blocks and from contact with the hull of the ship.

This damage included cracks in the lifeboat hull, the forward and after access hatches were partially pulled from the canopy, and the forward handhold adjacent to the access hatch was totally ripped from the canopy (Figures 5–9).

The damage was repaired in Hobart and *L'Astrolabe* was cleared to continue its operations by its Classification Society and the Australian Maritime Safety Authority (AMSA).

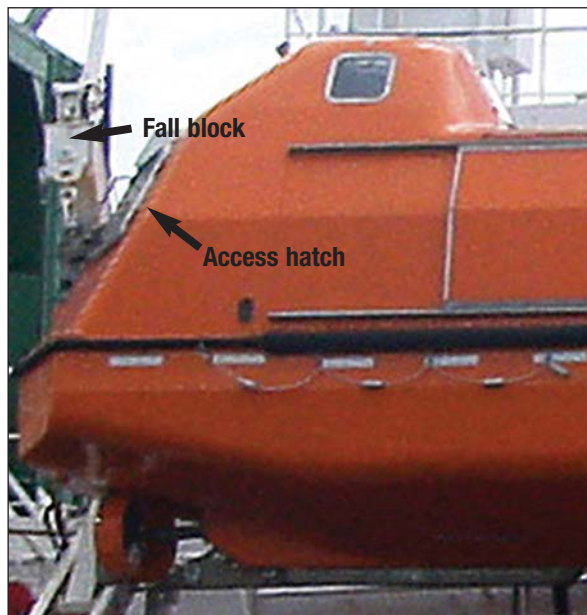
Figure 10: Starboard lifeboat's after access hatch

The after access hatch on *L'Astrolabe*'s lifeboats is located on the outboard side of the boat's canopy and not on the centreline. This location made the task of connecting the suspension ring on the fall blocks to the lifeboat's hook assembly extremely difficult. The crew member was required to position himself in the hatch then lean out (exposing his head and upper body to the dangers of the swinging fall block), while endeavouring to take hold of the swinging fall block or suspension ring and then manoeuvre it into position on the hook.

The off centre location of the hatch meant that he not only had to concentrate on keeping his hands, and head, clear of the swinging fall block, but also on maintaining his balance while leaning out through the hatch.

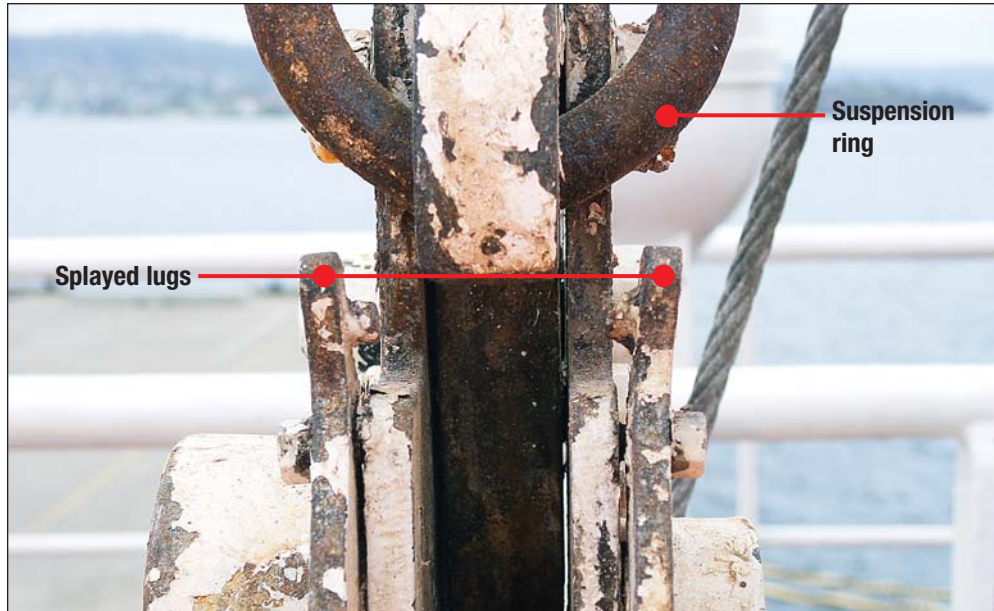
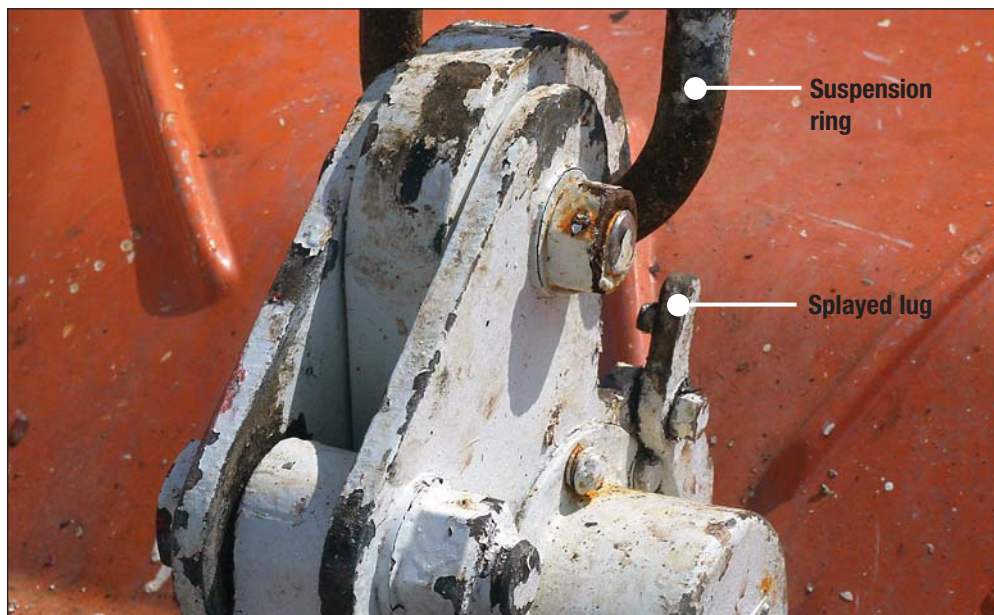
Figures 11: Port lifeboat's forward lifting assembly

Inspection of the port lifeboat's forward hook arrangement (Figures 11 and 12) revealed damage to the latch mechanism. It was not possible to tell whether the damage occurred during the incident on 27 January, or before that date.

The damage consisted of a splaying of the lugs, which had allowed the suspension ring to readily detach from the lifeboat's forward hook during the incident. It is probable that this damage added to the difficulty experienced during the recovery operation, prior to the painters being lowered to the lifeboat.

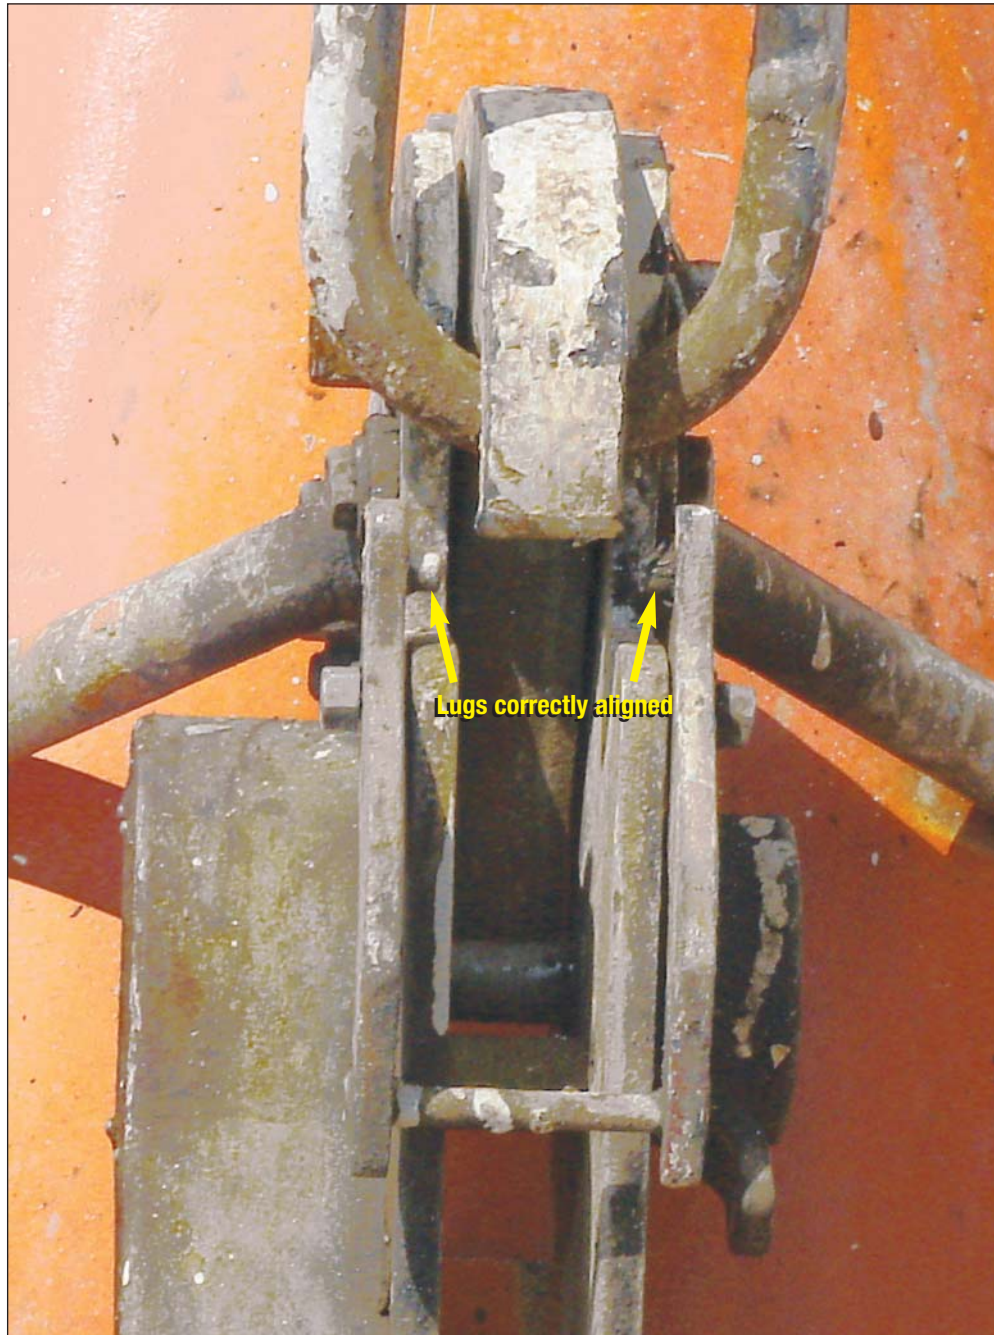
Figures 13: Port lifeboat's after lifting assembly

The aft latch mechanism was not damaged in this way (Figure 13).

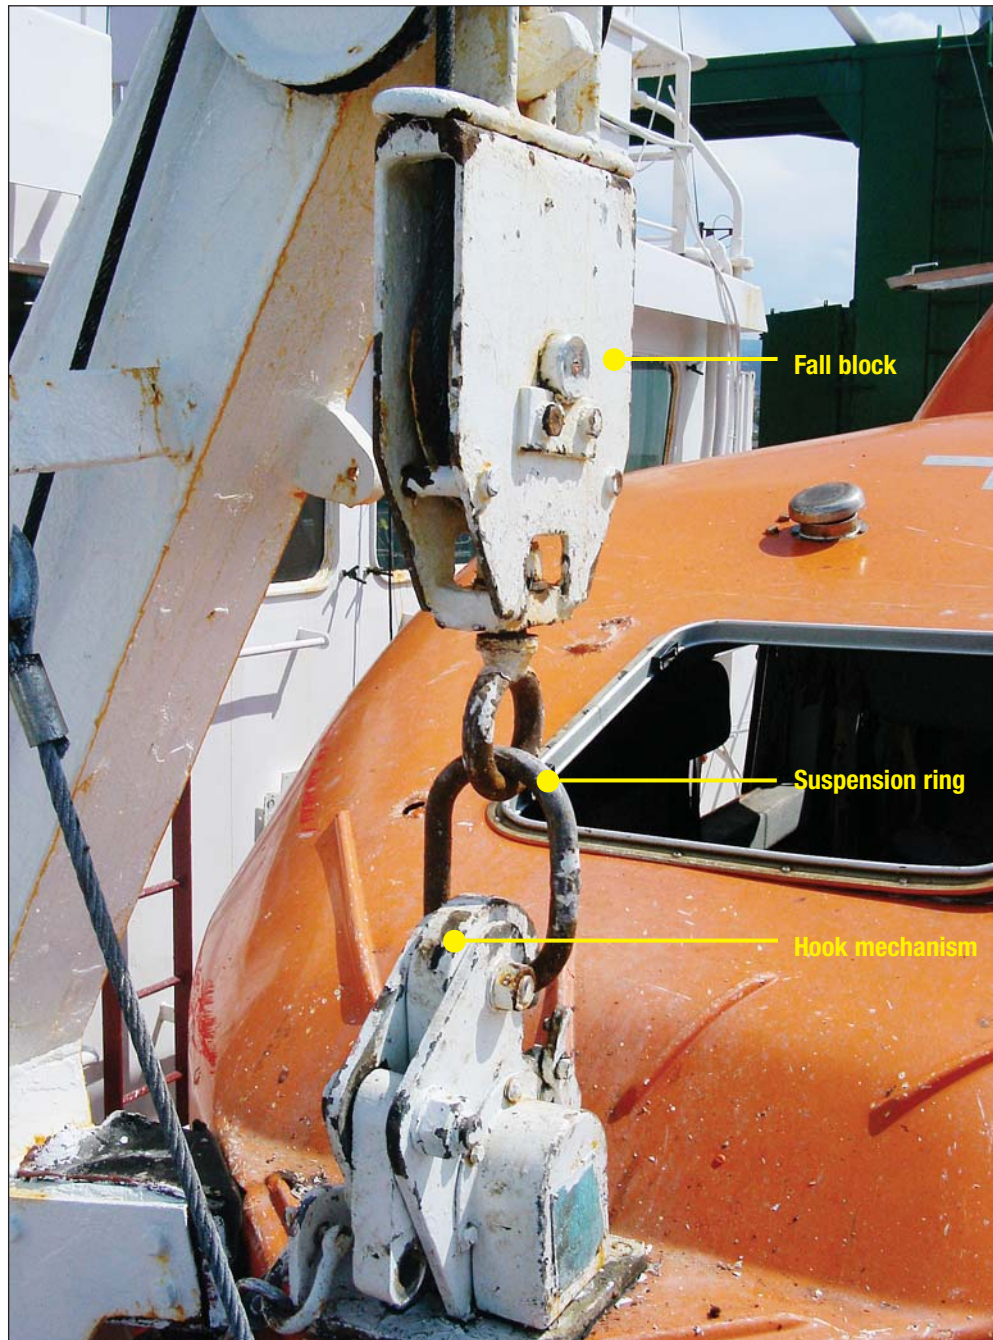
Figure 14: Port lifeboat's forward lifting assembly

The fall blocks and suspension rings on *L'Astrolabe's* lifeboats (Figure 14) did not have 'hand holds' attached to them. 'Hand holds' would have enabled the crew members to easily grasp the fall block or suspension ring without placing their hands in direct contact with the blocks or rings.

The lack of 'hand holds' increased the likelihood that the crew of the lifeboat would have had to place their hands between the blocks/rings and the lifeboat or its fittings in order to connect the suspension ring to the lifeboat hook.

- Owners, operators and masters of vessels fitted with totally enclosed lifeboats should consider replacing suspension rings attached to the lifeboats' fall blocks with suitably designed rings with 'hand holds' attached.
