ATSB TRANSPORT SAFETY INVESTIGATION REPORT  
Marine Occurrence Investigation No. 210  
Final

Independent investigation into the  
collision between the Indian registered bulk carrier

**Goa**  
and the Australian sailing vessel  
**Marie Chocolat**

off the port of Newcastle, NSW  
19 February 2005

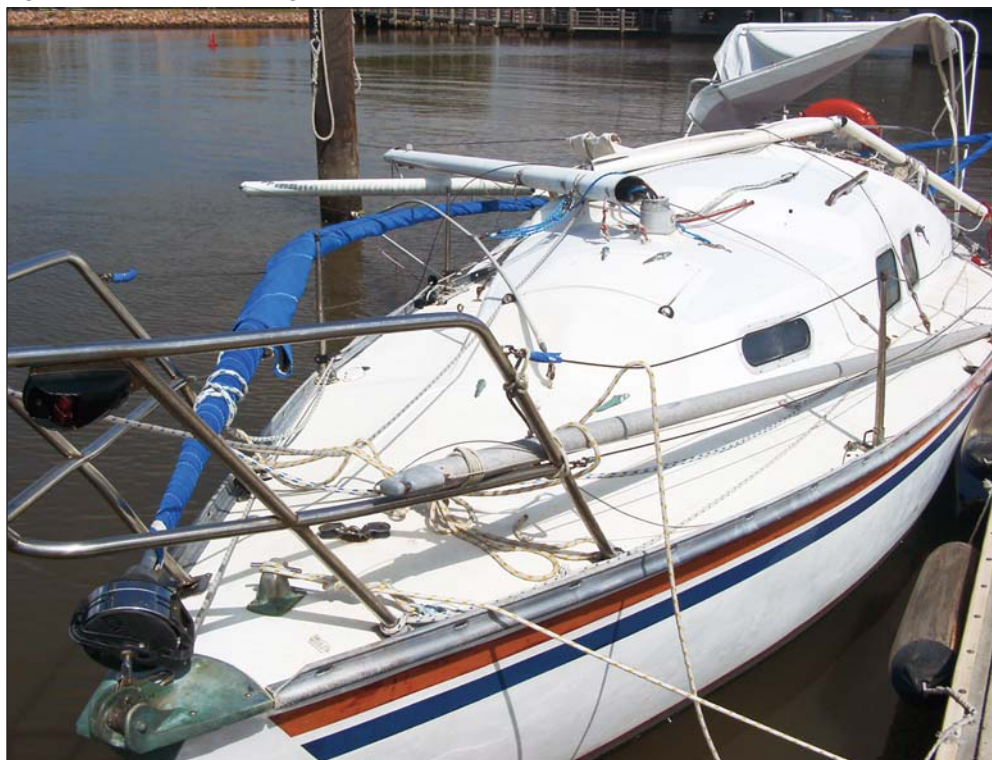
**Figure 2: *Marie Chocolat* alongside Newcastle Water Police wharf**

*Marie Chocolat* sustained damage to its hull, mast, rigging and deck in the collision. The yacht's skipper initiated a distress call using an EPIRB<sup>1</sup> and a mobile (cellular) telephone. He then took the yacht to Newcastle under power for assessment and possible repair. *Goa* sustained only slight scratching to the paintwork on the ship's side and continued to its designated anchorage. *Goa* confirmed the location and time of the collision some three quarters of an hour after the event when queried by the local harbour authorities.

The crew felt the collision occur as the ship struck *Marie Chocolat's* port side, at about midships. The ship's side also struck the end of the mainsail boom as the yacht scraped along the hull and this caused the mast to buckle and break. The skipper could see a light coming from the ship and thought it was a torch used by someone on deck near the forward end of the ship. He felt that the boat had been struck by the forward end of the ship. The skipper and the deckhand were unable to do anything but watch as the ship passed.

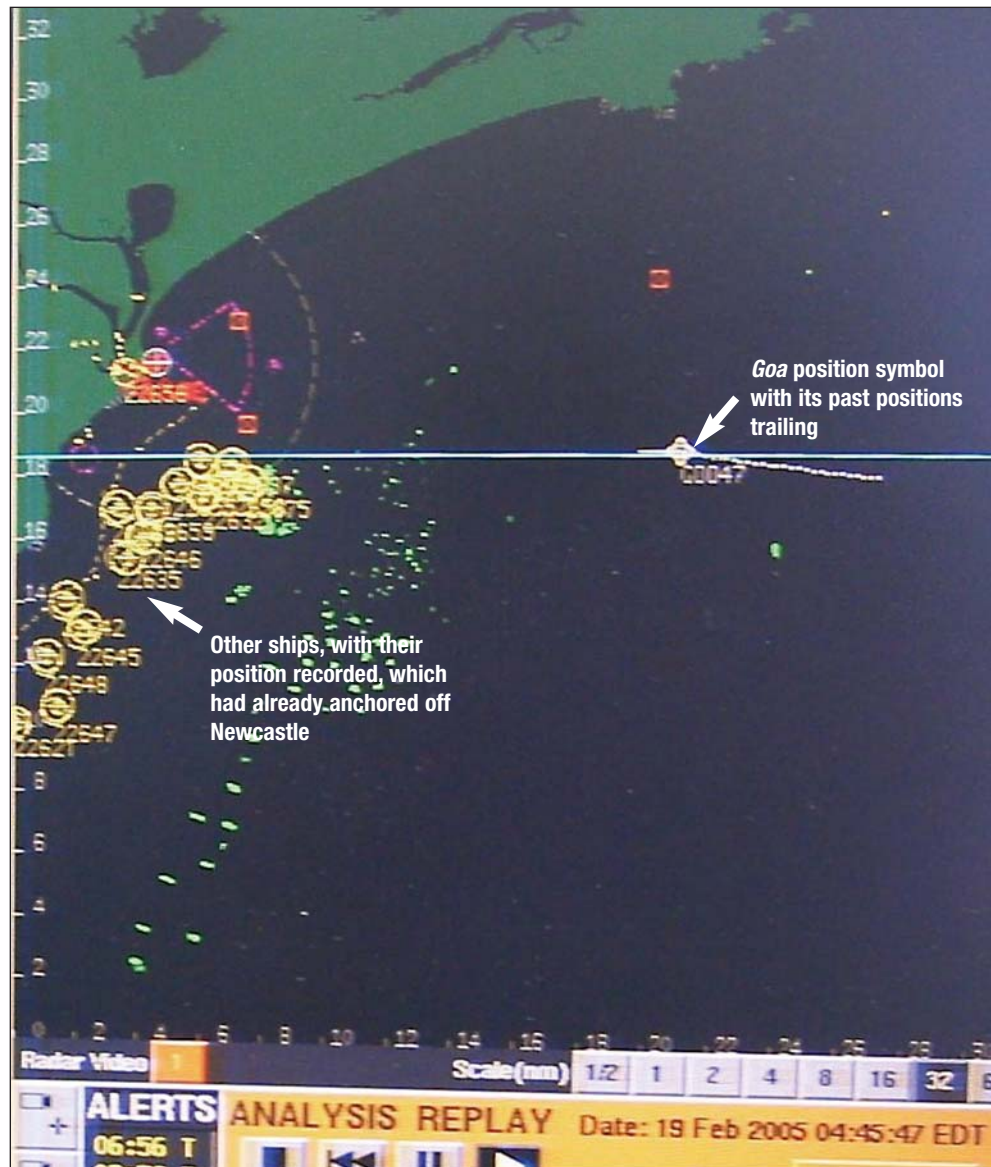
Figure 3: A still photograph of the Vessel Traffic System 'replay' display for the time of the collision

Note: Only the ship is displayed; the yacht is not detected.

It was noted that the approach of *Goa* toward Newcastle was clearly tracked, and *Marie Chocolat* was not detected, by the Newcastle VTS radar system at the time of the collision.

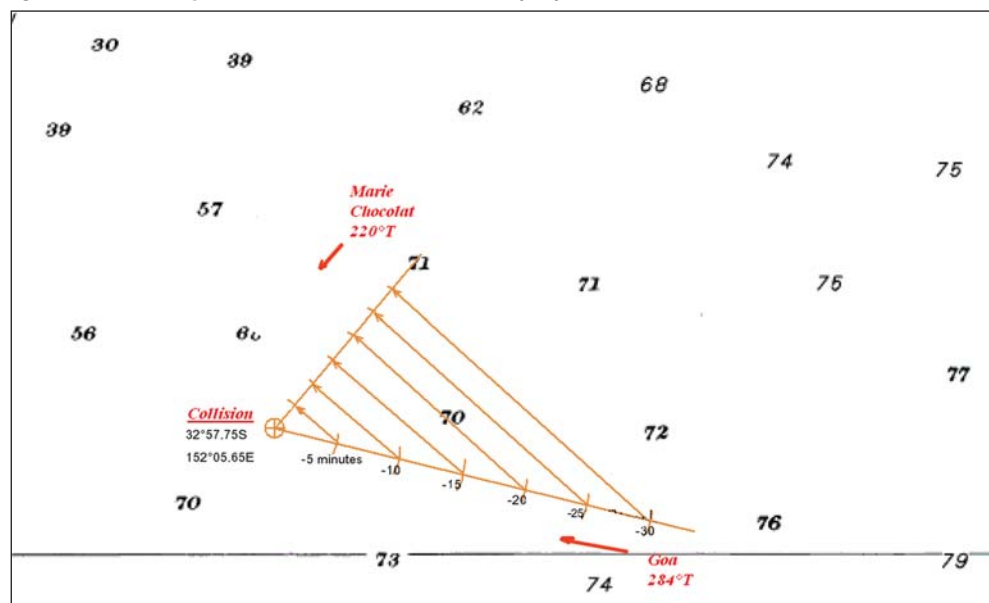
**Figure 6: Relative positions from 30 minutes before (-30) until the time of the collision**

The yawing of *Marie Chocolat*, with the waves on the starboard quarter, may have introduced some uncertainty to a visual observer about whether the situation was a crossing one or an overtaking situation as the sidelight or sternlight alternately became visible.

In the half hour or so from 0400 reconstructed in Figure 6, neither the crew on *Goa* nor the crew on *Marie Chocolat* effectively identified the other vessel. The second mate on *Goa* had not detected *Marie Chocolat* and the skipper of the yacht had made the incorrect assumption based on scanty information, that *Goa* was overtaking him. Due to the inadequate lookouts being kept on both vessels, there was no full appraisal or assessment of the risk of collision as required under Rule 7 of the COLREGS.

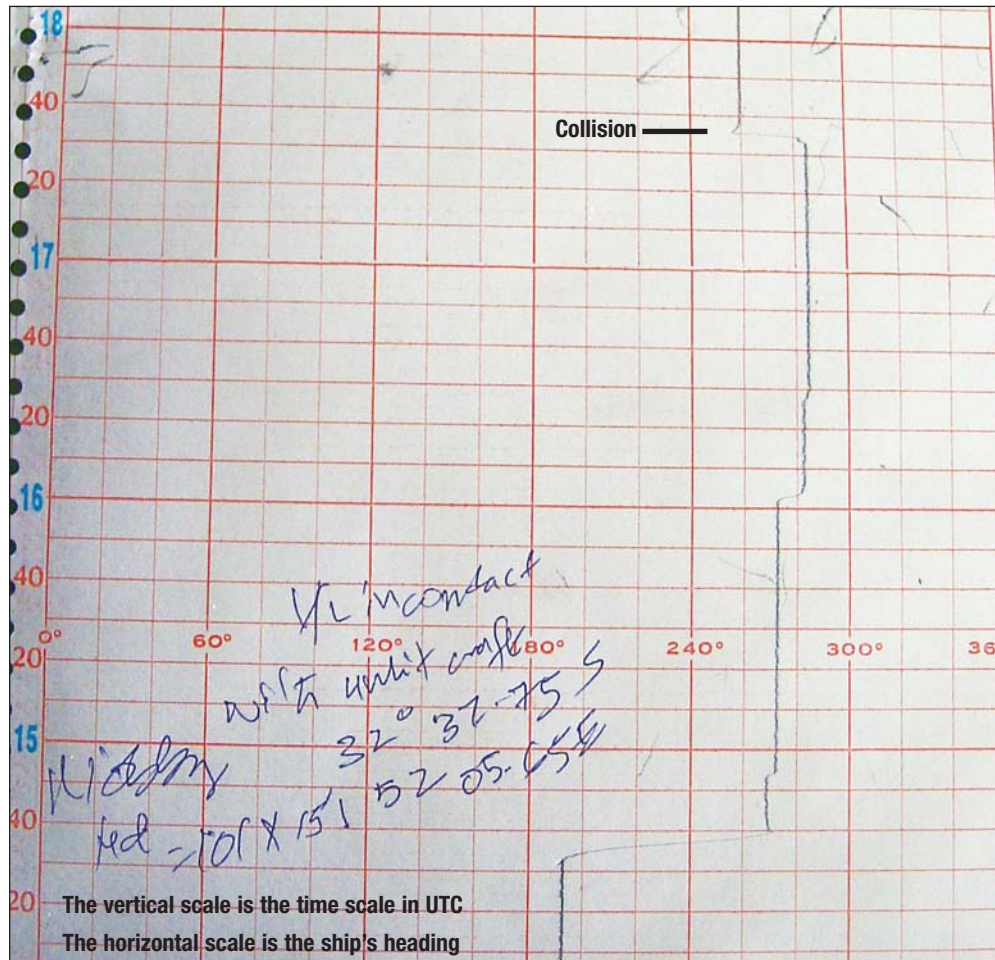
Figure 7: Goa course recorder trace

The actions of the second mate in turning to port initially and then turning to starboard as the yacht ran along the ship's side approaching the stern (propeller) seem reasonable in light of the short time and small distances involved in these last manoeuvres. The reported manoeuvres are supported by the ship's course recorder trace.

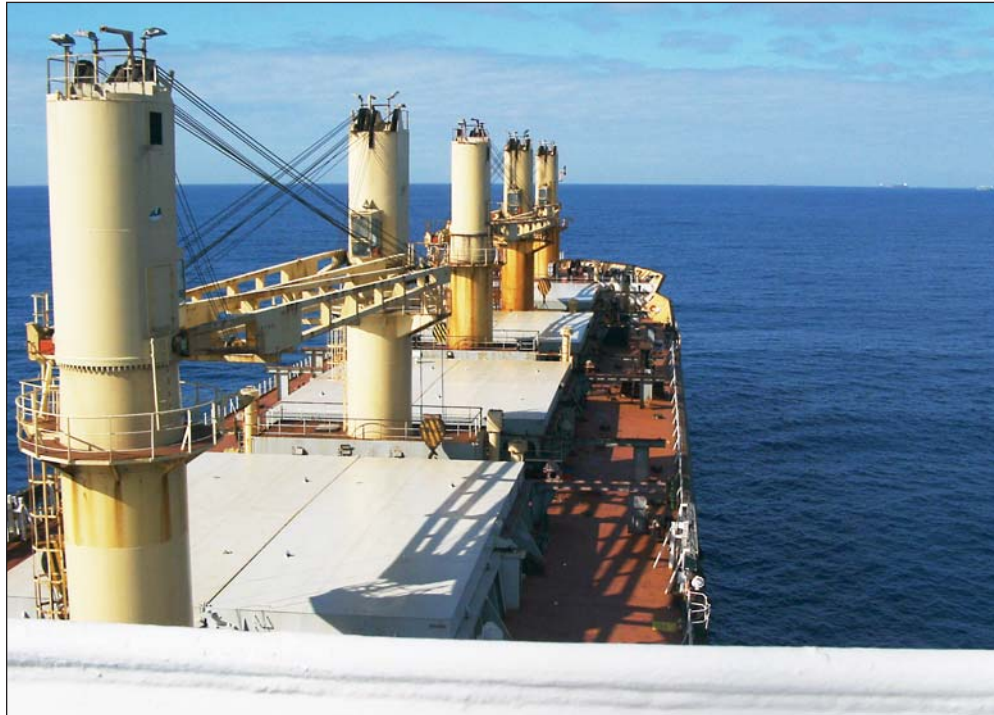
**Figure 5: The view from the starboard bridgewing of *Goa* (taken at Newcastle anchorage)**

*Goa* has a number of deck cranes mounted on the centreline forward of the navigating bridge. These restrict visibility forward to some degree especially in the first few points from ahead to each side of the bow (see Figure 5). Even though the seaman on lookout duties was experienced, the second mate did not direct him in his duties or brief him about the ship's current position and situation.

The second mate had a number of distractions during this watch which reduced his capacity to keep a good visual lookout himself. The master coming to the bridge, the preparations for arriving at the anchorage including the advice at recurring intervals to the engineers so that they could prepare the engine for manoeuvring and the navigational position fixing requirement had all distracted the second mate from his visual lookout.

The lookout being kept by *Goa*'s bridge team was deficient. Had a better lookout been kept, the likelihood of the collision would have been significantly reduced.

Masters and skippers need to be aware of the difficulty of detecting small craft especially as the weather deteriorates. A full briefing and instruction to any lookout, especially the inexperienced, should be given to use them to maximum advantage to ensure that an effective lookout is kept at all times.

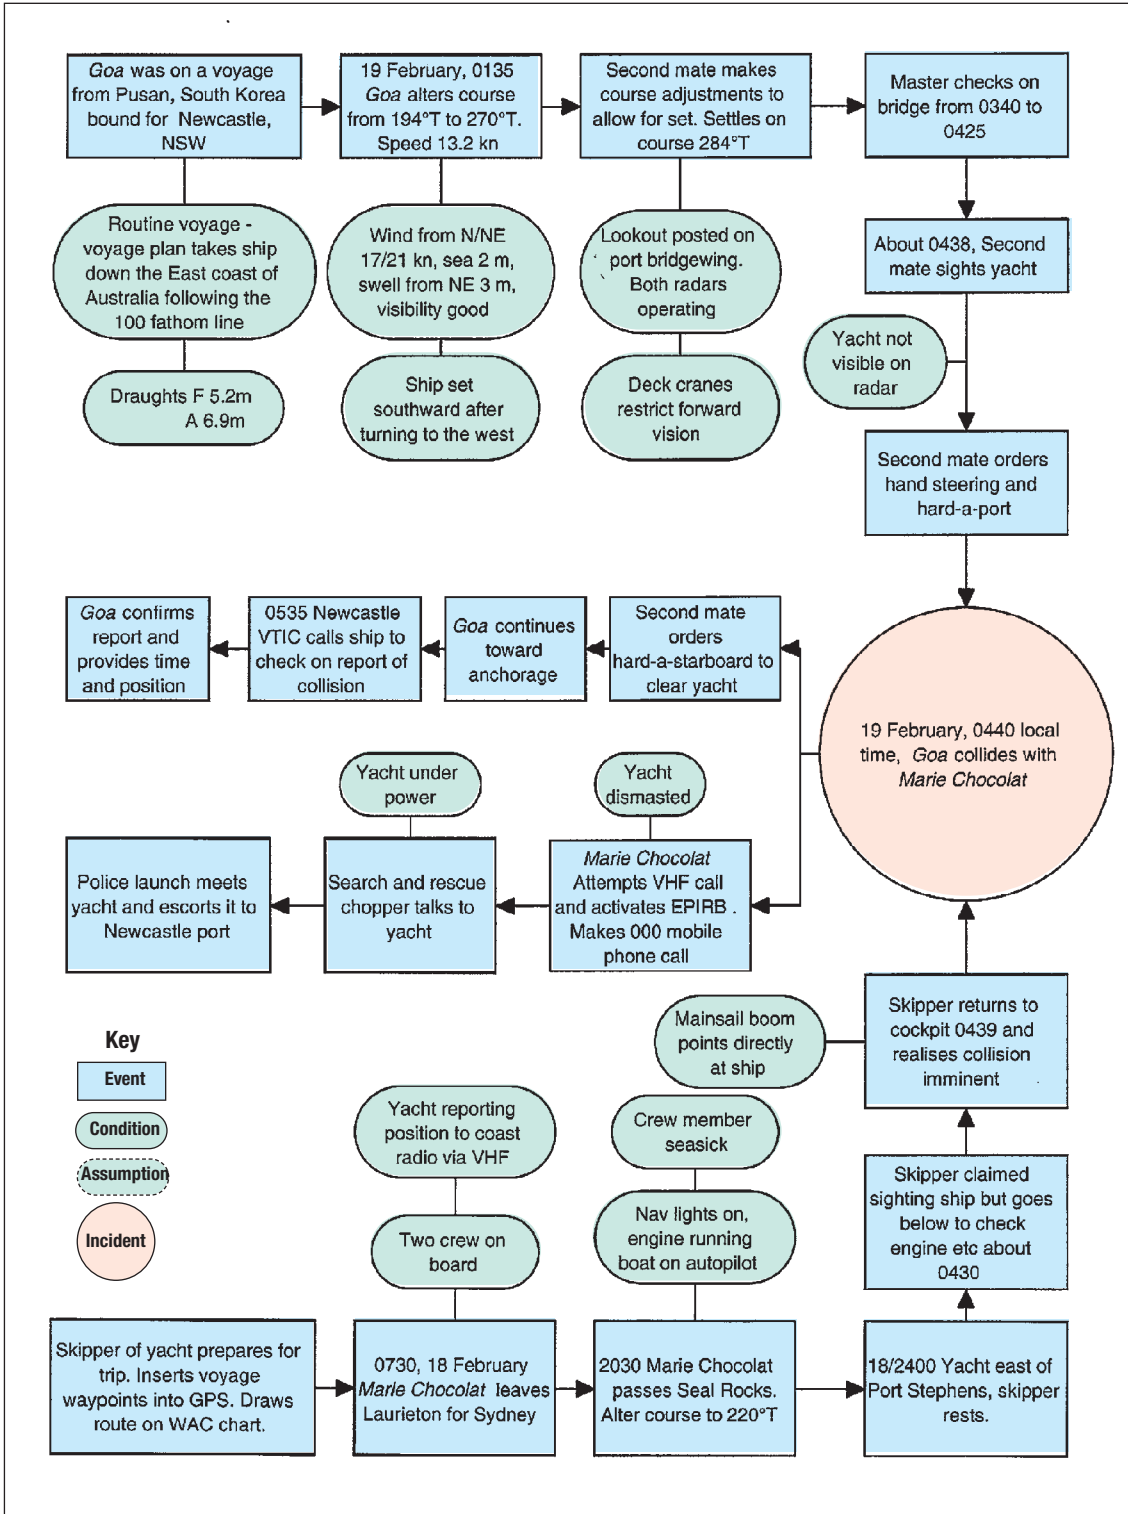
Figure 6: Events and causal factors chart

1. There was an inadequate lookout being kept aboard *Goa*.
2. There was a lack of effective lookout aboard *Marie Chocolat*.
3. The material from which *Marie Chocolat* was constructed and the angle of its mainsail significantly reduced the likelihood of its detection by the ship either visually or by radar.
4. *Marie Chocolat* presented a poor radar and visual target in the prevailing weather conditions and was not detected with sufficient time for the Officer on Watch of *Goa* to prevent the collision.
5. There was an inadequate handover or briefing of the deckhand on *Marie Chocolat* before the skipper left him on watch.
6. The skipper of *Marie Chocolat* had an inadequate knowledge of the COLREGS.

1. *Goa's* master did not comply with his international obligation to render assistance after the collision by stopping or returning to the accident location or contacting the other vessel.
2. The skipper of *Marie Chocolat* was not fully conversant with the navigational equipment that he was using.
3. The absence of VHF recordings at Newcastle VTIC indicate that it is probable that the bridge team on *Goa* did not attempt to contact *Marie Chocolat* after the collision.
