ATSB TRANSPORT SAFETY INVESTIGATION REPORT

Marine Occurrence Investigation No. 221

Independent investigation into the serious injury of a
crew member onboard the Australian flag bulk carrier

River Embley

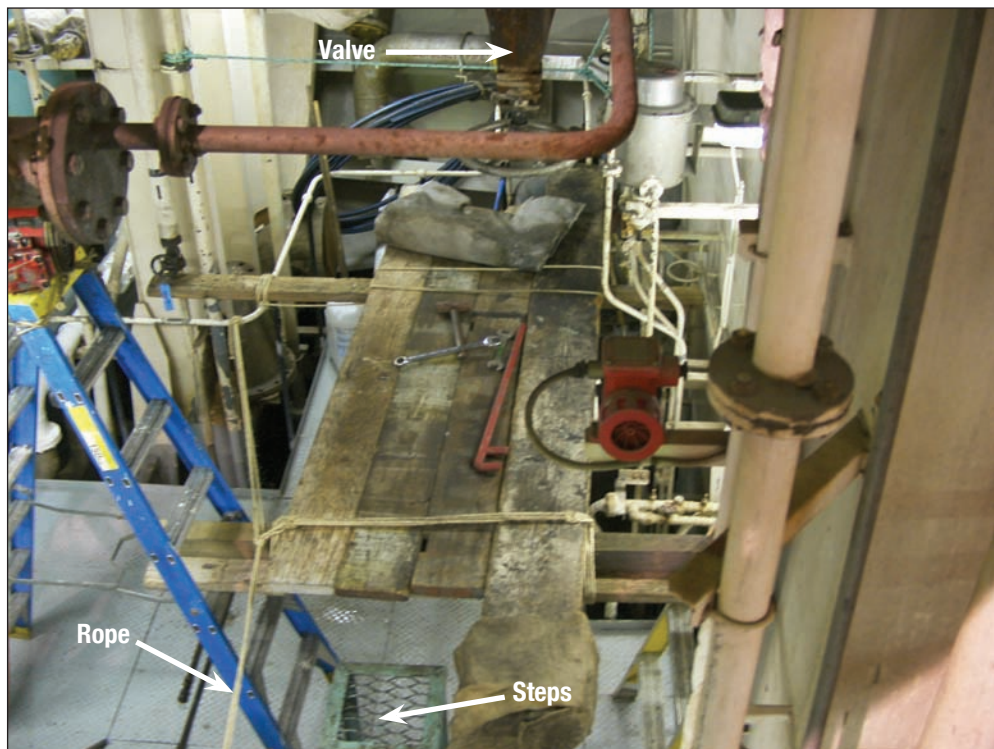
Figure 2: The No. 2 turbo alternator exhaust steam valve and staging

Prior to arriving off Gladstone, the engine room staff prepared for the replacement of the bonnet joint on the number two turbo alternator exhaust steam isolating gate valve (TAV2). Staging was set up beneath the TAV2, and mounted between a pair of ladders and the hand railings; it was also tied off to stop it from moving (Figure 2). Two bonnet retaining bolts were removed from the valve, and replaced with lengths of threaded bar and nuts. The threaded bar and retaining nuts would be used to control the lowering of the valve bonnet, as the valve was heavy and overhead (Figure 3).

The valve first started leaking after the steam plant was flashed up prior to the ship's departure from Sydney. The leak was from the gasket between the valve's bonnet and body. It was not unusual on board *River Embley* for exhaust steam joints to blow out during the flash-up process. This is primarily due to the age of the plant and the water hammer in this area of the system during the warm through process.

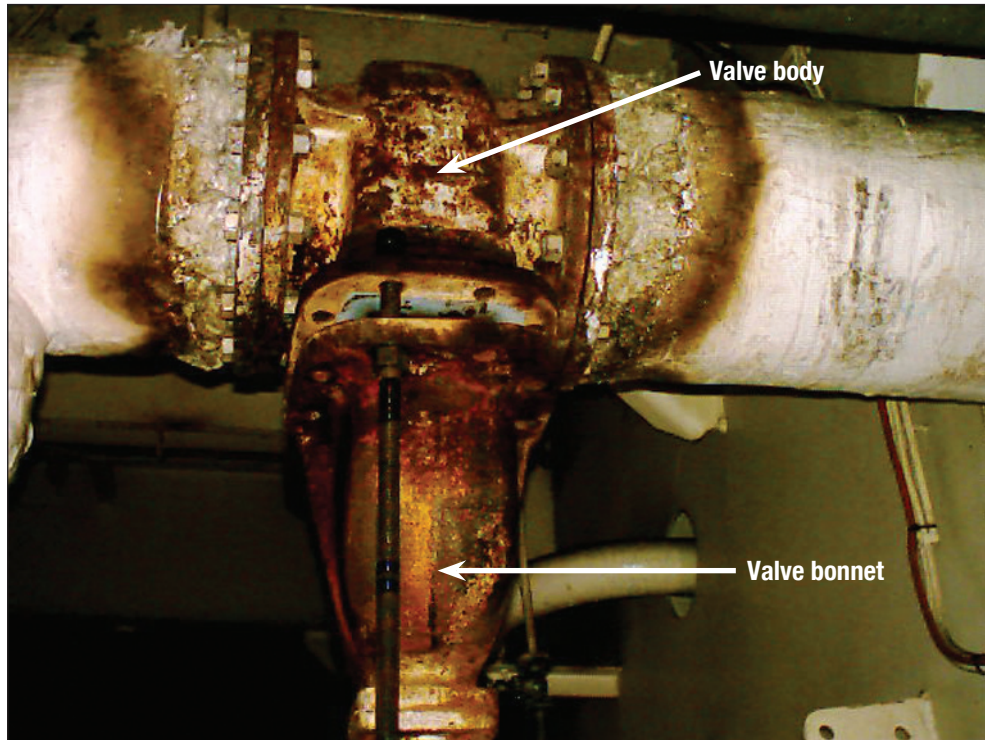
Figure 4: TAV2 showing the bonnet three centimetres clear of the valve body

When the valve was cracked open the bonnet suddenly dropped about two centimetres. The valve bonnet was now three centimetres clear of the valve body (Figure 4). Hot condensate unexpectedly started spraying out from the gap between the valve's bonnet and body. The condensate sprayed out horizontally in all directions and as far as two metres from the valve.

The initial five to ten litres of condensate that drained from the valve was probably from the valve bonnet space. It was not until the valve gate was cracked open and clear of its sealing faces that the condensate in the pipe after the valve started to spray from the three centimetre gap between the valve's bonnet and body (Figure 4). It was this subsequent spray of about 1000 litres³ of condensate that caught the men by surprise.

1. When the TAV2 was cracked open, the condensate trapped in the pipe lines between the TAV2 and the exhaust steam range sprayed from the partially dismantled valve.

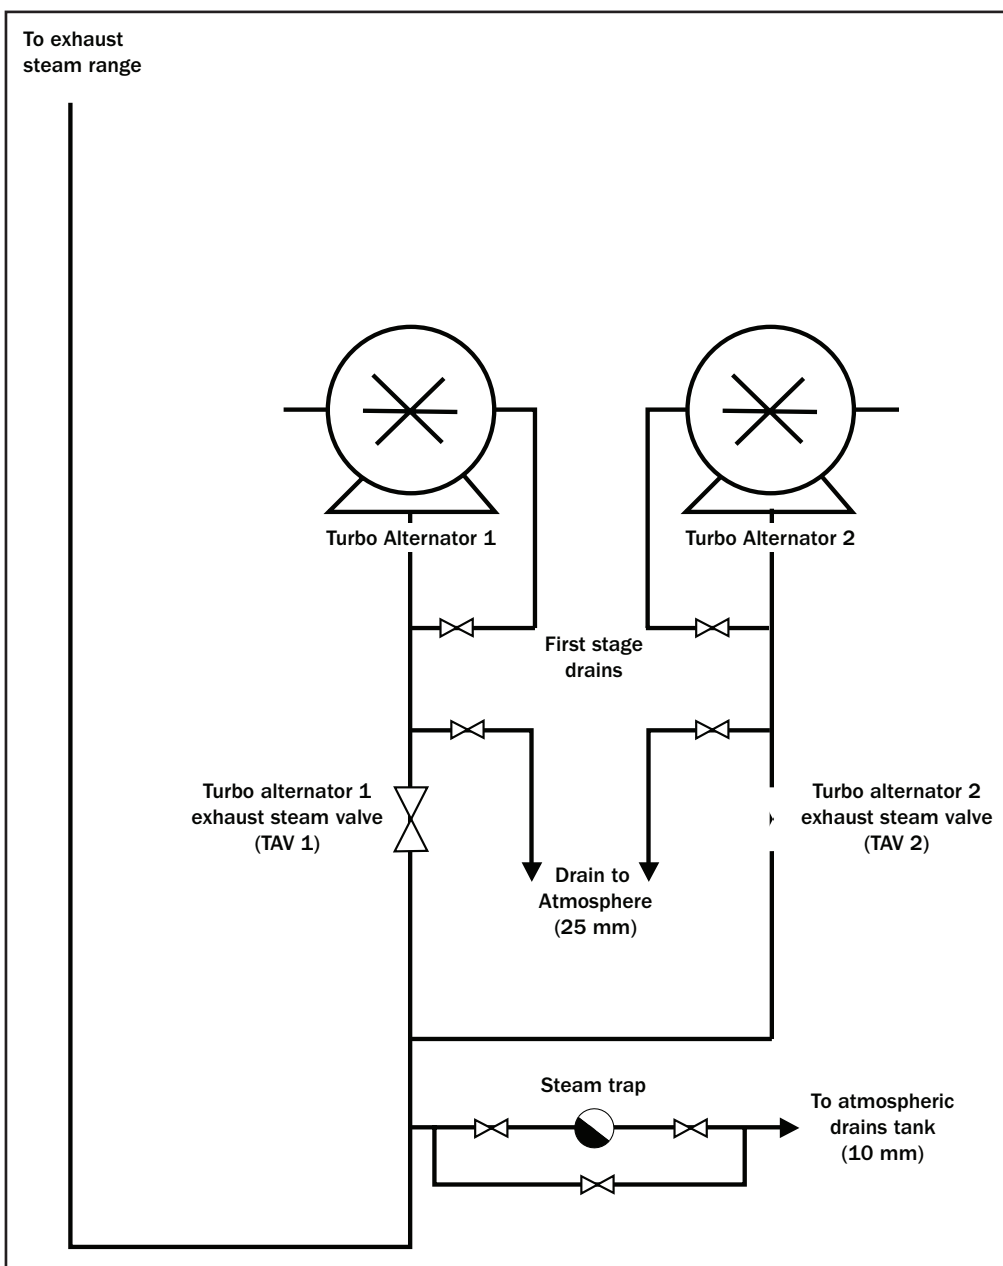
Figure 5: Schematic diagram of part of the steam system

The location of the TAV2 in the system meant that it was usual for some condensate to drain to its location when the steam plant is shut down. Consequently the sections of pipe work on either side of the valve are fitted with drain lines (Figure 5).
