**ATSB TRANSPORT SAFETY INVESTIGATION REPORT**  
Marine Occurrence Investigation No.222  
Final

# **Malu Sara**

in Torres Strait, Queensland, Australia  
15 October 2005

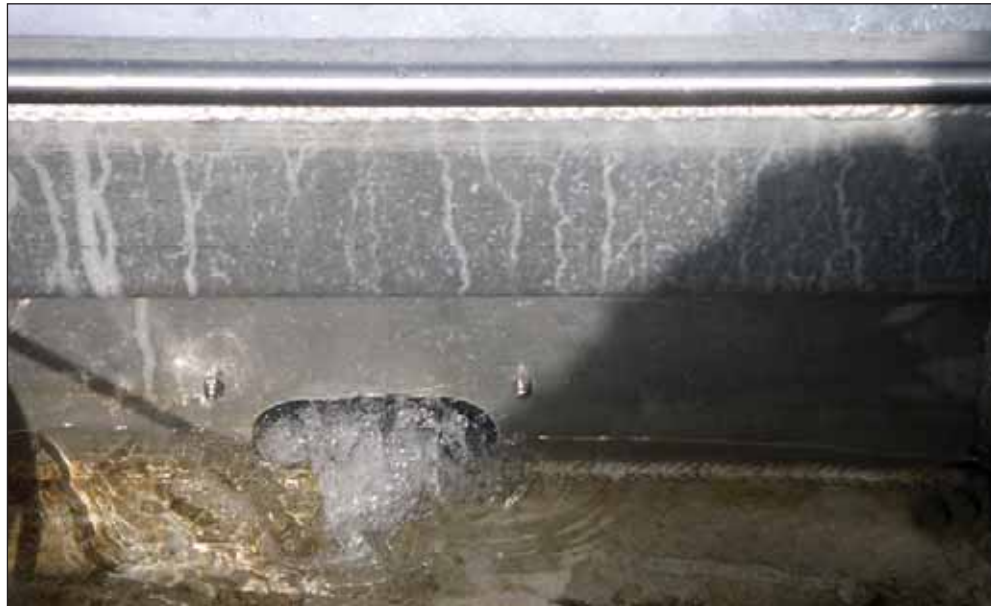
**Figure 10: Water flooding the motor-well at slow speed**

The USL Code and the Australian Standard 1799 contain design and testing requirements for vessel buoyancy and stability to ensure that in the event that a vessel becomes swamped it will remain afloat in an upright attitude. The intention is to safeguard the vessel's occupants by ensuring that as a last resort the vessel will act as a 'lifeboat'. For *Malu Sara's* occupants the evident failure of the vessel's design to meet these basic seaworthiness requirements meant that they effectively did not have this 'last line of defence' in the events which unfolded in the early hours of 15 October 2005.

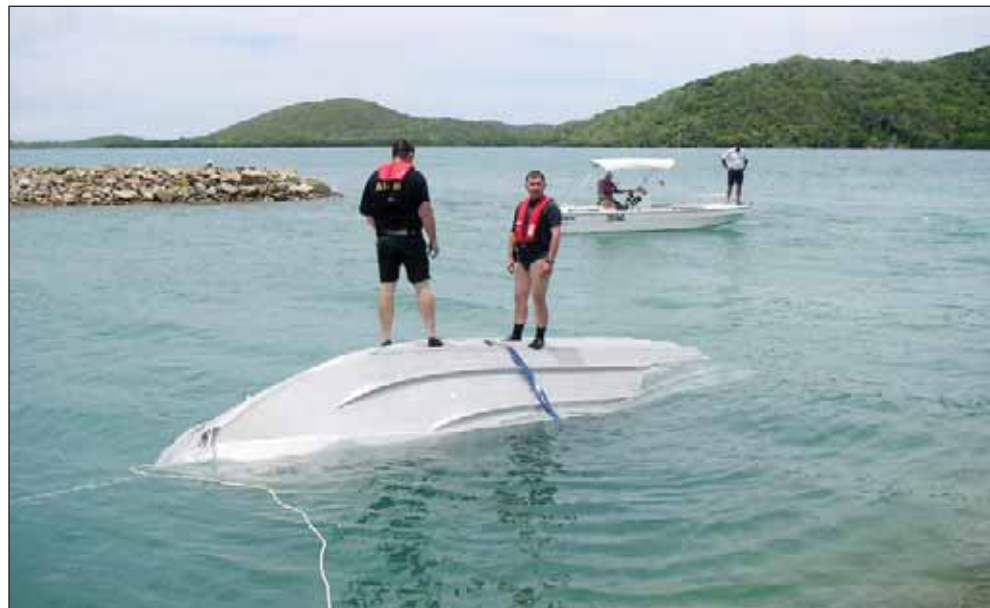
**Figure 13: Zueber Erkep floating inverted**

Although not floating upright, if watertight, the under deck void space would have provided some buoyancy to prevent the vessel from sinking. Before the swamp test on *Zueber Erkep* on 1 December 2005, the under deck void space was checked and proved dry. After the tests the under deck void space was drained of about 200 litres of water.

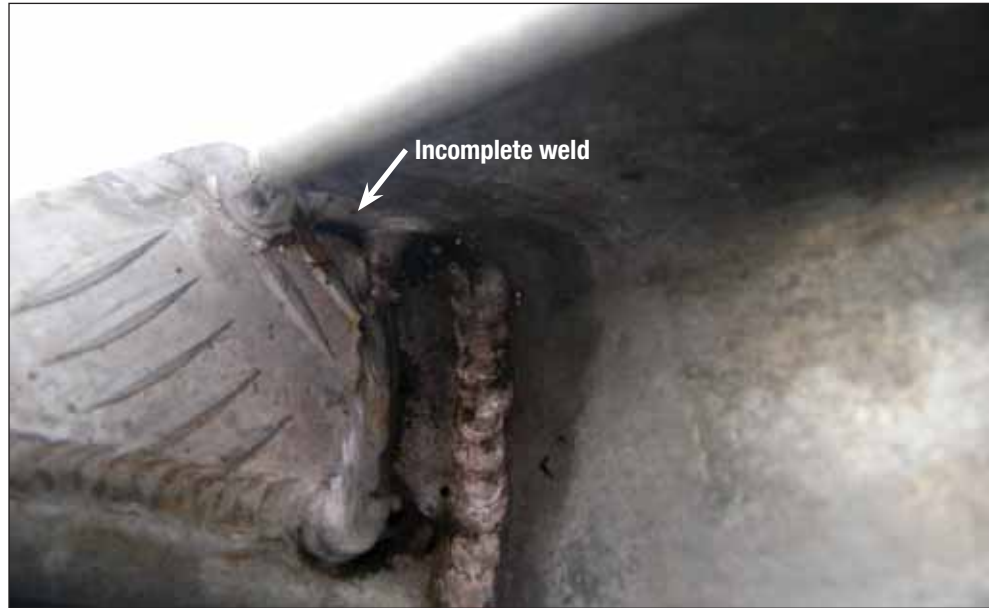
**Figure 14: Leak in *Zueber Erkep's* cockpit deck**

Examination of *Zueber Erkep* revealed a section of weld missing where a transverse frame penetrated the cockpit deck (Figure 14). The cockpit deck was therefore not watertight.

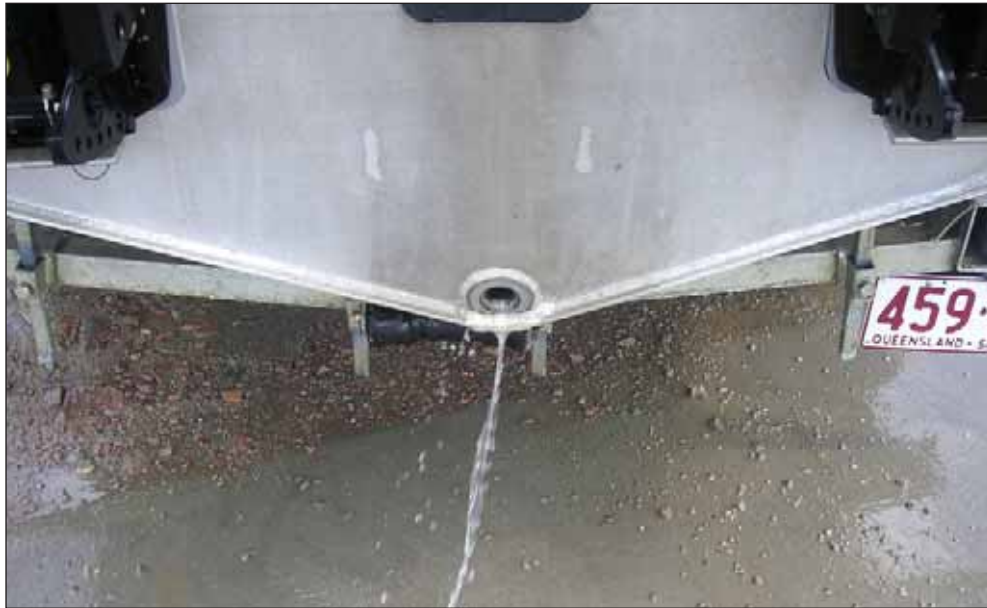
**Figure 15: Water being drained from the under deck void space**

A sea trial on board *Kang* was carried out on 29 November 2005. Before the sea trial the under deck void space was checked and proved dry. After the 74 minute sea trial the under deck void space was inspected and drained of about 20 to 40 litres of water (Figure 15).

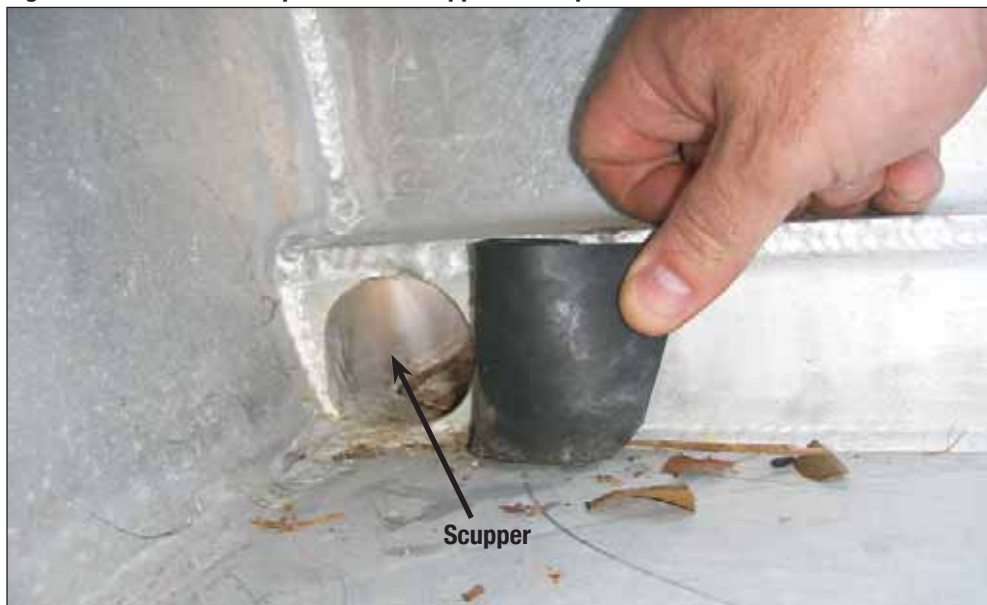
**Figure 16: Port side cockpit transom scupper and flap**

The IRVs are fitted with scuppers leading through the cockpit transom, port and starboard, to the motor-well deck (Figure 16). The motor-well deck has a single freeing port on the centreline of the motor-well transom (Figure 17). All of the freeing ports and scuppers are fitted with external flexible flaps. Any water shipped into the cockpit drains first to the motor-well through the scuppers and then overboard through the freeing port in the motor-well transom.

The scupper area from the main deck to the motor-well on *Malu Sara*'s sister vessels is 1 590 mm<sup>2</sup> on each side – a total of 3180 mm<sup>2</sup>. The area of the single freeing port in the motor-well transom of the five remaining IRVs varies between about 6 160 mm<sup>2</sup> and 8 215 mm<sup>2</sup>.

AS 1799 specifies a formula to calculate the minimum scupper size required according to the size of the deck area to be drained. In the case of the DIMIA IRVs the cockpit area is estimated at no less than eight square metres, after deductions for excluded areas such as lockers and compartments. The minimum required total effective area of all scuppers is 5 600 mm<sup>2</sup>. This means that the scupper areas in *Malu Sara*'s four sister vessels is 57 per cent of the minimum required by AS 1799.

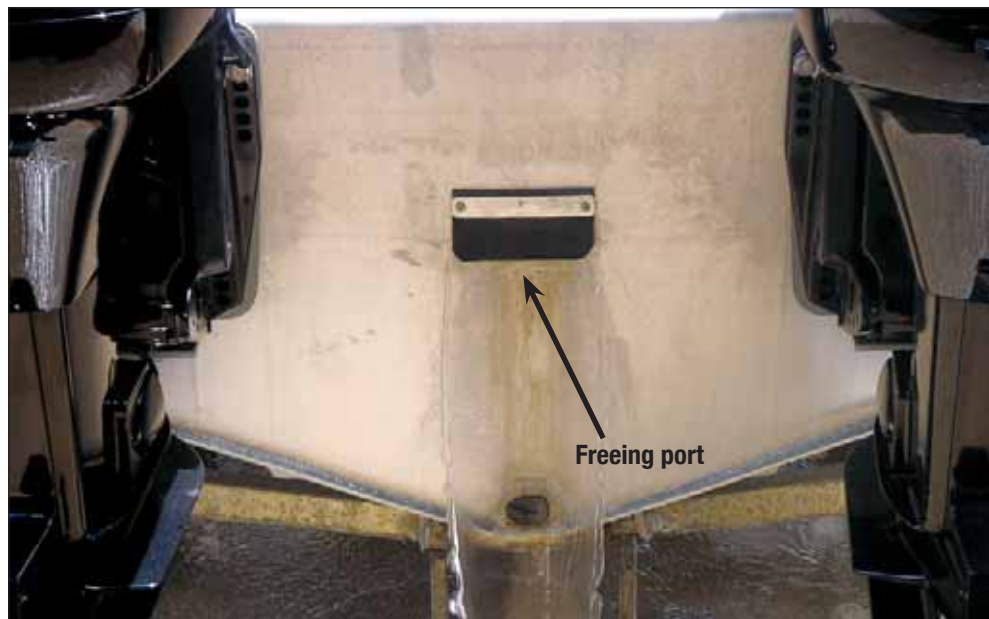
**Figure 17: Motor-well transom freeing port and flap**

The freeing port arrangement does not conform to the AS 1799 standard, which requires freeing ports, port and starboard.

If the freeing port just drained the motor-well, those fitted to the vessels exceed the minimum required size of 3500 mm<sup>2</sup>. However the freeing port was also an integral part of the cockpit drainage arrangement. As such the total area of the freeing port should have been a minimum of 72 000 mm<sup>2</sup>, or at least nine times larger than those fitted.

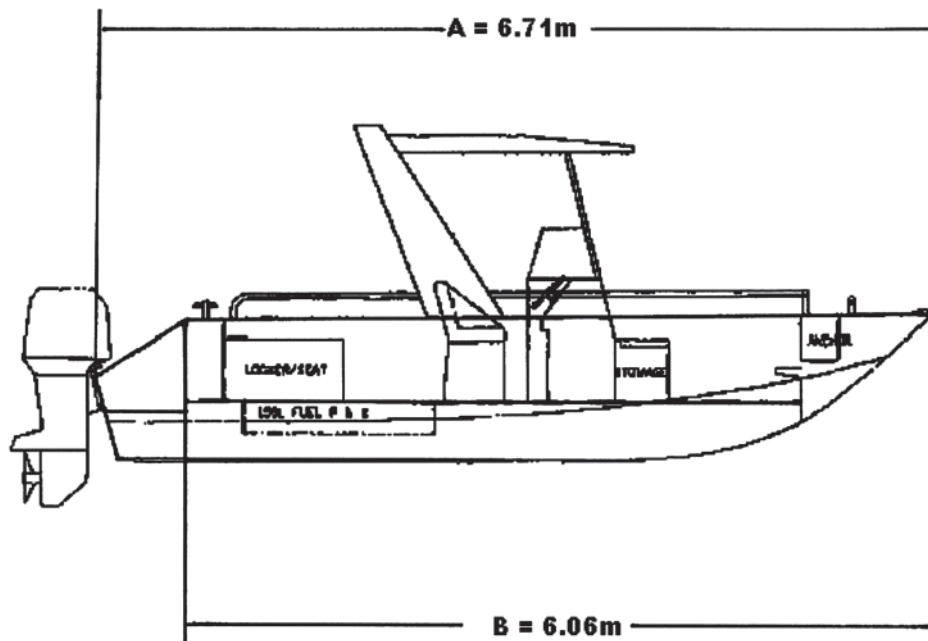
Figure 18: Vessel length measurement

*Zueber Erkep* was extensively examined and measured. The measurements of the remaining four vessels were also checked. The measurements of all the vessels were consistent, and are as follows, as shown in Figure 18. The relevant measurement is from the foremost part of the hull to the aftermost part of the hull which is 6.71 m. 96 per cent of that length is 6.44 m.

The measured length of the vessel is therefore 6.44 m, not 5.9 m as declared by the builder. As such, the IRVs could not be registered in Queensland as commercial vessels under six metres, a requirement of the building contract.

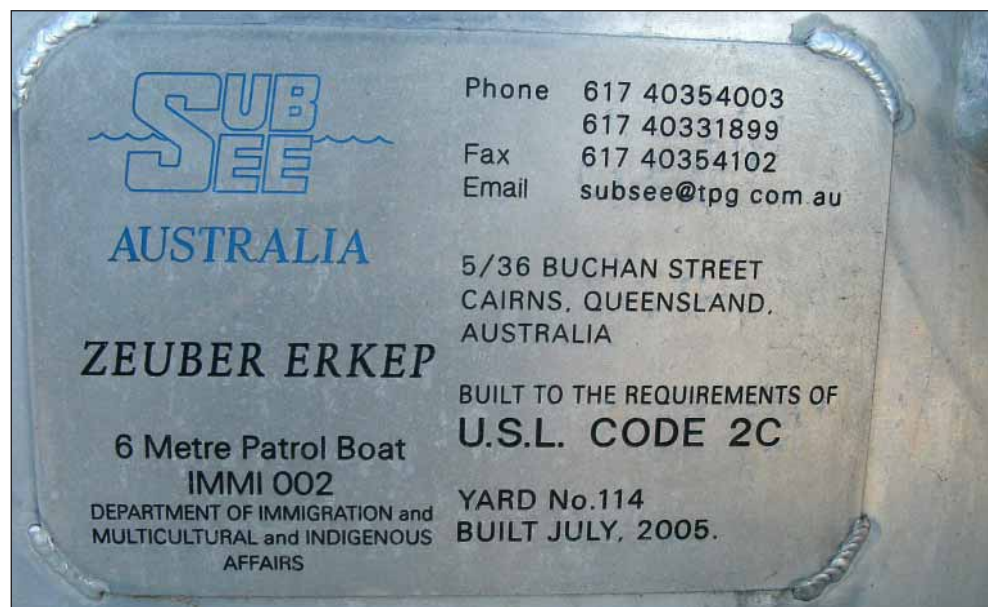
**Figure 19: Vessel capacity plate**

The capacity plates fitted in these vessels (Figure 19) do not nominate the maximum number of persons allowed on board or the maximum power for which the craft were designed and tested.

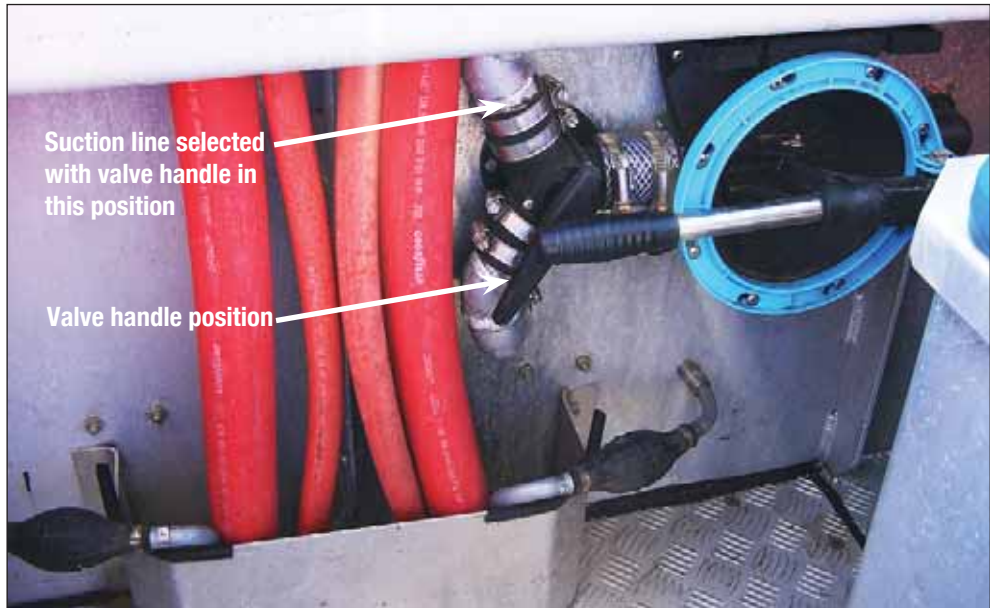
**Figure 21: Bilge pump suction valve**

In addition, the bilge pump two-way suction valve is counter intuitive and potentially confusing. The position of the valve handle does not clearly indicate from which line the pump is drawing (Figure 21). The evidence is that the skipper was apparently familiar with operation of the valve as he had used it on at least one occasion during the Saibai Island workshop. However, when the vessel was taking on water in darkness in the early hours of 15 October, it may have created needless confusion as it would not have been immediately clear whether water was being pumped from the void space or cockpit.

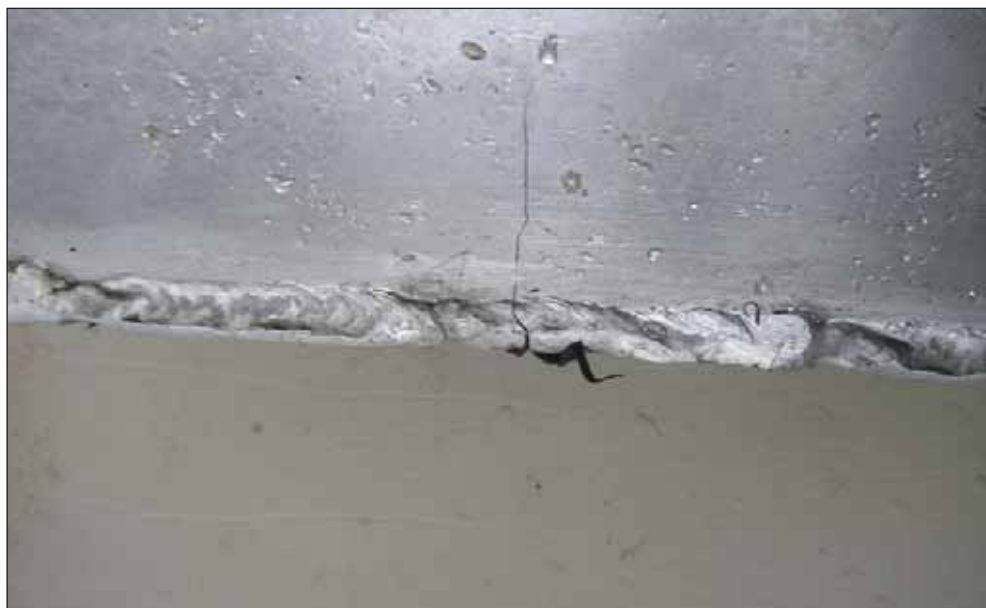
**Figure 23: Fuel tank weld quality**

The fuel tank from *Zueber Erkep* was removed and inspected to give some insight into the construction of the fuel tank arrangement. After removal the tank was not pressure tested but was simply filled with water, the tank immediately started to leak. The weld quality of the tanks seams was poor (Figure 23) and it was not able to withstand the ordinary pressure of the liquid within it, even under static conditions.

The casing surrounding the fuel tank was found to be full of water, and there was no means by which it could be emptied. There were a number of ways that water could have entered the casing. These included the unsealed penetration for the fuel fume detector cable, the unsealed screw holes in the fuel tank flange and several areas where the mastic had not formed a watertight seal.
