ATSB TRANSPORT SAFETY INVESTIGATION REPORT
Marine Occurrence Investigation No. 223
Final

Independent investigation into the grounding of the
Indian registered oil tanker

Desh Rakshak

in the entrance to Port Philip, Victoria

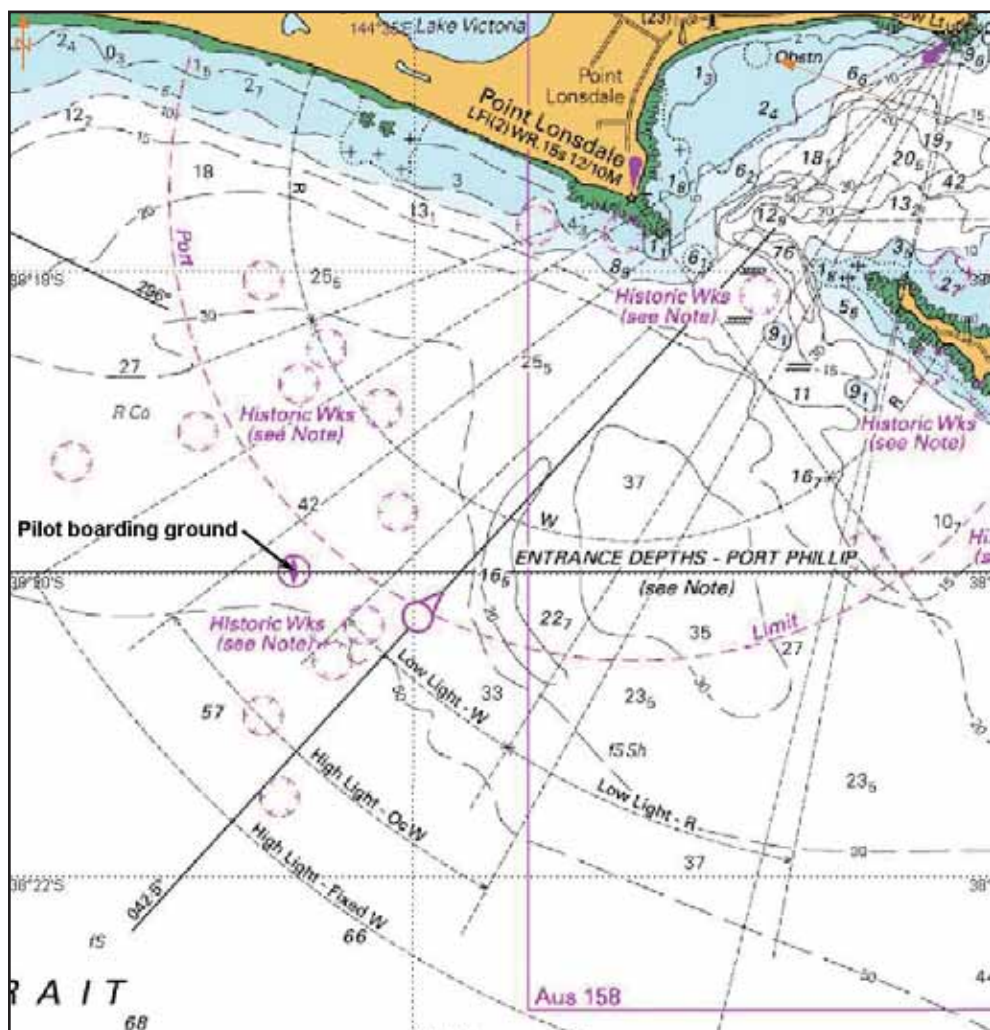
Figure 4: Section of navigational chart Aus 143 indicating the pilot boarding ground.

All pilotage services in Port Phillip are provided by Port Phillip Sea Pilots, a private company that operates subject to licensing by Marine Safety Victoria and safety oversight by the Port of Melbourne Corporation. Pilotage in the port is compulsory for all ships except exempted coastal ships. At the time of the incident the pilot boarding ground was located 3.3 miles southwest of the Point Lonsdale Lighthouse (Figure 4).

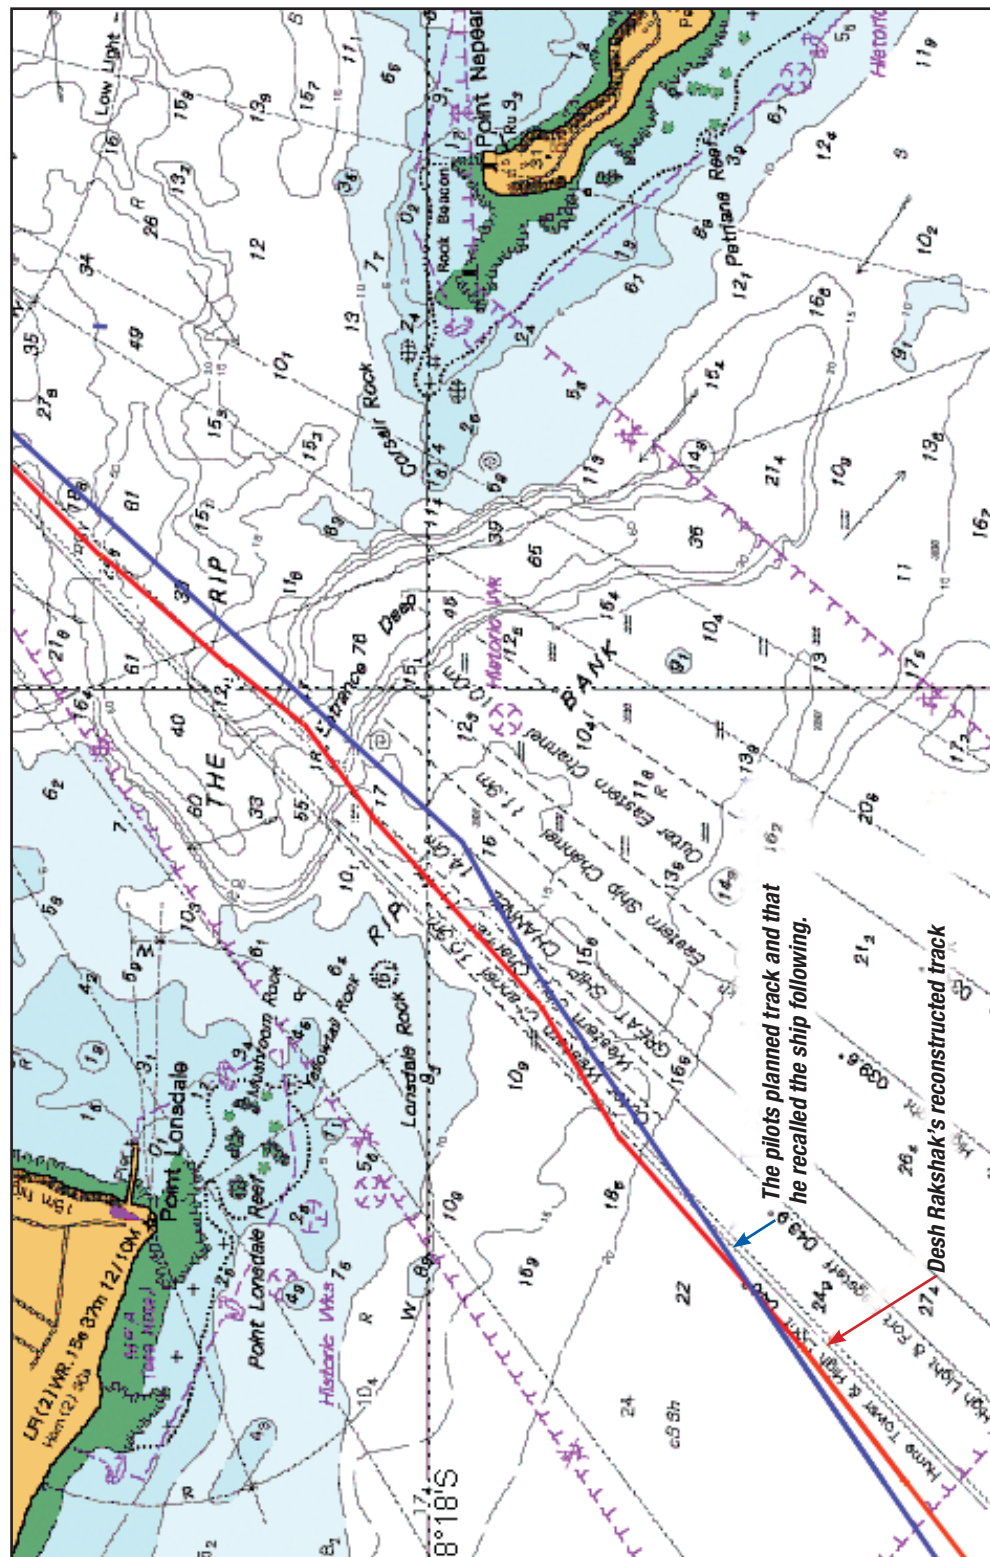
Figure 6: Section of navigational chart Aus 144 showing the pilot's planned track and the ship's reconstructed track.

The analysis of the rock found in *Desh Rakshak's* lower fore peak tank, combined with an analysis of the ship's track and the likely under keel clearance at various times during the transit, indicate that the ship probably grounded in one or more of the shallower areas in the Western or Outer Western Ship Channels when it was almost abeam of Point Lonsdale.
