ATSB TRANSPORT SAFETY INVESTIGATION REPORT
Marine Occurrence Investigation No. 225
Final

Independent investigation into the crew member fatality
on board the Bahamas registered passenger ship

Pacific Sun

5 February 2006

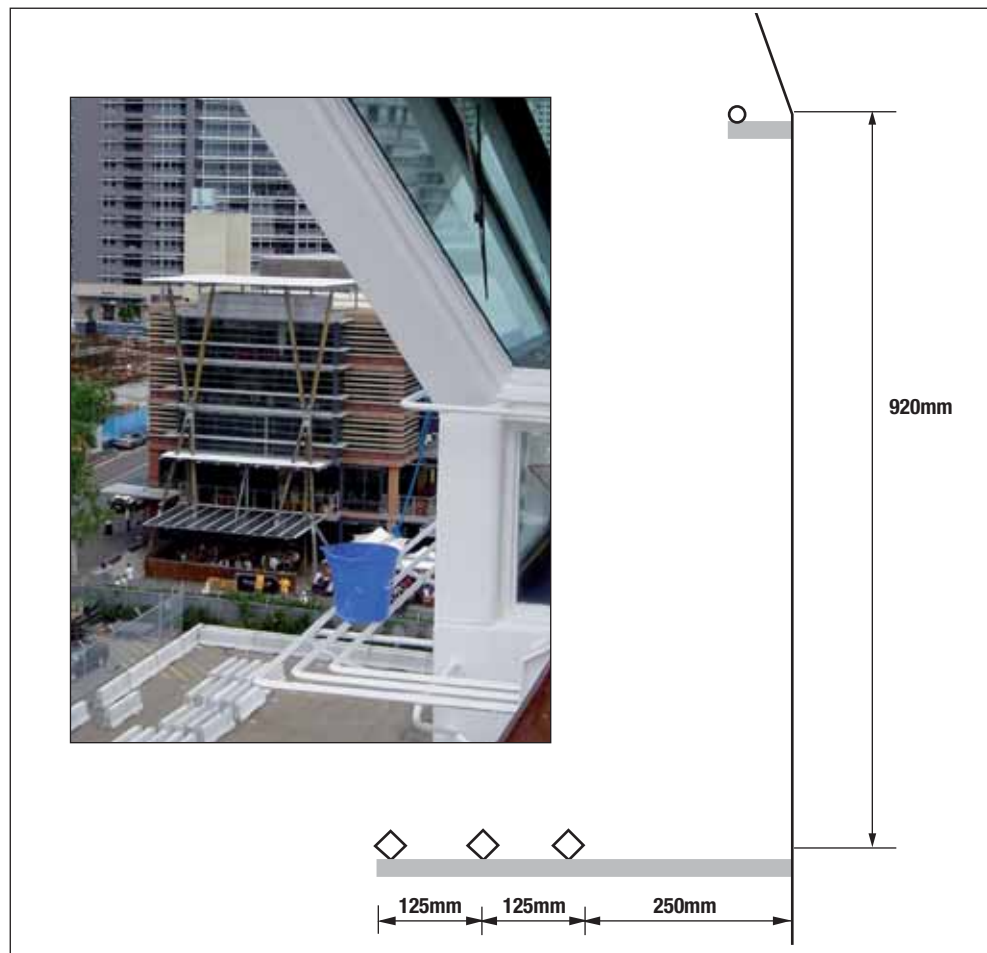
Figure 2: Catwalk arrangement with inset showing actual bridge wing catwalk

The catwalk for cleaning the bridge wing windows consists of three lengths of 25 mm square section steel bar welded on an angle to brackets that are permanently attached around the outside of the ship's bridge. These bars provide a working

platform 250 mm wide, set between 250 mm and 500 mm out from the sides of the bridge wing (Figure 2).

Inboard, a 25 mm round section grab rail is welded onto brackets approximately 100 mm from the bridge wing side below the windows (Figure 2). This rail serves as an anchoring point to secure a safety harness lanyard while working around the outside of the bridge.

2. The absence of a safety rail on the outboard side of the catwalk increased the risk of falling and required the quartermaster to wear a safety harness with its lanyard attached to the ship at all times.

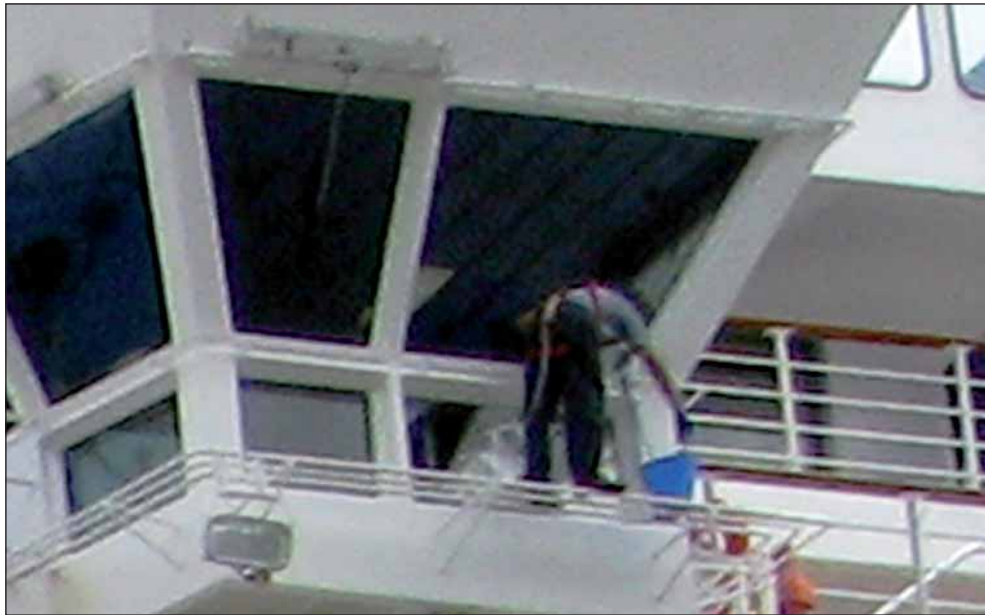
Figure 3: The quartermaster's foot extending beyond the edge of the catwalk

Normally, a person standing on such a catwalk would have their weight slightly forward when cleaning windows but because of the outward slope of the bridge wing windows, it is not always possible. There are times when the person must lean out and thereby have their centre of mass suspended over clear air and so the security of the harness is critical under these circumstances.

The quartermaster was wearing lace-up steel capped working shoes at the time of the incident. An examination of the shoes after the incident found that they were not laced up tightly, possibly to allow them to be slipped on and off when moving through passenger areas of the ship. These loosely laced shoes may have been insecure and unstable on his feet when working on the catwalk, a fact which, combined with the catwalk construction, may have led to him losing his footing.

3. The quartermaster probably lost his footing on the catwalk, possibly partly the result of having very loosely tied work shoes, while moving his harness lanyard past a grab rail bracket.

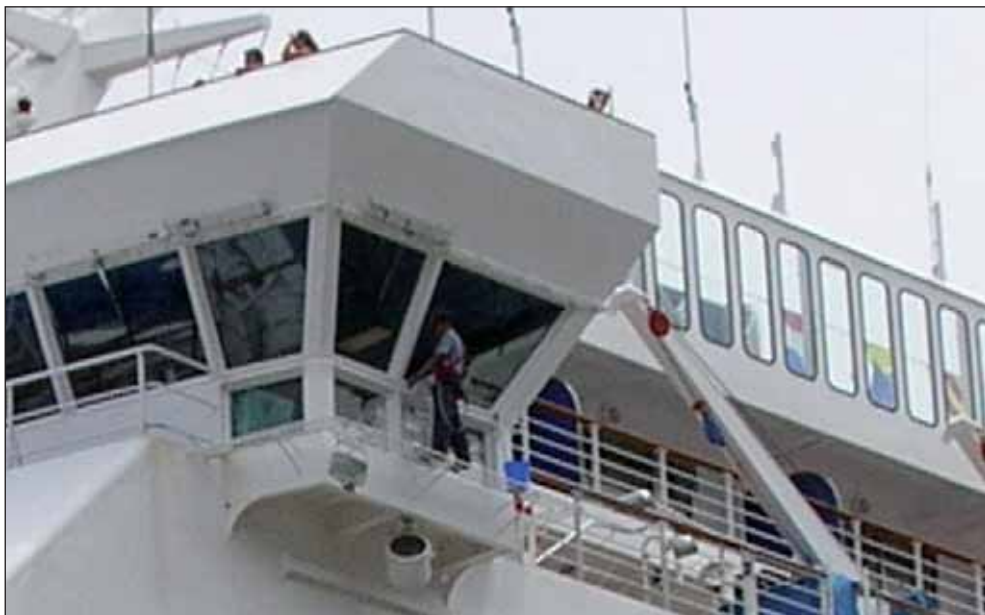
Figure 4: The quartermaster near the middle bracket immediately before the incident

From the time stamps on the witness photographs it was possible to construct a sequence of events which showed that the quartermaster had progressed all the way along the port side to the limit of the harness lanyard before returning to the grab rail bracket in the middle. The last photograph in the sequence shows the quartermaster standing on the catwalk adjacent to the middle bracket with both of his hands at the grab rail near the bracket (Figure 4). Considering his movement pattern, it is probable that he was moving the lanyard past this grab rail bracket when he lost his footing and fell.

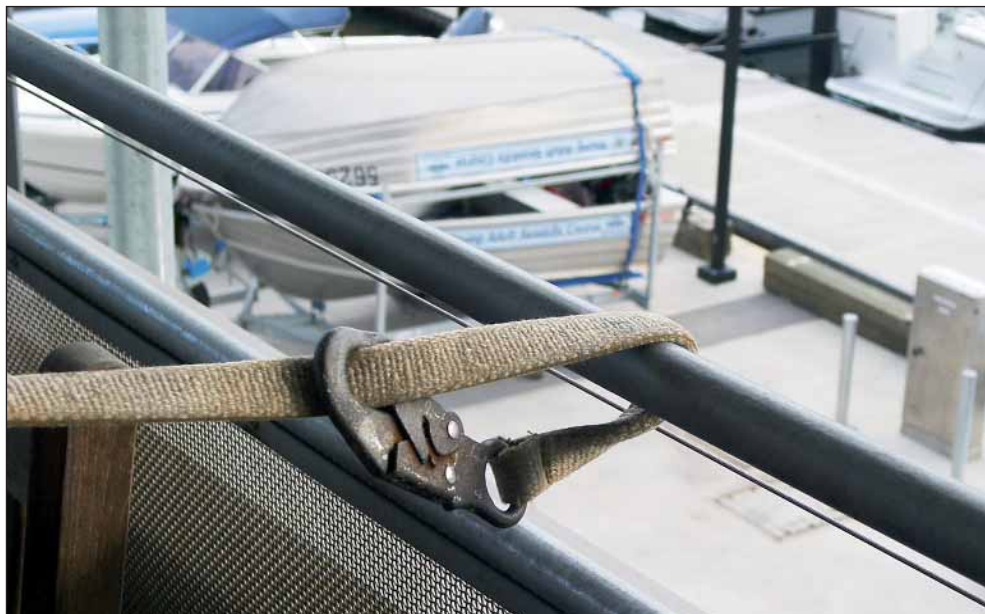
Figure 5: Method of clip attachment

A safety harness is required when working on the bridge wing catwalks. This harness must be secured to the grab rail by a lanyard at all times to ensure the security of the wearer. After the incident, the harness and lanyard were inspected by the ATSB and were found to be unbroken and still functional. The grab rail and brackets outside the bridge wing were also unbroken and undamaged. The evidence indicates that the lanyard was not properly connected at the time of the fall.

The clip on the single lanyard was too small to attach directly onto the grab rail. Instead, the lanyard had to be passed around the rail and then clipped back onto itself (Figure 5). The clip was of a suitable design for the purpose but the width of the strap made it difficult, when movement was restricted, to close the clip around the strap. If the strap was not curled into the clip, it would not latch closed, possibly allowing the strap to slip back out of the clip. Whilst it is possible to secure the clip around the rail using one hand, the investigators found during testing, and a demonstration by another quartermaster, that it was far easier to attach the lanyard using two hands.

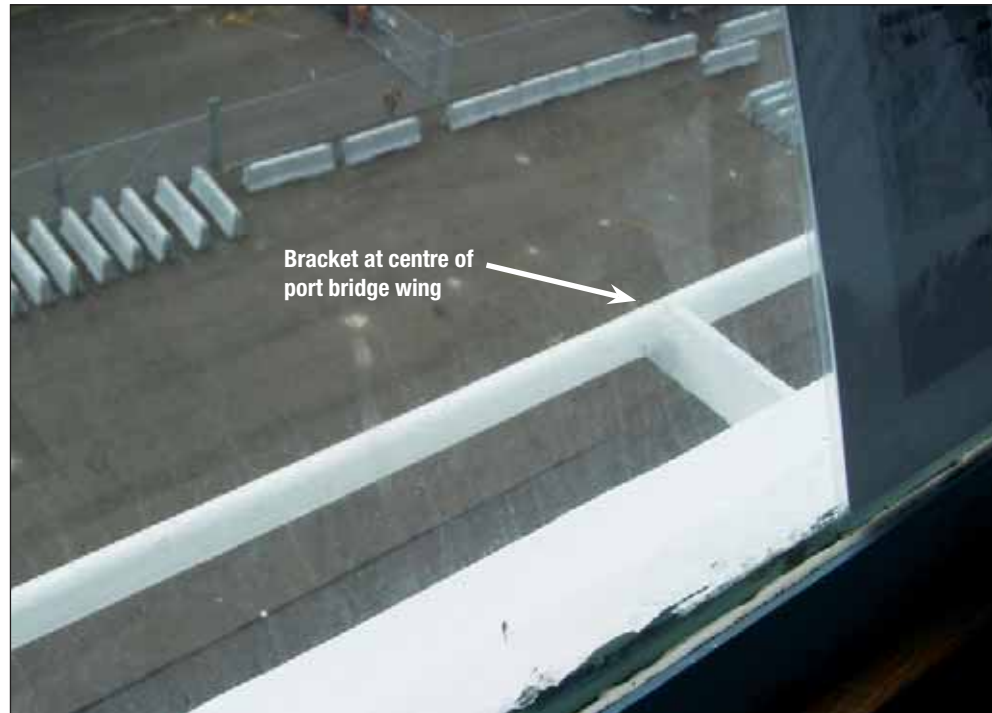
Figure 6: Grab rail bracket

Once secured, the lanyard cannot be moved past the brackets on the grab rail (Figure 6). To move along the catwalk, the wearer must disconnect the lanyard and reconnect the clip past each bracket. The fact that it is difficult to fasten the clip with one hand possibly encouraged the use of two hands to unclip, move and re-secure the lanyard. For this critical period of time it is likely that the wearer will have neither the lanyard secured nor a hand free to hold onto the grab rail.

The design of the harness with only a single lanyard did not allow the harness to be attached to the ship in any way while the lanyard was being moved past a bracket.

4. The single harness lanyard securing arrangement was inadequate in that it needed to be disconnected from the ship's structure in order to move it past brackets without having a secondary method of securing the quartermaster.
