Hawser failure and manoeuvring difficulties on board *Dampier Spirit* during cyclone Hubert

At 0958¹ on 6 April 2006, the mooring line (hawser) attaching *Dampier Spirit* to the CALM² buoy at the Stag oil platform off Dampier, Western Australia, parted and forced the ship to put to sea as a cyclone approached.

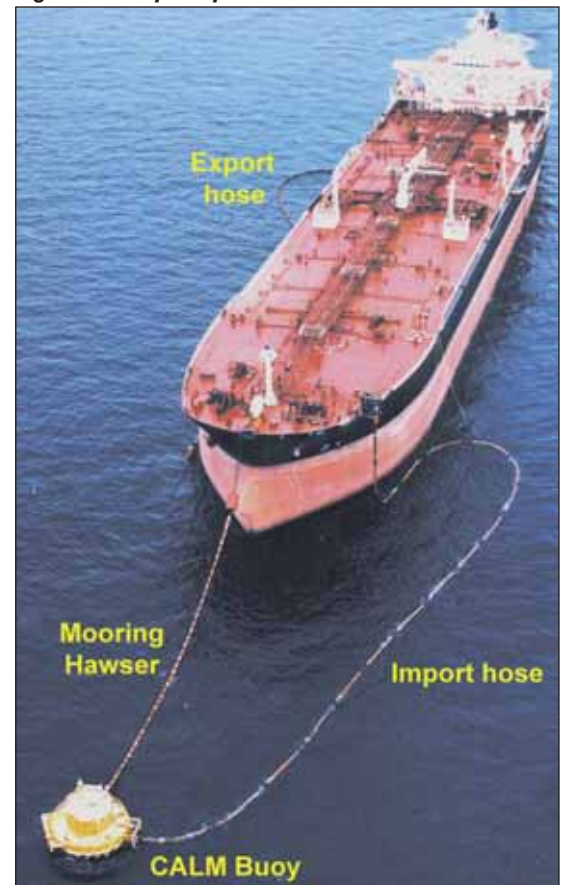
Figure 1: *Dampier Spirit*

Oil is delivered from the platform through a pipe on the seabed and up to the CALM buoy. From the CALM buoy, oil is transferred to *Dampier Spirit* through an import hose (Figure 1). The import hose is fitted with a

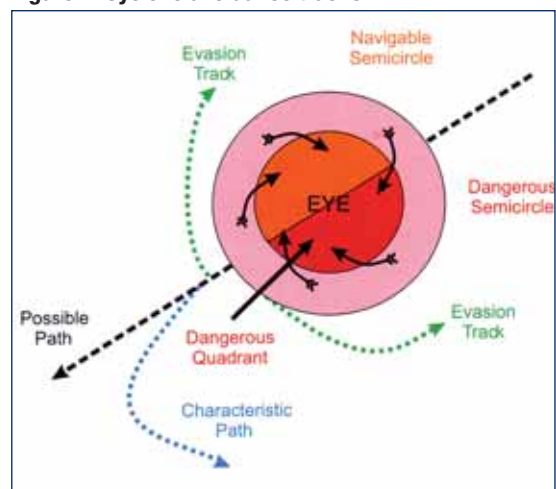
Figure 2: Cyclone avoidance tracks⁶

The dangerous semi-circle of a cyclone in the southern hemisphere is on its south-eastern side (Figure 2). This is the area which has the strongest winds and it is also the direction in which the cyclone is expected to move.

The handbook provides advice on the best tracks to use when evading a cyclone. If the ship is in the dangerous semi-circle the wind should be kept on the port bow and the ship should make its best possible speed to manoeuvre away from the cyclone. If the ship is in the navigable semi-circle, the wind should be placed on the port quarter to allow the ship to move clear.

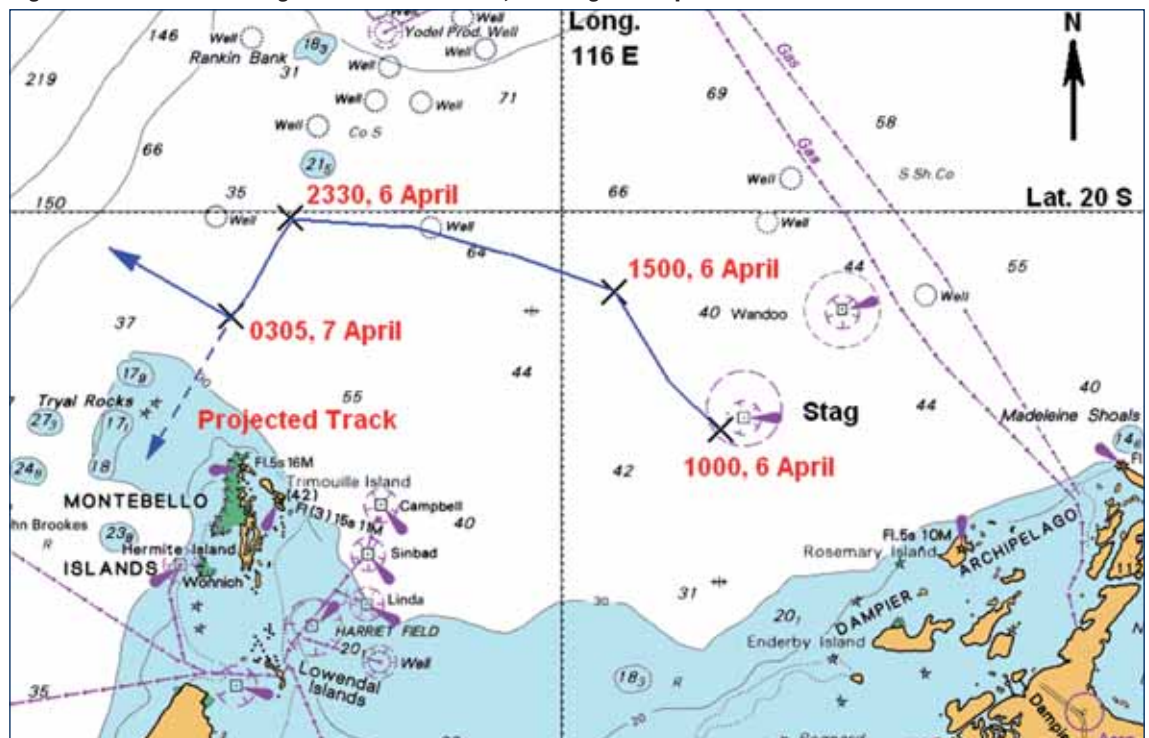
Figure 3: Extract from navigational chart Aus 416, showing the ship's track

After the hawser parted, the main engine was run at slow astern to move the ship clear of the CALM buoy. After clearing the buoy, the master attempted to take the ship to the northeast but the strong head winds, and the reduced engine power, made it impossible. He then decided to take the ship north, with the wind on the starboard bow, to move clear of the Dampier Archipelago. With the main engine running at slow ahead, *Dampier Spirit* was making good a course of 325° while steering due north (Figure 3).

At about 2330, the wind swung around to the port bow. By midnight the ship's heading was between 060° and 105° with the wind on the port side. However, the ship was being pushed astern and making good 212°.

At midnight, *Dampier Spirit* was 17.2 miles from Tryal Rocks and the projected track would put the ship within one mile of Tryal Rocks.
