ATSB TRANSPORT SAFETY INVESTIGATION REPORT  
Marine Occurrence Investigation No. 229  
Final

Independent investigation into the main engine failure  
on board the self discharging bulk carrier

# Enterprise

10 July 2006

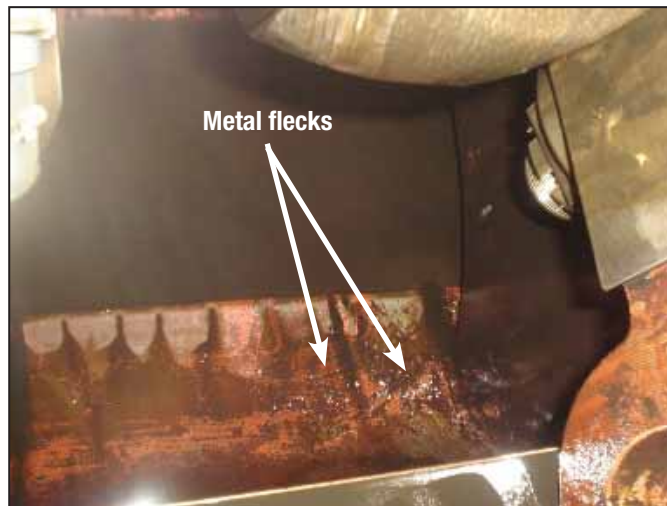
The chief engineer carried out a main engine crankcase inspection and saw flecks of metal in the bottom of two of the crankcase spaces. At about 1830, he advised the master that the main engine may be seriously damaged and that further inspections were being undertaken. At 2000, he further advised the master that the main engine could not be run due to probable bearing damage and that the ship would need to be towed to the nearest port for repairs. The chief engineer discovered, at this time, that the main lubricating oil pump had also failed.

**Figure 7: Metal flecks in the bottom of number five crankcase.**

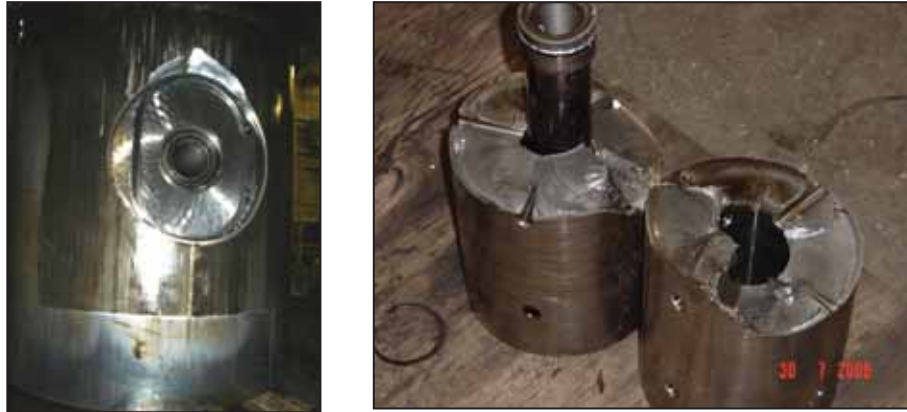
On 29 July 2006, number five piston was removed from the engine. The gudgeon pin was found to have catastrophically failed and the piston skirt was also damaged (Figure 9). The cylinder liner was also removed from the engine.

**Figure 9: Number five piston and gudgeon pin**

A new piston and cylinder liner were fitted to the engine before engine trials were successfully conducted.

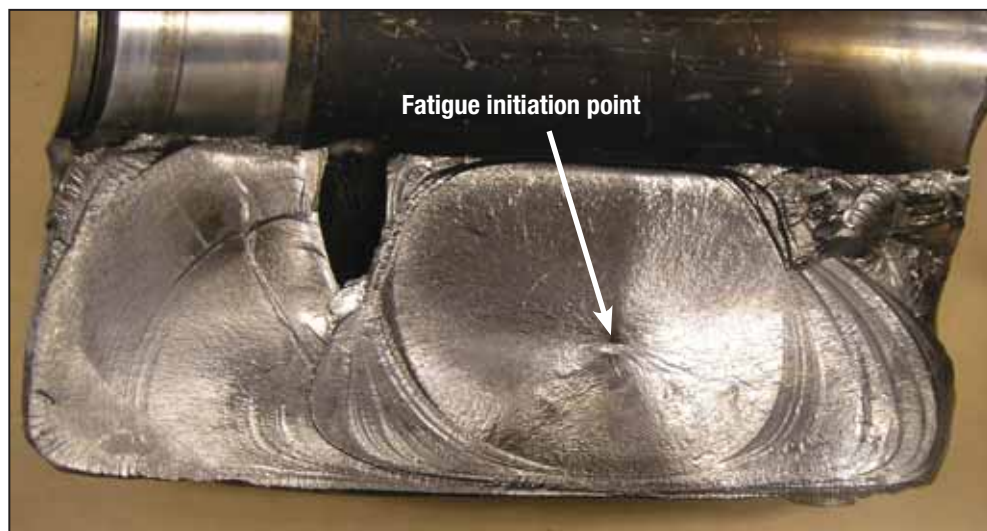
The gudgeon pin presented multiple, intersecting planes of transverse and longitudinal fatigue cracking. Although having primarily failed as a result of fatigue cracking and fracture along a central transverse plane, the suspected initial origin of fatigue cracking was located at an internal, mid-thickness position (Figure 10), and had initiated a single, longitudinal (radial) plane of cracking, which had developed through the full section thickness and for the full length of the gudgeon pin. Transfer of stresses and loss of rigidity associated with the growing longitudinal cracks resulted in the initiation and development of transverse cracking and the eventual structural failure of the gudgeon pin, as observed. The obvious mechanical damage and staining on fracture surfaces of the gudgeon pin suggested that the fatigue crack growth was over an extended period of time.

**Figure 10: Gudgeon pin failure**

The source of the microscopic flaw that led to the failure was not determined but could only have been present from the time that the gudgeon pin was manufactured.

The initial crack that led to the failure of the gudgeon pin was both longitudinal and inside the bore of the gudgeon pin. It is unlikely that this would have been detected by a visual inspection during the last cylinder overhaul before the failure. While a fine crack would be difficult to locate using a purely visual inspection, the chances of finding a flaw would have been significantly improved if other methods of crack detection were used.

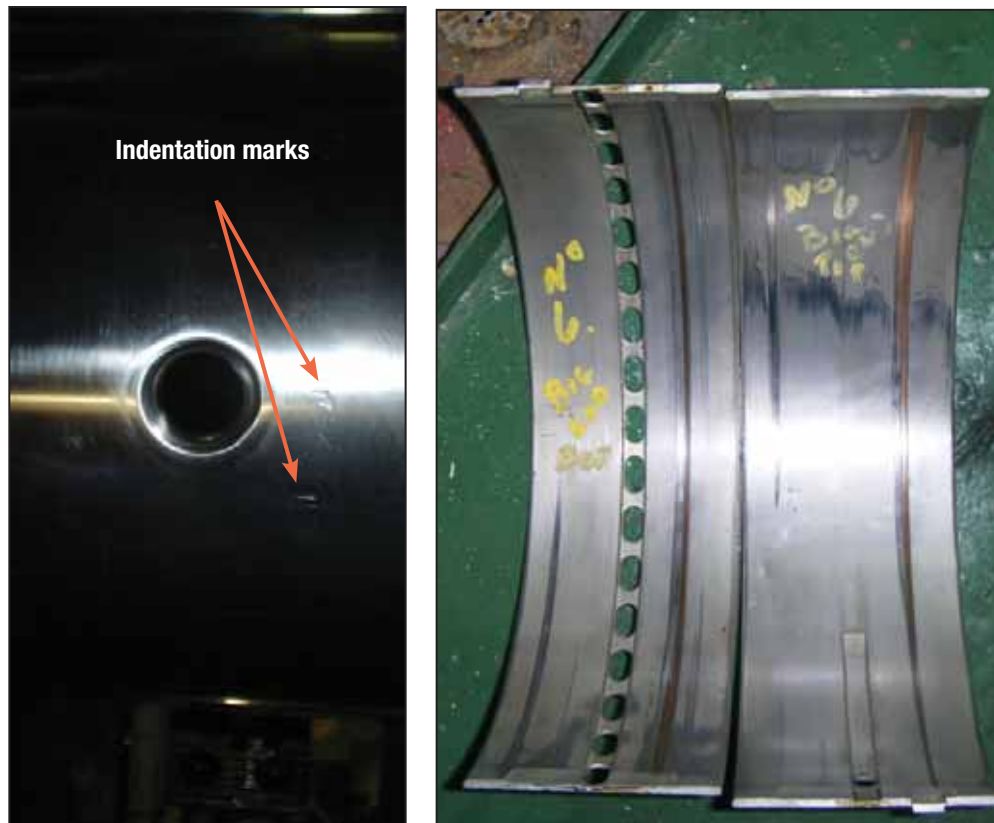
All main and bottom end bearings were inspected in Melbourne. A large gouge mark was found on number six bottom end bearing and a mark was found on the corresponding crankshaft journal. There was very little evidence of particle scouring or particle damage to the bearings examined, but some small pieces of metal were found on top of number five main bearing cap. The engineers concluded at the time that the metal that was observed in the crankcase had originated from the number six bottom end bearing

Following the incident, an indentation mark was observed on the crankshaft journal (Figure 11) consistent with the connecting rod making hard contact with the journal during reassembly. This probably occurred during a previous overhaul when the piston and connecting rod assembly was being lowered into the cylinder liner.

It was also reported that a small piece of white metal and copper was found in the bearing on disassembly, in line with the mark on the journal, but that this piece of metal had fallen out of the bearing when it was disassembled for inspection. This piece of metal is consistent with bearing material being gouged from the surface of the bearing shell by contact with the indentation mark on the journal.

**Figure 11: Number six crank pin and bottom end bearing**

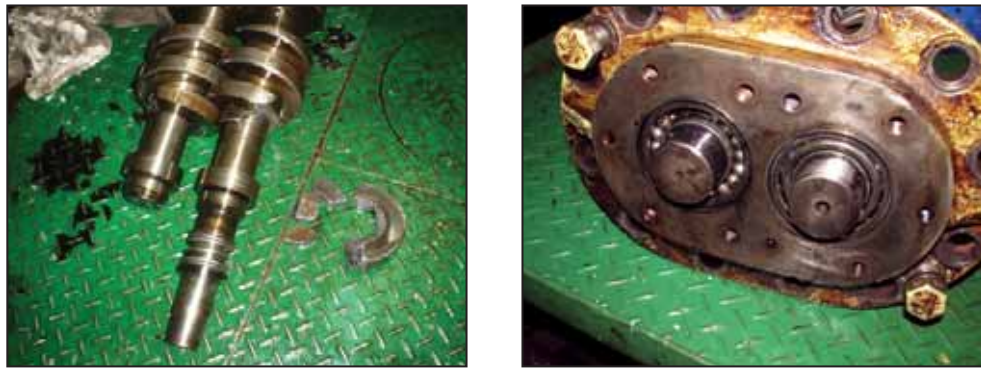
At this time, attempts to reinsert the main oil pump suction strainer were frustrated by an obstruction in the filter housing which was caused by broken pieces of a lubricating oil pump screw. The main oil pump was dismantled and inspected. One bearing was found to have failed and the screw elements were damaged with pieces missing.

**Figure 12: Broken pump scrolls and collapsed pump bearing**

The planning of maintenance for the main engine driven lubricating oil pump was ineffective because regular inspections of the pump bearings, in accordance with the manufacturer's recommendations, were not programmed in the ship's CMMS. The pump bearings had previously failed and had been allowed to run for 30 715 hours since repairs after that failure, despite the manufacturers recommended bearing service interval of 20 000 hours. Furthermore, a previous failure of the pump bearings had not resulted in updating the planned maintenance system for the inclusion of the required pump bearing inspections.
