ATSB TRANSPORT SAFETY INVESTIGATION REPORT
Marine Occurrence Investigation No. 232
Final

Independent investigation into the breakaway and grounding
of the Hong Kong registered bulk carrier

Crecente

at Port Hedland, Western Australia
12 September 2006

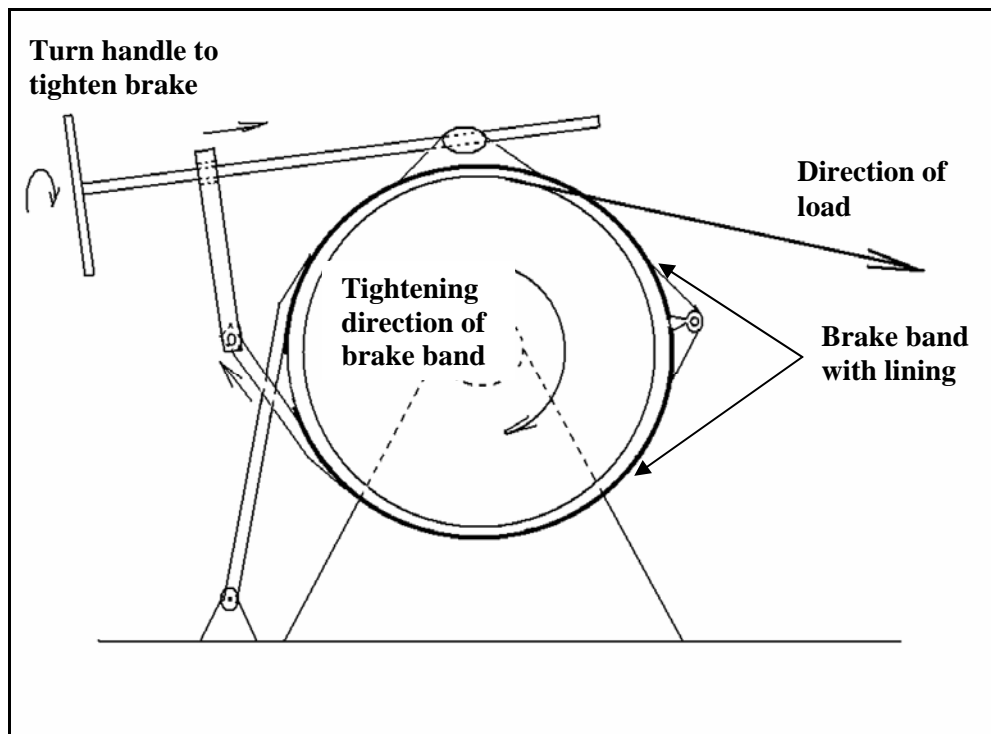
Figure 4: Mooring winch band brake

The brake on each mooring winch is designed to be tightened by turning the hand-wheel clockwise, as tightly as possible. The hand-wheel turns a screw that draws the ends of the brake bands together, which brings the brake lining into contact with the drum (Figure 4).

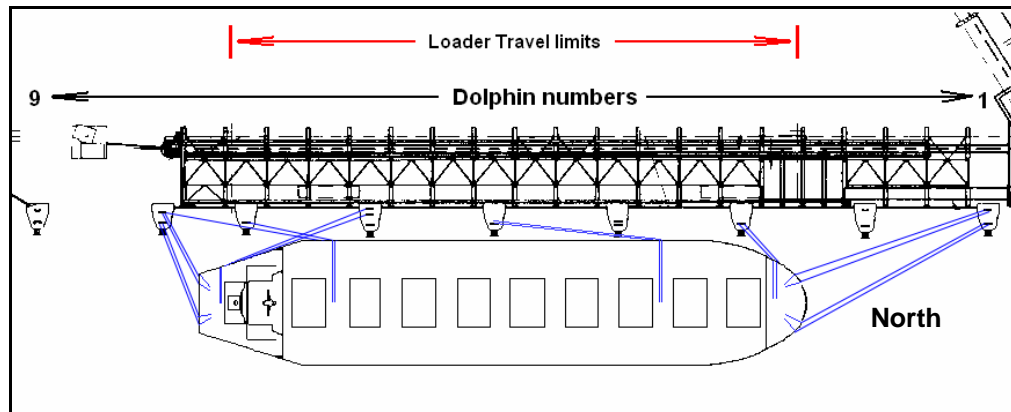
Figure 8: *Creciente's* mooring arrangement at Finucane Island berth D

Under the revised mooring plan, the ship's bridge marker was located about 45 m from the southern end of the wharf, about 30 m further north along the wharf. This provided an extra lead for the stern lines without the ship's position exceeding the travel limits for the loader.

The forward mooring lines were arranged as per the normal plan (Figure 7). However, the arrangement for the aft lines was different. Two breast lines were led from the outboard winches to number eight dolphin along with two from the inboard side of the aft deck. Two spring lines were made fast to number six dolphin. Two stern lines were run from forward of the accommodation. The original plan called for both of these to be run to number eight dolphin but on 10 September, one led to number seven dolphin and the other to number eight dolphin (Figure 8).

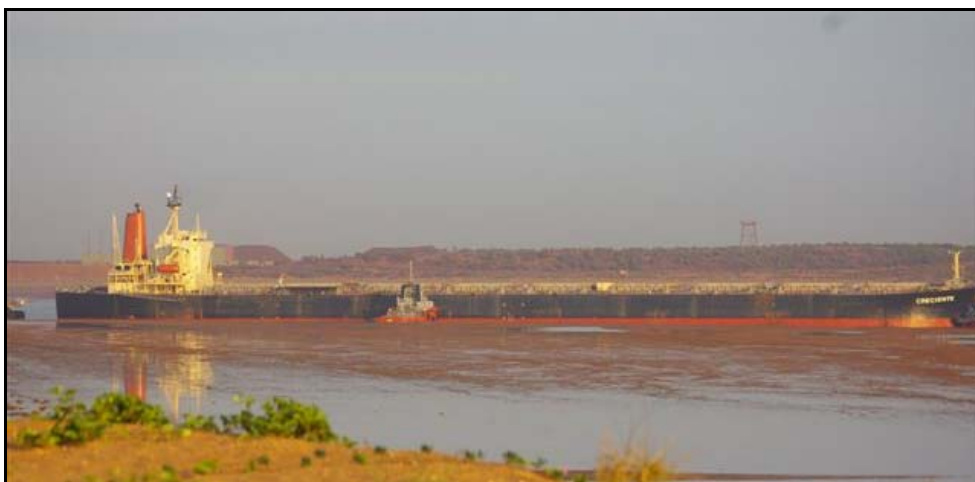
Figure 10: *Creciente* aground in Port Hedland

An underwater assessment of the damage to the ship revealed that the rudder was cracked and the rudder stock appeared to be twisted by about six degrees to port. Four of the five propeller blades were bent, three to forward and one to aft. The side plating was set in by as much as 300 mm in way of number two starboard, number three port and number four starboard water ballast tanks and the bottom stiffeners were set up by about 100 mm.

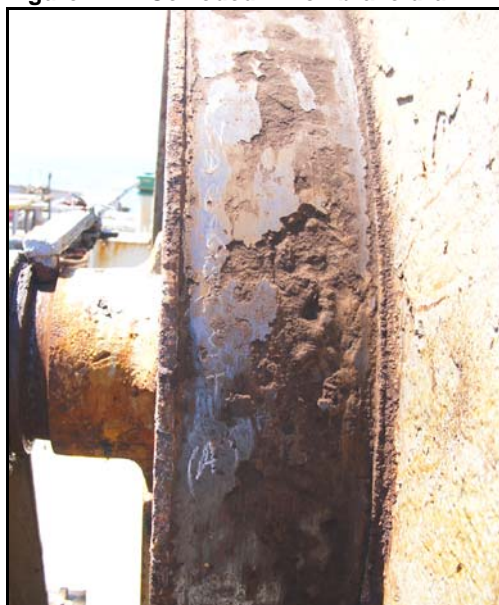
Figure 11: Corroded winch brake drum

An examination of the winch brake linings, and a review of the ship's maintenance records, revealed that the brake linings were not excessively worn and were still serviceable. However, the examination of the brake drums revealed that they were corroded and pitted (Figure 11) and that some of the brake band hinges were frozen with rust and paint, indicating a lack of maintenance (Figure 12).

The pitting and corrosion would have reduced the contact area between the brake lining and the brake drum metal face which would have reduced the brake's effectiveness. The worst brake drum (Figure 11) was on the forward breast line winch's aft drum and this brake's effectiveness was estimated to be about 40 per cent. The best brakes examined probably had an effectiveness of about 70 per cent.

The evidence indicates that the maintenance of the winch brake drums on board *Creciente* had been ineffective in that it did not adequately address the pitting and corrosion of the drums or the frozen hinge pins. As a result, the effectiveness of the brakes had been severely compromised, allowing the brakes to slip more readily which contributed to the ship's breakaway from its berth on 12 September 2006.

The use of a powered wire brush or needle gun to clean the brake drum would have removed the surface rust and scale but would have had limited effect on improving the contact area between the brake drum and the brake lining because of the depth of the pitting. The grinding of the surface following de-scaling would have served to flatten out the indentations and pitting on the surface but would not have provided a uniform contact surface for the whole brake lining.

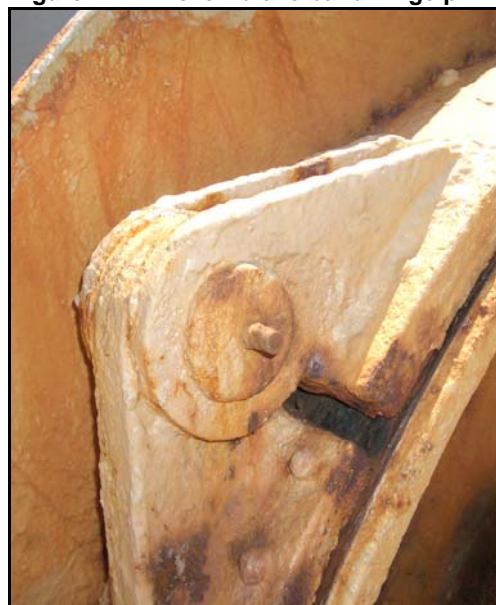
Figure 12: Frozen brake band hinge pin

The frozen hinge pin (Figure 12) would probably have prevented the brake linings from having an evenly distributed contact with the metal face of the brake drum, allowing only the areas opposite the hinge to effectively contact the drum. This would have reduced the frozen winch brake's effectiveness by approximately another 50 per cent. There were four winch brakes with frozen hinge pins and most of the others showed some signs of corrosion and lack of maintenance.

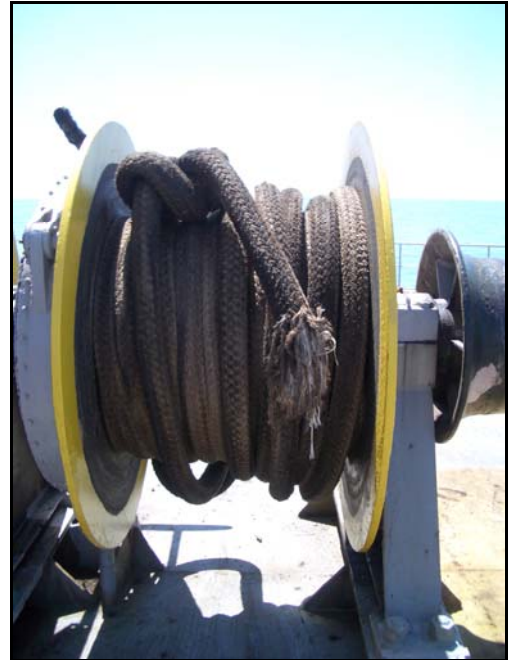
Figure 14: *Creciente's* winch drum

The mooring winch brake's holding capacity was specified in the ship's equipment manuals as 67.4 tonnes with one layer of mooring rope on the drum. As the number of layers increased, the effective holding power of the brake decreased due to the greater diameter that the mooring line load is acting upon. The brake's effectiveness can be simply calculated using the ratios of the effective diameters (Table 2).

All of *Creciente's* mooring lines were originally 220 m long, the length of a standard coil of mooring rope, although some of them had subsequently been shortened due to damage. Consequently, given the distance from the winch drum to the mooring dolphins at Finucane Island berth D for each line, all of *Creciente's* mooring lines had at least two layers of rope remaining on their winch drums. The four aft breast lines, leading to number eight and number seven dolphins, all had five layers of mooring line remaining on their drum, limiting the effectiveness of the winch brakes.

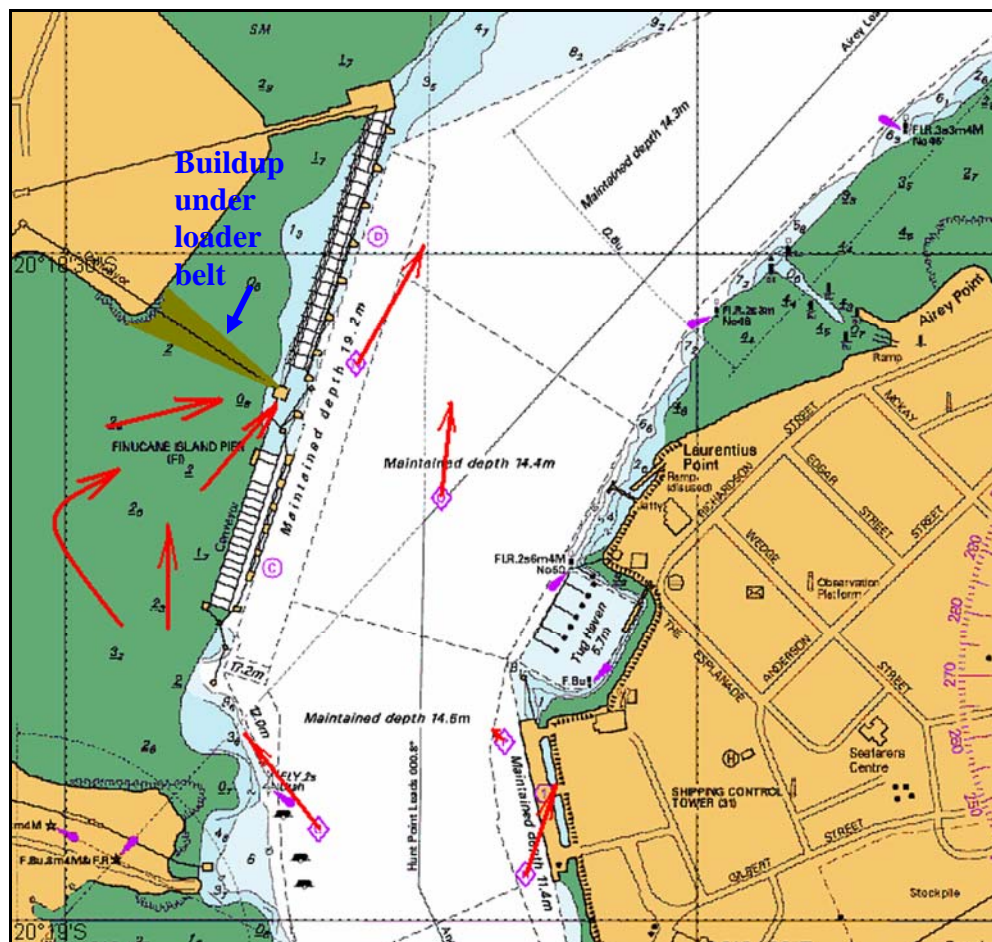
Figure 15: Tidal flow affected by build up under the loader belt

The spring tides in Port Hedland are recorded as having a tidal range of up to about 7.2 m. The maximum ebb tidal flow of about 1.9 knots at Finucane Island berth D, listed on the navigational charts for Port Hedland, is directed away from the wharf by about two degrees and acts on the port quarter of a ship alongside the berth.

This tidal flow within the harbour was plotted in March 1998, as part of the planning for redevelopment within the port and was found to be consistent with the navigational chart data. However, since that time, iron ore has spilled from the belt feeding the ship loader on Finucane Island berth C and has accumulated in the water under the belt (Figure 15). This would have the effect of reducing the tidal water flow under the loader belt. The resultant water flow would probably be directed more towards the main harbour and at a greater angle than is represented on the navigational chart, possibly an angle of up to about 30 degrees to the wharf (Figure 15). Furthermore, to a ship alongside the wharf, the actual tidal flow may have been at up to 2.5 knots instead of the 1.9 knots indicated on the chart.

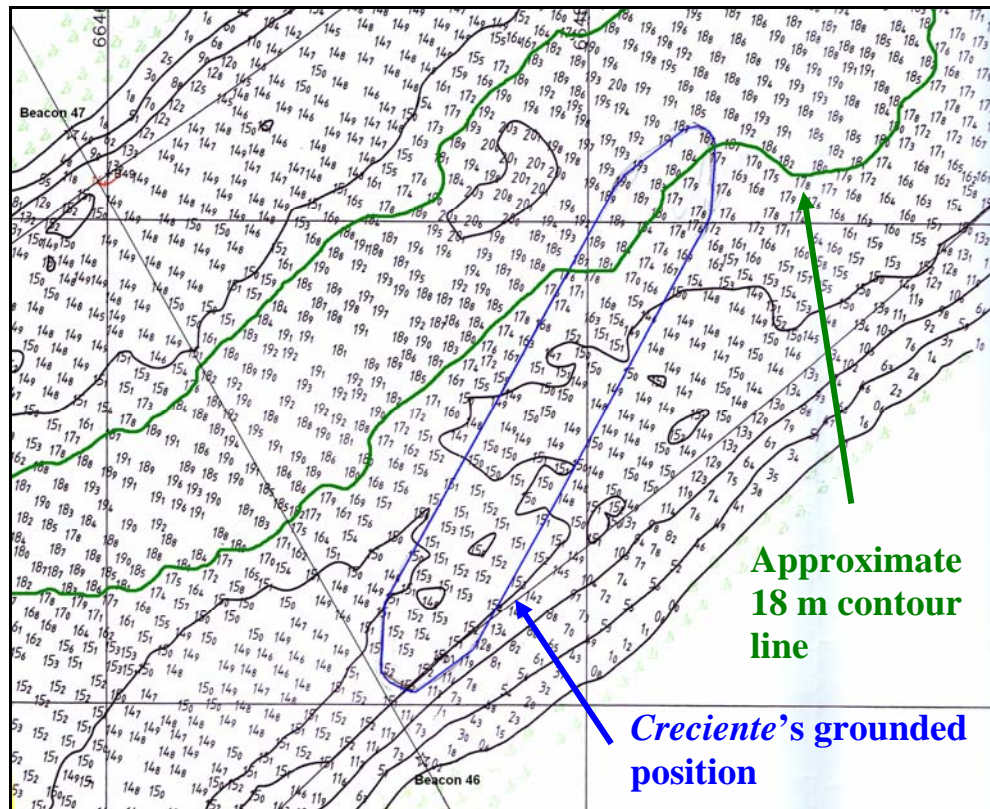
Figure 16: Port Hedland hydrographic survey data showing the deep water pocket and *Creciente's* grounding position

Creciente almost certainly touched the bottom twice. The first occasion was just after the breakaway, when the ship made brief contact with the side of the channel. The second grounding occurred at about 0515 when the ship grounded in the Port Hedland harbour channel, close to beacon number 46.
