High pressure oxygen system flash-fire on board *Searoad Mersey*

Crew member burnt in oxygen system flash fire

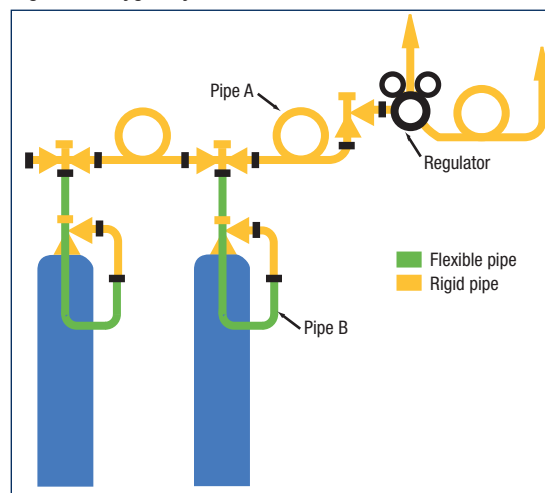
Figure 2: Oxygen system

The oxygen locker contained three oxygen gas cylinders, two of which were connected to the manifold (Figure 2) with the third stored as a spare. The oxygen regulator reduced the gas pressure from the cylinder pressure of about 200 bar⁴ to the system pressure of about 7 bar. The low pressure side of the regulator was fitted with a relief valve that vented to the atmosphere.

On 18 May 2006, the pipe loop between the manifold valve and the regulator isolating valve was found to be leaking (Pipe A in Figure 2). When requested to by one of the ship's engineers, the Enzed hose assembler supplied and fitted a hose into the system to replace the leaking pipe. However, this hose subsequently failed so the hose assembler supplied and fitted a new hose with a higher pressure rating.

In early August, the first engineer inspected the oxygen system and found that two hoses in the oxygen locker were leaking; one of the original hoses from a cylinder to the manifold was cracked (Pipe B in Figure 2) and the new hose that had been fitted between the manifold and regulator was leaking from where the hose was joined onto the end fitting (Pipe A in Figure 2).

On 18 August, the first engineer replaced the leaking hoses with the two spares. He then pressurised the system and checked it for leaks.

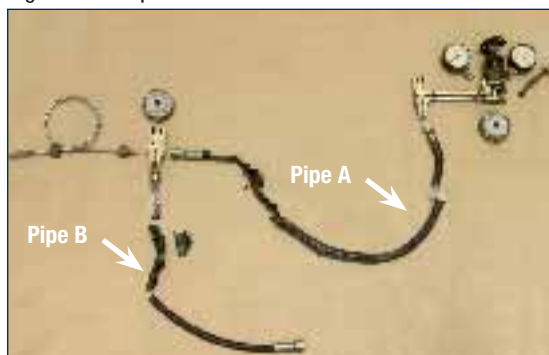
Figure 3: Components sectioned for examination

An analysis of the system components was performed by the ATSB. When the hose between the manifold and the regulator (Pipe A in Figures 2 and 3) was sectioned, it was revealed that the entire inner core had been burnt in the fire. The damage to the hose liner was greatest near the pressure regulator shut-off valve and the damage decreased back towards the mid-stage manifold valve. The burning of the hose liner adjacent to the regulator valve, followed by a rapid advance of the flame back along the lining of the hose, suggests that near-adiabatic compression was the most likely ignition source.

When the trainee engineer opened the oxygen cylinder valve quickly, the oxygen from the cylinder flowed into the manifold and compressed the oxygen that was already in the system until the pressures had equalised. The compression was near-adiabatic and it heated the hose liner to above its auto-ignition temperature, causing it to ignite in the pure oxygen environment.

The combustion products increased the system pressure. The over pressurisation within the system caused the regulator to fail and caused the other hose, also heat damaged by the fire, to rupture.

Two different hoses were installed on board *Searoad Mersey* on 18 August although they appeared to be very similar. One hose (Pipe A in Figure 3) was marked as a 'Parker 580N'

series hose and the other (Pipe B in Figure 3) as a 'Gates 4C8S' hose. The fittings used on both hose assemblies were similar and the ferrules were stamped with the same markings (SN8-4). The fittings on both hoses appeared to have been swaged using a similar machine.

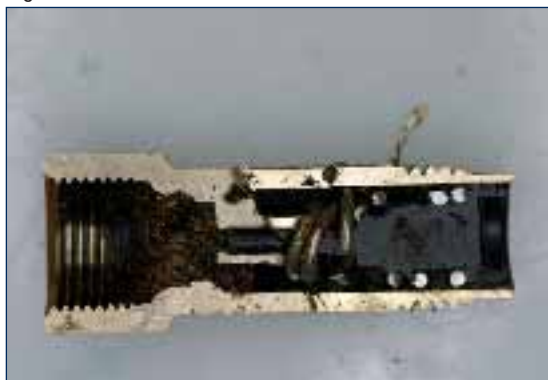
Figure 4: Corroded and blocked relief valve

The pressure relief valve on the regulator was designed to protect the low pressure system. The condition of the relief valve, which had become corroded and blocked (Figure 4), was indicative of the lack of maintenance on the oxy-acetylene system.

The blockage in the pressure relief valve and associated piping had remained undetected because the system had not been inspected or maintained in accordance with Marine Orders Part 12.
