ATSB TRANSPORT SAFETY INVESTIGATION REPORT
Marine Occurrence Investigation No. 235
Final

Independent investigation into the crew member fatality
on board the Isle of Man registered oil tanker

British Mallard

while berthed in Kwinana, Western Australia

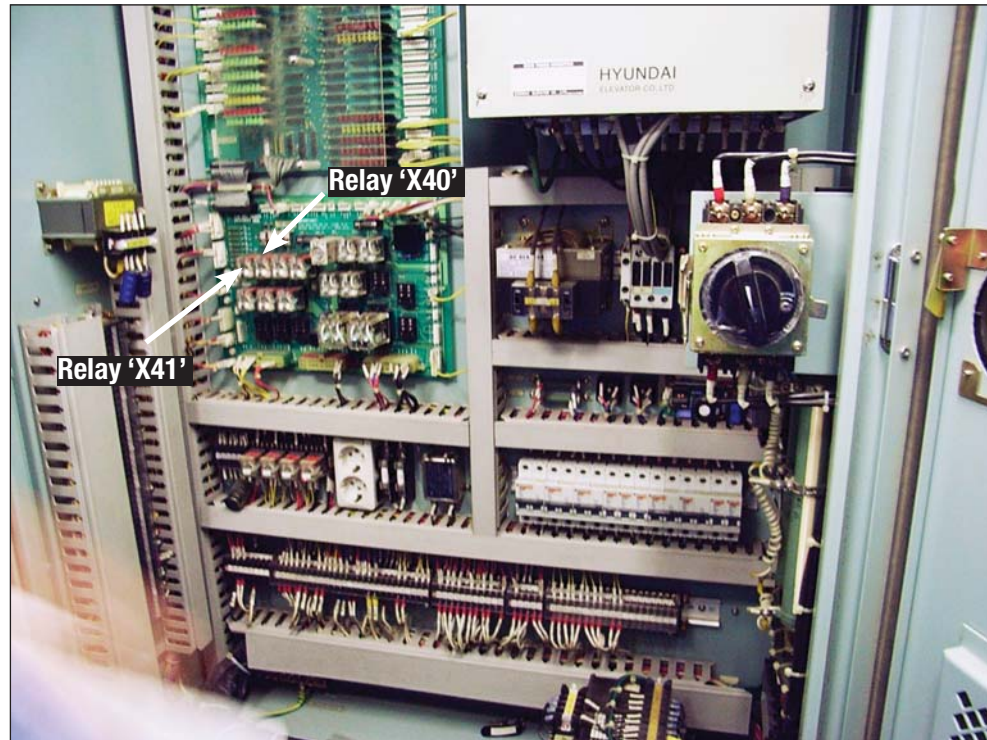
Figure 3: Elevator control cabinet

The elevator's car is raised and lowered, at a maximum speed of one metre per second, by wire cables that are propelled by an electric motor driven traction machine. The operation of the elevator, and all of its associated safety interlocks, is controlled by a micro-processor control unit. The traction machine and control unit (Figure 3) are located in the elevator machinery room. The machinery room is located in the engine room, on the third deck.

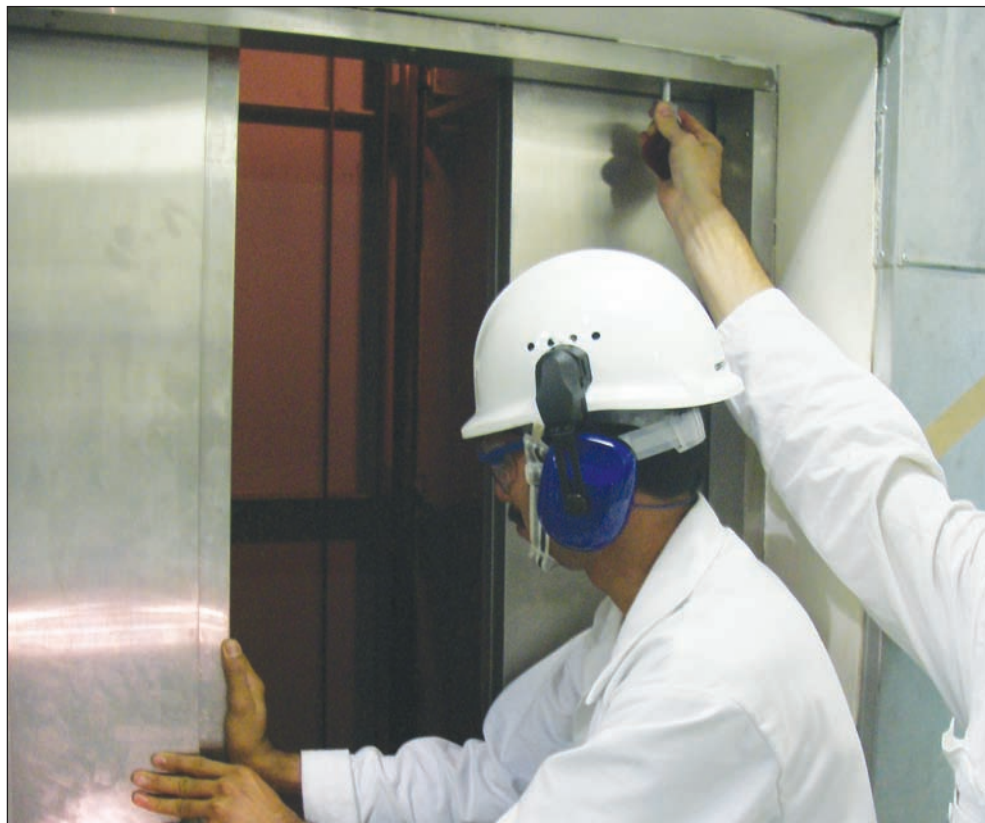
Figure 4: Elevator landing doors being manually opened

The second engineer and the electrical technician then went to the second deck and manually opened the elevator landing doors. The electrical technician started working on the landing door switches (Figure 5). After making some adjustments to the switches he stepped onto the ladder in the elevator shaft. He asked the second engineer to let the doors close behind him. He also told the second engineer that he would tap on the doors when he wanted them opened again.

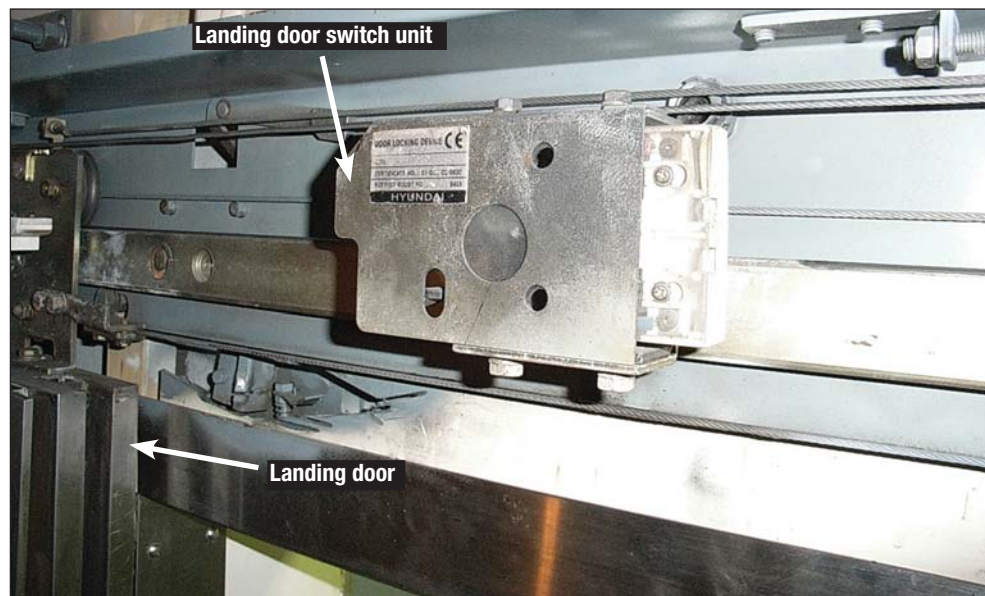
Figure 5: Second deck elevator landing door switch unit

At about 1750, when the electrical technician was preparing to work on the second deck elevator landing door switches, he was aware that the electrical power supply to the elevator had not been isolated. He had probably planned to leave the power on so that he could trace the fault in the elevator control system. His intention was for the second and third engineers to communicate with each other, via hand held radios, while he repaired the door switches. The third engineer was to report to the second engineer when relay 'X41' either energised or de-energised. The relay energising would indicate that the elevator door safety switches were closed and correctly latched.

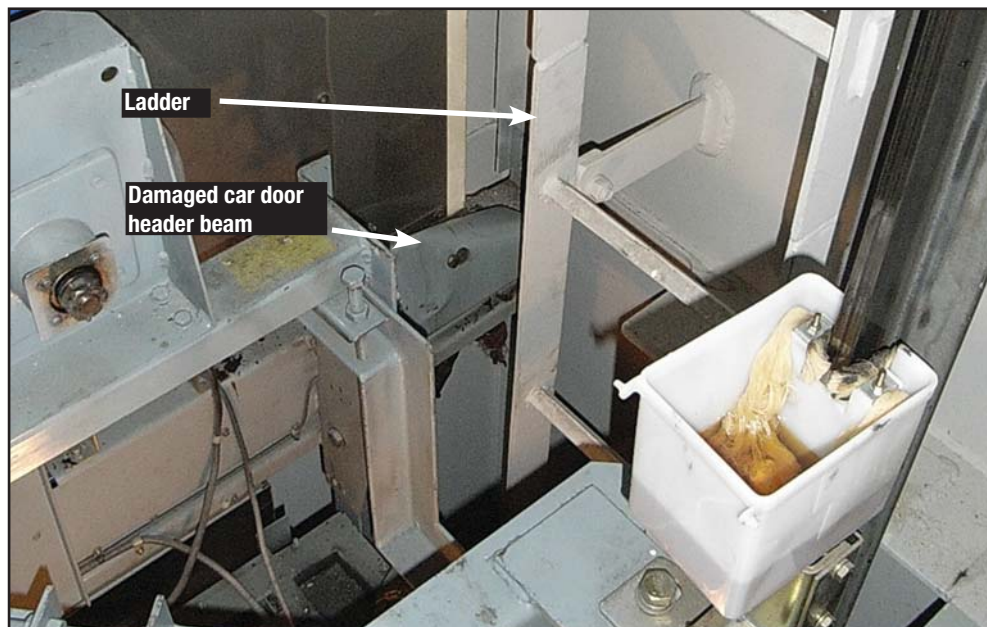
Figure 6: Damaged elevator car door header beam

While the elevator car was in motion, the car door operating wire held the doors closed (Figure 7). When the car door header beam was damaged, as a result of the accident, it is likely that the tension in the operating wire was released. The release of the wire probably resulted in the car doors opening slightly, enough to activate the door safety switches. The control system then stopped the elevator.
