ATSB TRANSPORT SAFETY INVESTIGATION REPORT
Marine Occurrence Investigation No. 236
Final

**Independent investigation into the engine
room fire on board the Bahamas registered
general cargo ship**

Baltimar Boreas

9 February 2007

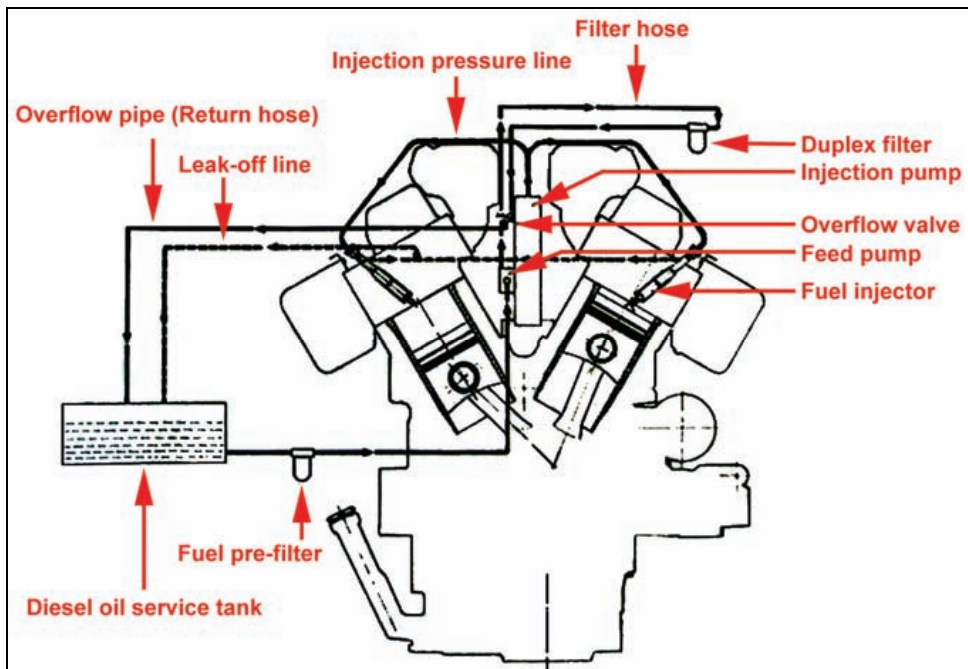
Figure 3: Generator fuel system

The two fuel hoses retained by the ATSB investigators were located on top of number three generator and showed clearly visible signs of damage and failure. One of the failed hoses (Figure 3) was fitted between the feed pump and the duplex filter (filter hose) and the other hose led from the overflow valve to just above the deck where it was connected to the fixed return line (return hose). The return hose was found in two pieces. It had apparently separated when a temporary repair joining the two sections of hose had failed. Analysis of the filter hose confirmed that it had failed due to mechanical rubbing or chafing over a long period of time.

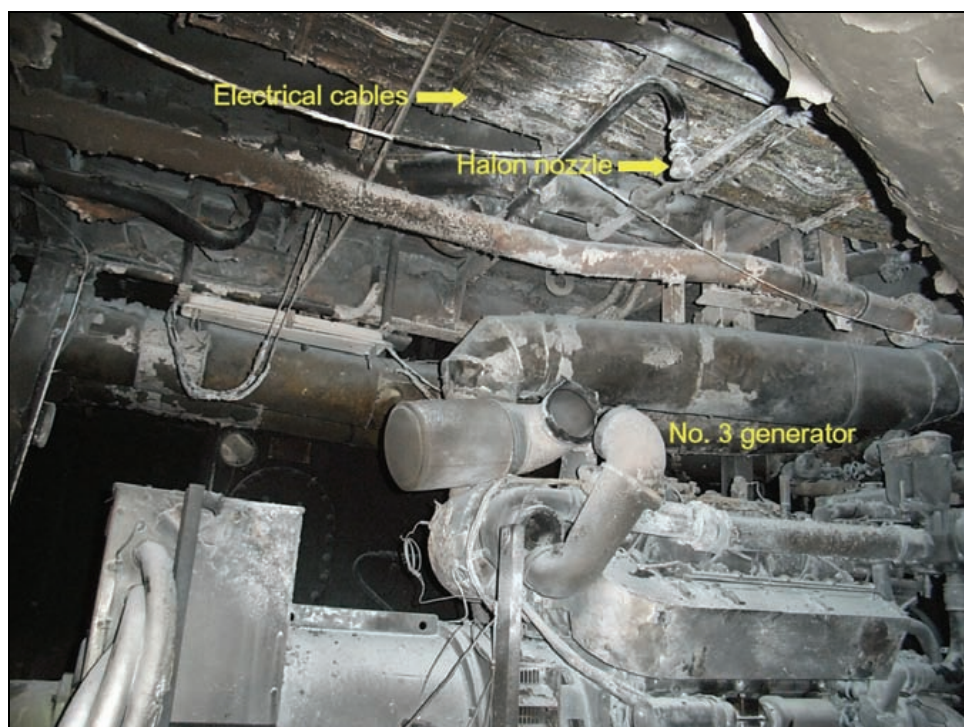
Figure 8: Number three generator and cables above it after the fire

At 0505, the chief engineer and three crew members, not wearing BA, entered the engine room. Ten minutes later, the chief engineer reported that number three generator had been badly damaged by the fire and that the electrical cables above it were burnt and had 'collapsed' (Figure 8).

The investigators found that the most serious fire damage was confined to number three generator and the electrical cables above it. Several components of the generator's control and fuel systems were also badly damaged, rendering it inoperable. The area adjacent to the generator had only minor smoke and radiant heat damage, mostly on the deck-head, the main deck above and inside the funnel casing which is immediately abaft the generator. Numbers one and two generators, about 1.5 m forward of number three generator, suffered only slight damage to some electrical components but were otherwise unaffected by the fire.

Baltimar Boreas remained in Newcastle for the next four weeks. A reconditioned engine was supplied to replace the number three generator engine and repairs were made to the ship's electrical system. An electrical consultant from Germany supervised the repairs and remained on board the ship to assist.

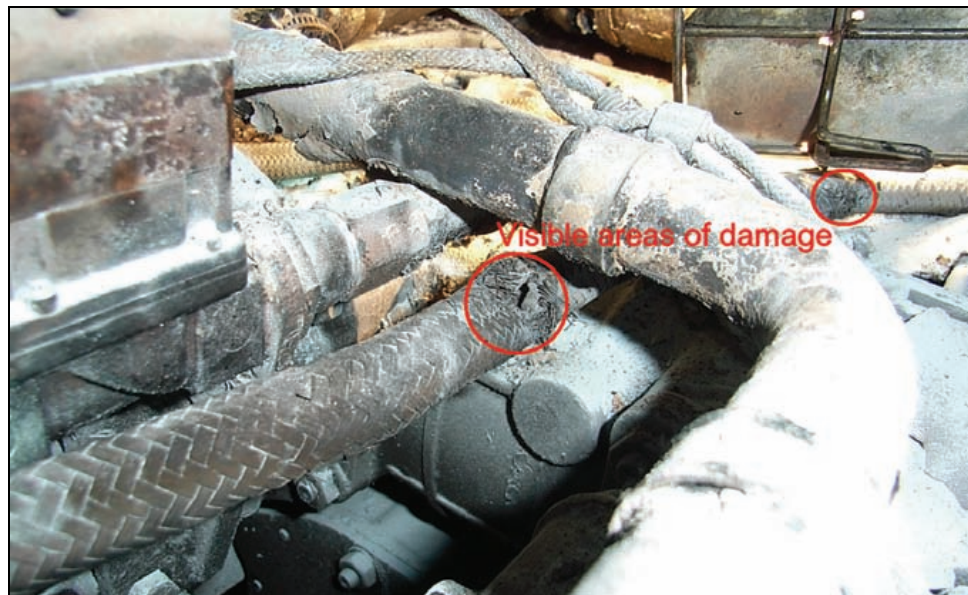
Figure 9: Failed 'filter hose' in situ with two visible areas of damage

The ATSB examination of the two failed hoses (the filter hose and the return hose) showed that they comprised a single protective outer layer of braided wire enclosing an internal fuel resistant rubber hose. The filter hose was connected to the feed pump inside the 'vee' of number three generator engine and its 700 mm length was led across the charge air cooler before being connected to the duplex fuel filter (Figure 9).

consistent with the manufacturer's specifications for the hose to be fitted in that position. Four distinct, significantly sized areas of damage were identified on the hose. Examination of the damaged areas under a low power stereo microscope indicated that abrasive wear was the principal process of primary wire braid failure in each location (Figure 10). Further examination under a scanning electron microscope confirmed that each wire in the braid had been worn to a thin flat profile by a process of wear. No other failure mechanisms, such as overload from excessive pressure or wire fatigue from cyclic oscillations, were evident.

The filter hose could have failed at any of the four areas of damage located on it. As the fire had affected the entire length of the internal rubber hose, it was impossible to say with certainty exactly where the hose may have failed before the fire. However, it is likely that the hose's failure provided the fuel to initiate the fire. It operated at a higher pressure than the return hose even though both may have been subject to much higher than normal pressures for very short periods of time due to pressure pulses in the generator's low pressure fuel system. The filter hose's normal working pressure was probably between two and five bar.

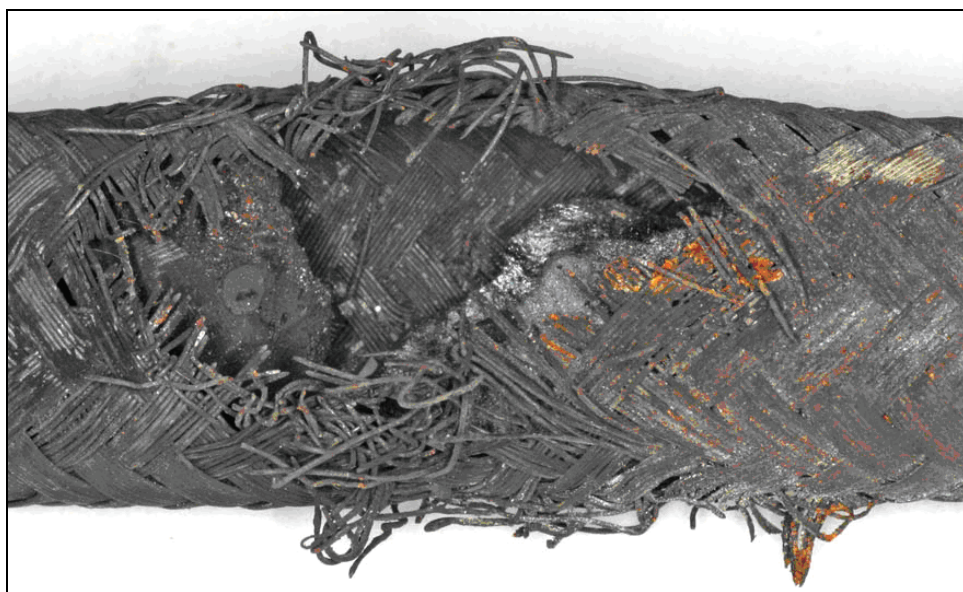
Figure 10: Close-up of the filter hose's wire braid wear

Analysis of the filter hose indicated that wear of the wire braid took place over a considerable period of time while it was in hard contact with solid surfaces on the engine. Vibration of the engine and fuel pressurisation cycles would have provided the necessary conditions for the process. Burnt rubber foam covered an area of pre-existing wire braid damage and indicated that an attempt to isolate the hose from further damage had been made some time before the fire.

In two areas of damage on the filter hose, including the one shown in Figure 10, the internal rubber hose had been entirely consumed. This indicates that the intensity of the fire was much greater in these locations. Once the wire braid at either location was worn, wear on the internal rubber hose would have weakened it. The evidence therefore indicates that a failure at either of these locations was more likely to have provided fuel to start the fire.

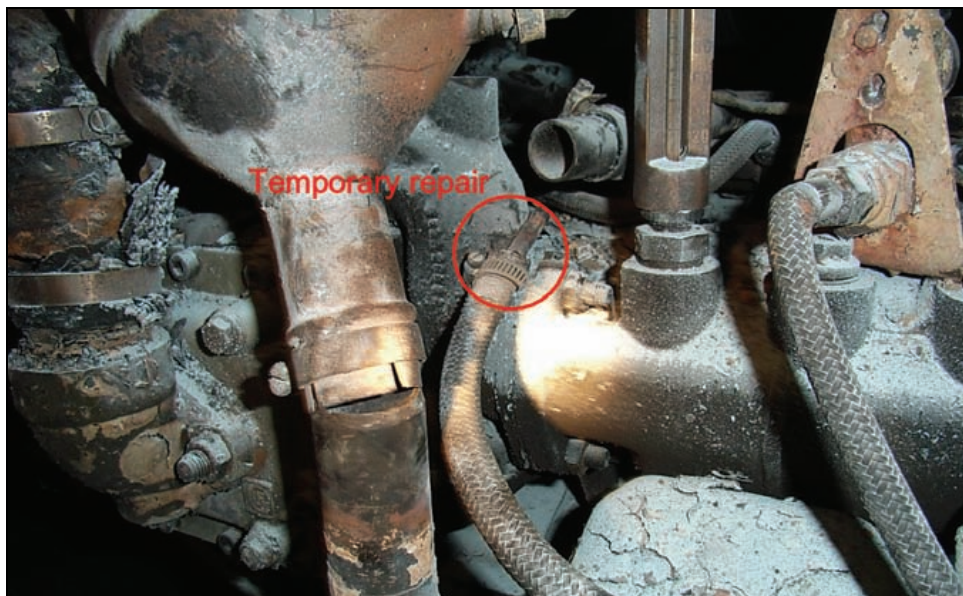
Figure 11: Failed 'return hose', lower part, in situ

The return hose probably failed after the fire started. The hose extended from the stop solenoid and overflow valve on top of the engine, across the exhaust manifold casing and down to deck level. A temporary repair had been made to it by inserting

a copper pipe between two pieces of the hose with a jubilee clip on either side to hold the connecting pipe in place. The repair is likely to have been made because of the lack of spares and on the basis that it was thought to be acceptable because the pressure in the hose was relatively low.

The wire braid on both sides of the temporary repair was worn where the hose had initially failed before being repaired. The hose then failed when the repair had come apart, probably after the fire started. The copper pipe remained attached to the longer lower part of the hose (Figure 11).

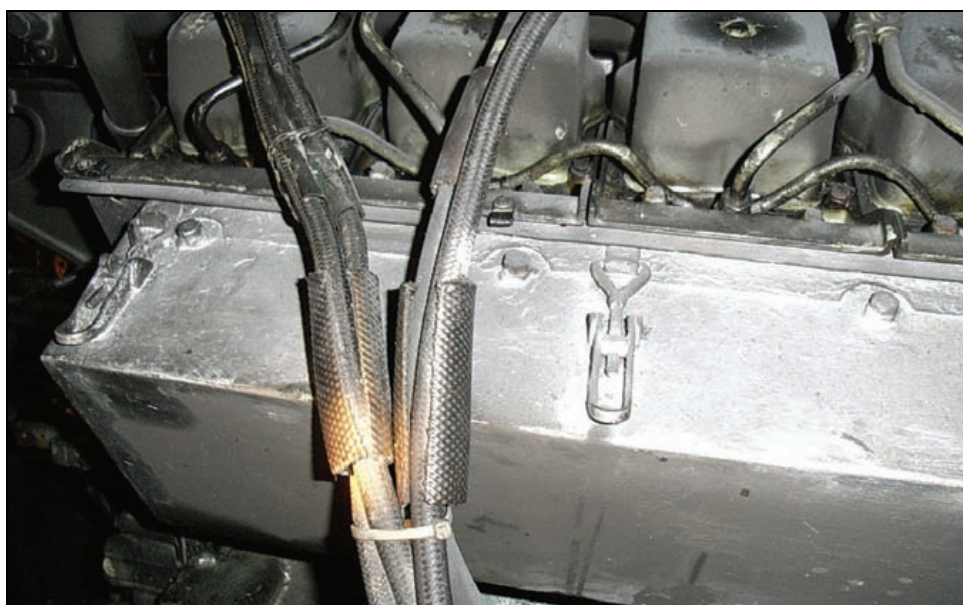
Figure 12: Protective sleeves on hoses

The extensive use of protective rubber or plastic sleeves, held in place with seizing wire or cable ties, on the fuel hoses suggests that the engineers had recognised the risks of the hoses chafing and had taken measures to prevent wear (Figure 12). In some locations, the sleeves had vibrated, slipped or come loose, leaving the hose unprotected. A few locations where the hoses were in contact with hard surfaces and could suffer wear damage had also been overlooked. Temporary repairs, similar to that found on the failed return hose, had also been made to other hoses.

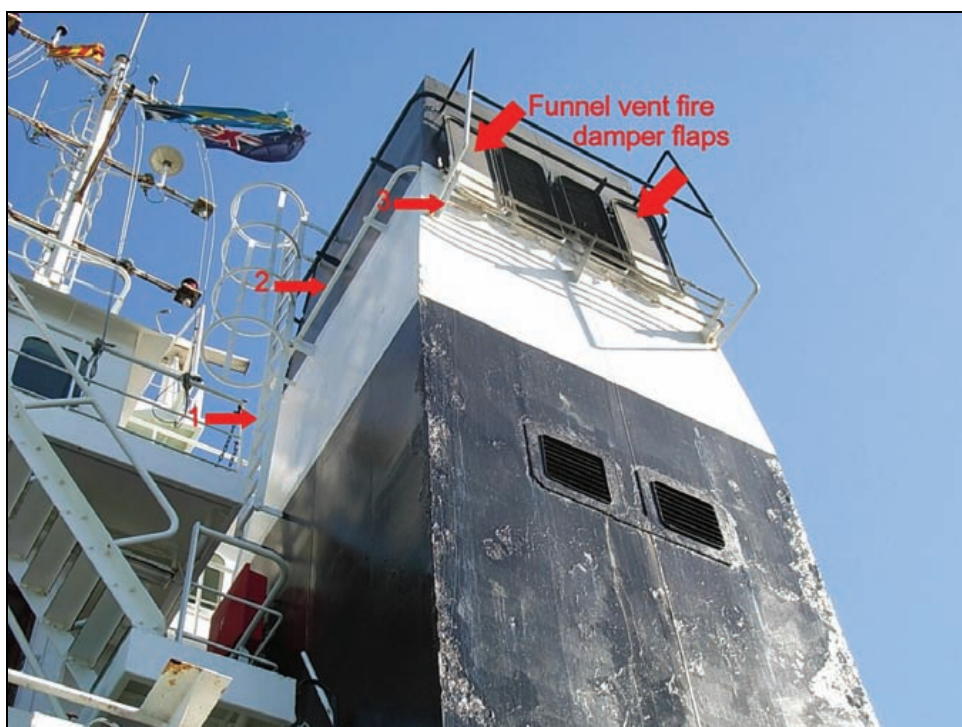
Figure 13: Access to funnel vent fire damper flaps

Baltimar Boreas's funnel vent fire dampers (Figure 13) could not be closed remotely, with provision only for physically closing them locally. Access was via a ladder (1) on the port side of the funnel, then by holding a rail while standing on another rail (2) and moving to the platform (3) on the aft part of the funnel. Here, while standing on the platform about 12 m above the main deck, the two damper flaps could be closed and dogged shut. Furthermore, closing the flaps required moving across an open vent at least once. With the emission of smoke, sparks and flame from the vents during the fire, closing the damper flaps was practically impossible.

The ship's funnel vent closing arrangements, therefore, did not meet the intent of the relevant SOLAS requirements and similar Lloyd's Register (LR) fire safety measures and rules. Despite this, they had been approved by LR and passed during subsequent class surveys. There was also no evidence to indicate that the deficiency had been noted by LR during audits required under the ISM Code or noted during maintenance, drills and inspections and reported.
