ATSB TRANSPORT SAFETY INVESTIGATION REPORT  
Marine Occurrence Investigation No. 238  
Final

Independent investigation into the boiler explosions  
on board the Panamanian registered bulk carrier

# Shirane

2 April 2007

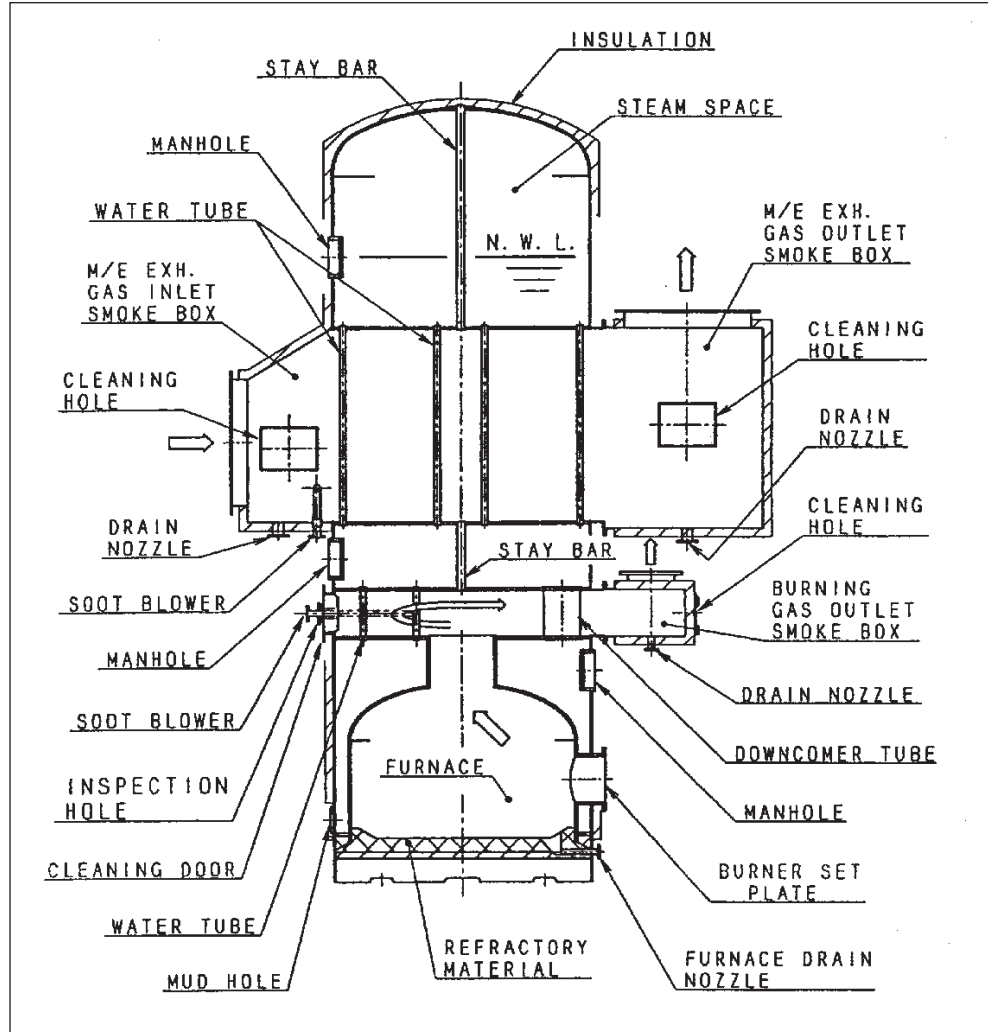
**Figure 3: Schematic diagram of boiler**

The upper section of the boiler water space houses the economiser part of the boiler (Figure 3). In this section, the main engine exhaust gases are directed over a bank of water tubes. Beneath the economiser section is the smoke box, which has a hot gas inlet from the furnace, another bank of boiler water tubes and an exhaust gas outlet.

The truncated hemispherical steel furnace lies below the smoke box. The furnace chamber has a single oil firing unit opening at one side. When the burner is firing, the flame is directed at the furnace wall opposite the burner opening with the flow of hot gas sweeping the periphery of the cylindrical furnace chamber before rising to the smoke box inlet.

Many auxiliary boiler designs have a water space around the entire furnace that acts to cool the furnace. However, this is not the case with the Osaka OEVC2 boiler. While the top part of the furnace is water cooled, the furnace floor is not. Furthermore, the floor is lined with refractory material which cools relatively slowly after the boiler has been firing.

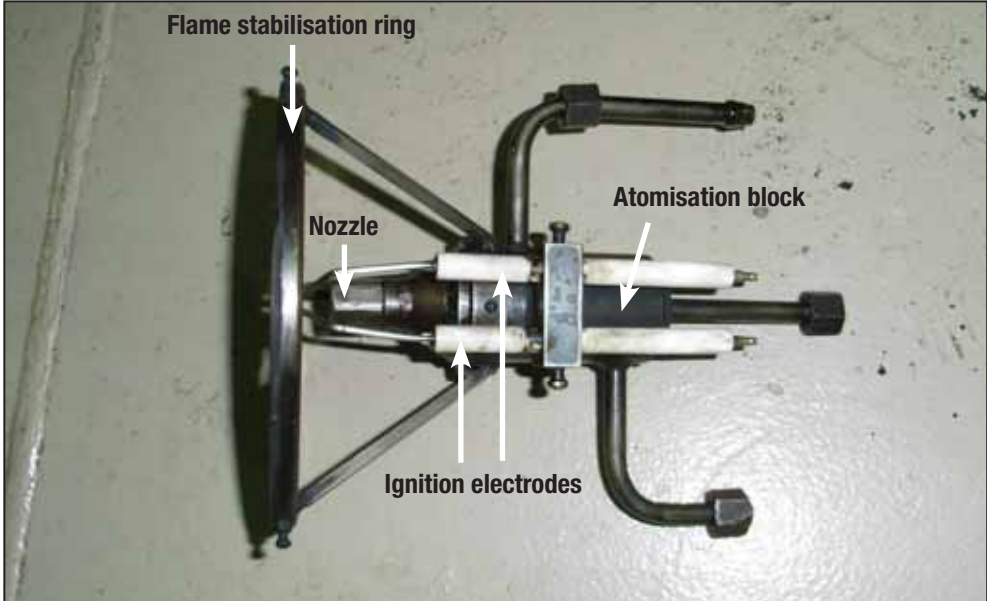
**Figure 5: Oil firing unit burner**

The burner (Figure 5) is fitted inside the oil firing unit at the boiler furnace opening. The burner consists of an atomiser block, which holds a single fuel nozzle, to which a flame stabilisation ring and a pair of ignition electrodes are attached. The atomiser block has three fuel line connections; one line is led from an electric solenoid valve which supplies the fuel nozzle, and the two other lines allow fuel circulation through the atomiser block. The burner may be removed from the oil firing unit through a maintenance cover at the top of the unit, after the ignition electrode cables and the three fuel pipes have been disconnected.

It was not unusual for *Shirane*'s boiler to misfire due to a build-up of carbon on the flame stabilisation ring. Consequently, during periods when the boiler was operating, it was normal practice for the burner to be exchanged with a clean replacement unit every few days.

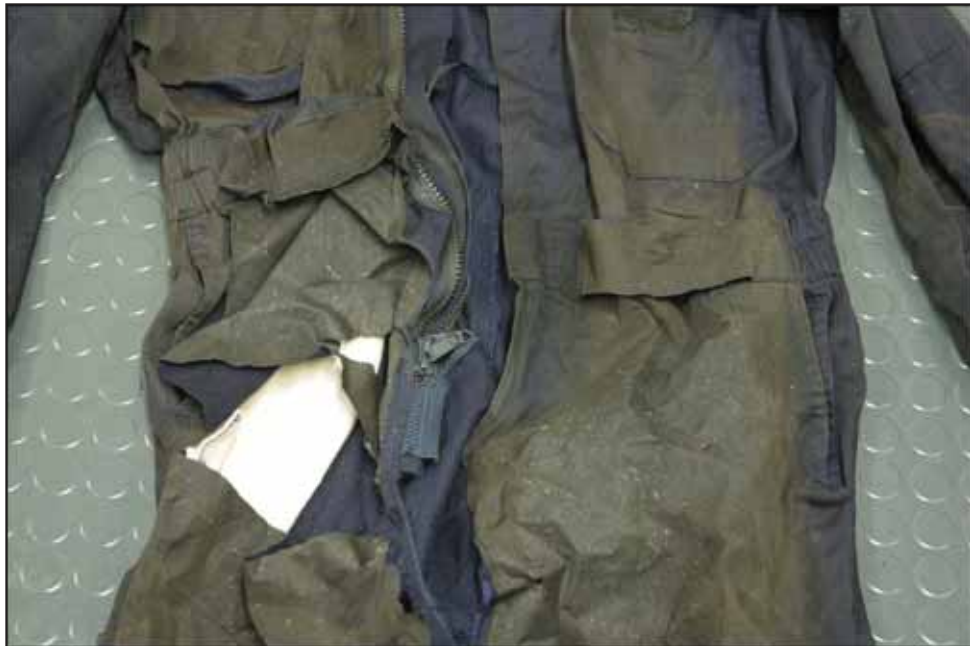
**Figure 6: The third engineer's polyester/viscose overalls**

When the third engineer's overalls were hit by the flames from the furnace flashback, the central zipper melted and the overall material ignited (Figure 6). The overalls had provided inadequate protection to the third engineer and, as a result, he sustained burn injuries to his stomach.

Neither the synthetic overalls nor the cotton overalls provided the engineers with the protection they needed. Therefore, they were not appropriate for the task.

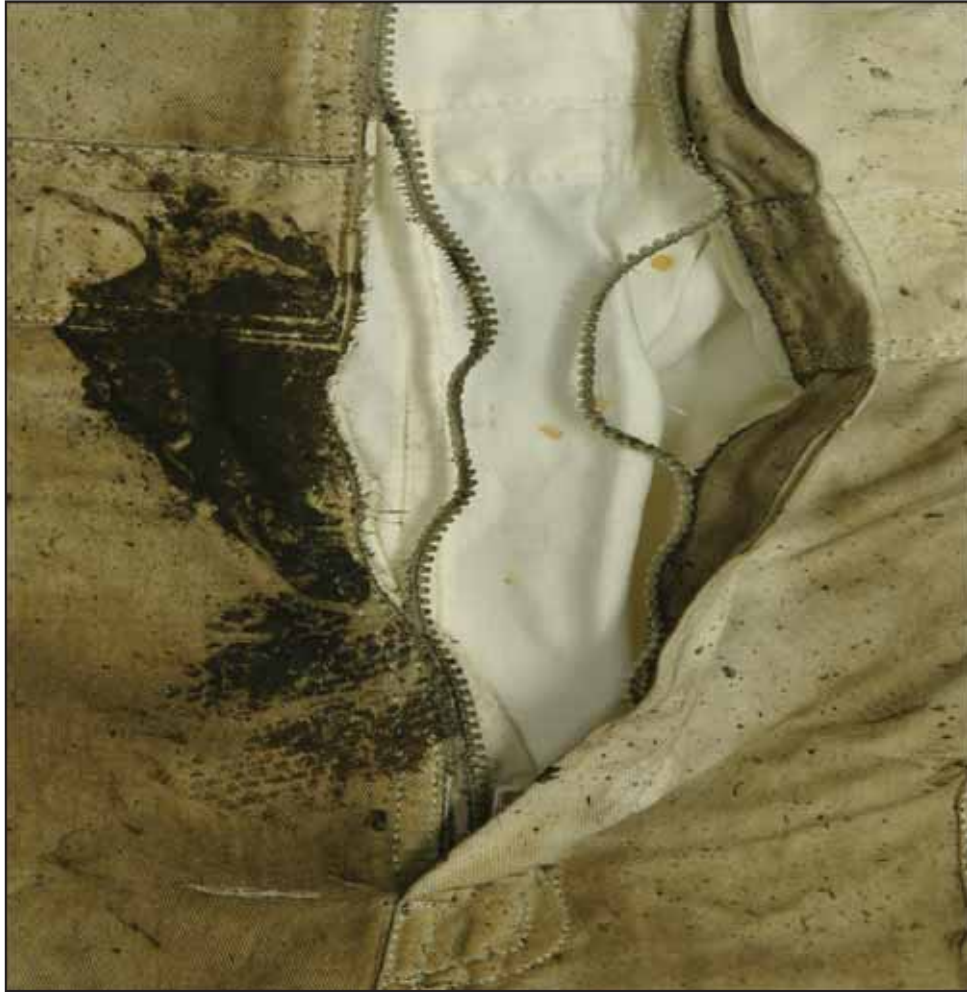
**Figure 7: The chief engineer's 100% cotton overalls**

On 2 April, the chief engineer and the second engineer were both wearing their issued white cotton overalls. While the second engineer's overalls were not severely damaged by the flashback, the chief engineer's overalls were. It is likely that the chief engineer's overalls were exposed to more flame because of the position he was in at the time of the flashback.

The central zipper in the front of the white cotton overalls was plastic and it was stitched into the overalls using a synthetic thread. When the chief engineer's overalls were exposed to the flashback, the zipper, and the thread holding it in place, melted (Figure 7). This allowed the overalls to fall open and resulted in the chief engineer sustaining burns to his stomach.
