ATSB TRANSPORT SAFETY REPORT  
Marine Occurrence Investigation No. 241  
Final

Independent investigation into the grounding  
of the Antigua and Barbuda registered bulk carrier

# Enterprise

Grassy Harbour, King Island, Tasmania

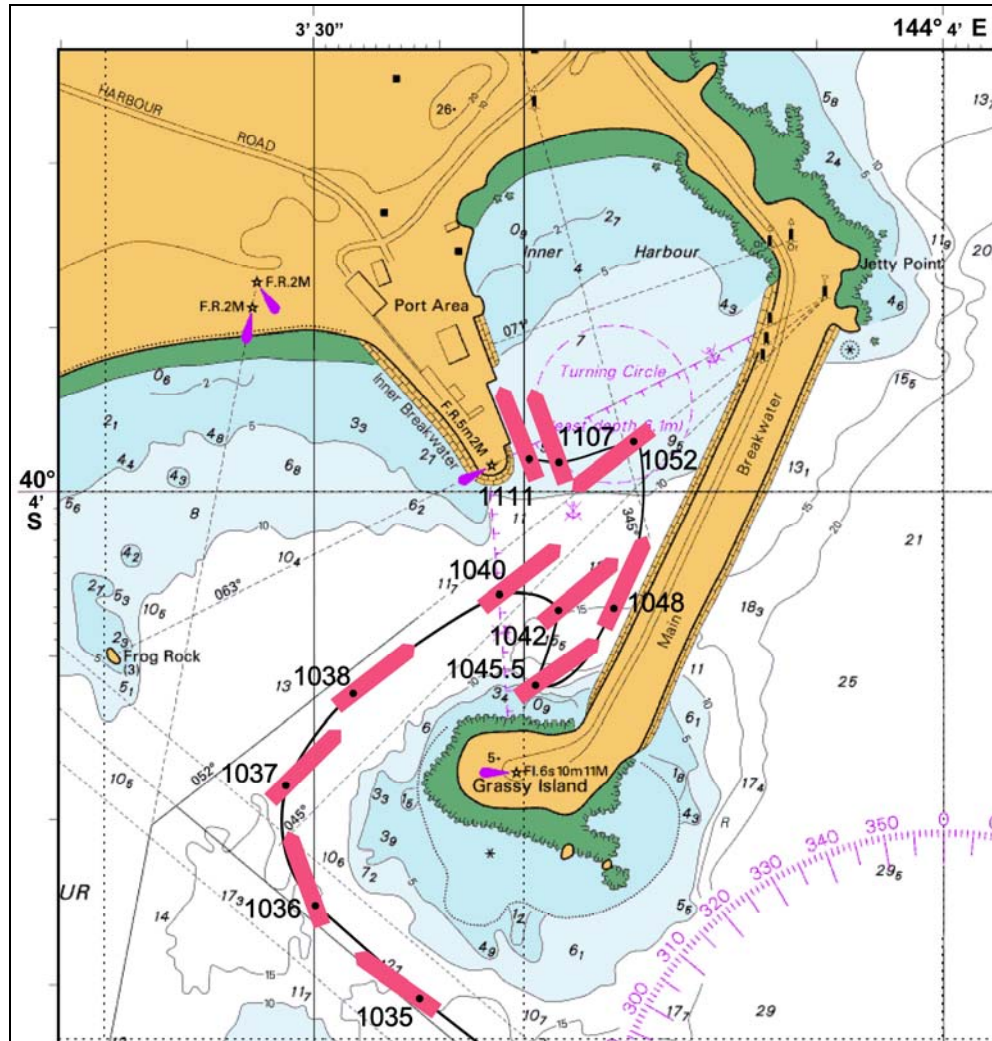
**Figure 6: Section of navigational chart Aus 178 indicating the ship's track with scale images, aligned to its heading, superimposed**

By 1040, the ship's speed had reduced to two knots and at 1041, the pilot ordered half astern. The stern was more than a ship's length off the berth and moving away from it, too far for the mooring line boat to take the stern line ashore.

By 1042, the ship was making sternway and the pilot reduced the propeller's pitch to zero. The main breakwater was about half a ship's length (55 m) to starboard and closing. The second mate and the third mate began reporting distances off the breakwater from their respective stations. The mooring line boat was called to assist getting *Enterprise* back into the centre of the channel, by pushing on the ship's starboard quarter but, with the rocks in close proximity, it was not able to maintain its position there.

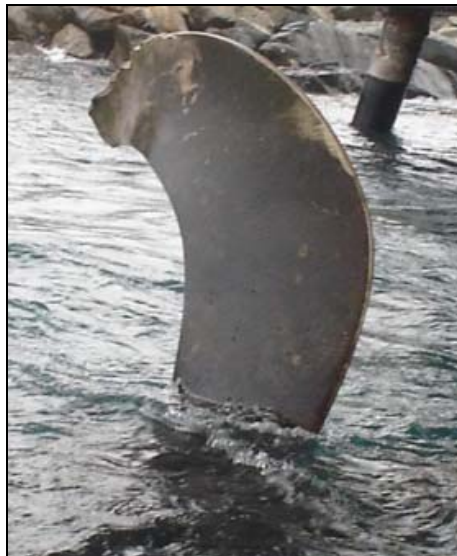
**Figure 7: Most damaged blade**

On 12 May, divers carried out an inspection of *Enterprise*'s hull and assessed the damage. All four of the propeller blades were damaged with extensive gouging, chipping, bending and cracking on their leading edges. One blade was missing 250 mm of its tip (Figure 7). There was slight damage to the rudder and only small areas of the bottom hull plating aft were set in, the most serious being about 35 mm deep over an area of about 400 mm by 250 mm.

A DNV surveyor attended the ship and, based on the damage assessment, two conditions of class were imposed. Under the conditions, the ship was permitted to proceed to its next port at reduced power and any excessive vibrations were to be reported. Repairs to the propeller were to be completed by 12 June 2007 and all other required repairs by the end of 2007.

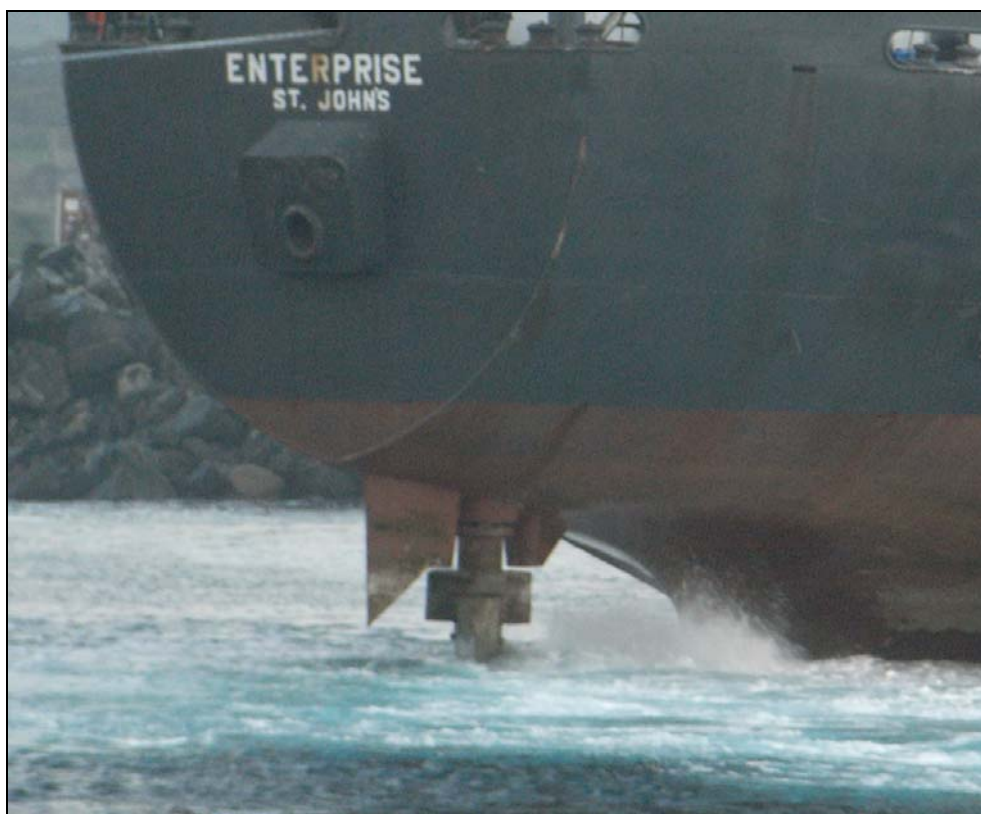
**Figure 9: Enterprise's propeller not fully submerged on departing Grassy**

Because propeller immersion is a very important factor to be taken into account when considering a ship's manoeuvrability, ship stability books provide mariners with all the necessary information to calculate propeller immersion.

- The pilot and master did not appropriately consider the adverse effect a partially submerged propeller would have on the ship's manoeuvring characteristics given the conditions that the ship was expected to experience during the berthing in Grassy.

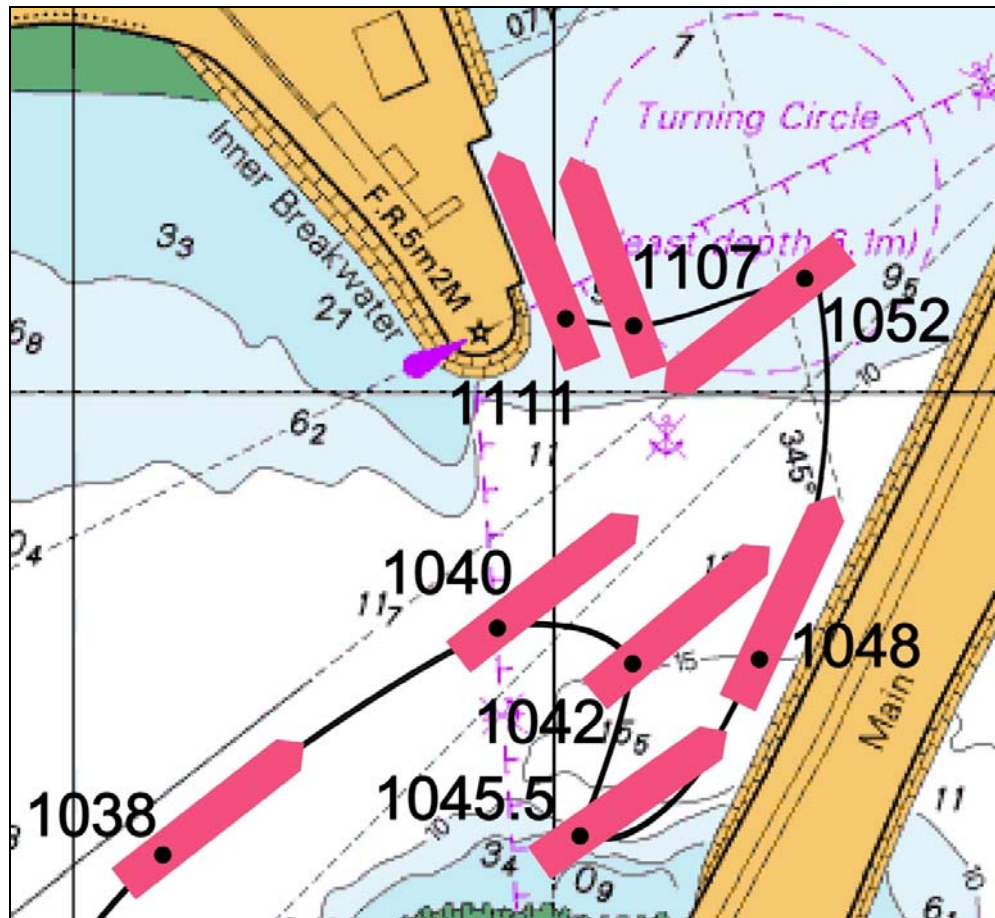
Figure 10: *Enterprise's* berthing on 10 May, ship images to scale

However, by 1038, the ship was still moving forward at the same speed (Figure 10). Any speed reduction due to the turn had probably been counteracted by the wind and tidal stream, both of which were now astern.

At 1038½, the pilot ordered full astern and, in a continued attempt to maintain the bow's position in the channel, ordered full starboard thrust on the bow thruster. By 1040, the ship's speed had fallen to 2.0 knots, which then made the bow thruster and propeller's transverse thrust more effective and the ship started to move bodily to starboard. It was at this time that the ship's lateral movement became readily apparent to the master and pilot.

At 1041, the ship was moving bodily to starboard at about 1.0 knot. The fact that the ship was to starboard of the leads after the turn now compounded the problem, as there was an even smaller margin for error in relation to the breakwater that was to starboard of *Enterprise*. The ship's position and pronounced movement in the confined area probably made it evident to the pilot that the plan would not succeed. As a result, the pilot and master decided to abort the approach and take the ship, stern first, out of the harbour.
