ATSB TRANSPORT SAFETY INVESTIGATION REPORT
Marine Occurrence Investigation No. 242
Final

Independent investigation into the near collision
between the bulk carrier

Ormiston

Searoad Mersey

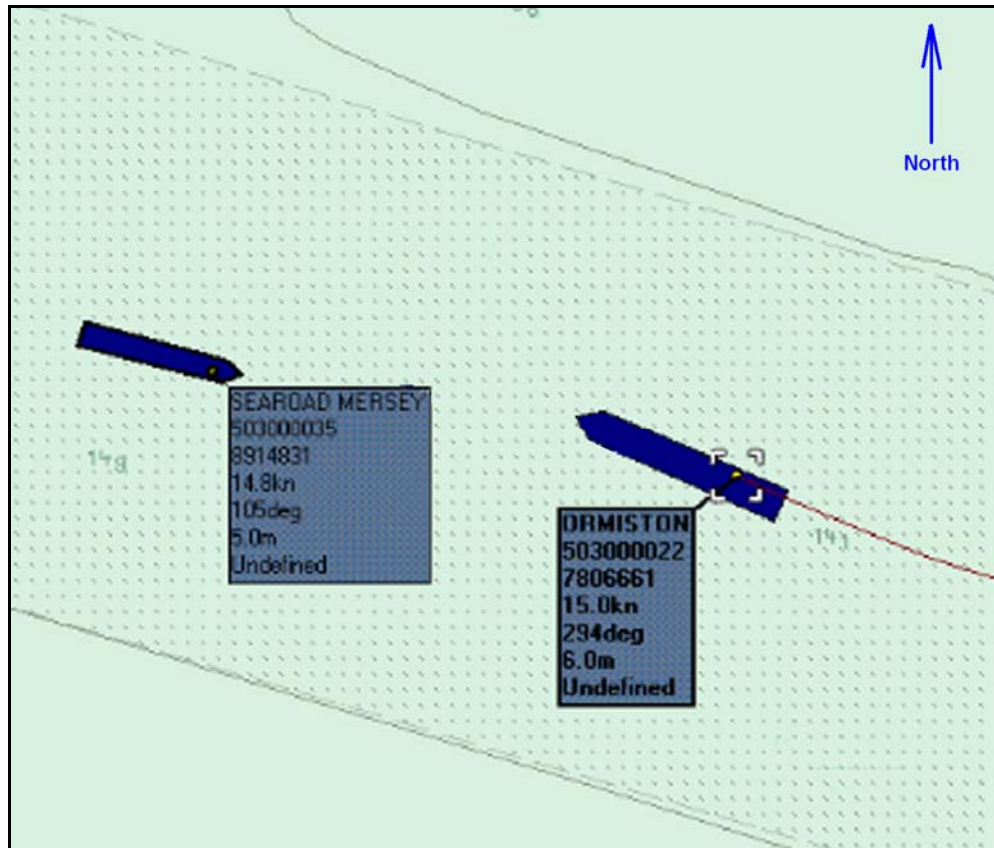
Figure 5: VTS AIS image of the both ships near the centreline of the channel at about 0523

At about 0521, *Ormiston* passed number 14 beacon and entered 'The Cut' from the east on a course of 286° (T). *Ormiston*'s chief mate confirmed to the master that the ship was still to the north of the centreline of the channel but suggested that the ship could go further north in the channel to provide a greater clearance from *Searoad Mersey*. *Ormiston*'s master thought that *Searoad Mersey* appeared to be coming down the centreline of 'The Cut' (Figure 5) so he directed the helmsman to alter course to 290° (T). He continued to stand near the steering console with the helmsman and visually monitored the ship's proximity to the northern edge of the channel and guided the ship as far to starboard as he considered possible, while still remaining in the channel.

Shortly afterwards, *Ormiston*'s helmsman reported to the master that he had gone further to starboard than the ordered course of 290° (T). The master told him not to come back to port.

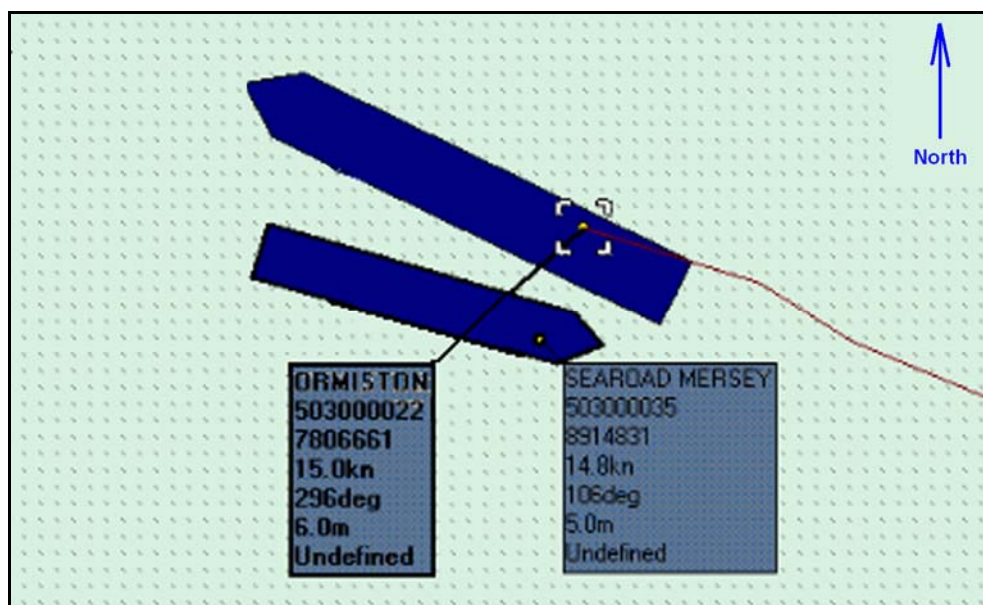
Figure 6: VTS AIS image of the ships passing at about 0523½

According to AIS data, at about 0523½, *Ormiston* and *Searoad Mersey* passed each other less than 20 m apart in ‘The Cut’ (Figure 6).

Based upon VTS AIS data and information gathered from both ships, it was determined that at about 0523 ½ on 16 May 2007, *Ormiston* and *Searoad Mersey* passed in 'The Cut' in the Port Phillip South Channel, less than 20 m apart, whilst travelling at a combined speed of almost 30 knots. If the ships had collided, there would have been very significant damage to the ships and they may have blocked the main channel into Melbourne and probably caused significant pollution.
