AUSTRALIAN TRANSPORT SAFETY INVESTIGATION REPORT
Marine Occurrence Investigation No. 244

Crew member fatality on board *Oceanic Angel*

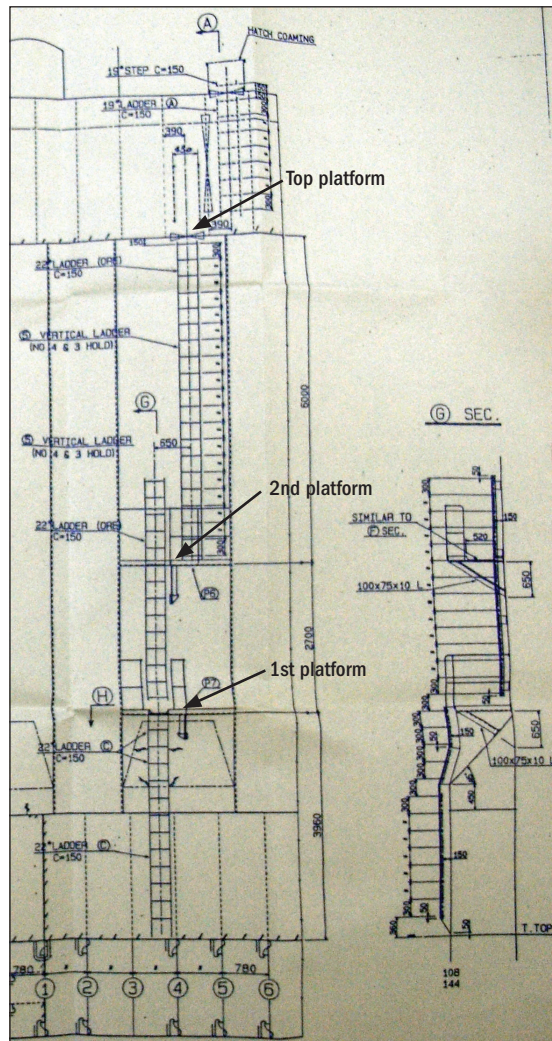
Figure 2: No. 3 cargo hold forward ladder

One of the seamen made his way to the cargo hold's aft ladder and started climbing out of the hold, while the other went to the forward ladder (Figure 2) to do likewise.

The ladder was in good condition and there was no evidence found on board the ship to suggest anything other than that the seaman slipped and fell from the cargo hold ladder.

The forward and aft cargo hold ladders were constructed differently. The middle section of the aft cargo hold ladder was an inclined staircase and, hence, probably easier to climb. However, no one on board the ship knew why the deceased seaman decided to exit the hold via the forward ladder.

Therefore, the seaman probably reached a height on the ladder that was beyond the first platform (Figure 2), where the face mask was found, but lower than the top platform, the height that the other seaman had reached.

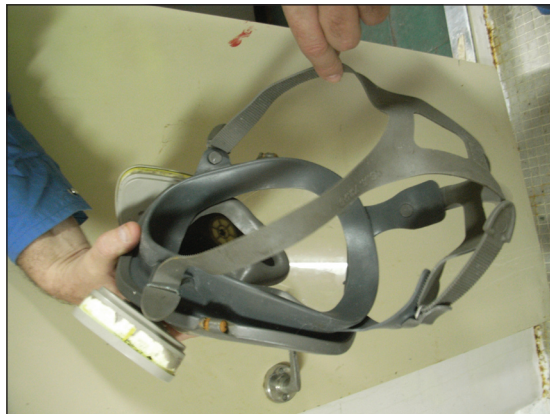
Figure 3: Respirator/face mask

The seaman was not wearing his face mask when he was found. The mask was found on the first platform of the ladder, about four metres above the tank top, and its securing straps had been deliberately released (Figure 3). It is likely that the seaman had removed the mask either before climbing the ladder, or while on one of the ladder's platforms. The action of removing the mask would, almost certainly, have delayed his exit from the cargo hold.

Since the seaman had removed his face mask, it is likely that he was carrying it when he fell. Carrying any item while climbing a ladder can make the task more difficult, as it can get snagged or interfere with the individual's hold on the ladder.
