ATSB TRANSPORT SAFETY INVESTIGATION REPORT  
Marine Occurrence Investigation No. 245  
Final

Independent investigation into the fire on board  
the Antigua and Barbuda registered general cargo ship

# BBC Islander

14 August 2007

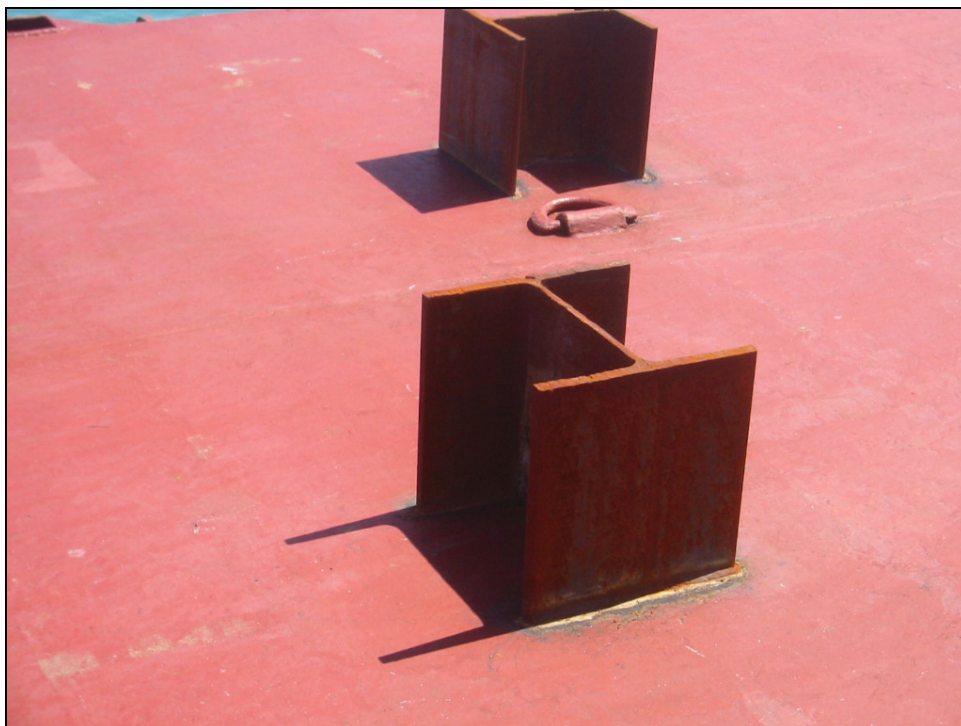
**Figure 2: Stoppers welded to the hatch covers.**

At 0740, the boatswain came to the bridge for his morning work meeting with the chief mate. Amongst other things, they discussed the need to remove the stoppers from the hatch covers. The task was assigned to the ship's fitter, who was to cut the stoppers off the deck using oxy-acetylene cutting equipment and then grind off any remaining material so the hatch covers were smooth.

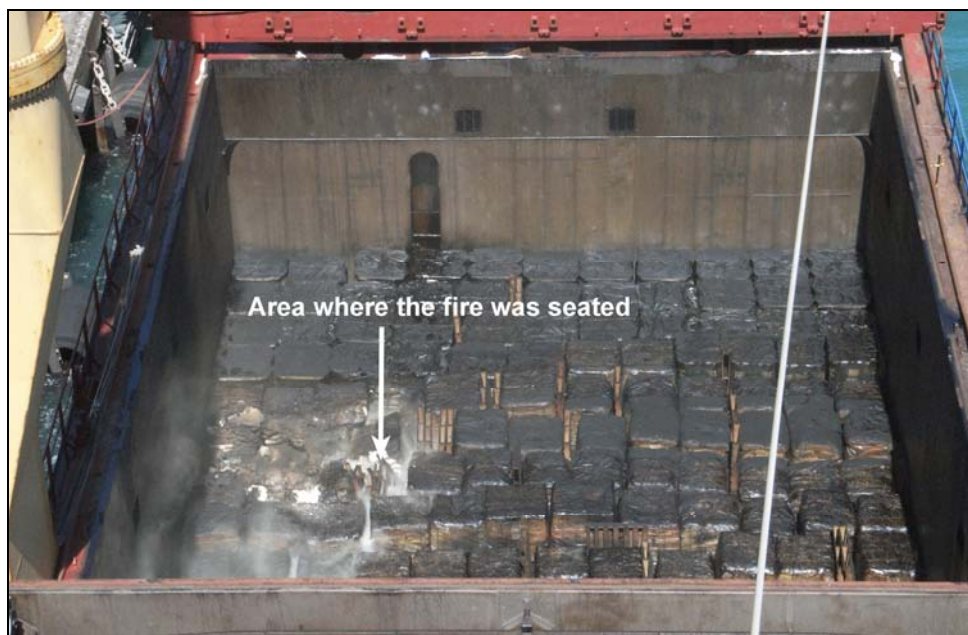
**Figure 3: The aft cargo hold after the smoke had cleared.**

At about 1620, the aft cargo hold hatch covers were opened and, after the smoke had cleared, the area where the fire was seated could be identified (Figure 3). However, the introduction of air into the cargo hold caused the fire to reignite. Some flames were detected and they were extinguished using a small amount of water.

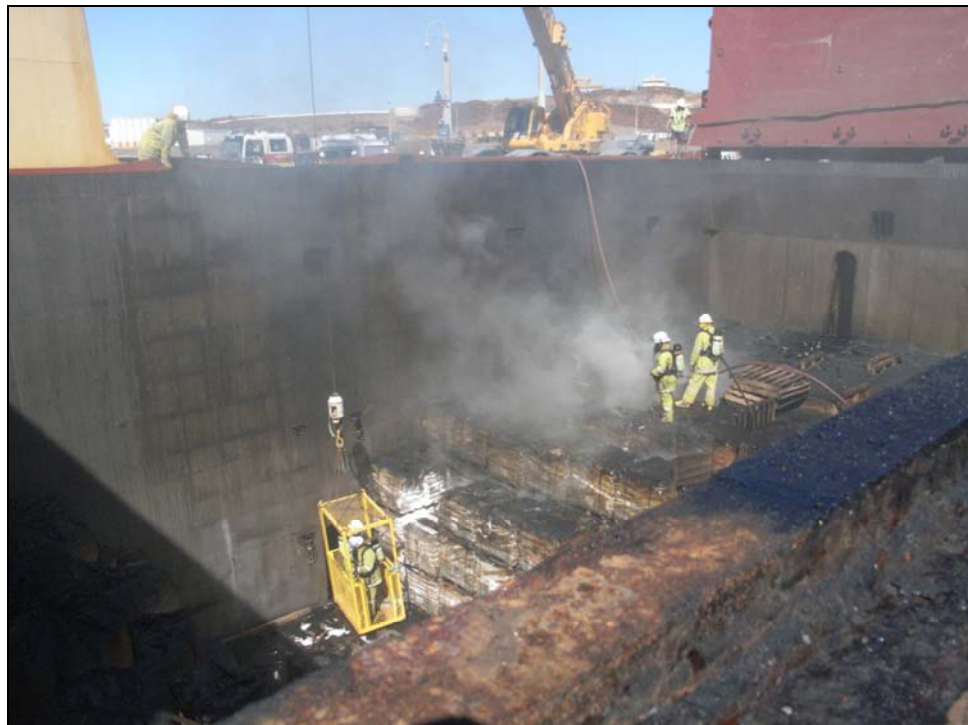
**Figure 4: Fire fighters attempting to access the seat of the fire**

At about 1630, operations were stopped and the fire fighters were removed from the hold. The forward stack of cargo had become unstable and the forklift was slipping and sliding on the wet tank top. Furthermore, the introduction of air, when the pallets of cargo were moved to access the seat of the fire, had caused the fire to spread. A blanket of foam was spread over the fire affected area of cargo and the hatch covers were partly closed.

However, the attempt to access the seat of the fire on board *BBC Islander* and extinguish it may have been destined to fail, primarily because the fire fighters had complied with the master's request to limit their use of water. Without using sufficient amounts of water it was unlikely that the fire fighters were going to be able to extinguish the deep seated fire.

The fire fighters may have experienced difficulty even if they had been free to use large amounts of water to extinguish the fire. It was the water lying on the cargo hold tank top that led to the difficulty they experienced controlling the forklift while they were attempting to access the seat of the fire. Furthermore, as the fire developed and the fire fighters applied water in an attempt to extinguish it, the stack of cargo became unstable. Eventually, this attempt to access the seat of the fire and extinguish it was abandoned because it was deemed unsafe to allow the fire fighters to continue working in the hold.

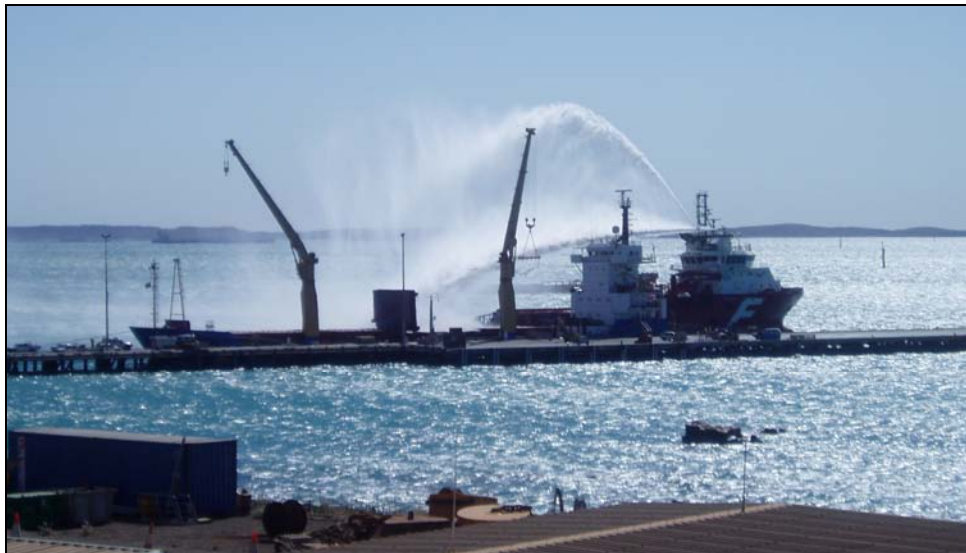
**Figure 5:** *Far Sword's* fire monitor being used to extinguish the fire

At 1410, the hatch covers were opened and the offshore supply vessel *Far Sword* came alongside *BBC Islander*. A jet of water from *Far Sword*'s fire monitor was then directed over the cargo in *BBC Islander*'s aft cargo hold (Figure 5). In about 12 minutes, approximately 700 tonnes of water was pumped into the hold (Figure 6).

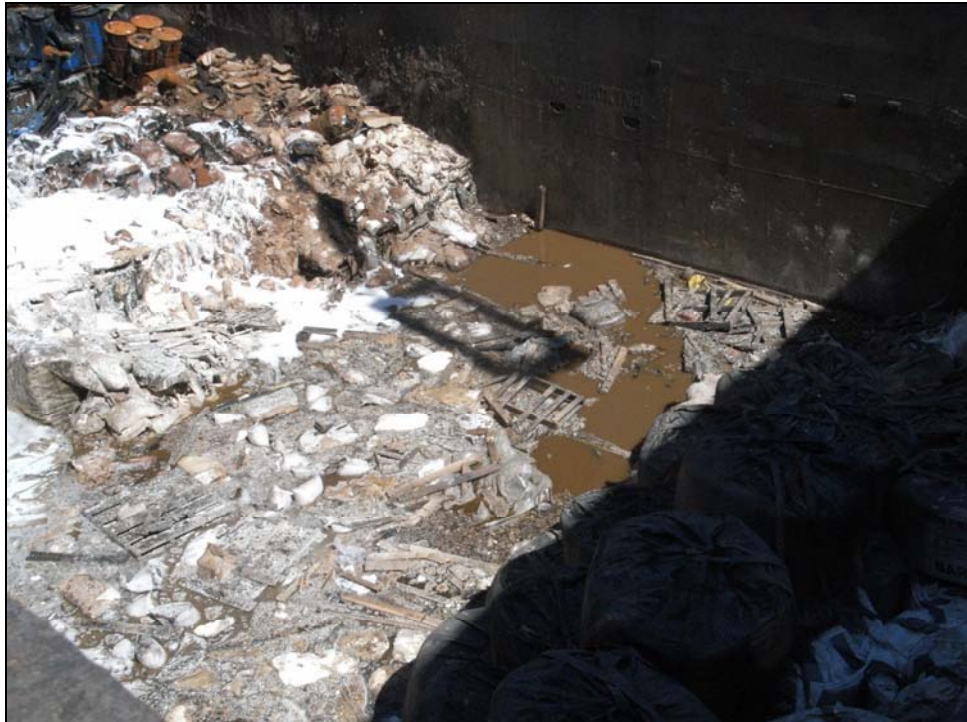
**Figure 6: The hold flooded with liquid to a depth of about two metres.**

The water in the hold had mixed with the cargo and, on the morning of 19 August, a sample was taken to determine the level of contamination. The contaminated water had a pH<sup>5</sup> reading of 11 and was, therefore, corrosive and had to be removed from the ship and disposed of appropriately.

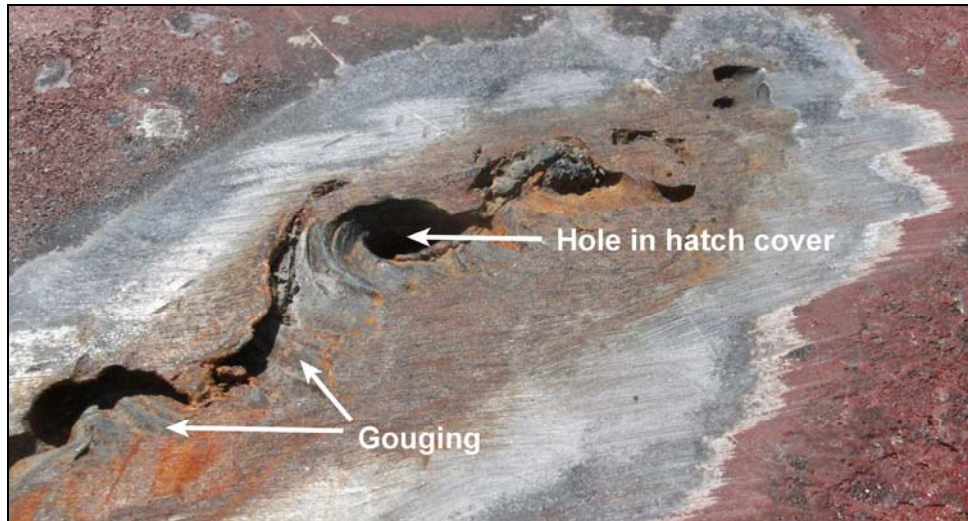
**Figure 9: The gouging of the hatch cover**

The stoppers were made from sections of mild steel I-beam and were about 15 mm thick so the fitter tried to cut them off as close as possible to the hatch covers to ensure that the amount of material that was left to grind off was minimised. However, the design of the oxy-acetylene cutting torch (Figure 8) led to him directing the oxy-acetylene flame downwards, at an angle towards the hatch covers. This resulted in areas of the hatch cover material being gouged by the flame (Figure 9).

At about 1310, when the fitter removed the last stopper from the port side of the aft cargo hold hatch covers, he inadvertently cut a hole through the hatch cover. As a result, sparks and molten metal were blown into the cargo hold and onto the cargo stowed below.

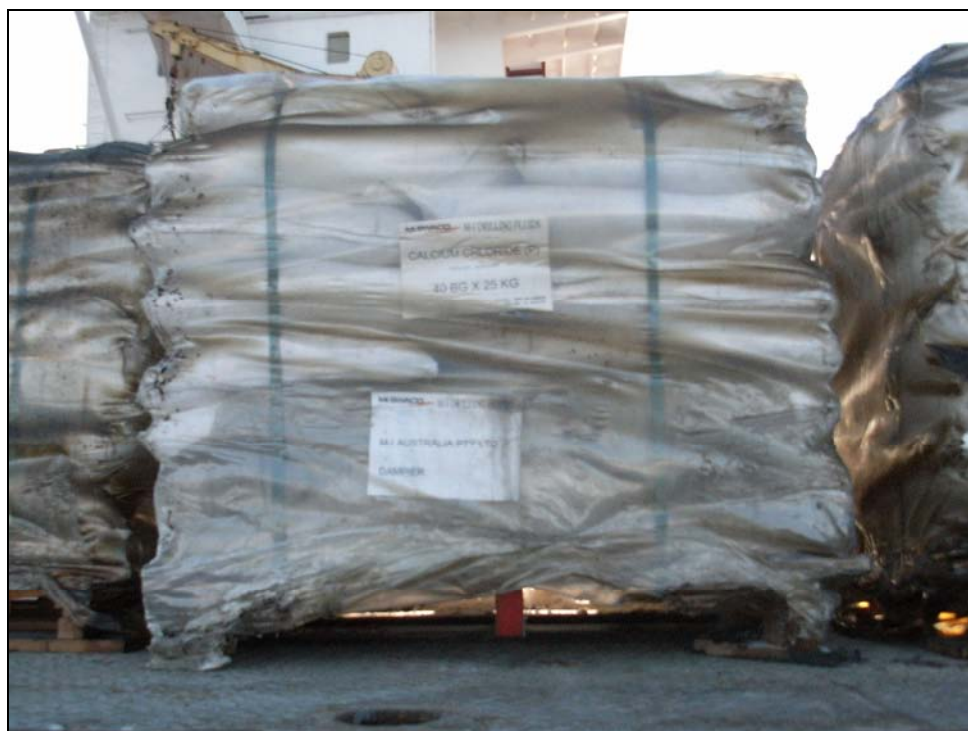
**Figure 10: Pallets of dry drilling mud**

The cargo stowed directly below the hole consisted of polyester bags of dry drilling mud that had been loaded onto wooden pallets and then shrink wrapped in plastic (Figure 10). Dunnage, mostly loose wooden pallets, had been placed between the stacks of cargo in order to stop any cargo movement in a seaway. It is likely that the sparks and molten metal fell down between the stacks of cargo and that the plastic shrink wrap started to melt. Soon afterwards the wooden pallets and dunnage probably ignited.

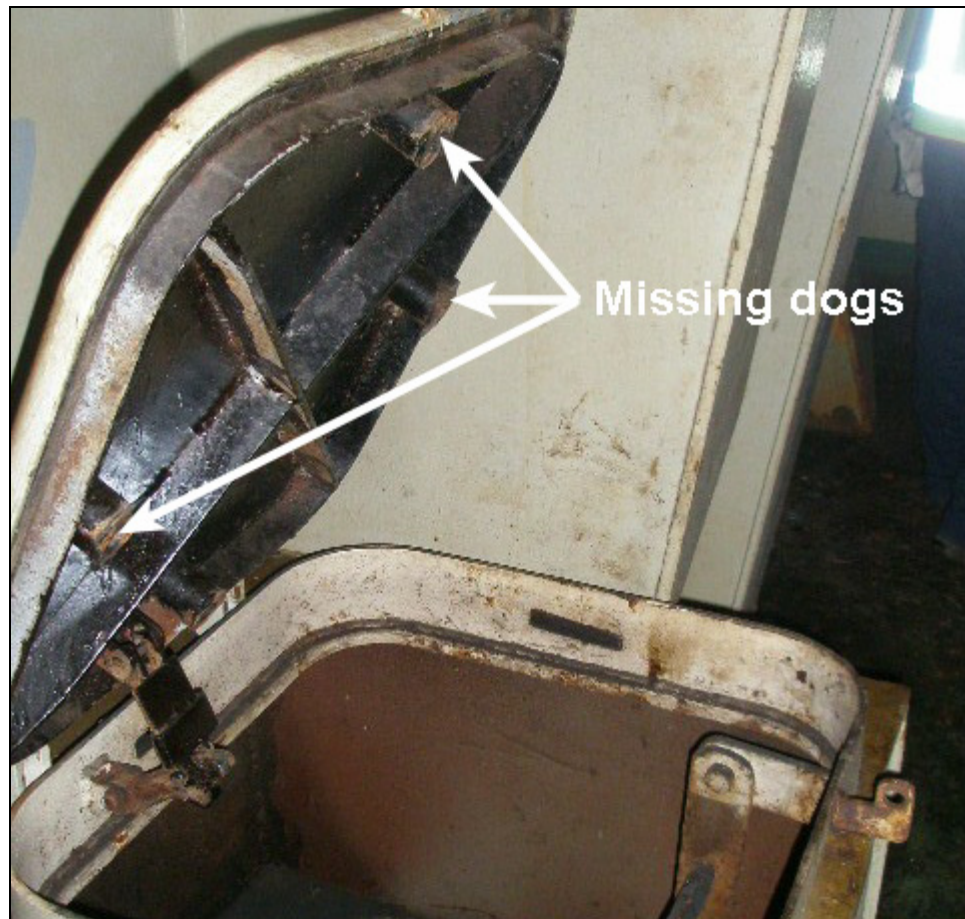
**Figure 12: Hatch with missing dogs**

When the AMSA surveyors carried out the port state inspection on board *BBC Islander* after the fire, they discovered that the dogs securing the small access hatch between the aft cargo hold and the port side longitudinal void space were missing (Figure 12). The hatch was about 700 mm x 700 mm in size and positioned half way along the hold, about two metres below the hatch cover. The hatch was closed but not sealing correctly. Consequently, on each occasion that CO<sub>2</sub> was discharged into the hold, a small amount of the gas may have escaped through the poorly sealed hatch. Therefore, the effectiveness of the CO<sub>2</sub> in extinguishing the fire may have been diminished.

- The access hatch between the ship's aft cargo hold and the port side longitudinal void space was not sealing correctly because its securing dogs were missing. As a result, some of the carbon dioxide may have escaped from the hold, thus reducing its effectiveness in extinguishing the fire in the cargo hold.
