Collision between *Namhae Gas* and *Rexandra*

30 November 2007

ABSTRACT

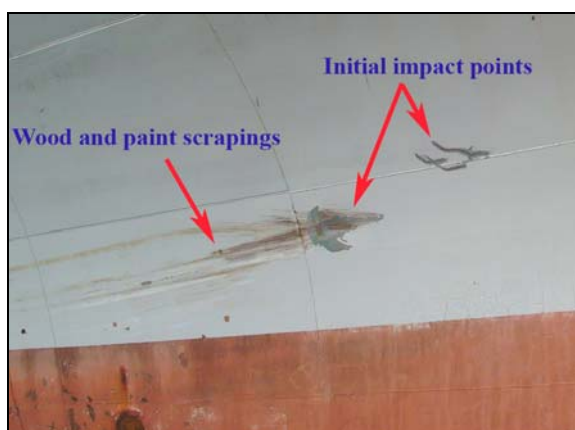
Figure 3: Markings on *Namhae Gas's* bow

The paint samples from *Namhae Gas* were taken from newly created contact marks on the ship's

starboard shoulder (Figure 3). The marks were consistent with the ship being hit by a metal and wooden object which then slid partway down the ship's starboard side.

The damage to *Rexandra's* bow was consistent with the fishing vessel hitting something nearly head on, then moving to port.

Forensic analysis of the paint samples strongly supports the proposition that the two vessels came into contact with each other.

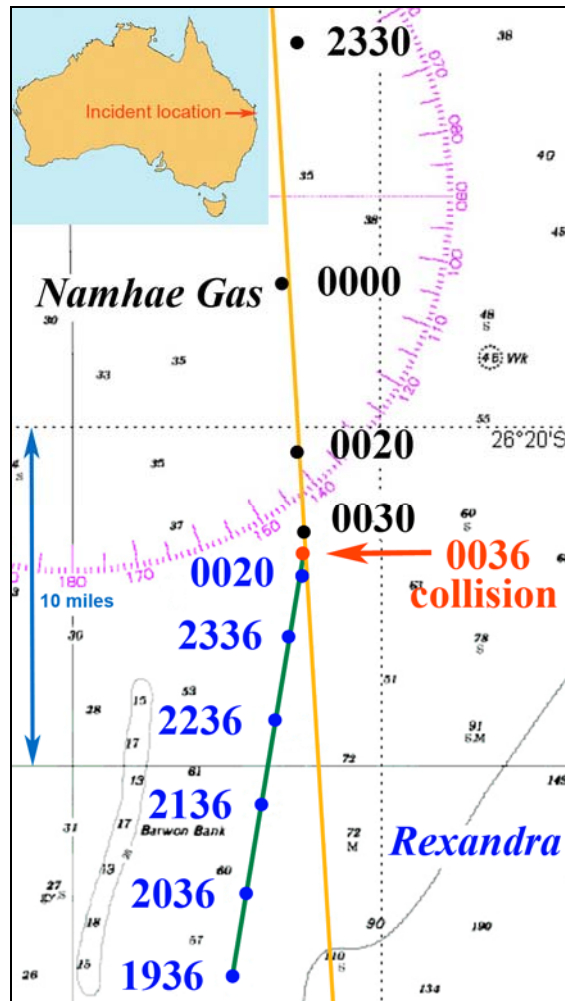
Figure 4: Section of navigation chart Aus 365

A reconstruction of the relative positions of the two vessels⁶ (Figure 4) shows that when he first saw the lights of the ship at 0020, they were only 3.6 miles apart, on an almost steady bearing.

The plotting of *Namhae Gas* and *Rexandra*'s tracks shows that the two vessels were on a relatively steady bearing for more than an hour before the collision occurred (Figure 4). Therefore, the risk of collision existed all of this time.
