ATSB TRANSPORT SAFETY REPORT  
Marine Occurrence Investigation No. 248  
Final

Independent investigation into the grounding of the  
Australian registered bulk carrier

# Endeavour River

at Gladstone, Queensland  
2 December 2007

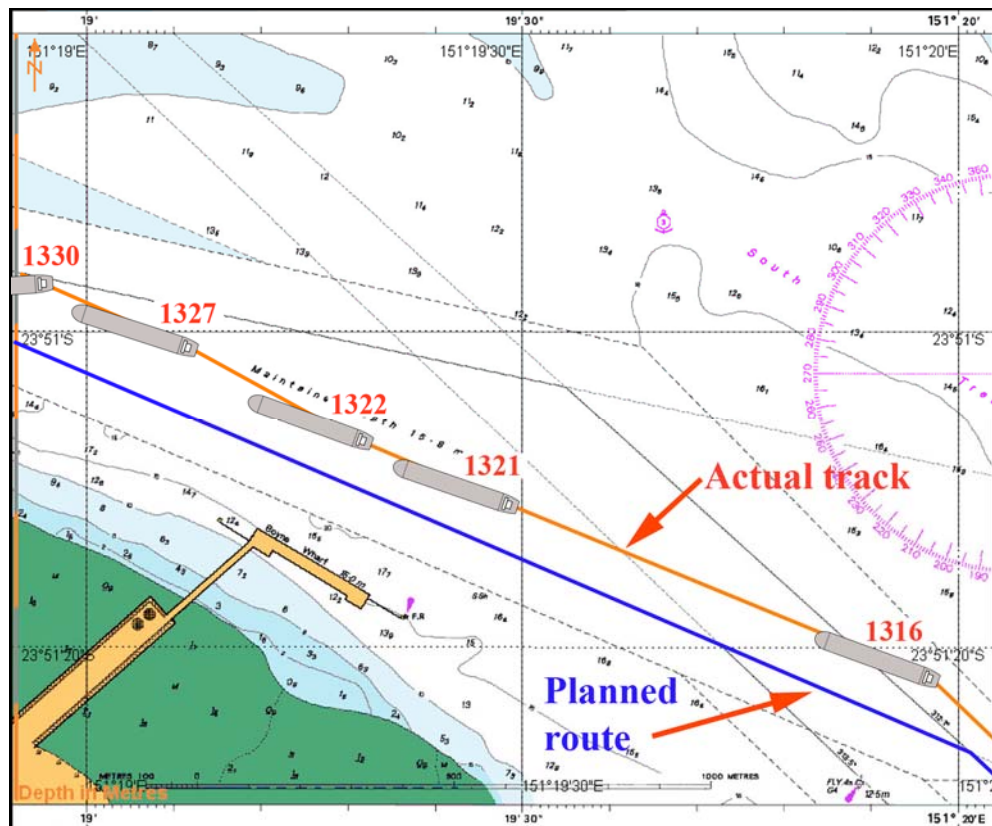
**Figure 7: Section of navigational chart Aus 244 showing *Endeavour River*'s planned route and actual track - images (to scale) of the ship, aligned to its heading at various times, have been superimposed on the actual track**

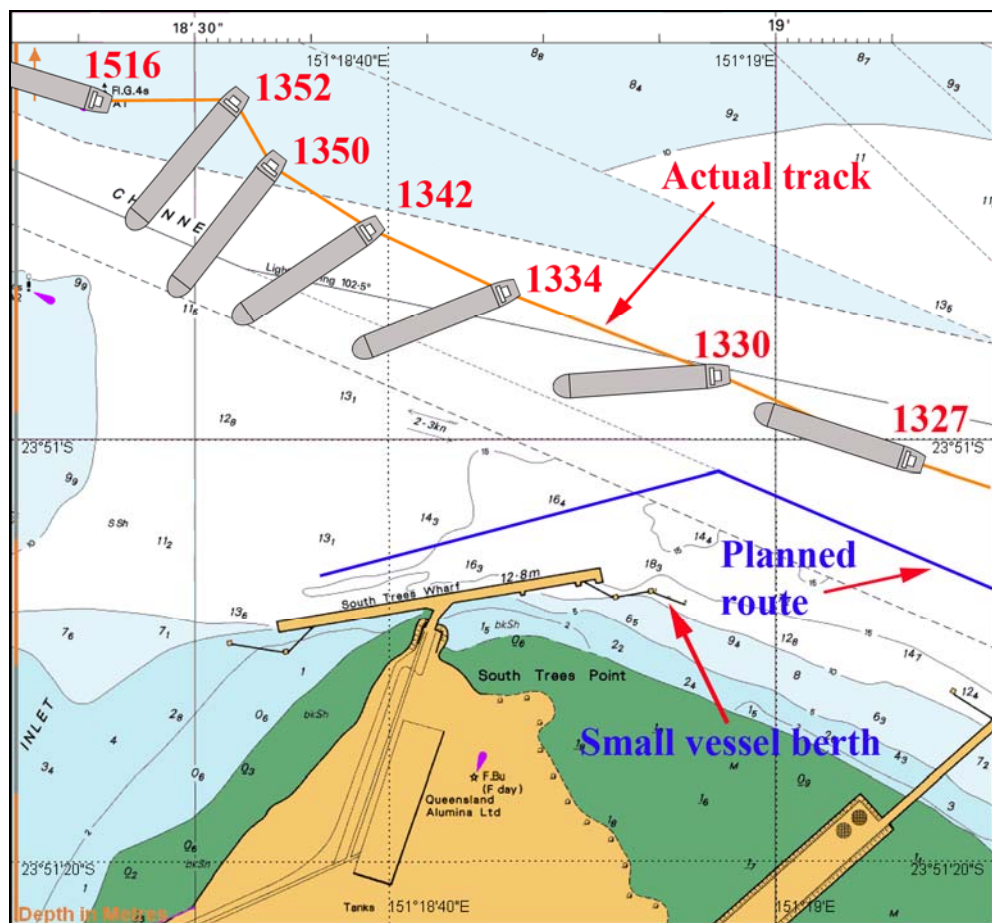
**Figure 8:** Section of navigational chart Aus 244 showing *Endeavour River*'s planned route and actual track - images (to scale) of the ship, aligned to its heading at various times, have been superimposed on the actual track

At 1325, *Endeavour River* approached the small vessel berth, just to the east of South Trees Wharf's east arm (Figure 8). The master began his intended turn to port, ordering the helm to be put hard-to-port and slightly increasing the ship's shaft speed to 20 rpm to assist the turn. At this time, the ship was making good 298° (T) at about three knots.

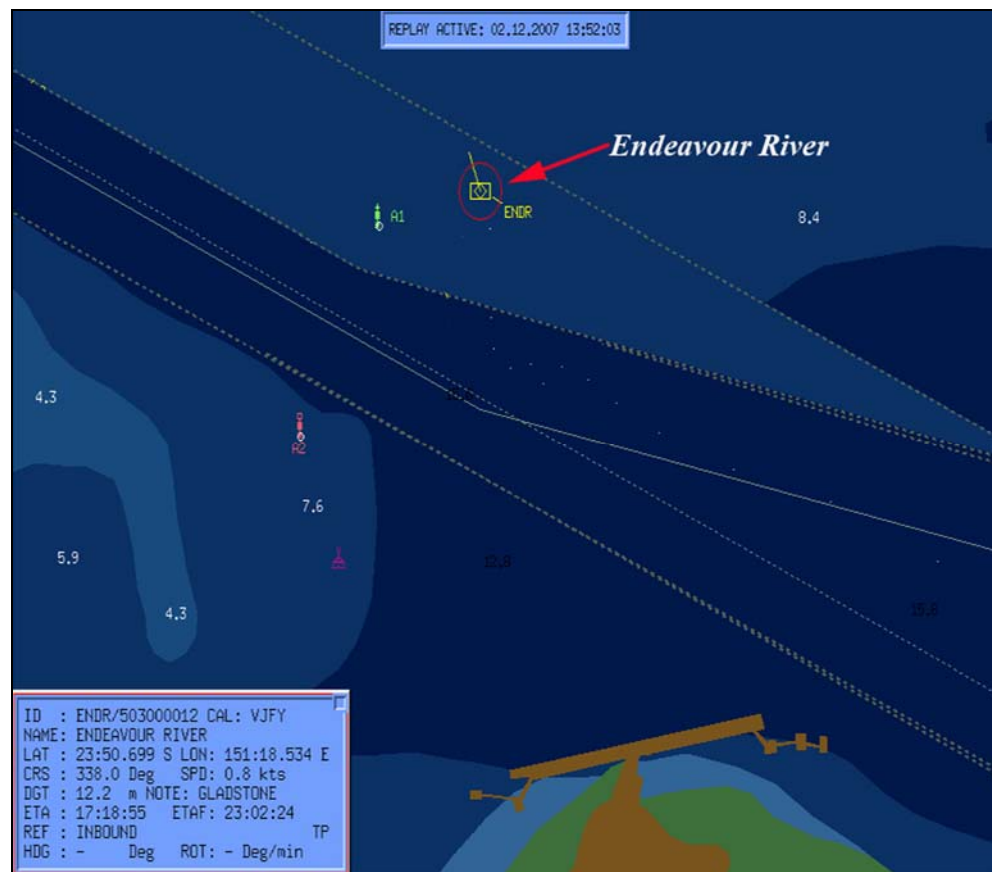
At 1352, even though the engine was still being used, *Endeavour River*'s speed remained below one knot, with the ship still about 80 m from A1 beacon (Figure 9).

**Figure 9:** Gladstone VTS AIS display showing the position of the ship at 1352

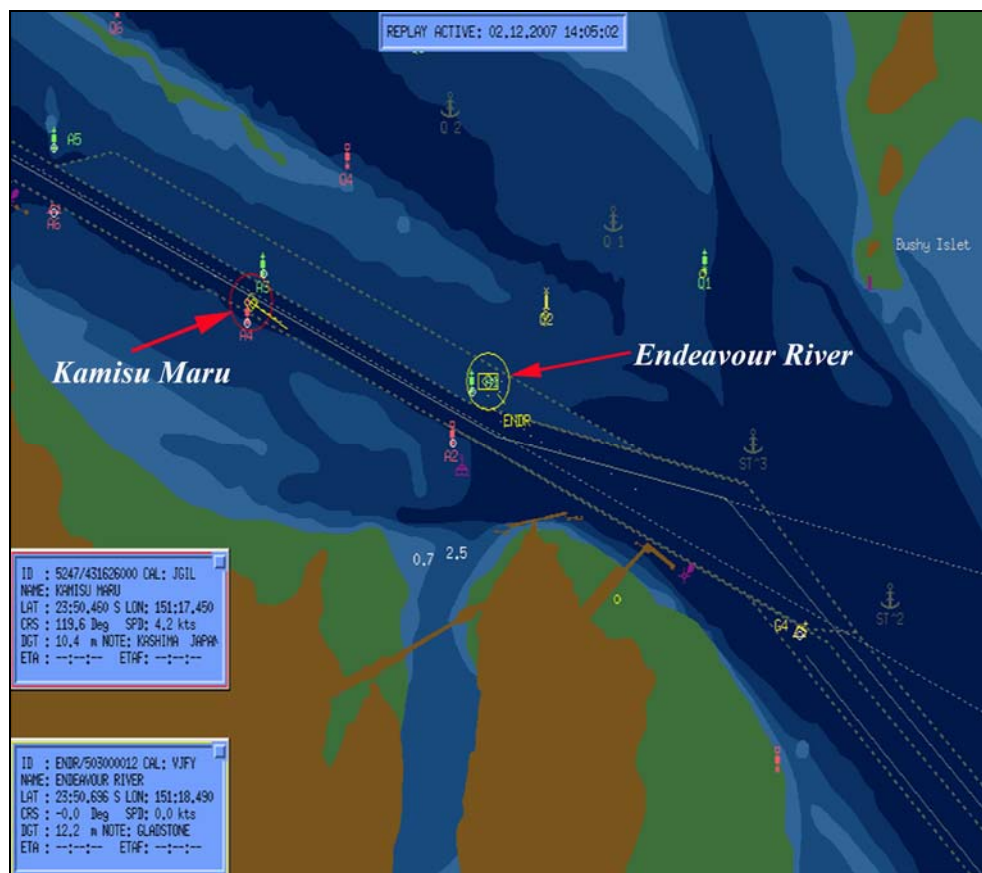
Between 1405 and 1414, while *Kamisu Maru* was in the vicinity of A3 beacon, *Endeavour River*'s bow was just to the north of the Auckland Channel's centreline. *Kamisu Maru*'s pilot's suggested course of action appeared to be beginning to take effect. *Endeavour River*'s heading changed from 220° to 233°, opening the channel enough for *Kamisu Maru* to pass ahead of *Endeavour River*. As *Endeavour River*'s heading was changing to starboard, *Kamisu Maru*'s pilot began moving the ship to the starboard side of the channel and increased the engine speed to slow ahead, to improve steerage.

**Figure 10: Gladstone VTS AIS display showing the positions of the two ship's at 1405**

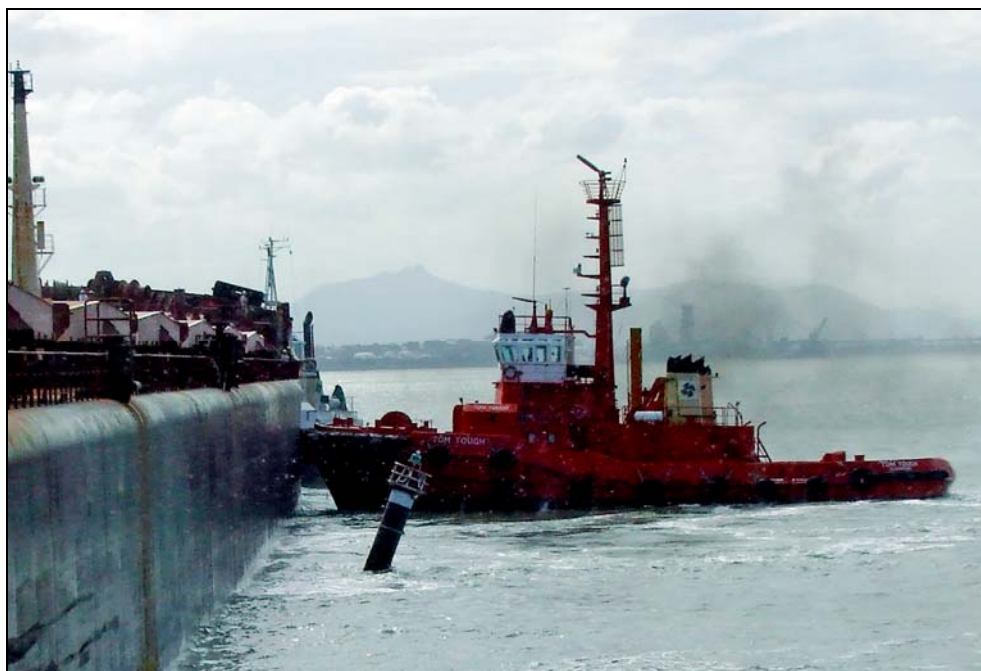
**Figure 12: Photo of A1 beacon following contact with *Endeavour River***

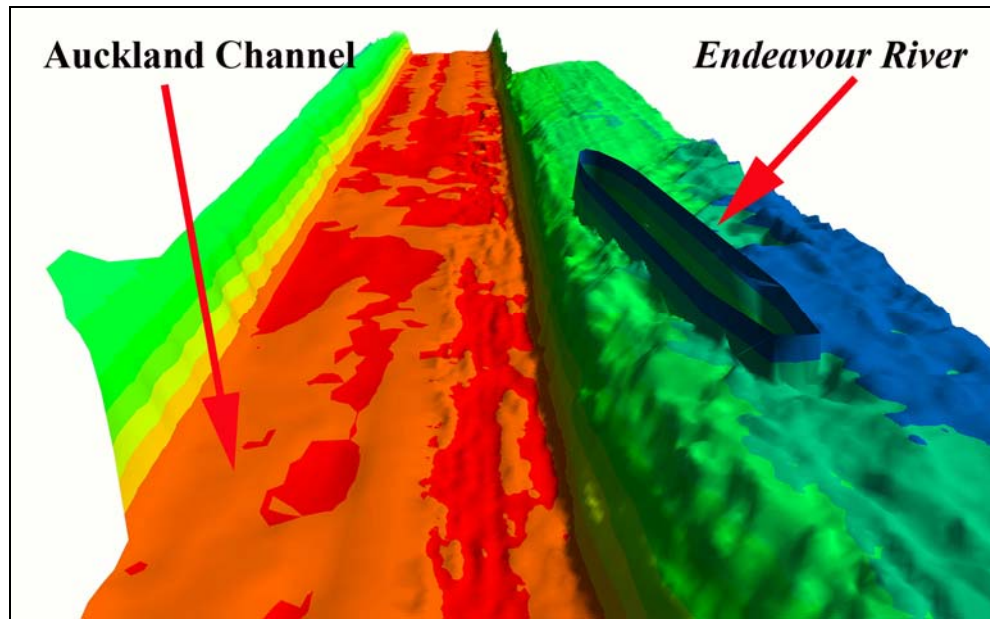
Figure 13: Sonar image of *Endeavour River*'s final grounding position

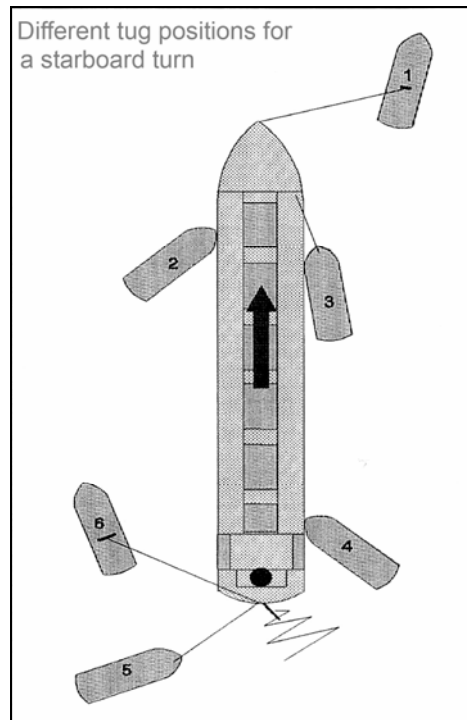
**Figure 14: Different tug positions**

Tug No 5 (Figure 14) is in a very effective position. The longest possible lever for steering forces and the transverse forces centred forward contribute to the swing. Also, the tug does not increase ship's speed. On the contrary, the tug also provides retarding forces while applying steering assistance.

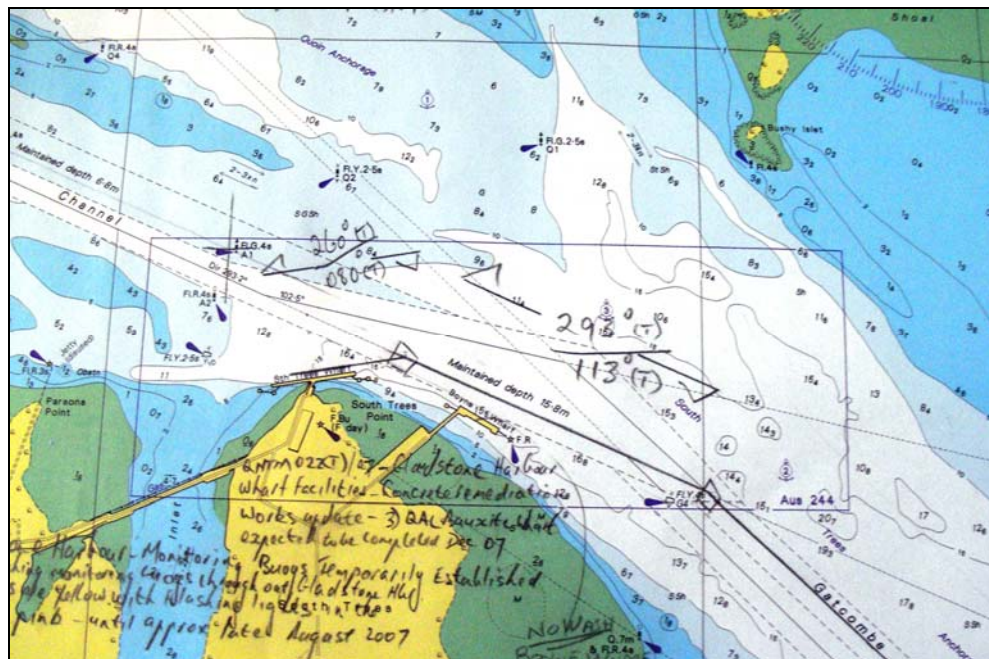
**Figure 15: Section of navigational chart Aus 244 showing passage information**

As the ship was not equipped with electronic charts, the bridge team was relying on paper charts. The only passage planning information on the charts were course lines drawn for both inwards and outwards passages (Figure 15). Wheel over positions and parallel indexing lines, as required by the ASP Vessel Operations Manual for passage plans in pilotage waters, were not indicated on the charts. In addition, there were no cross-track limits set in the ship's GPS unit or indicated on the charts in use, and the ASP checklist was not used.

Without these reference aids on the charts, the bridge team had no defined limits with which to gauge the progress of the ship in the channel and know when to alert the master if the limits were being reached.

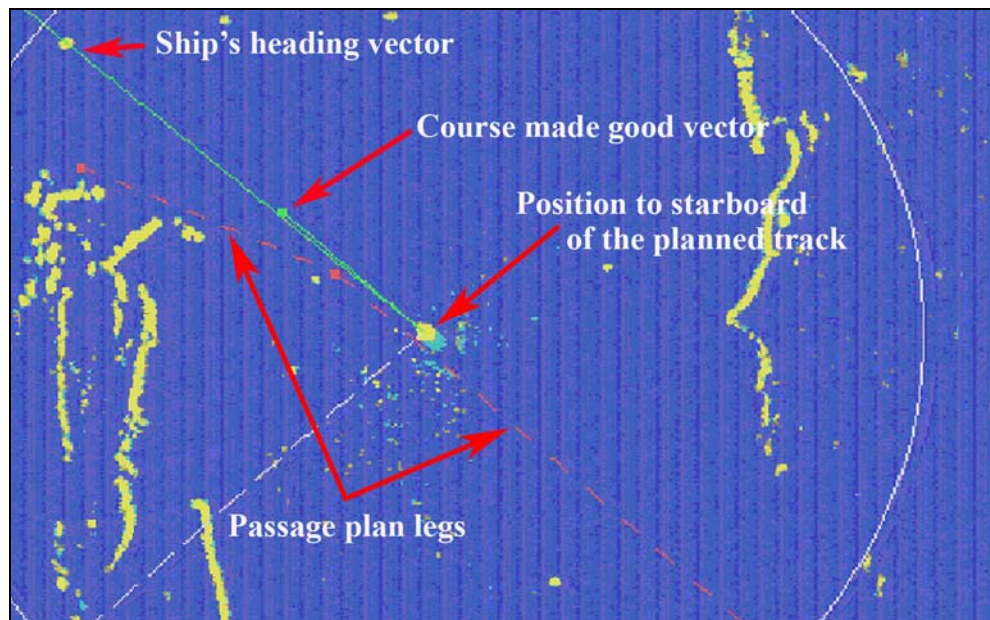
**Figure 16: Radar display showing position to starboard of track at 1311**

*Endeavour River*'s GPS unit was interfaced with the radars enabling the passage waypoints entered into the GPS unit to be displayed on the radars (Figure 16). The radars were then able to show the current leg of the passage and the leg after the next waypoint, thus allowing anyone observing the radar to get an immediate appreciation of the ship's position in relation to the planned route.

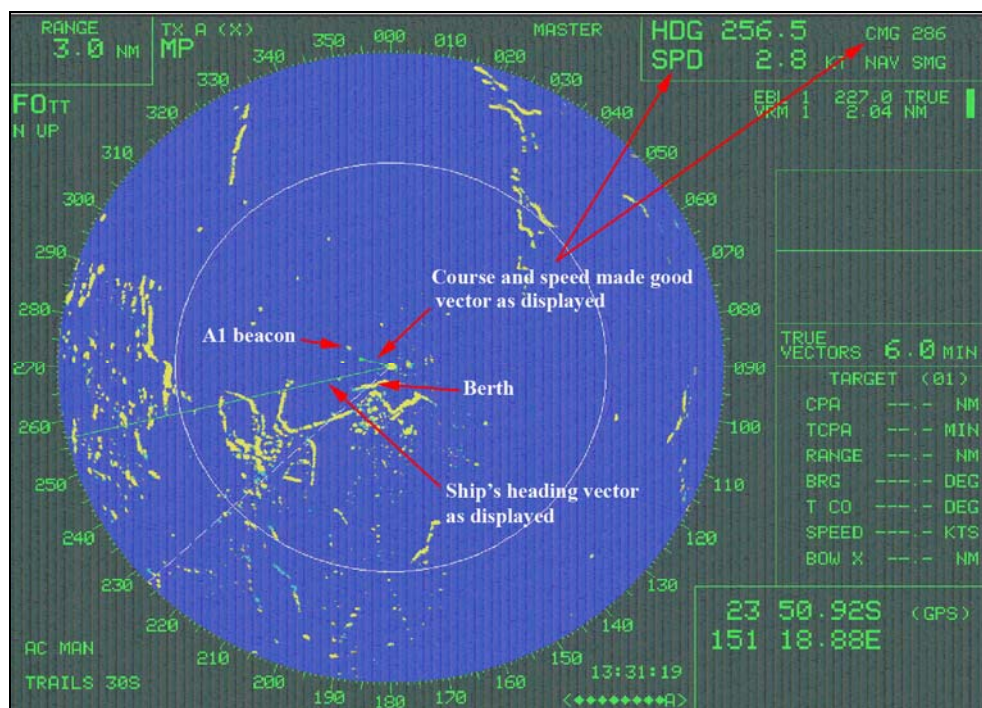
The radar display also showed the ship's heading vector, and, importantly, the vectors for course and speed made good as the ship progressed from the Gatcombe Channel (Figure 17). The display clearly showed that the ship was being set towards the A1 beacon and not progressing towards the berth as the master and chief mate believed.

**Figure 17: Radar display showing course and speed made good vectors, and ship's heading vector at 1331**

On 2 December 2007, no positions were put on the charts and radars were not used to monitor the passage. Therefore, no one on the bridge knew where the ship was in the channel, or with reference to the berth. As a result, when the ship was set towards the entrance to the Auckland Channel, its movement remained undetected until it was too late to rectify the situation.
