OUTLINE OF INCIDENT.

The fishing vessel "TAMMY-R" departed Eden on Wednesday 18 April 1990 bound for fishing grounds off Gabo Island.

The Skipper set a course to clear Cape Howe and about half an hour later the trawler was apparently in collision with a merchant vessel and sank. The two crew members took to a liferaft, eventually being rescued by helicopter some seven hours later.

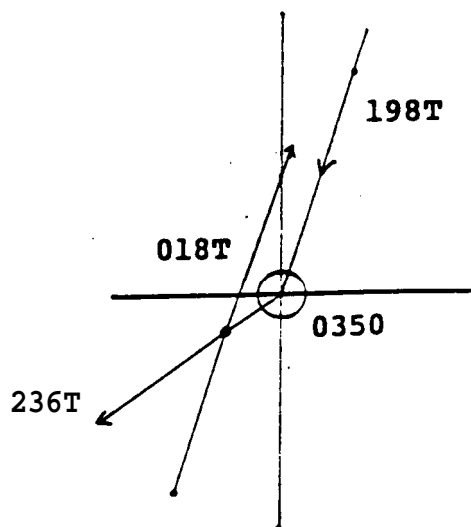
#### PARALLEL COURSES

In his Statement the Deckhand said that he considered that the other ship was approaching on a parallel course and would pass at a distance of half a mile. In reconstruction of this case TAMMY-R would have had to be on a course of 018T and, with METAL TRADER at six miles distance, would have needed to be in a position 2.9 miles SSW of METAL TRADER'S alter course position. This would place Cape Howe 30 degrees on the port bow at a distance of 17.1 miles. This is not consistent with the known facts.

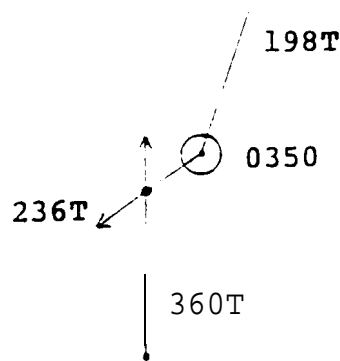
NEAR PARALLEL/CONVERGING COURSE

In this case TAMMY-R would have had to be 2.75 miles beyond (SSW of) the METAL TRADER's alter course position at the time of hand-over. This would place Cape Howe 11.5 degrees on the port bow at a distance of 16.9 miles.

This too is inconsistent with the known facts.

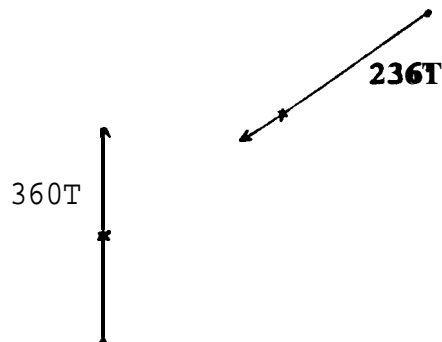
CROSSING COURSES

With METAL TRADER 45 degrees on TAMMY-R's starboard bow (i.e NE) at six miles and on a course of 23611, after 10 minutes TAMMY-R would be right ahead of METAL TRADER at a distance of 2.8 miles. METAL TRADER would then pass safely astern of TAMMY-R after a further 12 minutes, nearest approach being 0.75 miles.

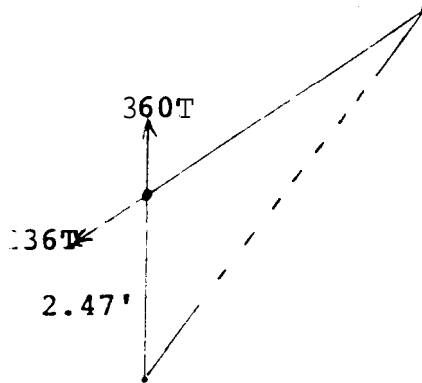
For a collision to occur in this crossing situation, at 6 miles distance METAL TRADER would need to be 36 degrees (a little over 3 points) on TAMMY-R's starboard bow. Collision would occur after 18.5 minutes, in which time TAMMY-R would have travelled 2.47 miles and METAL TRADER 4.27 miles.

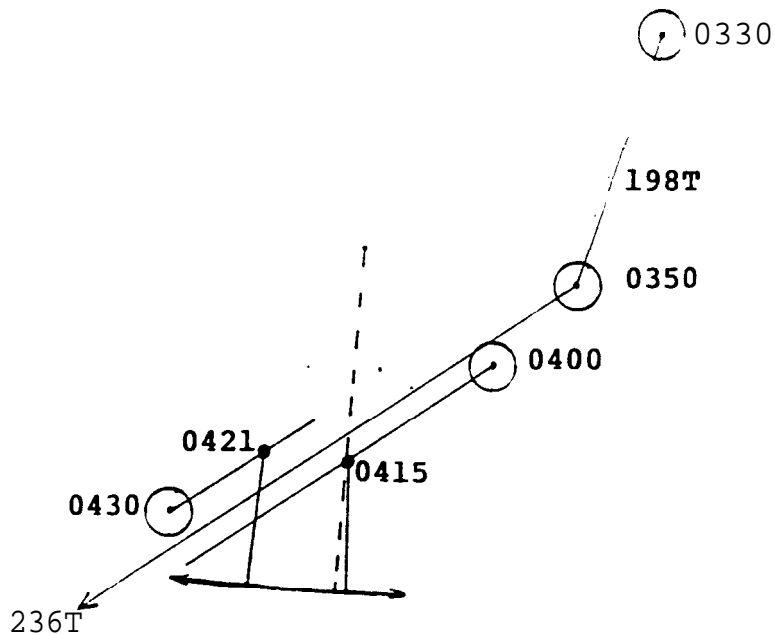
Laying off a distance of 2.47 miles along a course line of 360T from the 20 mile position line off Cape Howe cuts the METAL TRADER's 236T course line, produced from the 0400 position, 3.4 miles along that course line. At 13.84 knots this provides a time interval of 14.75 minutes.

The course from the position thus derived to clear Cape Howe by 1.0 miles is 004T. Transposing this course line to cut the 236T course line projected back from the METAL TRADER's plotted position for 0430 cuts that course line 2.0 miles back from the 0430 position. This provides a time interval of approximately 9 minutes and a time of 0421. The course from this position to clear Cape Howe by 1.0 miles is 009T.

The most likely time of the collision is therefore considered to be between 0414 and 0421, with TAMMY-R proceeding on a course a few degrees East of North.

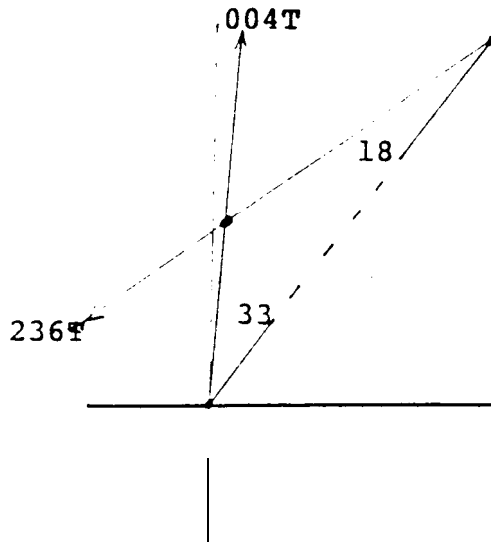
With TAMMY-R on a course of 004T speed 8 knots and METAL TRADER on a course of 236T speed 13.84 knots at 6 miles distance, METAL TRADER would be 33 degrees on TAMMY-R's starboard bow and in turn would have TAMMY-R 18 degrees on the port bow. Time to collision would be 18 minutes.

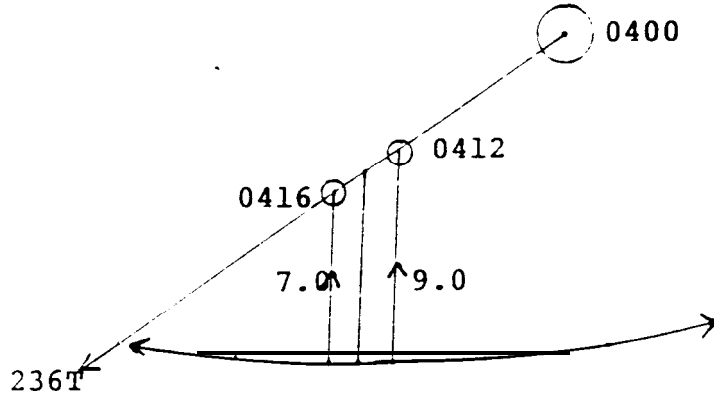
EFFECT OF VARIATION ON SPEED OF TAMMY-R

Assuming a speed of 9.0 knots for TAMMY-R, the time to collision is 18 minutes, with TAMMY-R advance 2.7 miles. Course intersection point is 2.8 miles from the 0400 position, giving a time of collision of 0412.

Therefore, if the speed of TAMMY-R was in excess of 8.0 knots the time of collision would have been slightly earlier: if less than 8.0 knots the time of collision would have been slightly later.

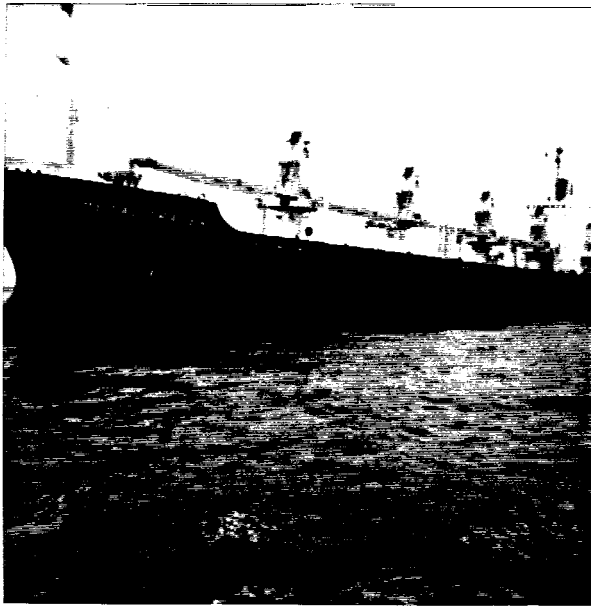
PHOTOGRAPHS OF PORT SIDE  
OF "METAL TRADER"

A Department of Transport and Communications Marine Surveyor inspected the sides of the METAL TRADER from the pilot boat at about 1320 hours 25 April and noted a white coloured scrape mark commencing from a position 6 to 8 metres aft of frame 143 on the port side. The mark was on the red boot topping and took the form of a white patch at the forward end with a curved scrape mark leading aft, terminating near frame 71. There was no indentation of the shell plating in way of the mark.

slight paint scratch marks between nos 2 and 4 hatches on the port side, attributed them to rubbing marks from wharf fenders in port. He noted that there was no indentation. The Master's protest was supported by statements by the Chief, Second and Third Officers in which they all said that there had been no collision. The AB Lookout on watch with each Officer countersigned the appropriate statements.

The paint flakes taken from the scrape marks on the shipside plating of METAL TRADER were analyzed and compared with a can of white paint which the Skipper of TAMMY-R stated was similar to the type used to paint his vessel. The paint flakes showed four layers, the top layer of which was found to be similar in chemical composition to the paint in the can (Attachment 8). The second layer was pink in colour, the third green and the fourth off-white.
