OUTLINE OF INCIDENT

At 0505 hours local time on 21 February 1990 the Australian flag bulk carrier IRON KEMBLA, whilst on passage from Newcastle NSW to Tobata, Japan, collided with the Japanese fishing vessel KASUGA MARU in a position approximately 4 miles WSW of Hino Misaki lighthouse in Kii Suido. The fishing vessel capsized and one of the two crew members lost his life.

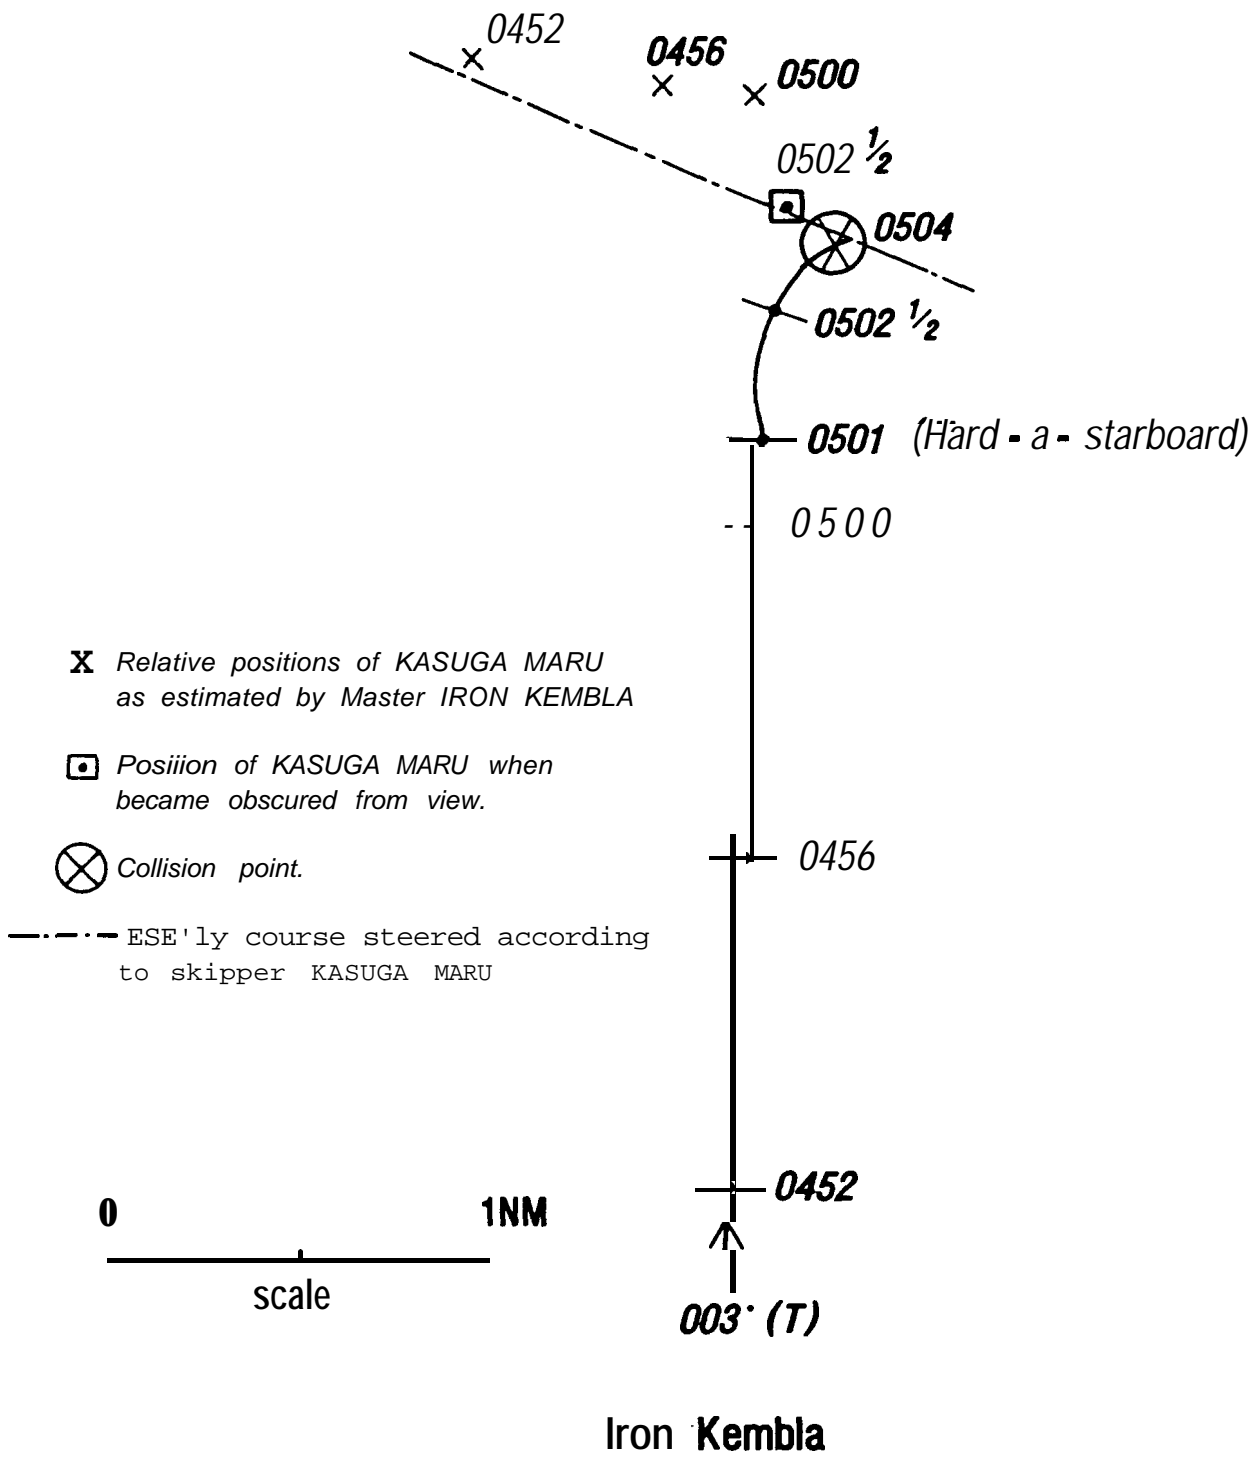
DIAGRAM OF RELATIVE POSITION OF THE TWO VESSELS

As the relative bearings and distances, possibly the times also, are approximate, reconstruction in diagramatic form is difficult. However, at around 0502.5 the KASUGA MARU was lost to view from the bridge of the IRON KEMBLA, due to the flare of the bow, thus being only some 240 metres from the bow. From this it is deduced that the Master over estimated distances by some 3 cables, certainly at 0500. A diagramatic indication of the approximate relative positions of the two vessels, based on the statement of the Master of IRON KEMBLA, is contained in Attachment 1.
