At 0320 West Australian time, 14 February 1991, the Panama registered bulk carrier *Sanko Harvest* grounded in shoal water between Hastings Island and Hood Island, in position 34° 07.4' South, 122° 05.1' East, approximately 19 miles south south east of Esperance, while on passage from Tampa, USA, via Cristobal, Panama, to Esperance, West Australia, loaded with 30,791 tonnes of fertiliser.

Captain C W Filor, Inspector of Marine Accidents, undertook an investigation into the circumstances leading to the incident with the object of identifying the cause.

# SANKO HARVEST

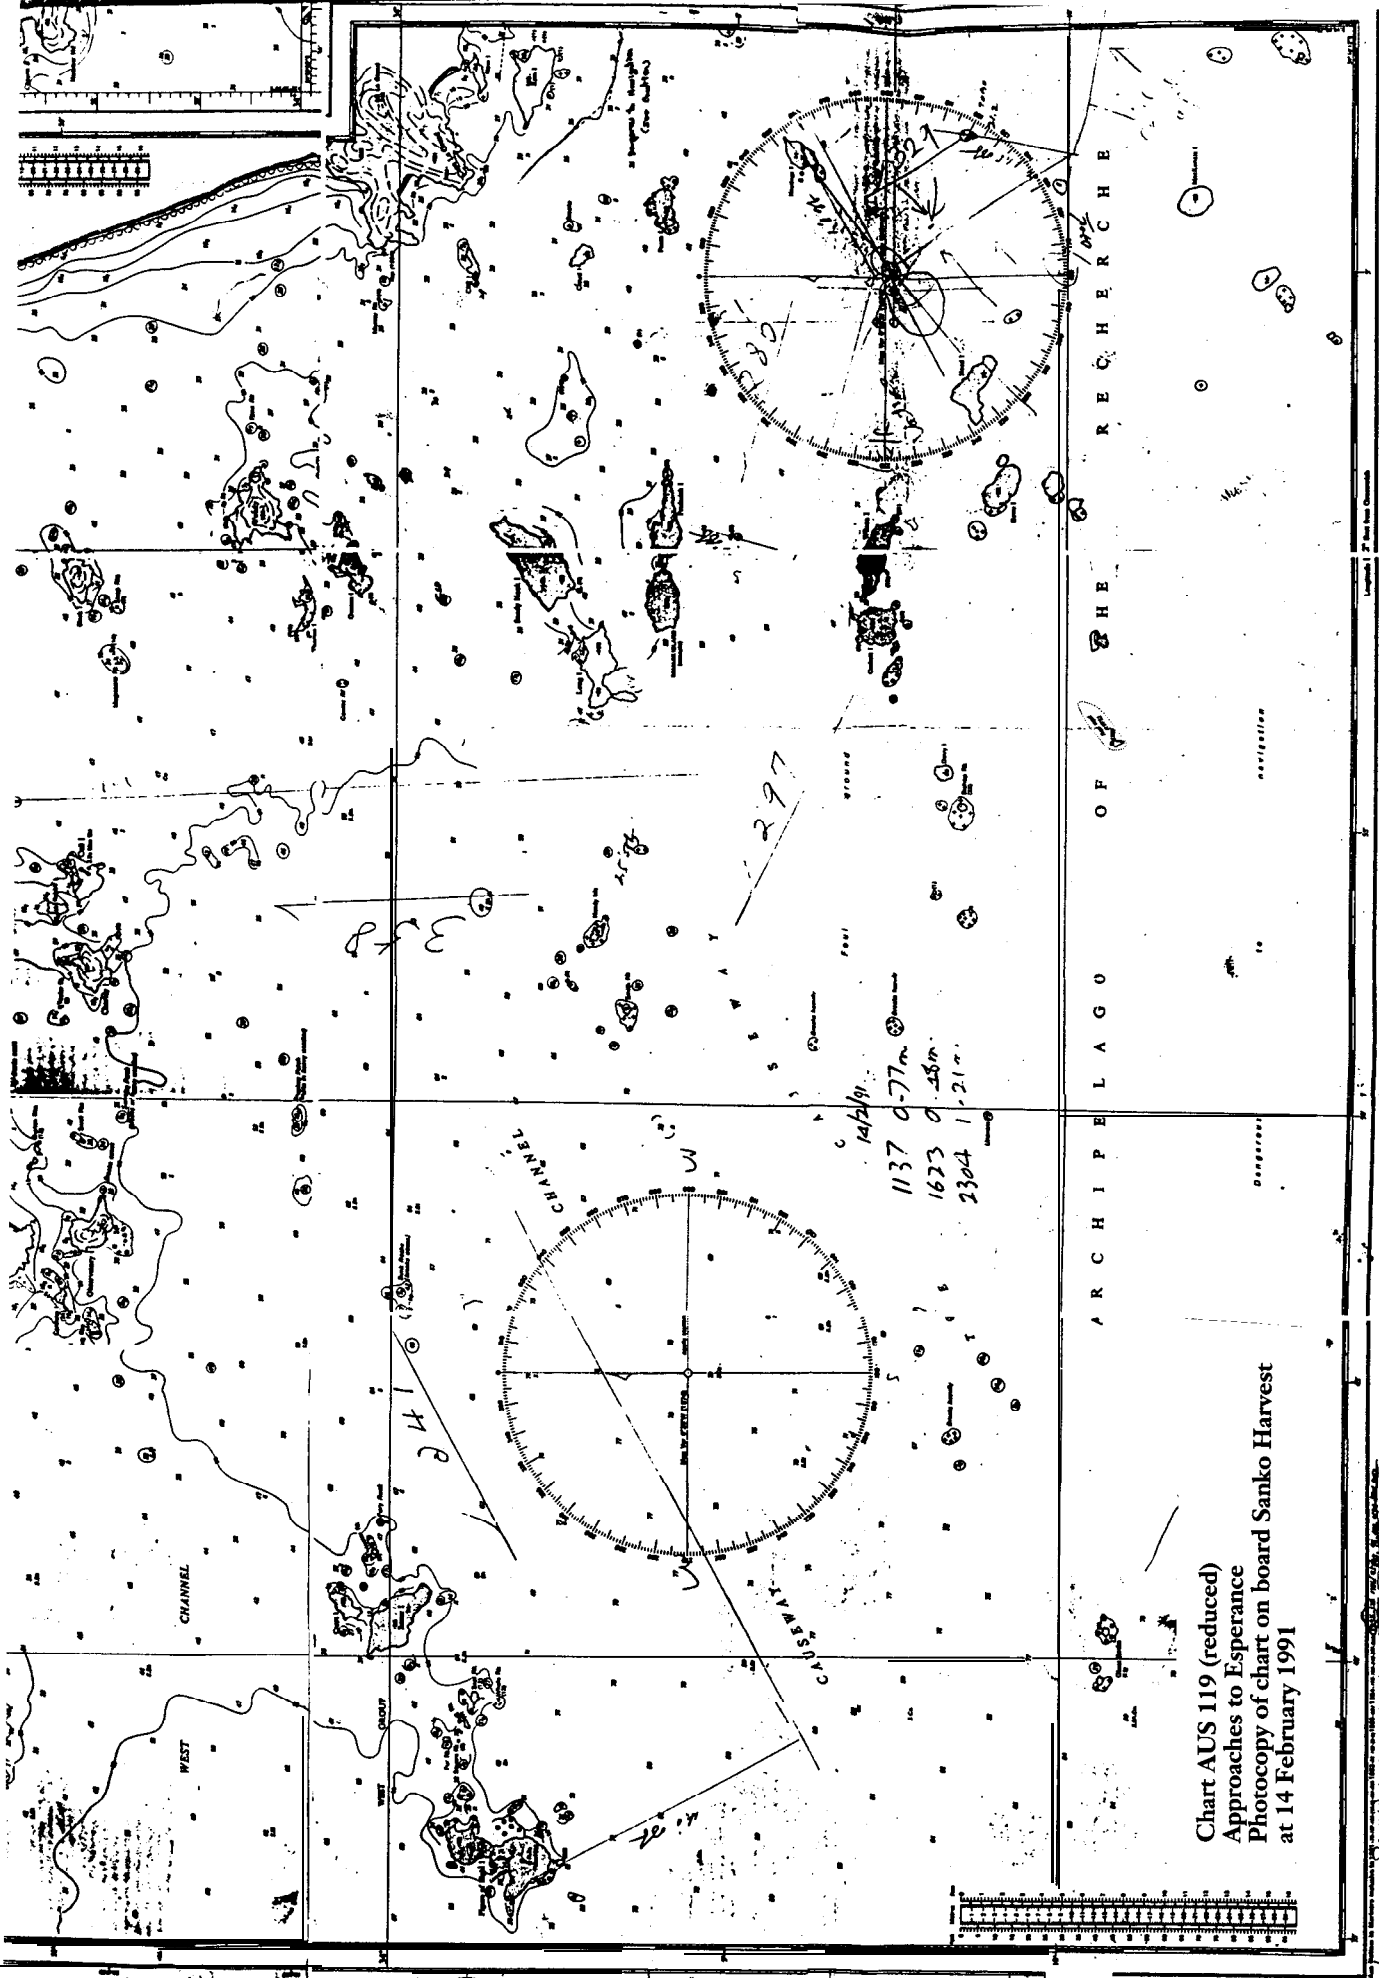
Chart AUS 119 (reduced)  
 Approaches to Esperance  
 Photocopy of chart on board Sanko Harvest  
 at 14 February 1991

Captain Harrod arrived on board the *Sanko Harvest* at 0800. He examined the ship's chart in use at the time (AUS 119) and observed that the last small correction noted in the bottom left hand corner was Aus 500. He stated that he told Captain Kim that the chart in use was not the latest edition. The ship's staff then referred to the notices to mariners on board and found Aus notice 577 notifying mariners that a new edition of the chart would be published shortly. Captain Harrod also stated that there was no suggestion that alcohol or drugs were a factor in the grounding.

While the 1974 edition differs from the 1990 edition, in that the route selected by the Master through the Recherche Archipelago was not contained within pecked lines denoting the unsurveyed area, it would, if properly corrected, show all the relevant navigational information to show that the area was inadequately surveyed and therefore dangerous to navigation. Charts BA 1059 and 3189 were the most recent editions available. The information given on any one of the charts available, including the absence of soundings on a coastal chart should have deterred the Master from attempting to navigate through the Archipelago.

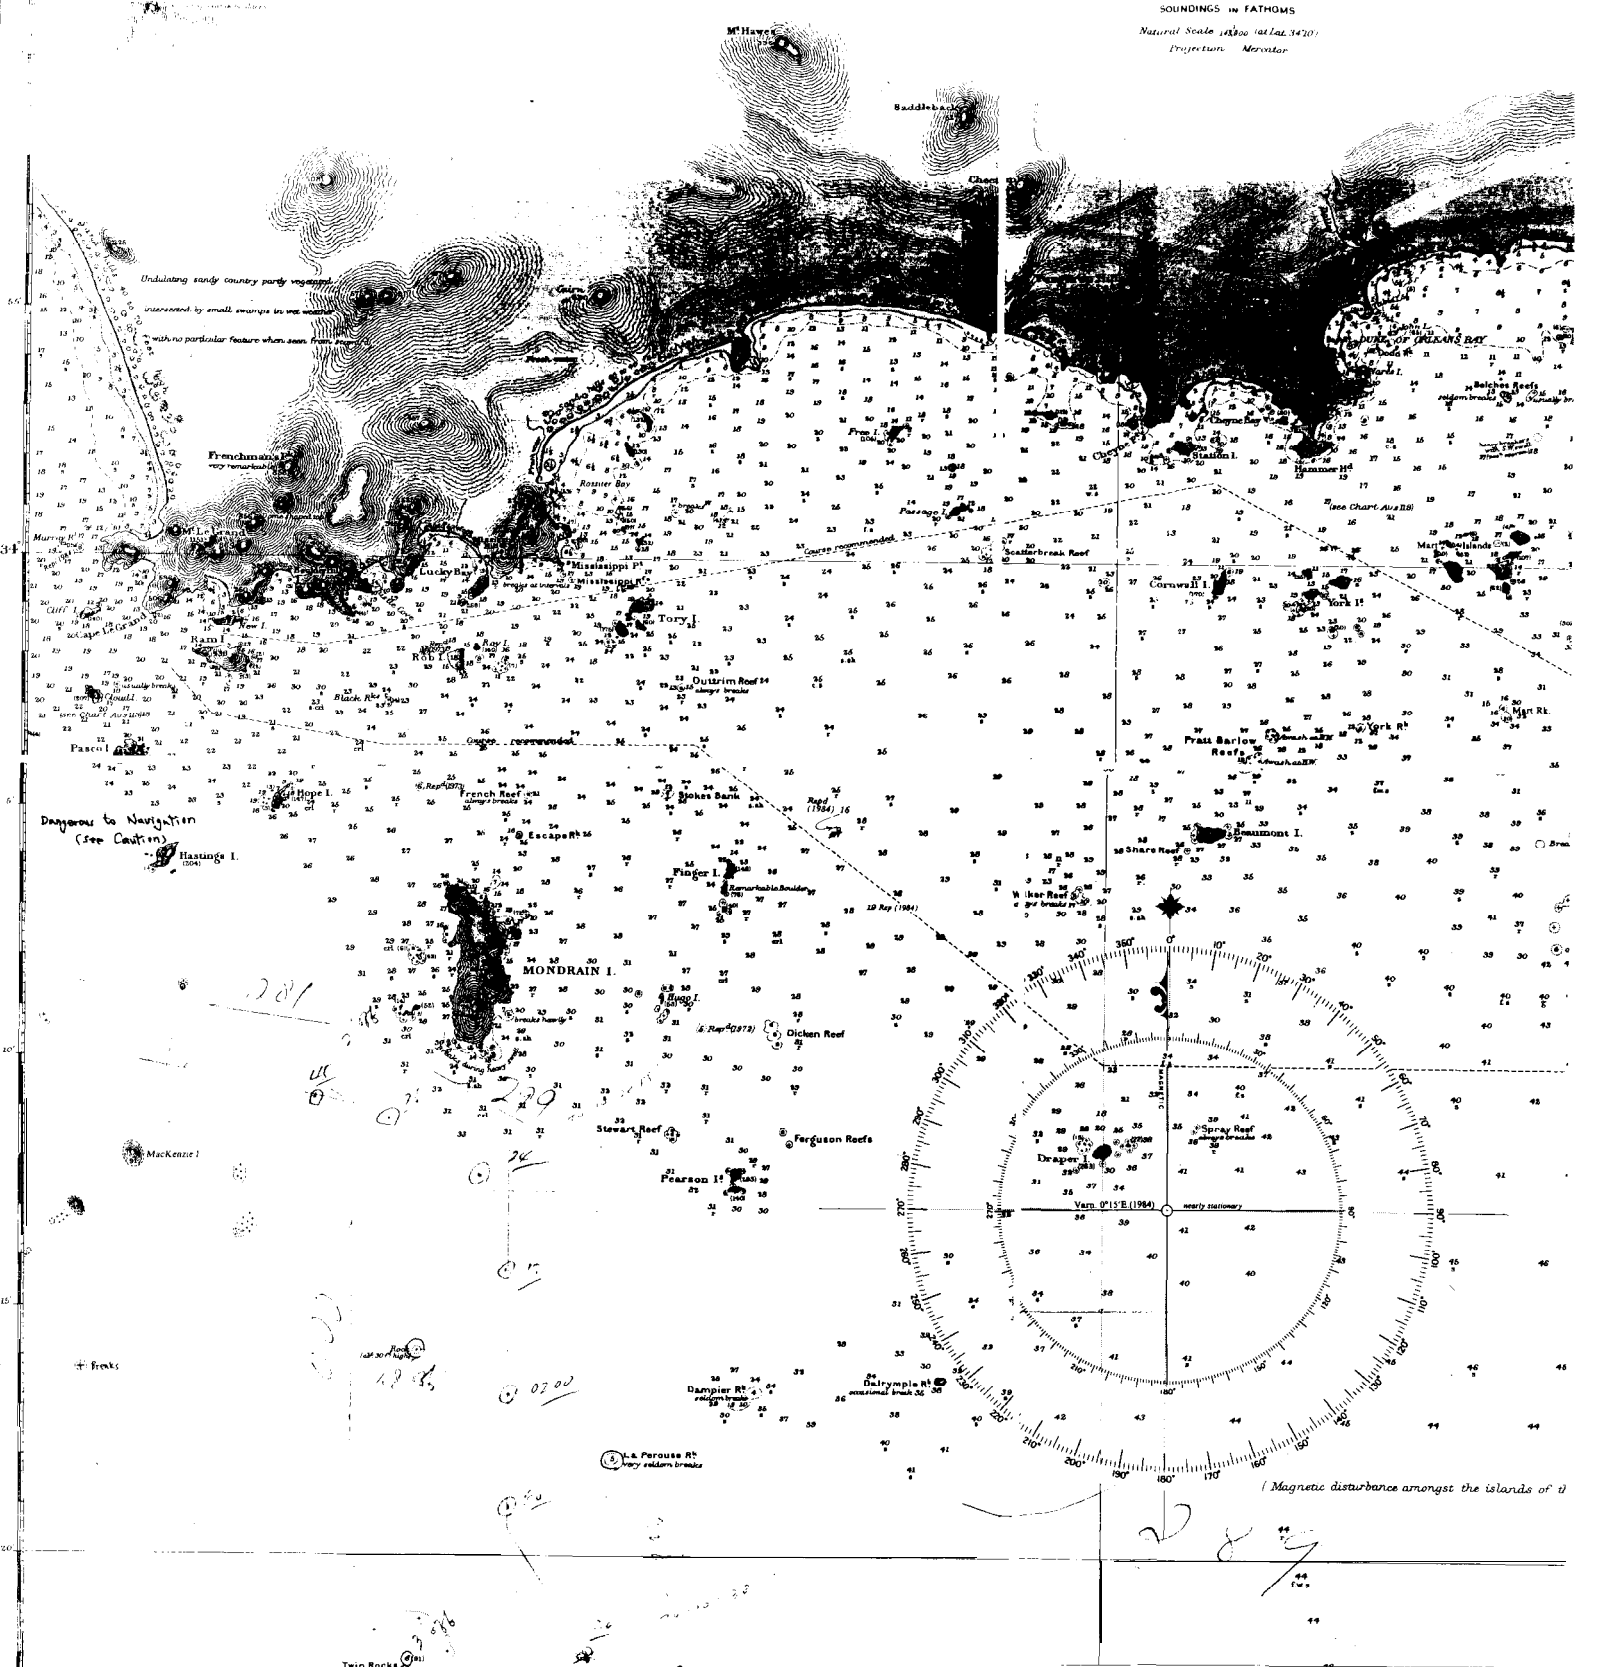
BA 3 189 (reduced) Cape Le Grande to Cape Pasley Copy of chart on board Sanko Harvest at 14 February 1991

Charts BA 3189 and BA 1059 also were effected by notice AUS 219, however neither chart had been corrected, the last small correction shown was 490 of 1986. Mr Gim had failed to enter either Aus 506 of 1987 or Aus 219 on chart BA 3189 or Aus 219 on chart BA 1059. Therefore, although the location of the reef in approximate position 34° 07.3' South 122° 04.5' East, had been properly promulgated and the relevant notice was aboard the *Sanko Harvest*, the relevant charts had not been corrected properly.

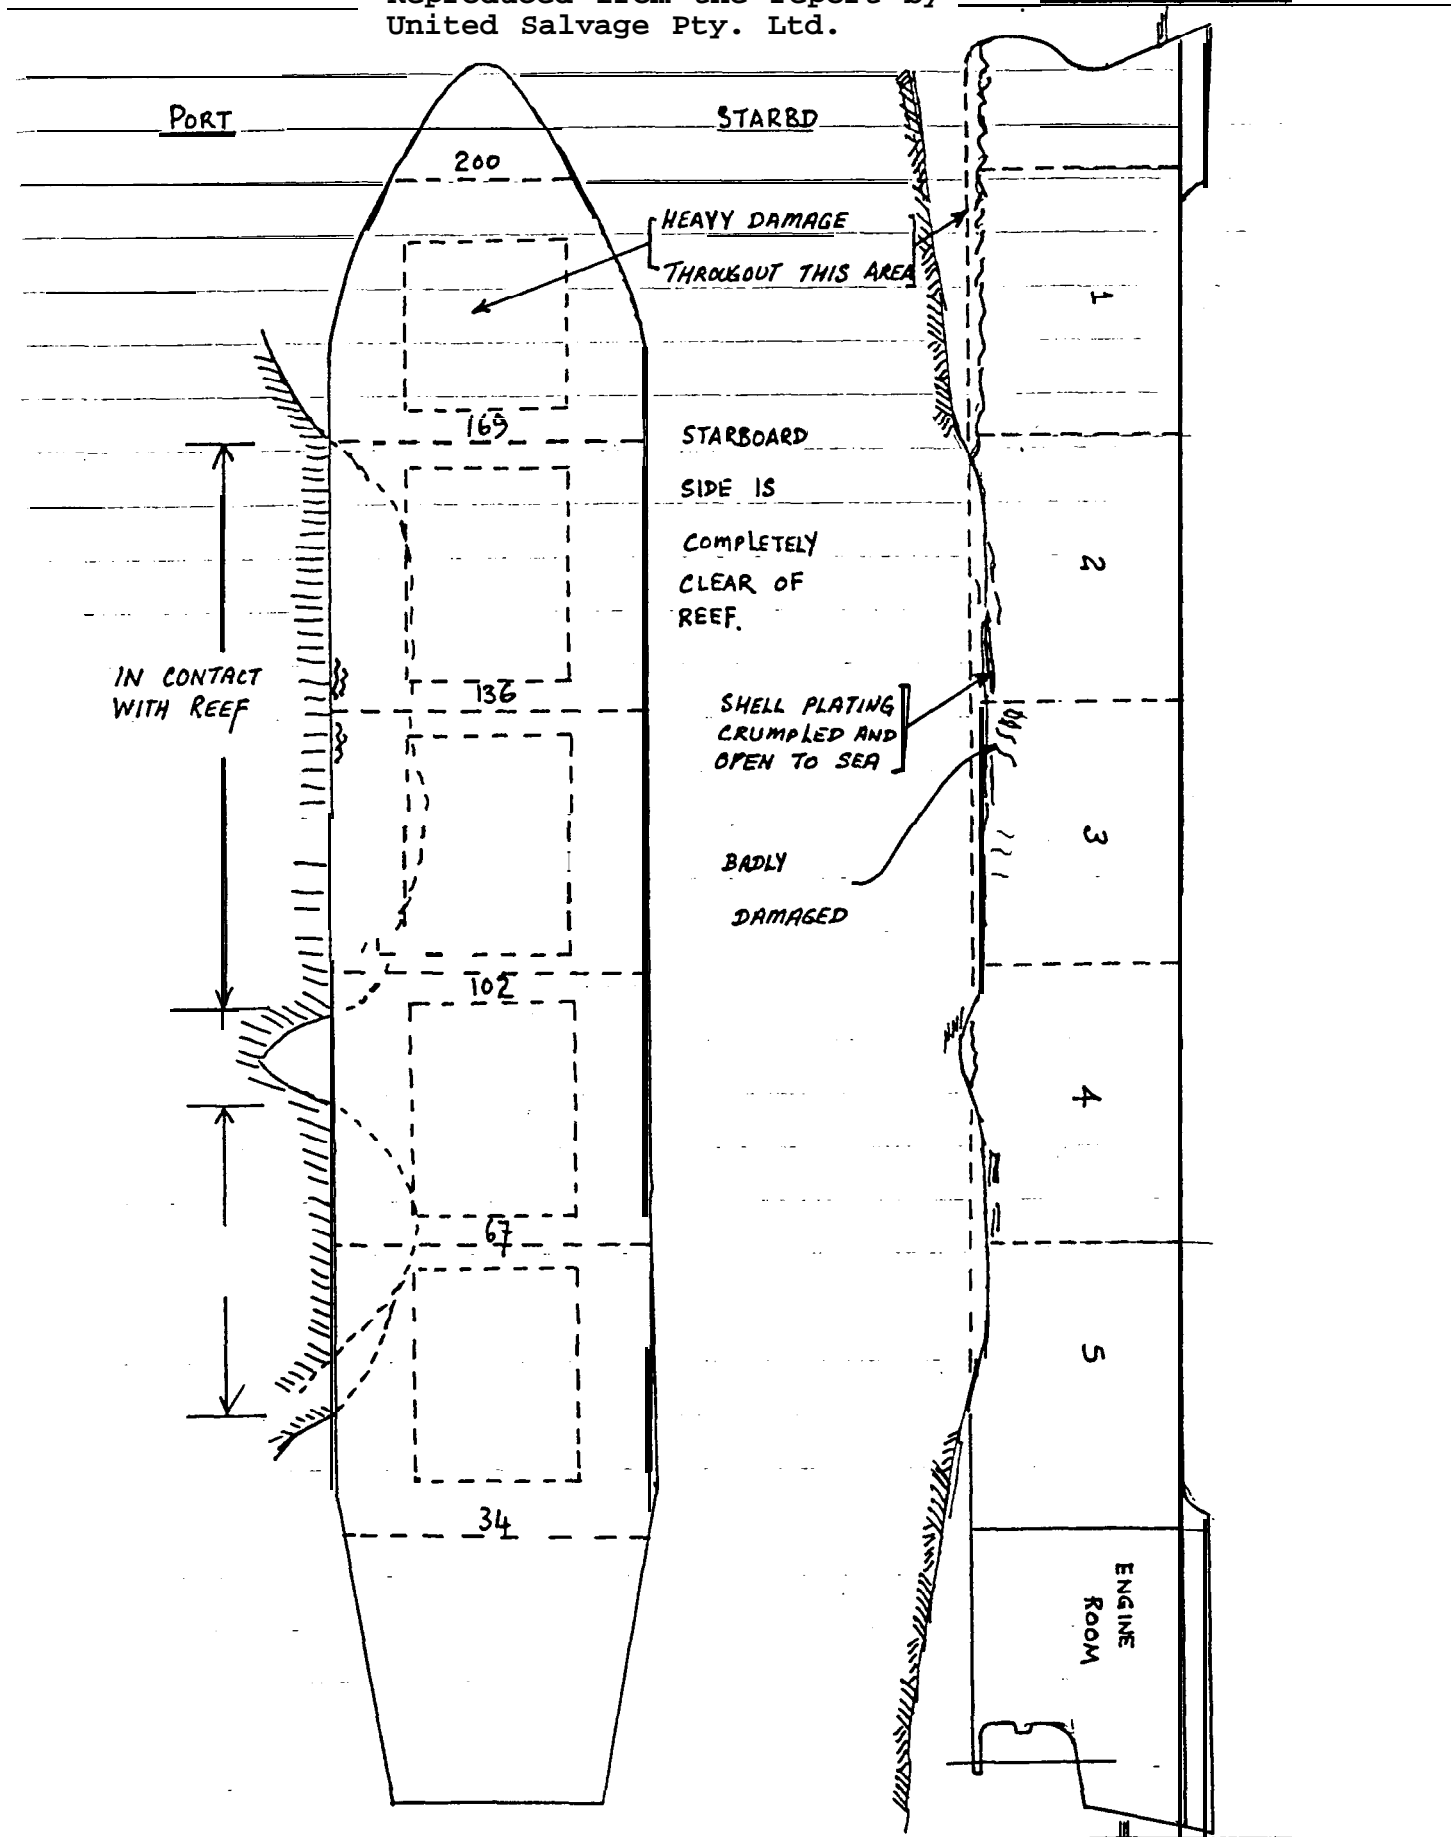
Reproduced from the report by  
United Salvage Pty. Ltd.

On the morning of the 15 February an underwater inspection was made of the hull. A great deal of buoyancy had been lost and the ship was effectively being prevented from sinking by the reef on which it had grounded (Attachment 6). There was serious doubt as to whether it would be possible to refloat the ship, particularly in view of the worsening sea condition. United Salvage, through its Sydney office notified the ship's owners at 1308:

*"Technically, the vessel was in a sunk condition yesterday with the loss of 4,900 T of ballast tank buoyancy and was only held up by contact with the reef on the port side. . . . , we believe it is only a matter of time before there is a further failure of the hull....."*
