Shortly before 0200 Eastern Standard Time 3 September 1991, the Russian container ship Khudozhnik loganson, whilst on passage from Manila to Melbourne, was in collision with the Australian prawn trawler Zodiac off Cairns.

No persons were injured, but the Zodiac sustained damage to the starboard fishing boom, the deckhouse starboard awning and to the stem post.

The Marine Incident Investigation Unit, under the provisions of Regulation 8 of the Navigation (Marine Casualty) Regulations undertook an investigation of the incident.

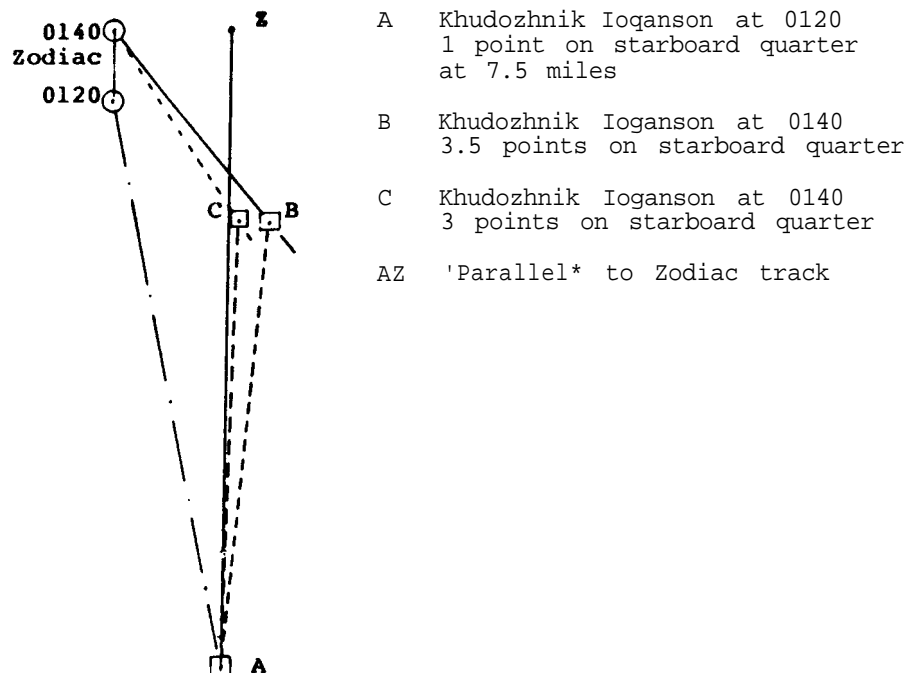
Diag. 1 Relative positions from Zodiac observations.

As both the times and bearings are only approximate, an accurate reconstruction is not possible. However, based upon the Deckhand's observations (Diagram 1) the two vessels are indicated as having been on slightly diverging courses.

Being fine on the port bow of the Khuhzhnik Ioganson, at 0120 the masthead lights of the Khdozhnik Ioganson would have been only slightly open to the Zodiac, not broadly as stated by the Deckhand.

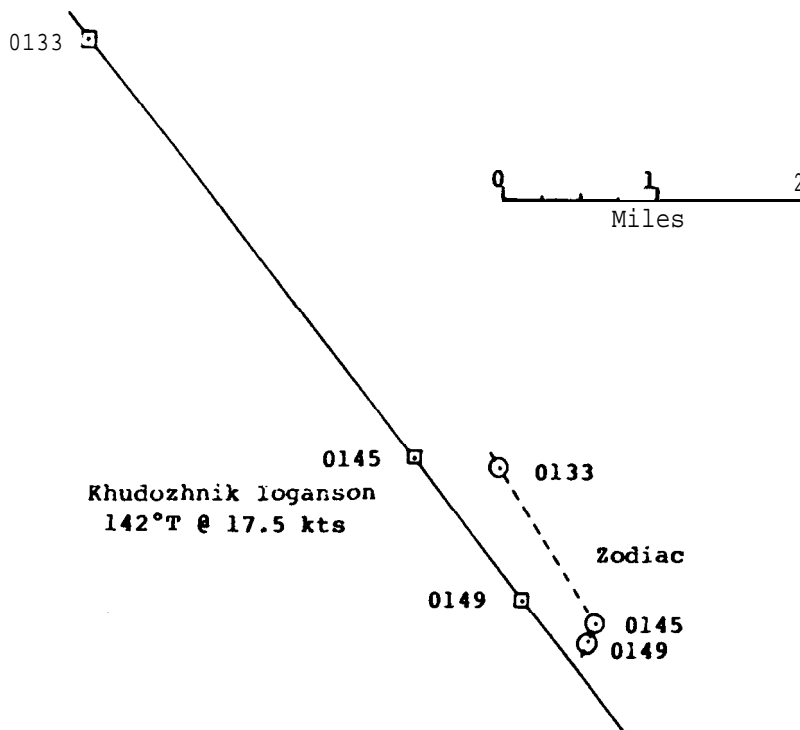
Diag. 2 Relative positions from Khudozhnik Ioganson observations

According to the Second Mate, at around 0120 the distance between the two vessels was about 6 miles. The visual bearing and radar distance of the Zodiac were noted at 0133 (137°, 3.9 miles), 0145 (133°, 1.6 miles) and 0149 (128°, 0.5 miles). Plotting these recorded bearings and distances (Diagram 2) gives the course and speed of the Zodiac between the times 0133 and 0145 as 148.5° True at 5.10 knots and between the times 0145 and 0149 as 203.5° True at 2.27 knots.

The Inspector accepts that the Second Mate noted down the visual bearings and radar distances as they were taken. However, given the inconsistencies in the speed of the Zodiac derived from the plots, it is considered probable that the times were recalled after the event and thus are not considered to be accurate.

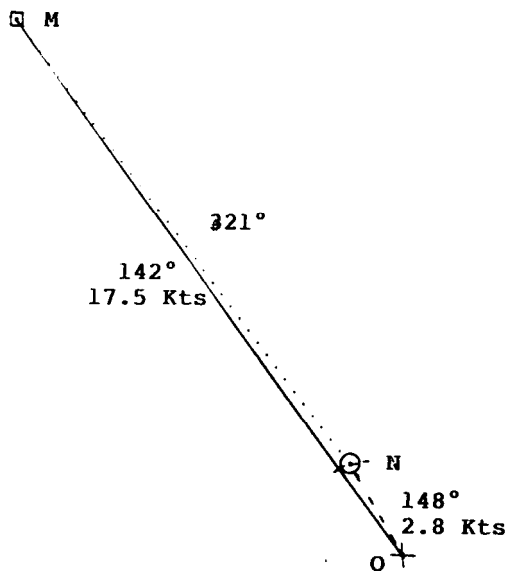
Diag.3 Vector diagram showing track of Zodiac relative to Khudozhnik Ioganson ("NM")

On a course of 148°T at 2.80 knots the Zodiac's movement relative to the Khudozhnik Ioganson would be in a direction of 321° ("NM" Diagram 3). Thus for the collision to occur the Zodiac would have had to remain on a steady bearing of 141°T, only 1 degree on the Khudozhnik Ioganson's port bow.

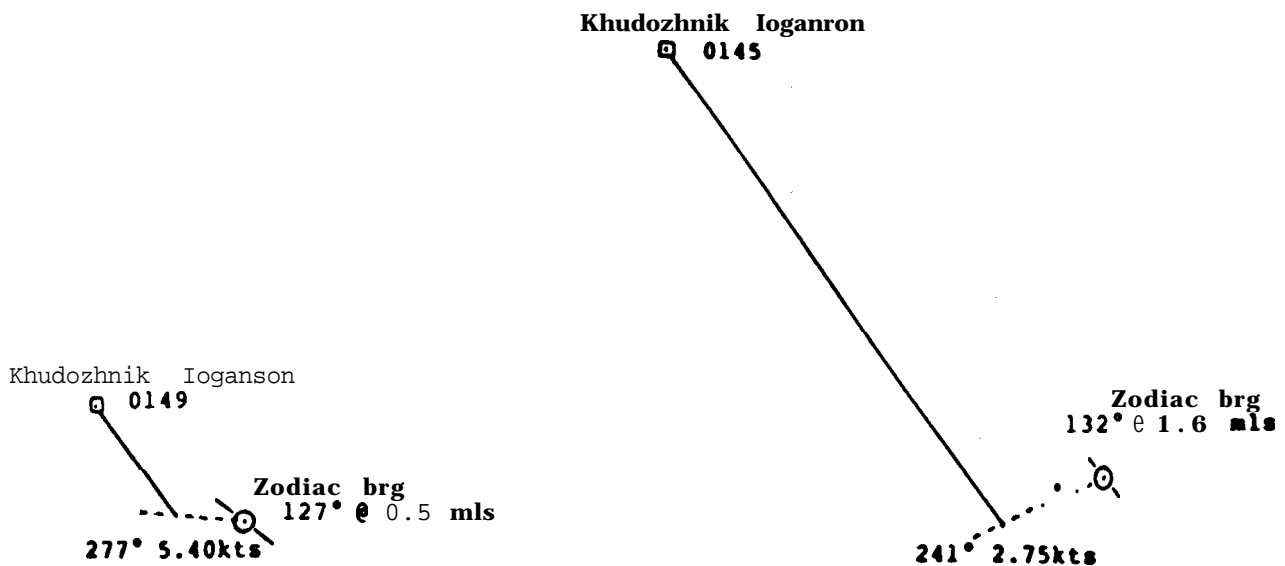
The bearing and distance noted by the Second Mate at 0149 (127°T at 0.5 miles) place the Zodiac 1.25 cables to port of the Khudozhnik Ioganson's track and 4.825 cables ahead of the bridge. For a collision to occur at 0151 from that situation the Zodiac would have had to be on a course of 277° T and proceeding at a speed of 5.40 knots (Diagram 5). The relative position of the Zodiac as noted by the Khudozhnik Ioganson at 0149 cannot be accepted as being accurate.

Diag. 5 Observed situation 0149

Diag. 6 Observed situation 0145

The bearing and distance noted at 0145 place the Zodiac in a position 2.70 cables to port and 1.58 miles ahead of the Khudozhnik Ioganson bridge (Diagram 6). For a collision to occur from this position the Zodiac would have had to be on a course of 241° T and making a speed of 2.75 knots. This throws some doubt upon this position also, as the green side light of the Zodiac would have had to have been visible for some time.

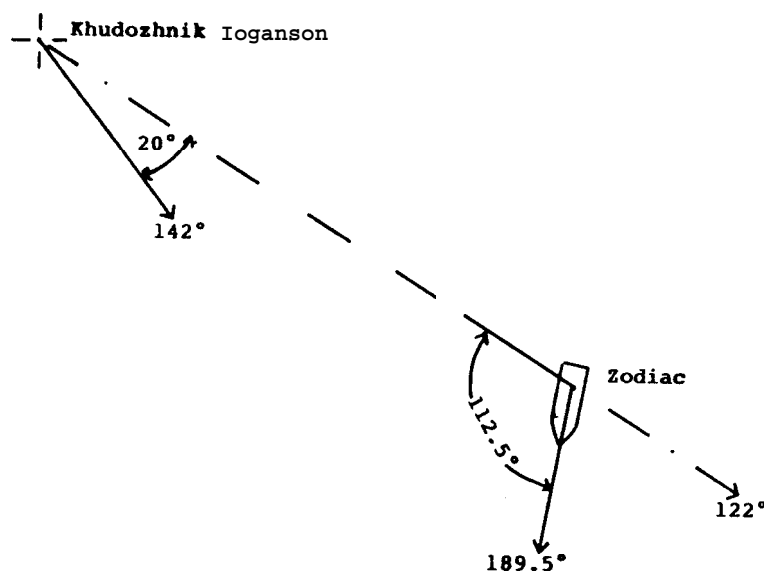
Diag .7 Least heading of Zodiac for green side light to be visible

When the green light was first noted the Zodiac was said to be bearing around 15 - 20 degrees on the bow, i.e. between 122° and 127° True. For this green sidelight to be visible to those on the Khudozhnik Ioganson the Zodiac had to be on a heading of at least 189.5° True (Diagram 7).

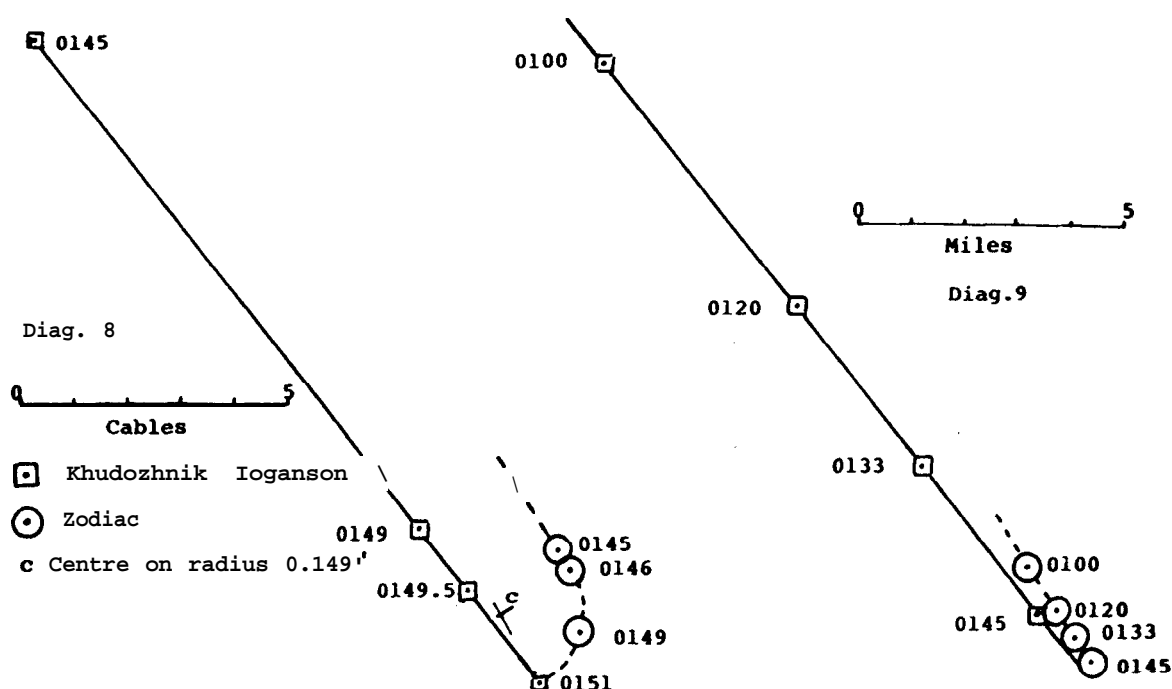
Reconstruction of incident based on zodiac speed 2.8kts, radius of turn 0.149mls

The time required for the Zodiac to alter course through 90 degrees in the sea conditions at that time was stated to be five minutes, thus the turn needed to commence at 0146. At a speed of 2.8 knots the radius of turn is 0.149 miles, which would place the Zodiac at a distance of 1.77 cables to port of the khudozhnik Ioganson's track at 0146 (Diagram 8). To arrive in that position on a course of 148° T and at a speed of 2.8 knots the bearings and distances of the Zodiac (Diagram 9) would have been as follows:

In these circumstances the Zodiac would have been only 1.5 degrees on the port bow when first seen and only 3.25 degrees on the port bow at 0133.

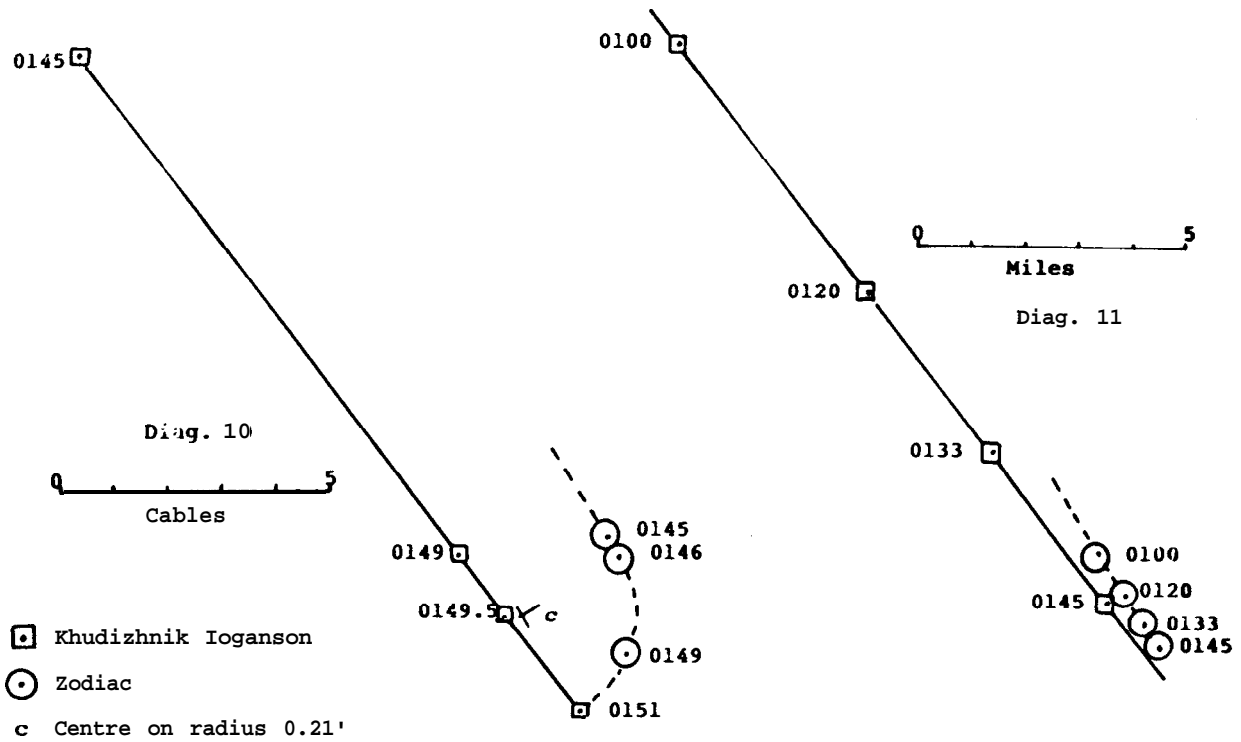
Reconstruction of incident based on 0145 brg of 132°

Reconstruction on the assumption that the bearing of 132° T at 0145 (Diagram 10) was correct provides a radius of turn of 0.21 miles, which requires a speed of 3.96 knots for the alteration of 90 degrees in 5 minutes.

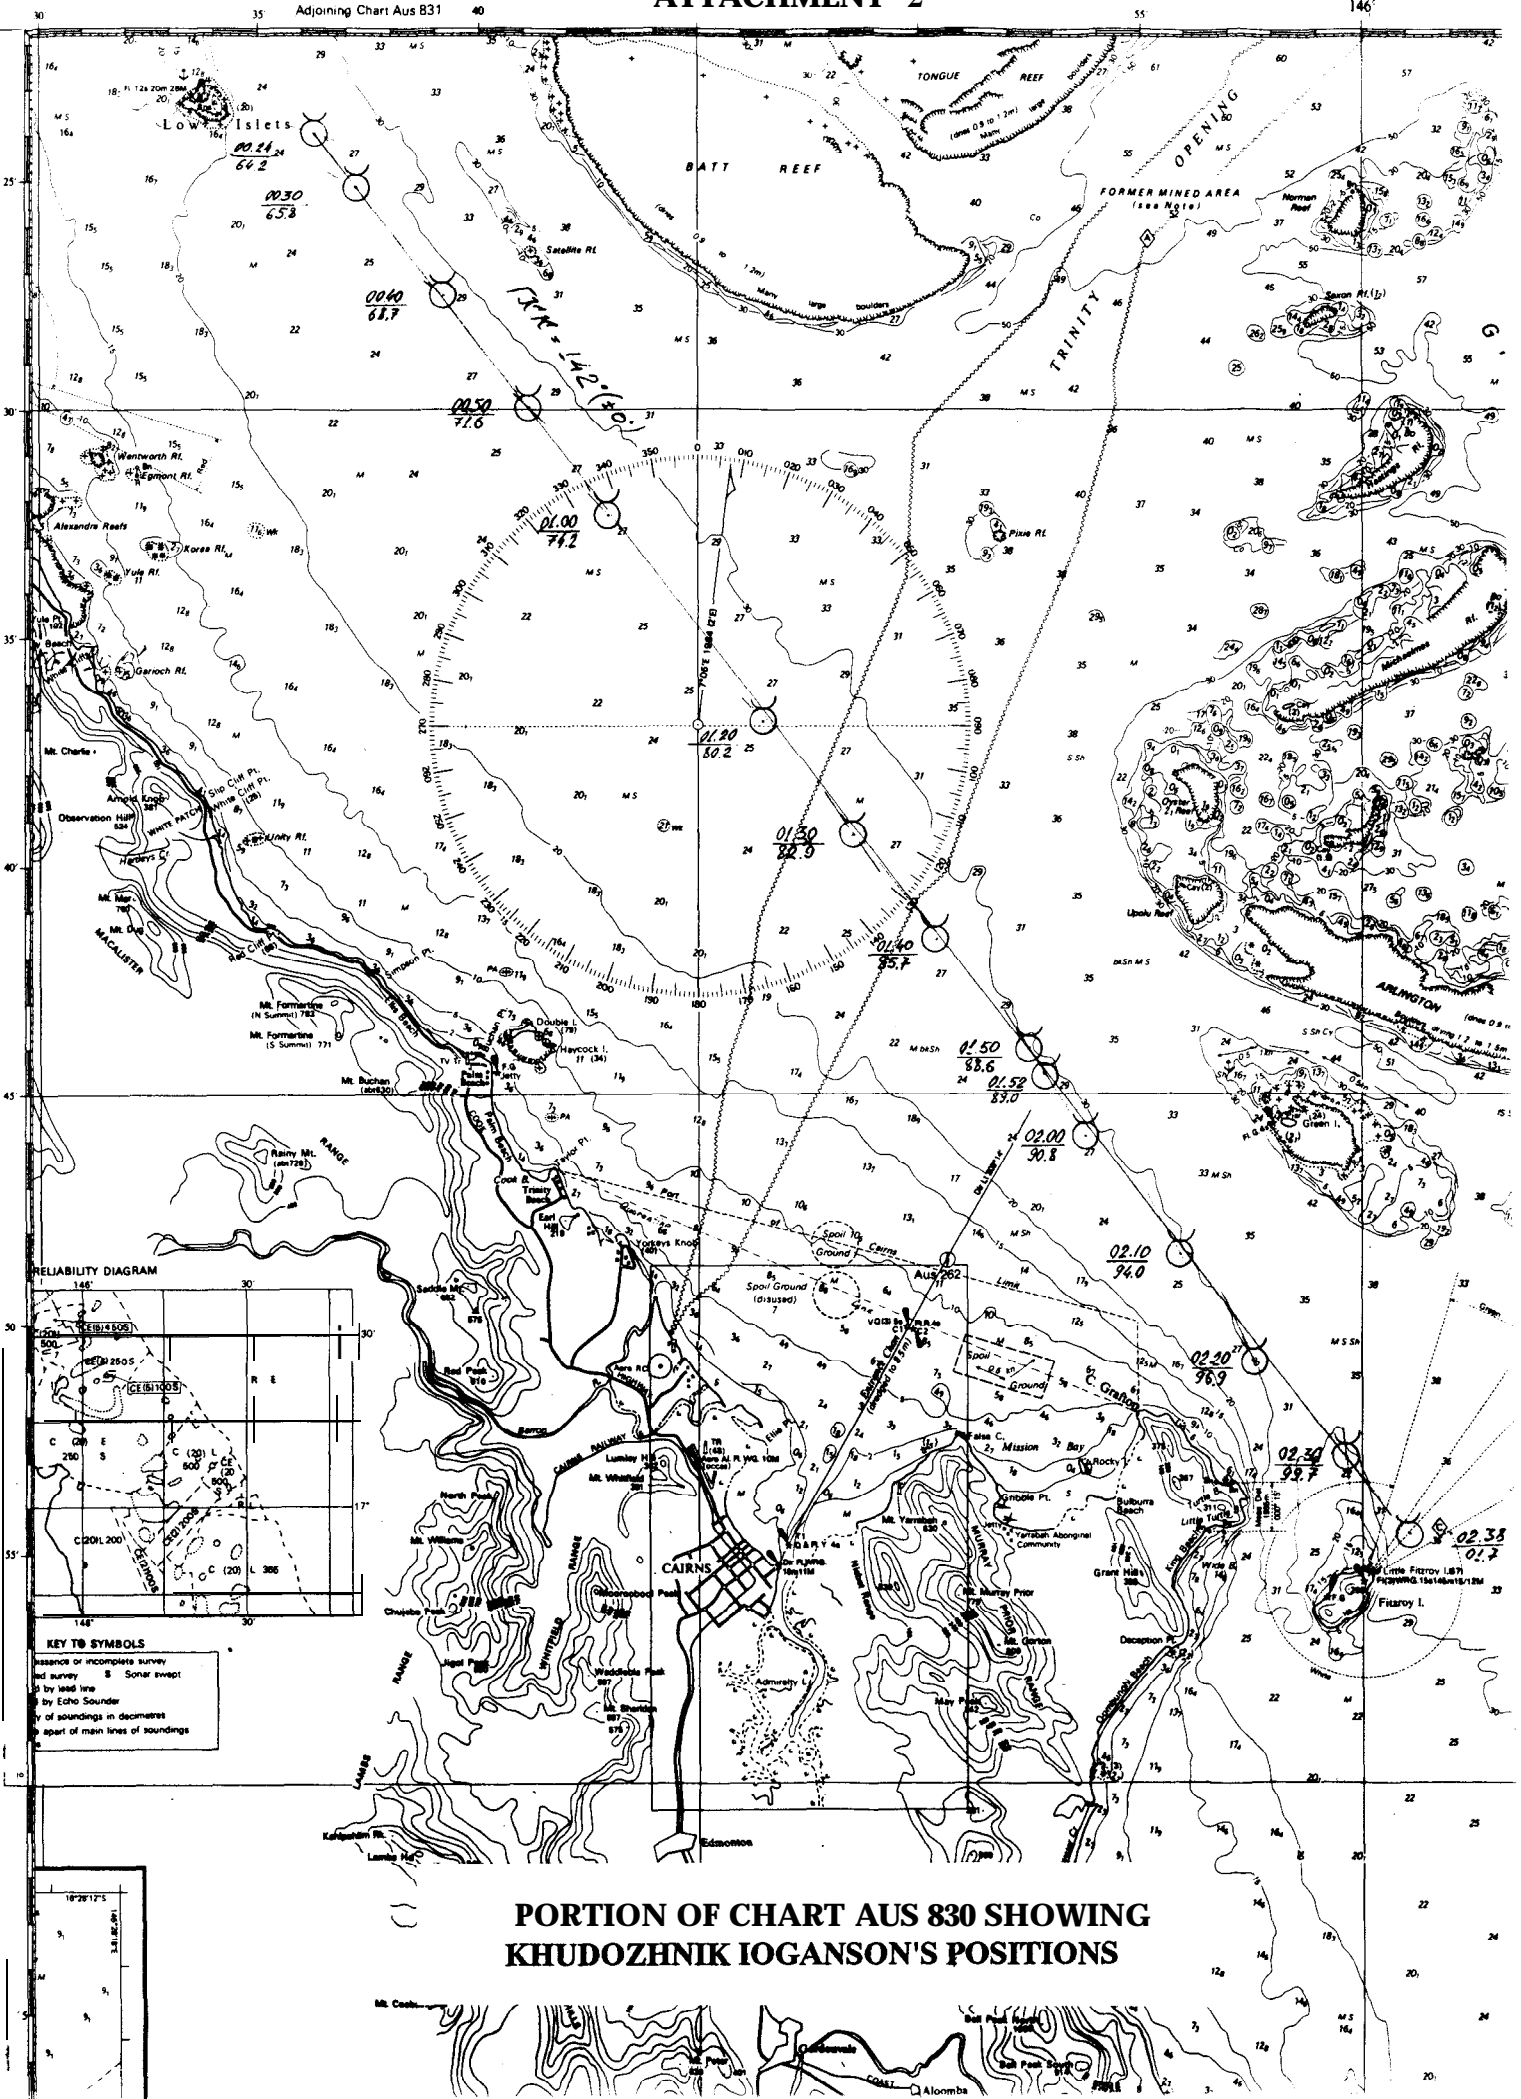
PORTION OF CHART AUS 830 SHOWING
KHUDOZHNIK IOGANSON'S POSITIONS

Reference to the chart upon which the positions had been plotted at 10-minute intervals (Attachment 2) shows that the Khudozhnik Ioganson was making good the course laid down on the chart, i.e 142° True.
