## Summary

On 4 October 1991 the Australian flag bulk carrier TNT Carpentaria was on passage from Weipa to Gladstone with a full cargo of bauxite and drawing a maximum draught of 12.13m.

At about 1754 the vessel grounded 0.7 miles north-west of Harrison Rock at the western end of Sunk Reefs.

# TNT Carpentaria General Arrangements

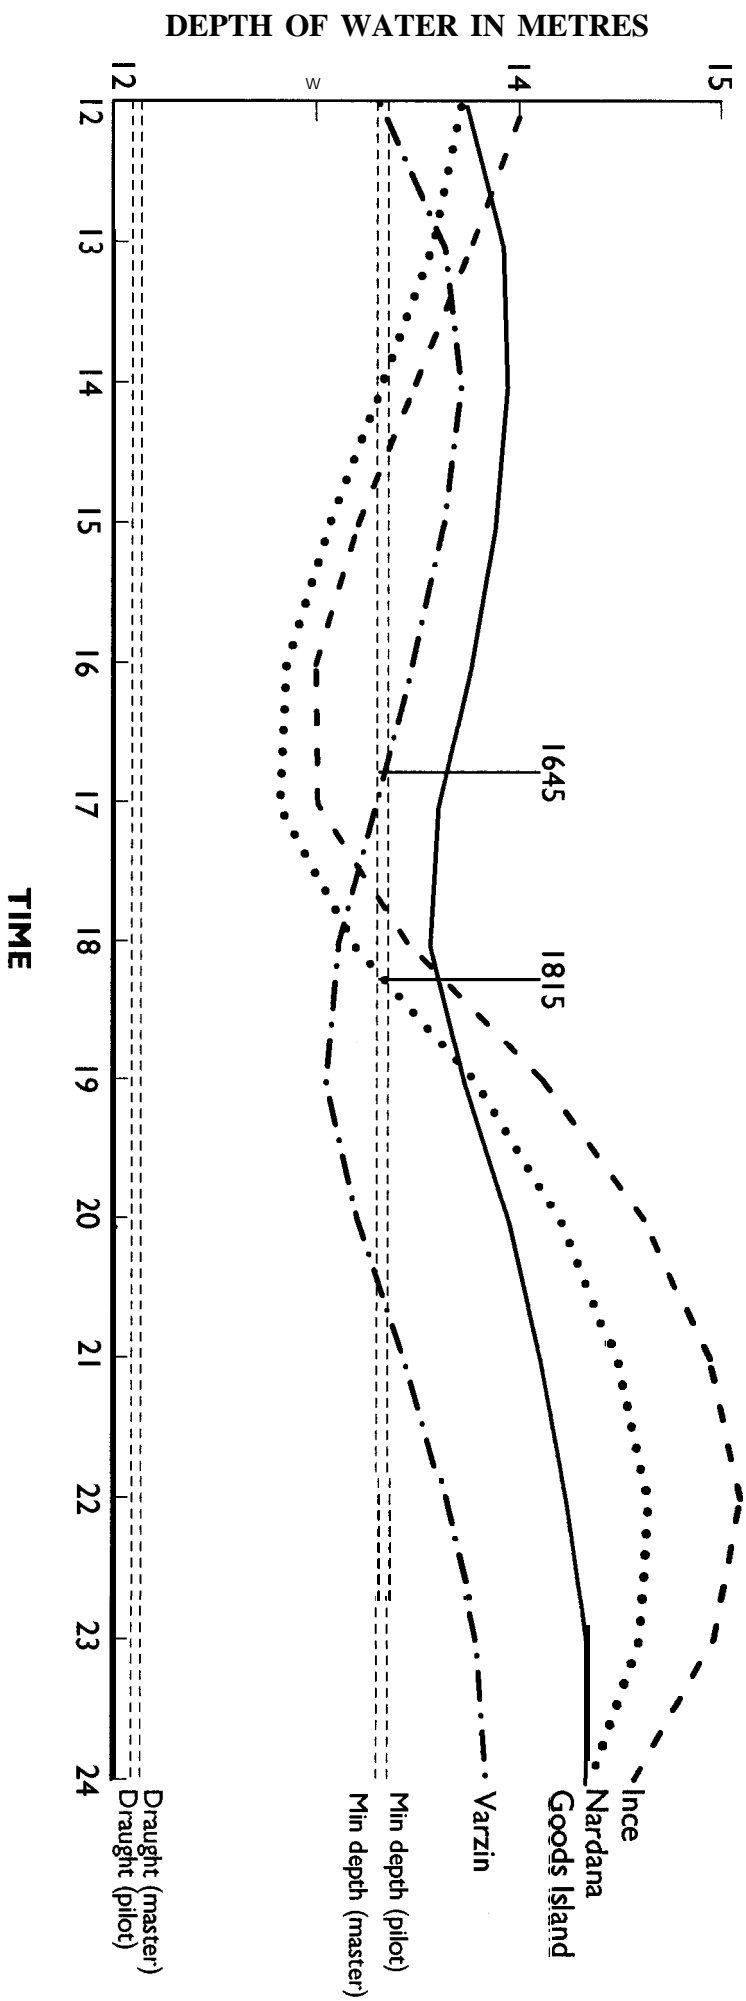
GRAPH 1

Graph of tidal curves taken from hourly predictions  
4 October 1991

On this basis the ship had to clear Varzin Passage by 1640, otherwise there would have been less water than the Master required. Had he adopted a 1m under-keel clearance, being the minimum recommended for Varzin Passage on the basis of tidal predictions, there would have been two windows of opportunity through which to navigate Varzin Passage. The first between 1145 and 1755 and the second between 1940 and some time after 0200 on 5 October.

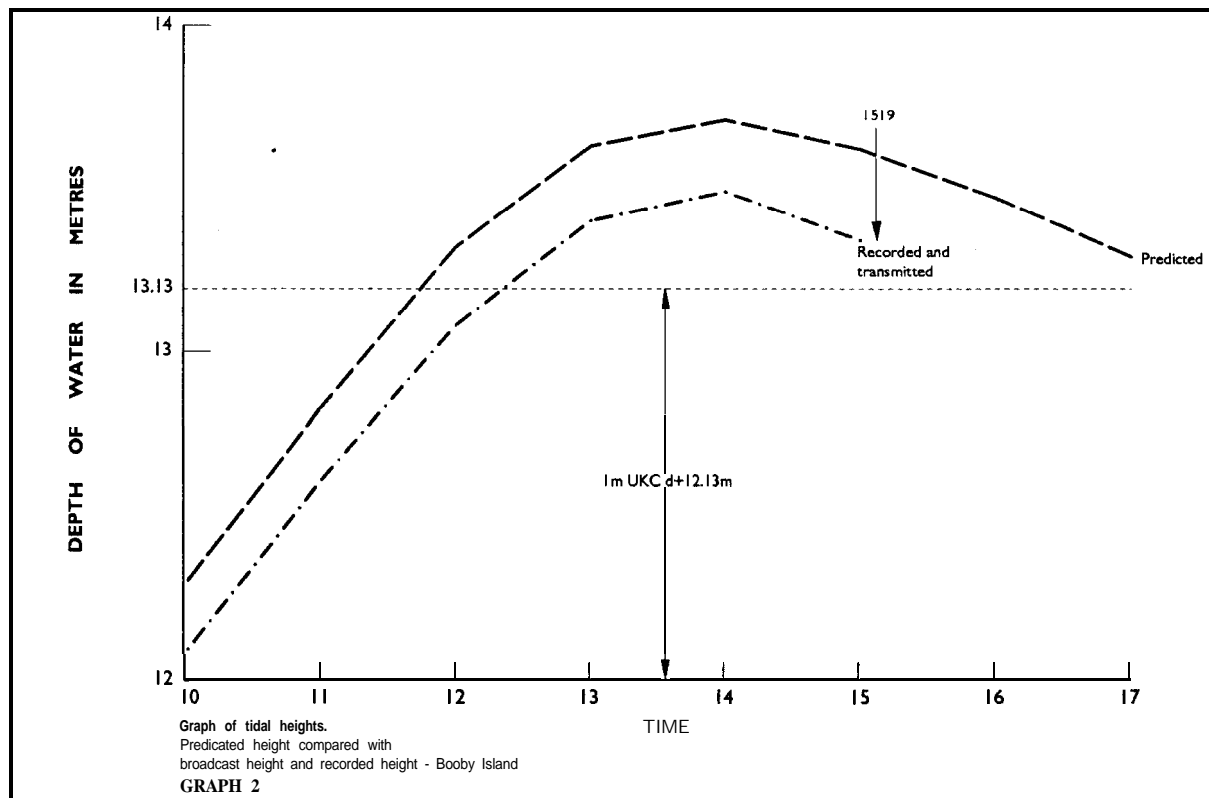
At 1400, Booby Island transmitted a tidal height of 2.9m, 0.3m less than the predicted 3.21m.

At 1519 the TNT Carpentaria cleared the eastern buoys of Varzin Passage and altered course to 100 degrees with Goods Island lighthouse ahead. The depth of water as transmitted by Booby Island tide gauge was 0.3m below that predicted giving a least depth of 13.3m. At all times, therefore, the recommended 1m under-keel clearance for Varzin Passage was maintained. In fact, the minimum under-keel clearance recorded by echo sounder was 1.6m at the eastern exit of Varzin Passage.

**Graphs of tidal heights  
predicted height compared with  
transmitted height and  
recorded height - Bobby Island**

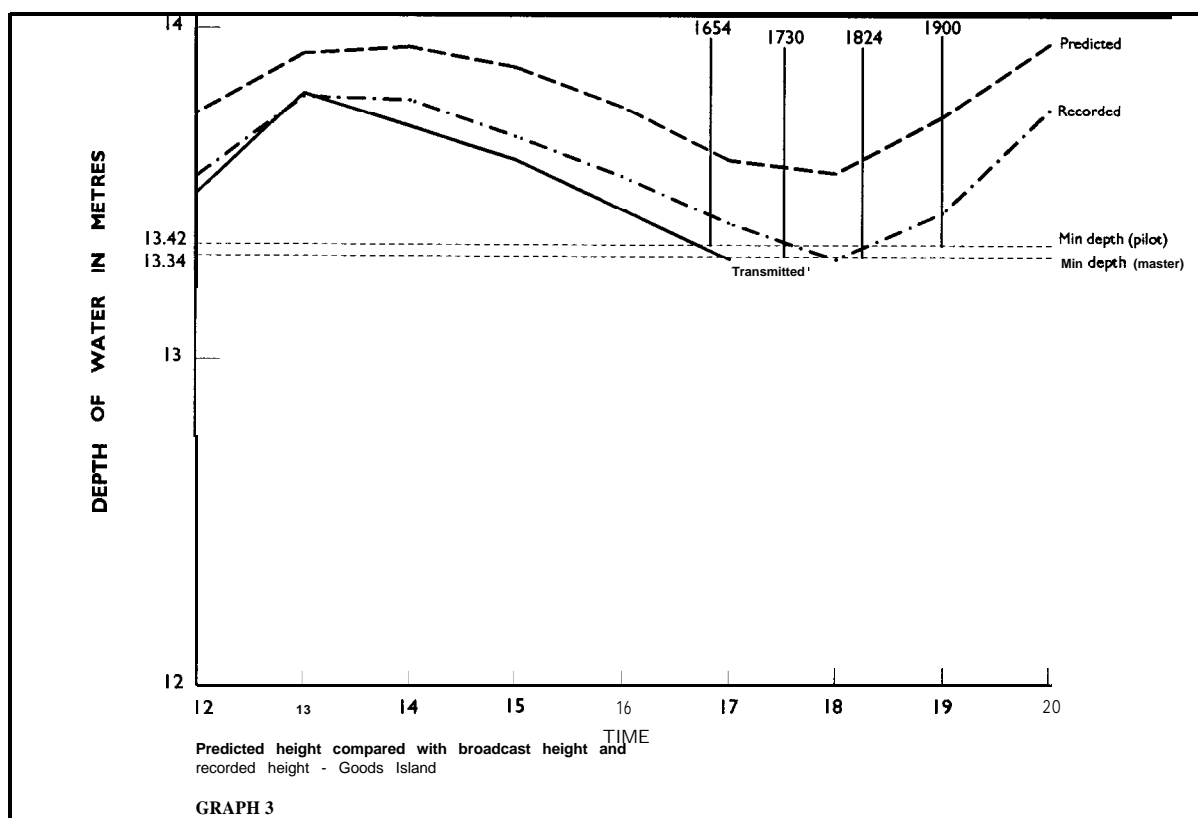
**Graphs of tidal heights  
predicted height compared with  
transmitted height and  
recorded height - Goods Island**

Low water at Goods Island was predicted at 1746 at a height of 2.2m above datum giving a height of 13.5m. At 1500 and at 1700 the tide gauge at Goods Island was transmitting a height of tide 0.3m below that predicted (the 1600 Goods Island transmission was not recorded). While the depth in the approaches to the west of Goods Island is about 12m, the datum at the western entrance to the Prince of Wales Channel is based on a sounding of 11.3m. On the information available to the Master, from the transmitting tide gauges, that the actual depth of water at Goods Island at 1500 was 13.6m on a falling tide, he should have realised that from about 1700 he would not be able to enter the Prince of Wales Channel with the recommended under-keel clearance. Further, the ship could not have passed the critical area off Nardana Patches until 1912.

Regardless of the water available at Nardana Patches, there was, according to the transmitting tide gauge at Goods Island, insufficient water off Harrison Rock to enter the Prince of Wales Channel with the minimum recommended under-keel clearance at 1730.

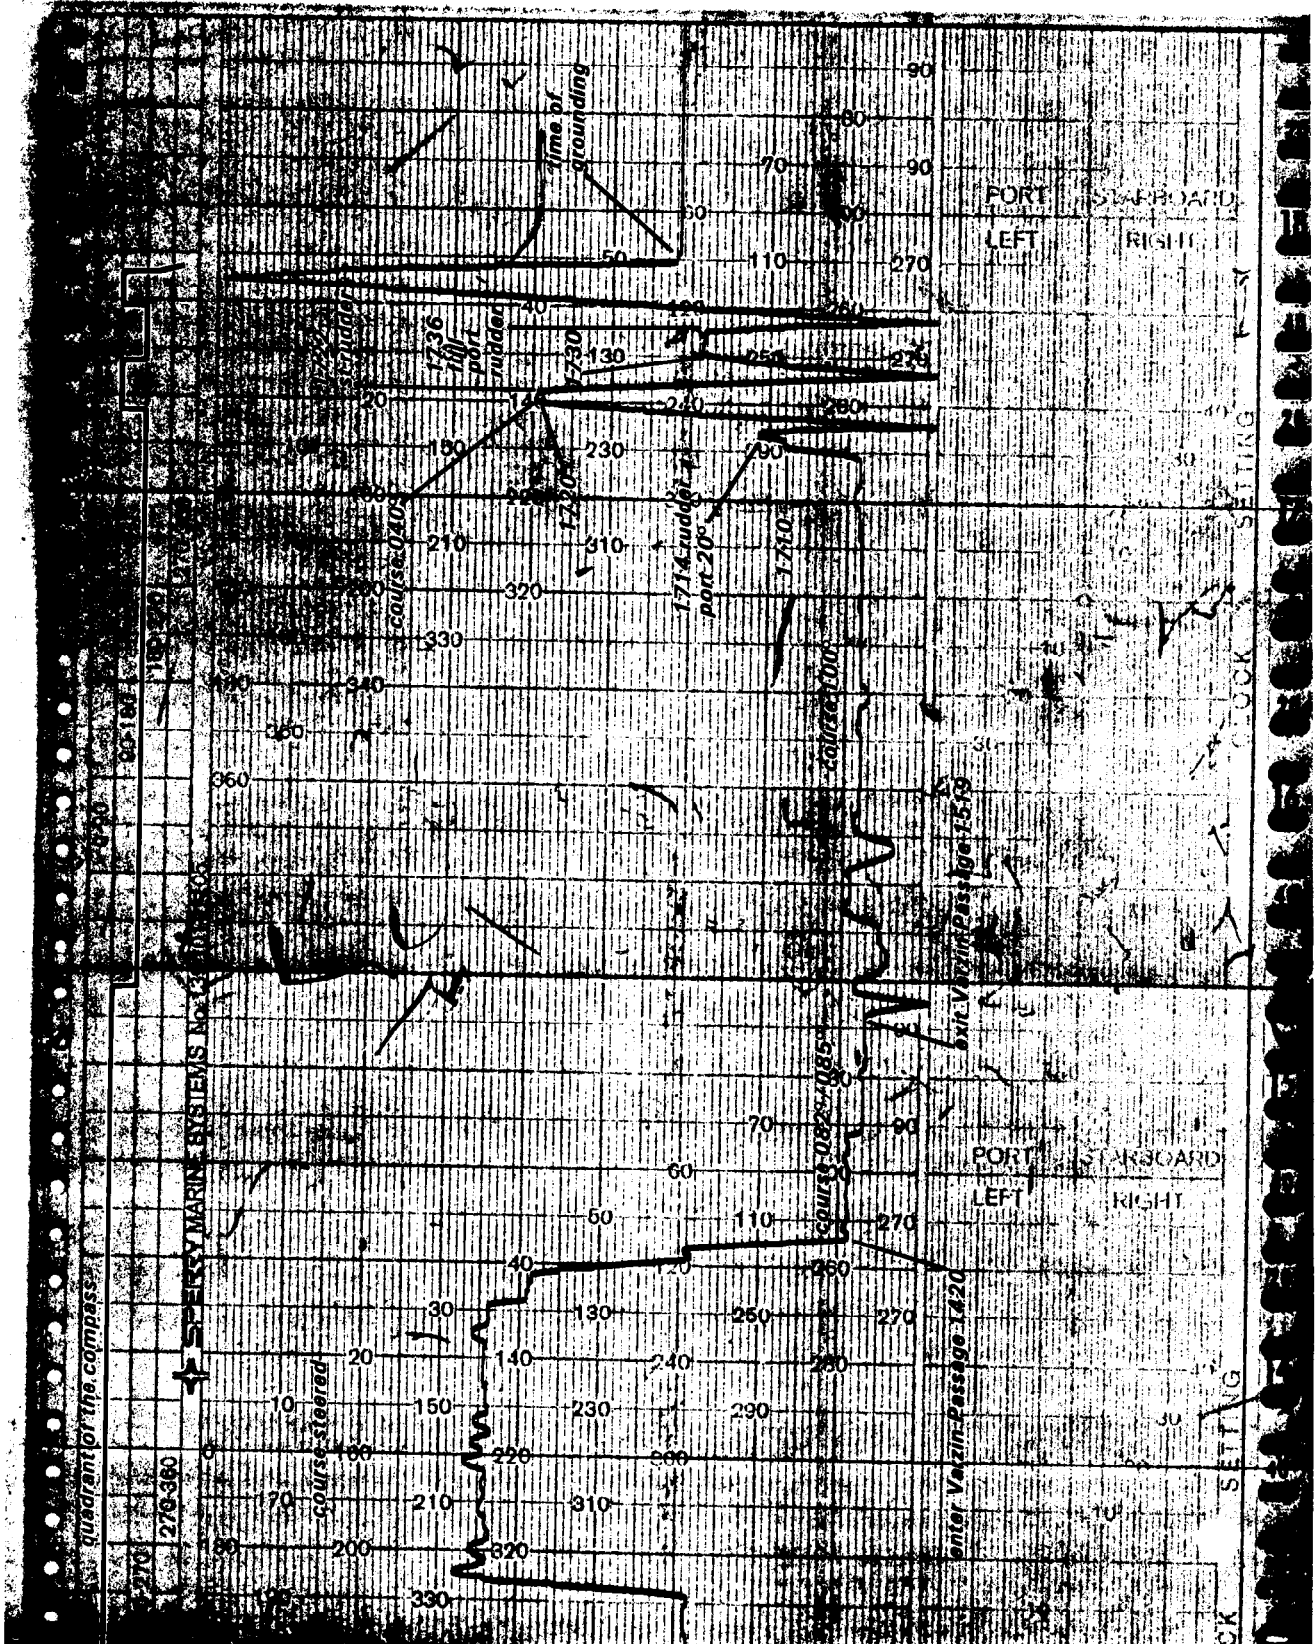
# TNT CARPENTARIA

At about 1750 the Master noted that the echo sounder reading showed zero and the lookout reported that the ship had stopped swinging. This was confirmed by the Helmsman. The ship's head at this time was 310 degrees. The Master and Pilot assumed that the vessel was aground. At 1753 hours the engine was stopped and at 1754 the engine was run astern until 1804.

COURSE RECORDER TRACE 1300 TO 1800 4 OCTOBER 1991

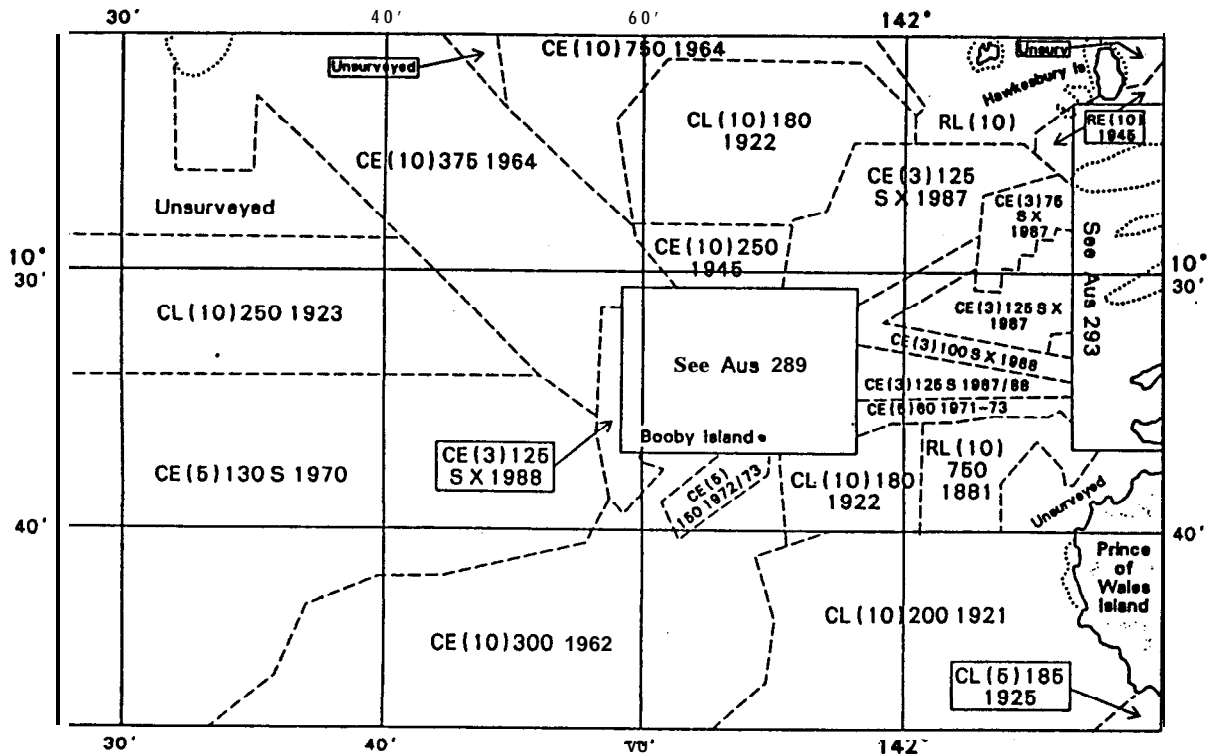
chart 296

Charts AUS 296 (Goods Island to Proudfoot Shoal) and AUS 293 (Prince of Wales Channel) carry a note below the title sourcing survey data, which is further illustrated by the reliability diagram (Attachment 7).
