At about 1836 on 26 March 1992, the Australian roll-on/roll-off vessel Searoad Mersey, was unberthing from Webb Dock, Melbourne to undertake its regular voyage from Melbourne to Devonport.

Searoad Mersey

SEAROAD MERSEY

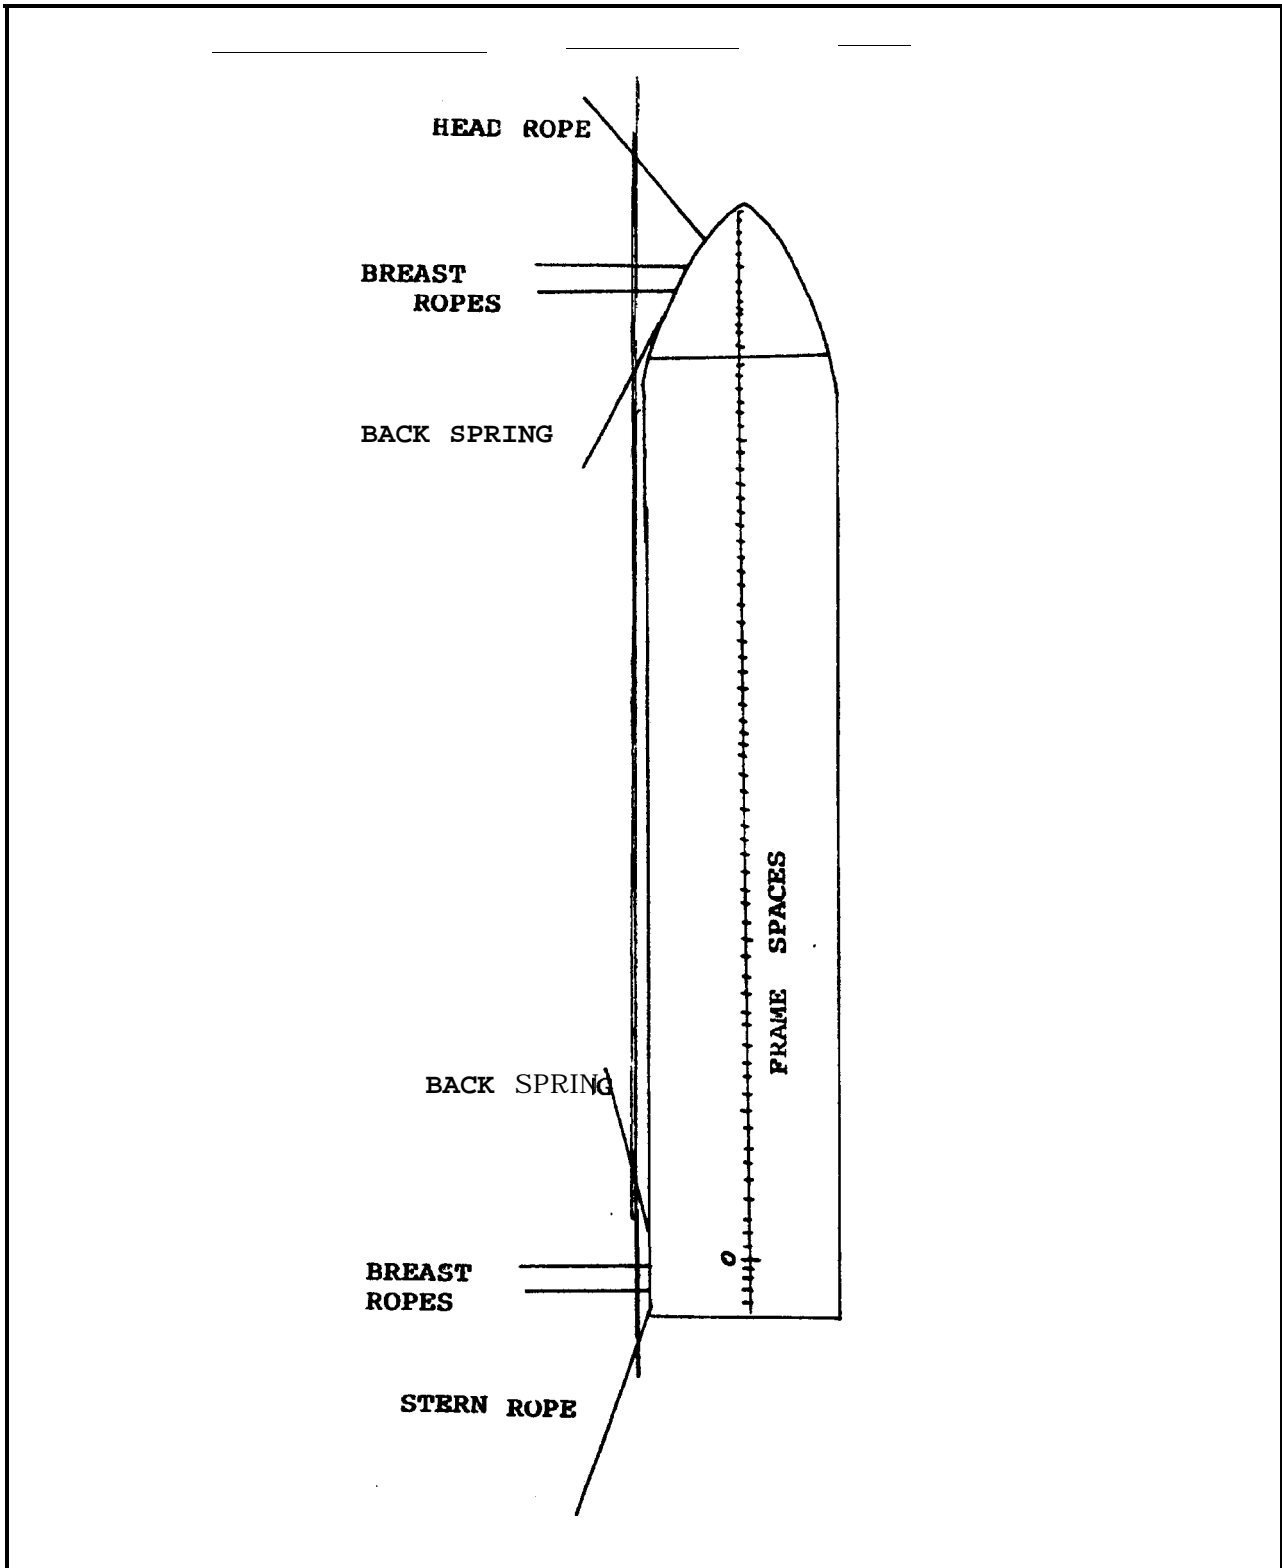
DIAGRAM OF TYPICAL MOORING PATTERN

The ship arrived at Webb Dock, Melbourne at 0802 on 26 March. It moored, as usual, port side to the berth, with a stern rope from the "blue" winch, two breast ropes and a back-spring from the "red", "green" and "yellow" winches respectively.
