Summary

While engaged in seismic operations in Tayabas Bay, Luzon, the Philippines, the Australian registered research vessel Rig Seismic grounded on an uncharted reef.

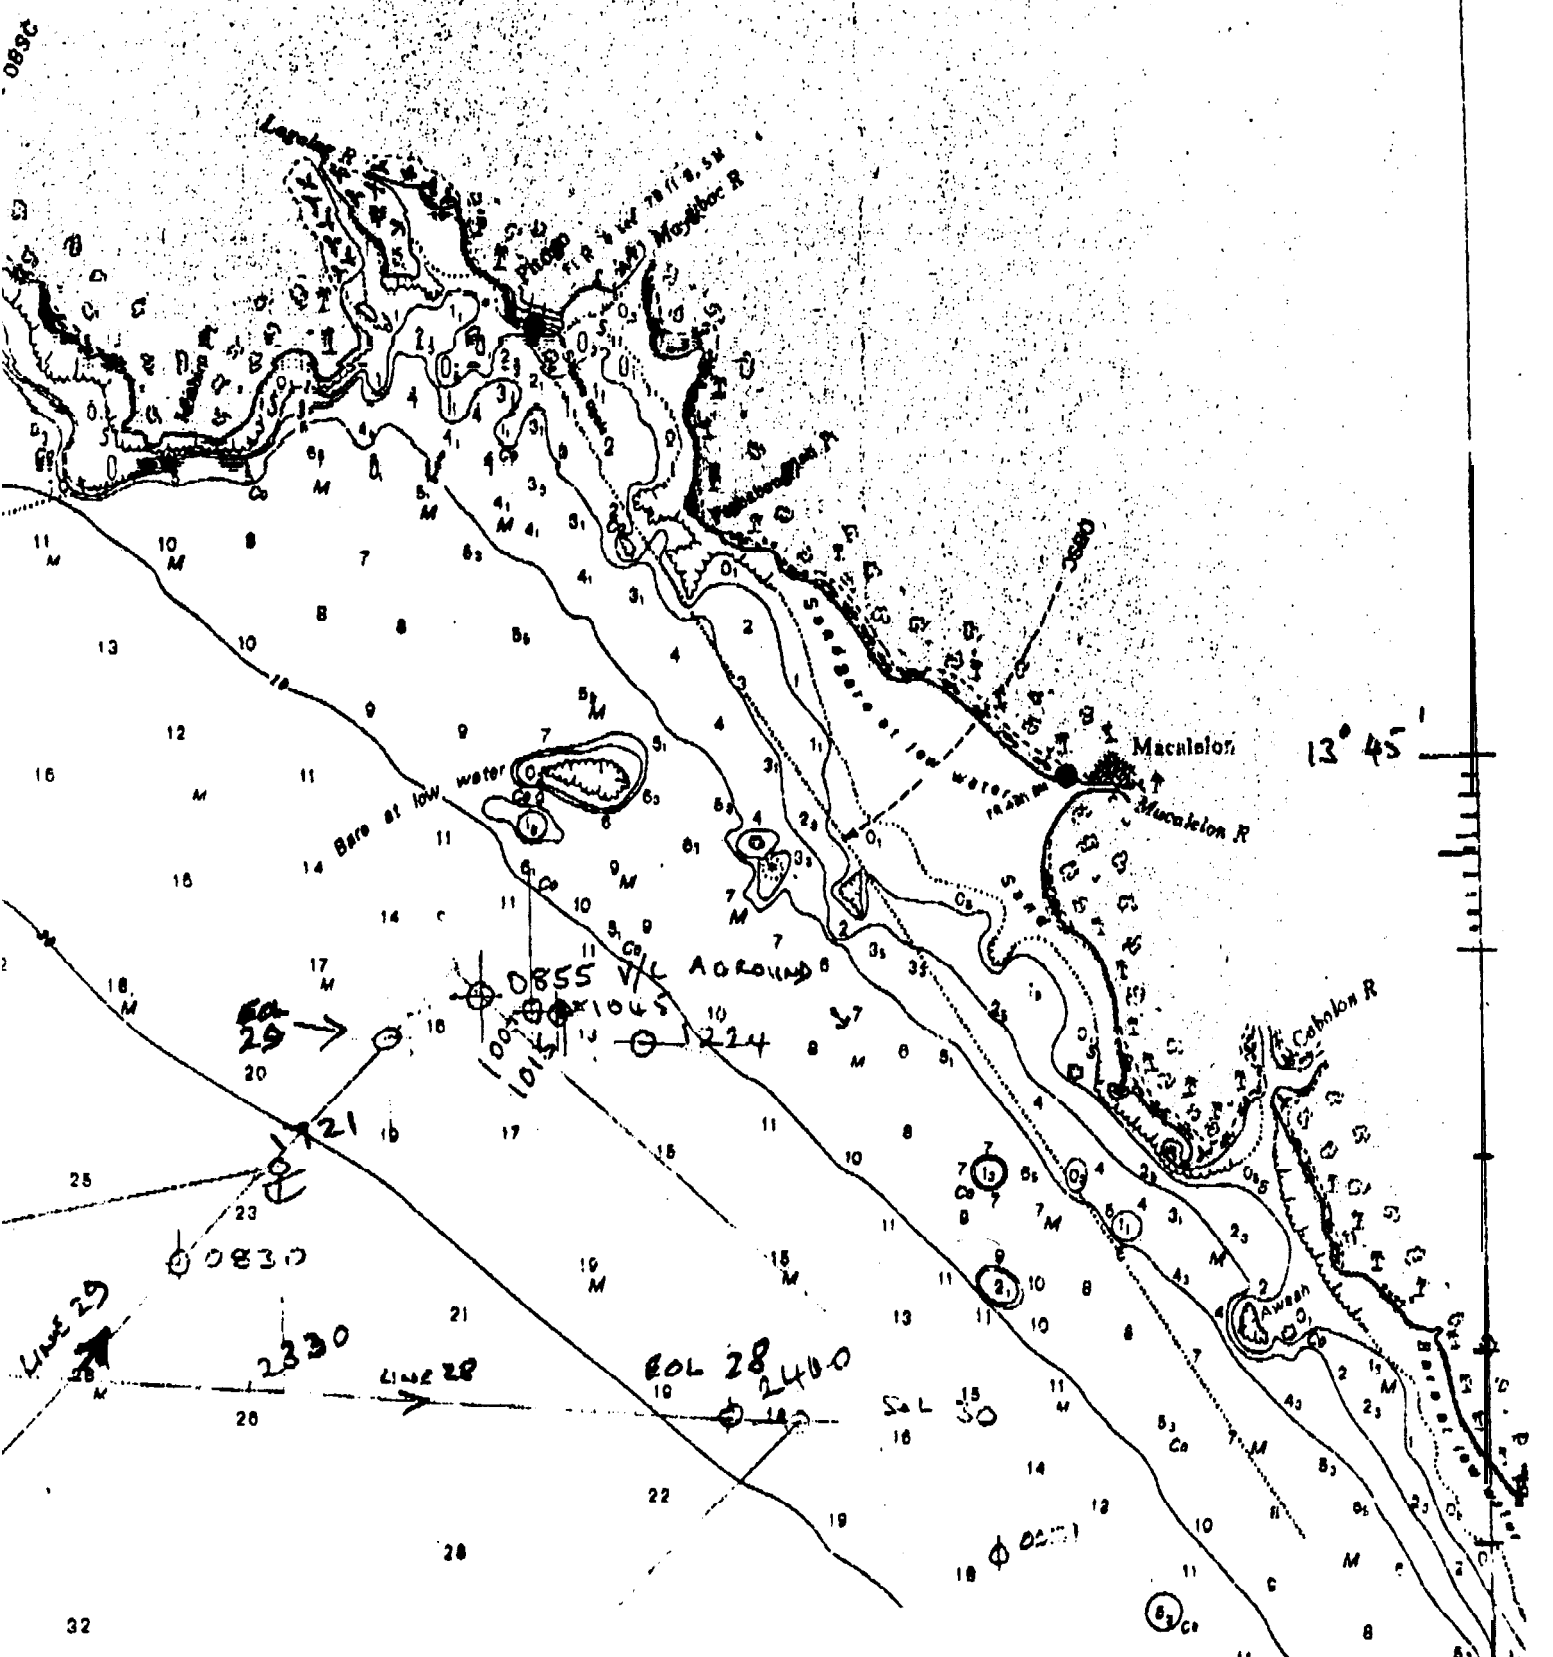
SHOWING POSITION OF GROUNDING

The area in which the Rig Seismic grounded is a space between soundings on all three of the navigational charts provided to the ship, the adjacent soundings indicating depths of 13 to 14 fathoms (24 to 26m). The closest charted reef lies about 8 cables (1480m) to the north of the grounding position. The satellite imagery of the area provided to the ship, which clearly depicts the charted reef to the north, does not depict the reef on which the ship grounded.

It is therefore accepted that the Rig Seismic grounded on an uncharted and unknown reef (unknown to the Master and officers of the Rig Seismic and to the hydrographic offices) and that the grounding was not due to an error in navigation.

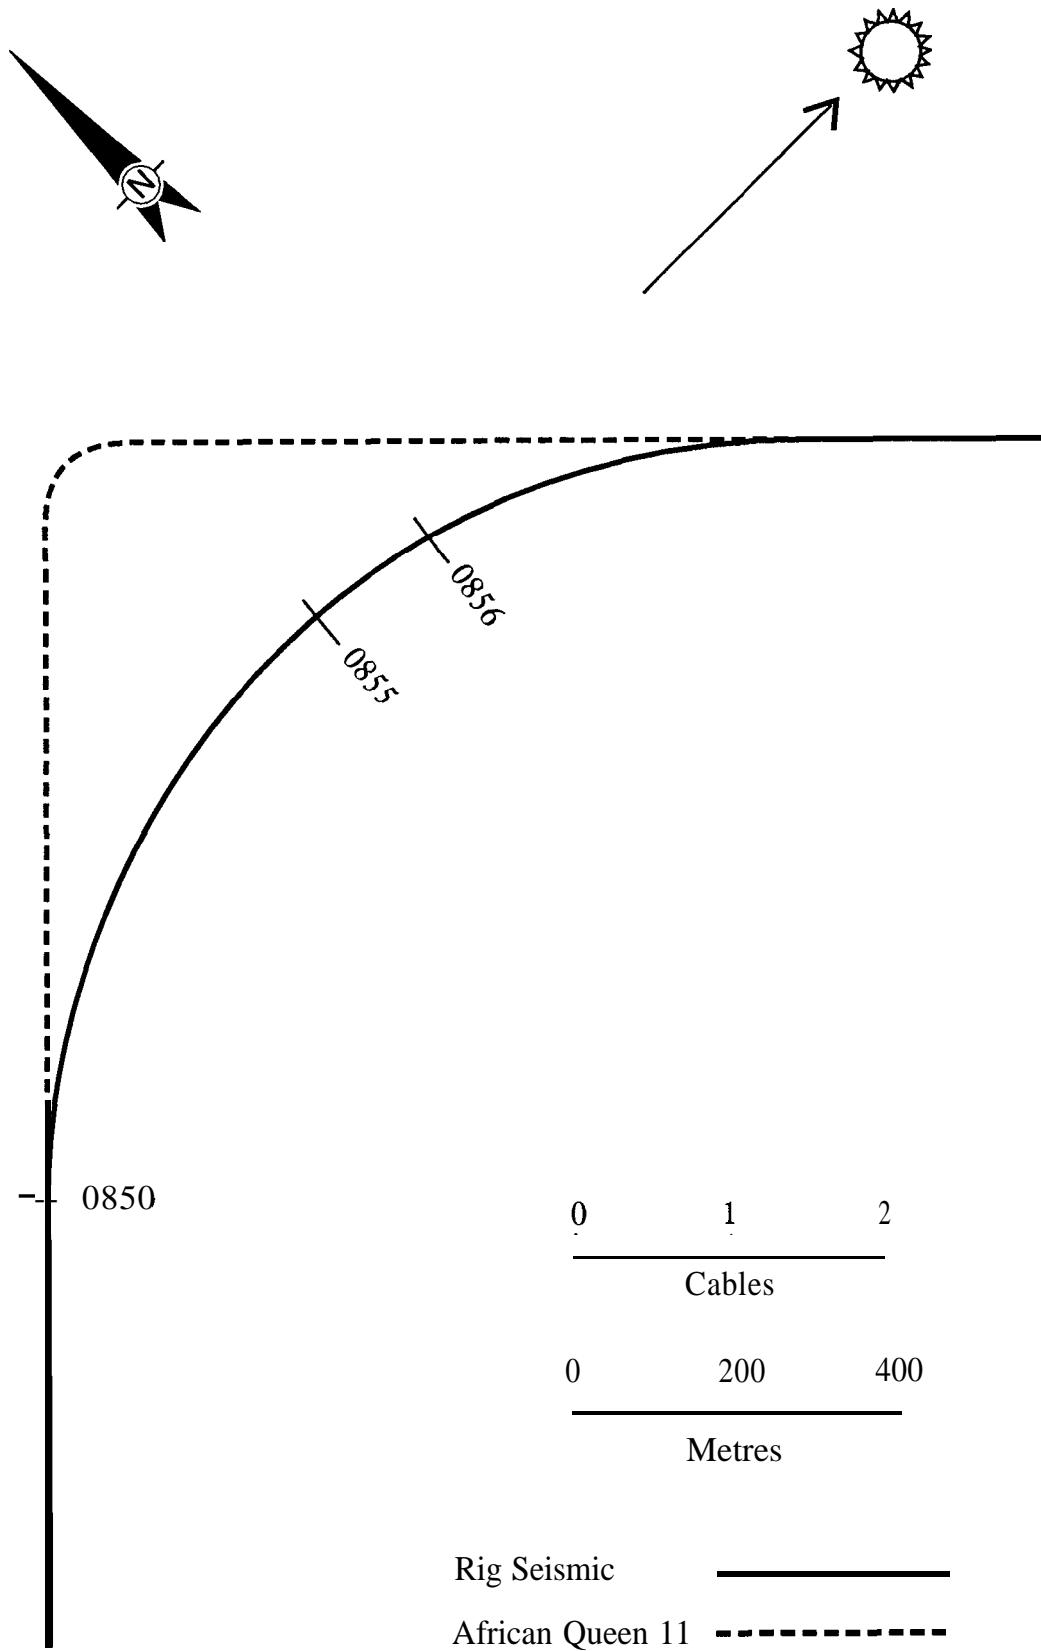
Diagram 1: Differing tracks of Rig Seismic and African Queen 11 during turn

On the occasion of the grounding the Extra Second Mate instructed the African Queen II to proceed 0.5 miles beyond the end of line point and then to alter 90 degrees to starboard. In making a controlled turn however, the Rig Seismic commenced the turn immediately on reaching the end of line position. Although both vessels would have ended up on the same course track at 90 degrees to the survey line once their respective turns were complete, they did not cover the same track in getting there (Diagram 1). At the point of furthest diversion the African Queen II’s track was some 350m from that of the Rig Seismic. In proceeding on the different track and in taking echo soundings directly underneath the vessel (not side sonar, for which it was not equipped), the African Queen II did not detect the existence of the reef on which the Rig Seismic grounded.

The disadvantages of the African Queen II proceeding on a different track during the 90-degree turns had been discussed on board, but no practical alternative found. However, after the incident a slightly modified operation was put in place, which resulted in a slightly closer track by the African Queen II during turns.

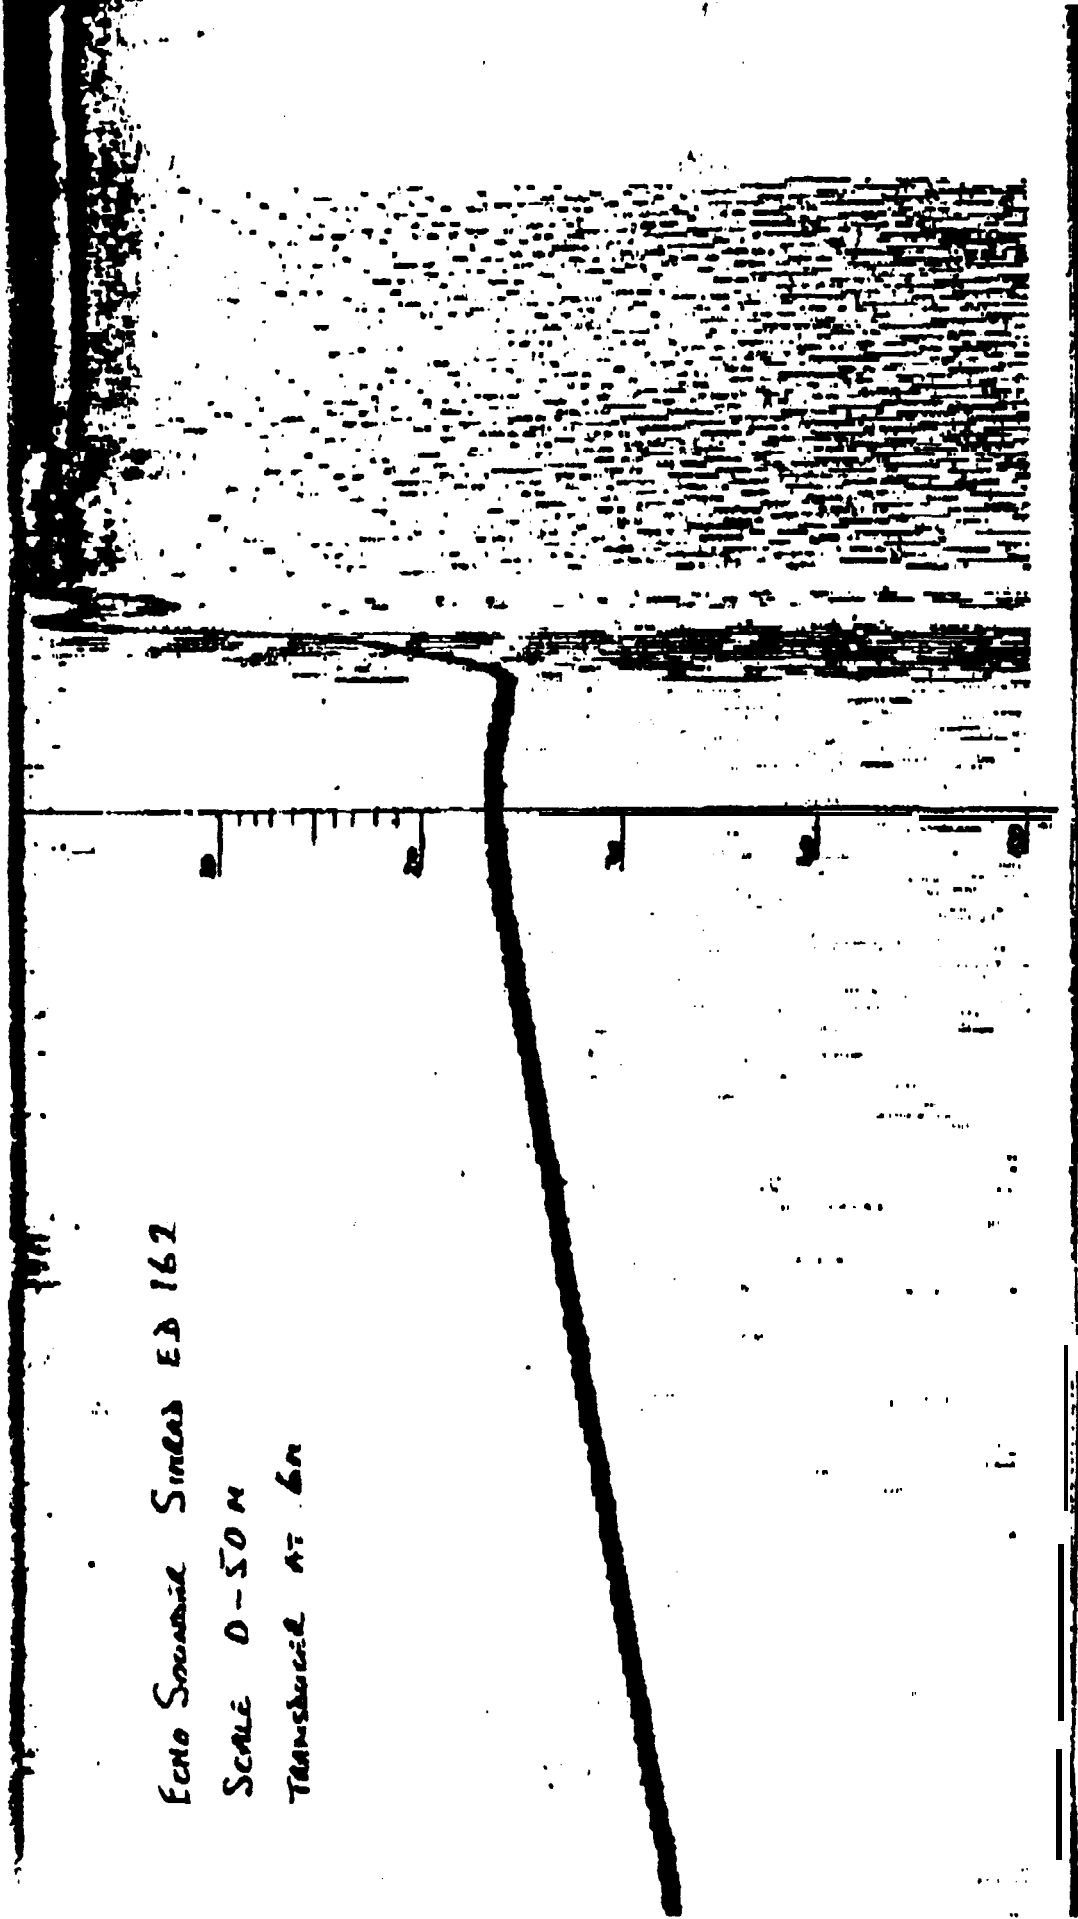
COPY OF ECHO SOUNDER TRACE

The trace on the Rig Seismic's echo sounder chart shows a gradual rise of the seabed, in accordance with the charted information and the echo sounder depths as reported by the African Queen II. The abrupt decrease in depth as the Rig Seismic passed over the edge of the reef provided insufficient warning to enable those on the bridge to respond.

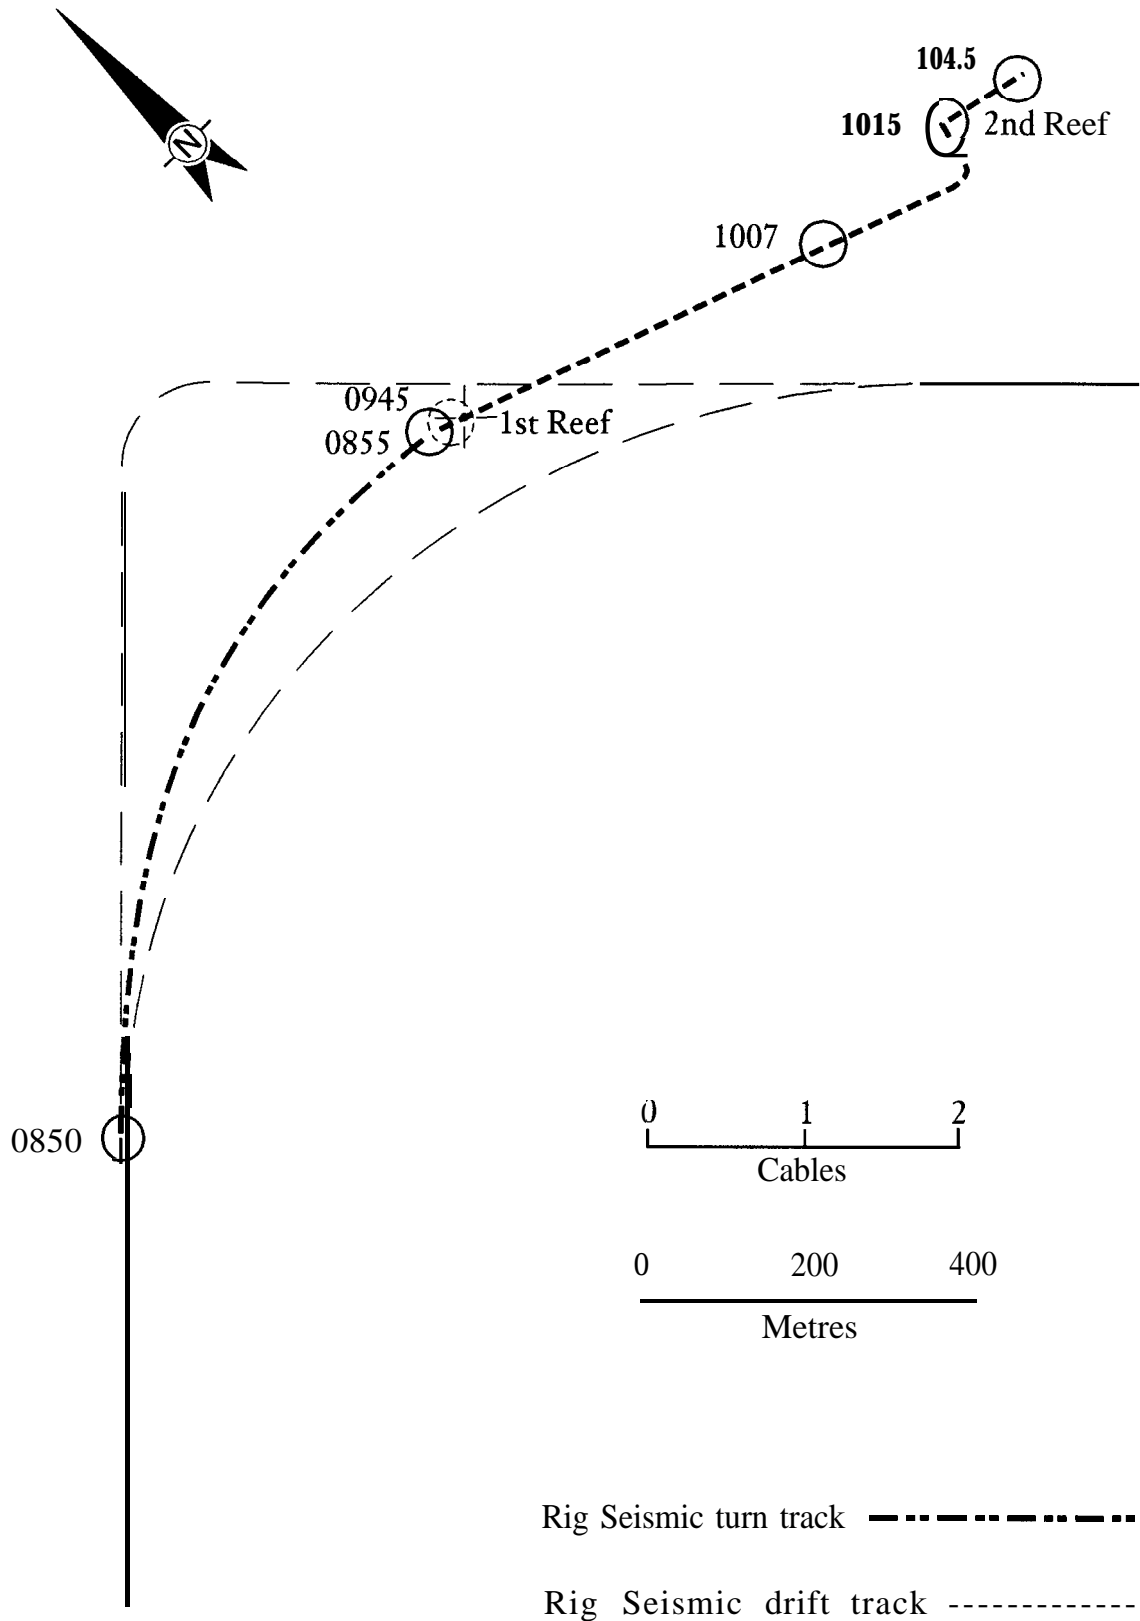
Diagram 2: Rig Seismic actual turn track and grounding positions

Study of the times and positions recorded from the time the ship first grounded until it was manoeuvred clear, indicates that there was not just one reef, but a number of reefs in the area (Diagram 2). The reef on which the ship first grounded was said to be about 50m in diameter. After drifting clear at 0945 the ship drifted about 600m in an easterly direction before drifting into shoaling water and embedding the rudder in a coral head. On inspection by the divers, this second shoal area was found to consist of two coral reefs, divided by a gully and surrounded by a number of coral heads of varying sizes.

When the Rig Seismic first grounded on the reef it is apparent that the only sections of the ship to come into contact with the reef were the after two fairings, the after section of the raked keel and the tips of the propeller blades.
