Summary

At about 1830 local time on 1 September 1992, the Australian yacht *Champers*, while on a voyage from Gladstone to Tweed Heads, was involved in a collision with a ship in a position 18.5 miles east of Bustard Head.

Photographs: yacht "Champers" and MV "Antares"

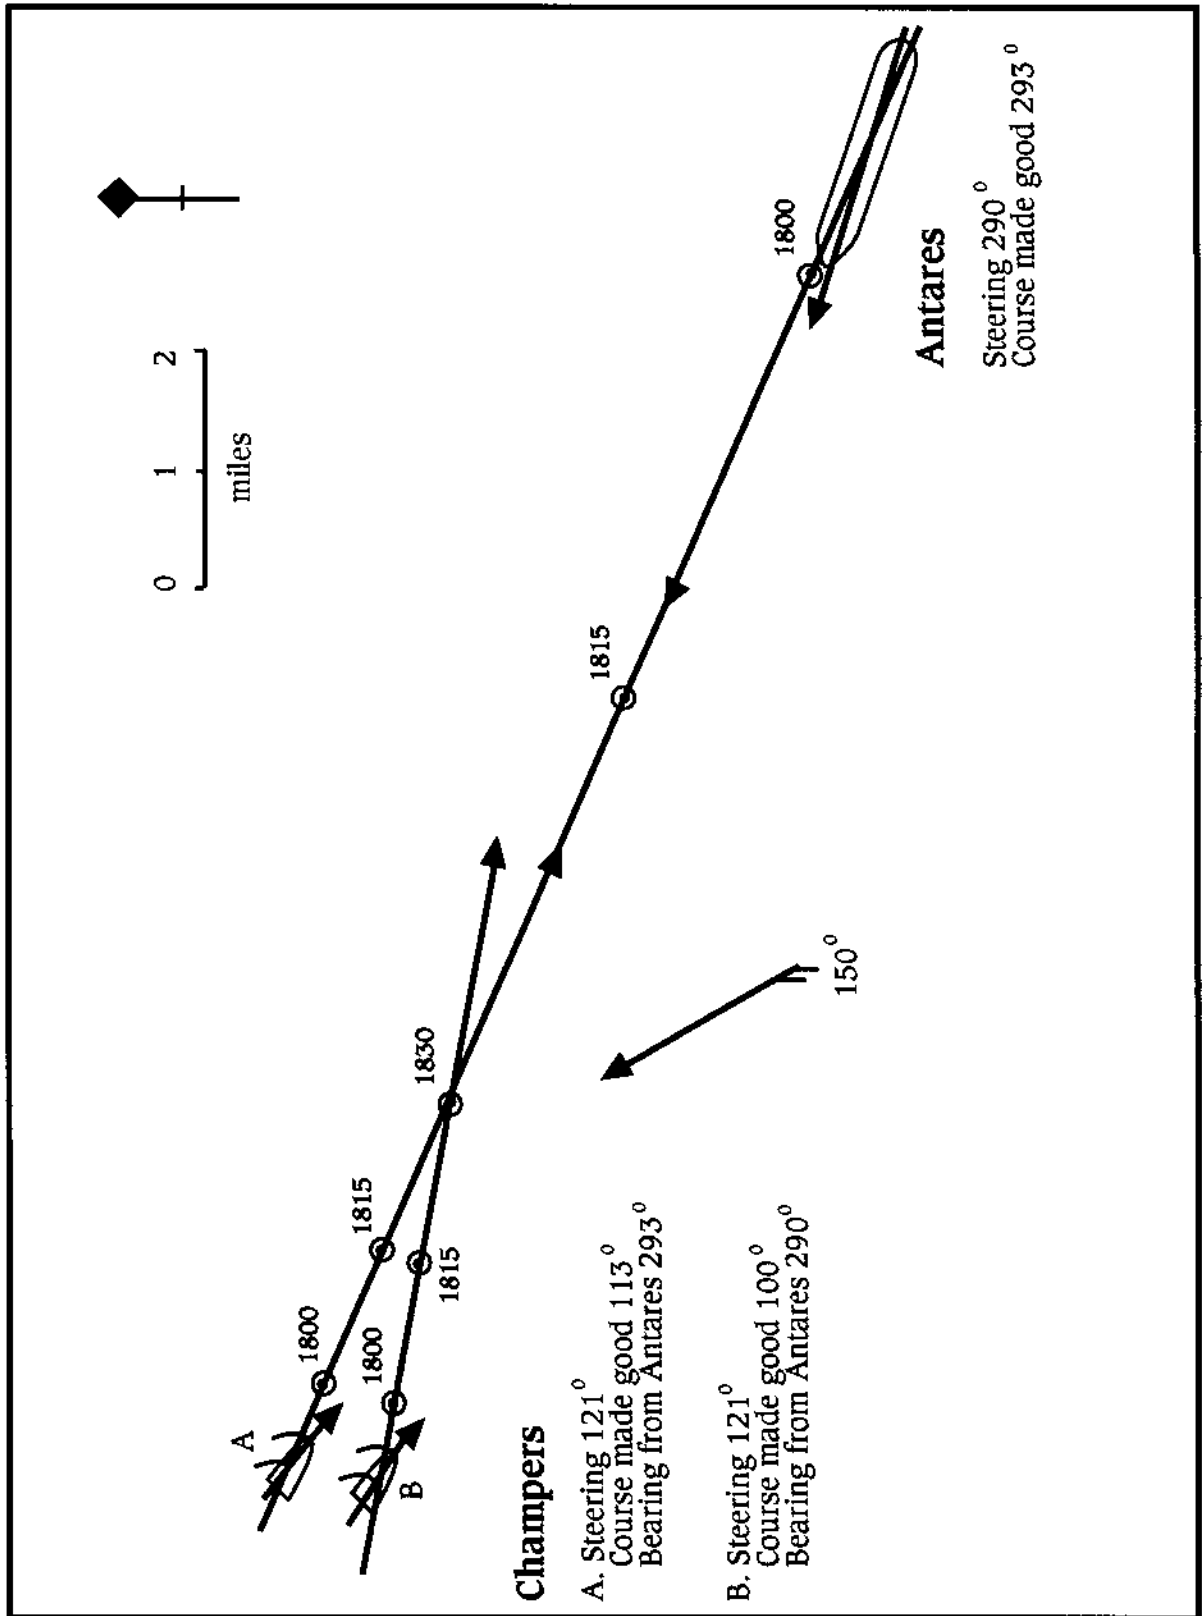
Reconstruction of collision

The reciprocal course to that made good by Antares is 113 degrees, (A in diagram on previous page) while if Champers approached Antares from right ahead, on a steady bearing of 290 degrees, the course required to be made good by Champers would have been 100 degrees (B in diagram on previous page). Had Champers approached on Antares' port bow, it would not have passed down the starboard side of Antares after a bow contact.

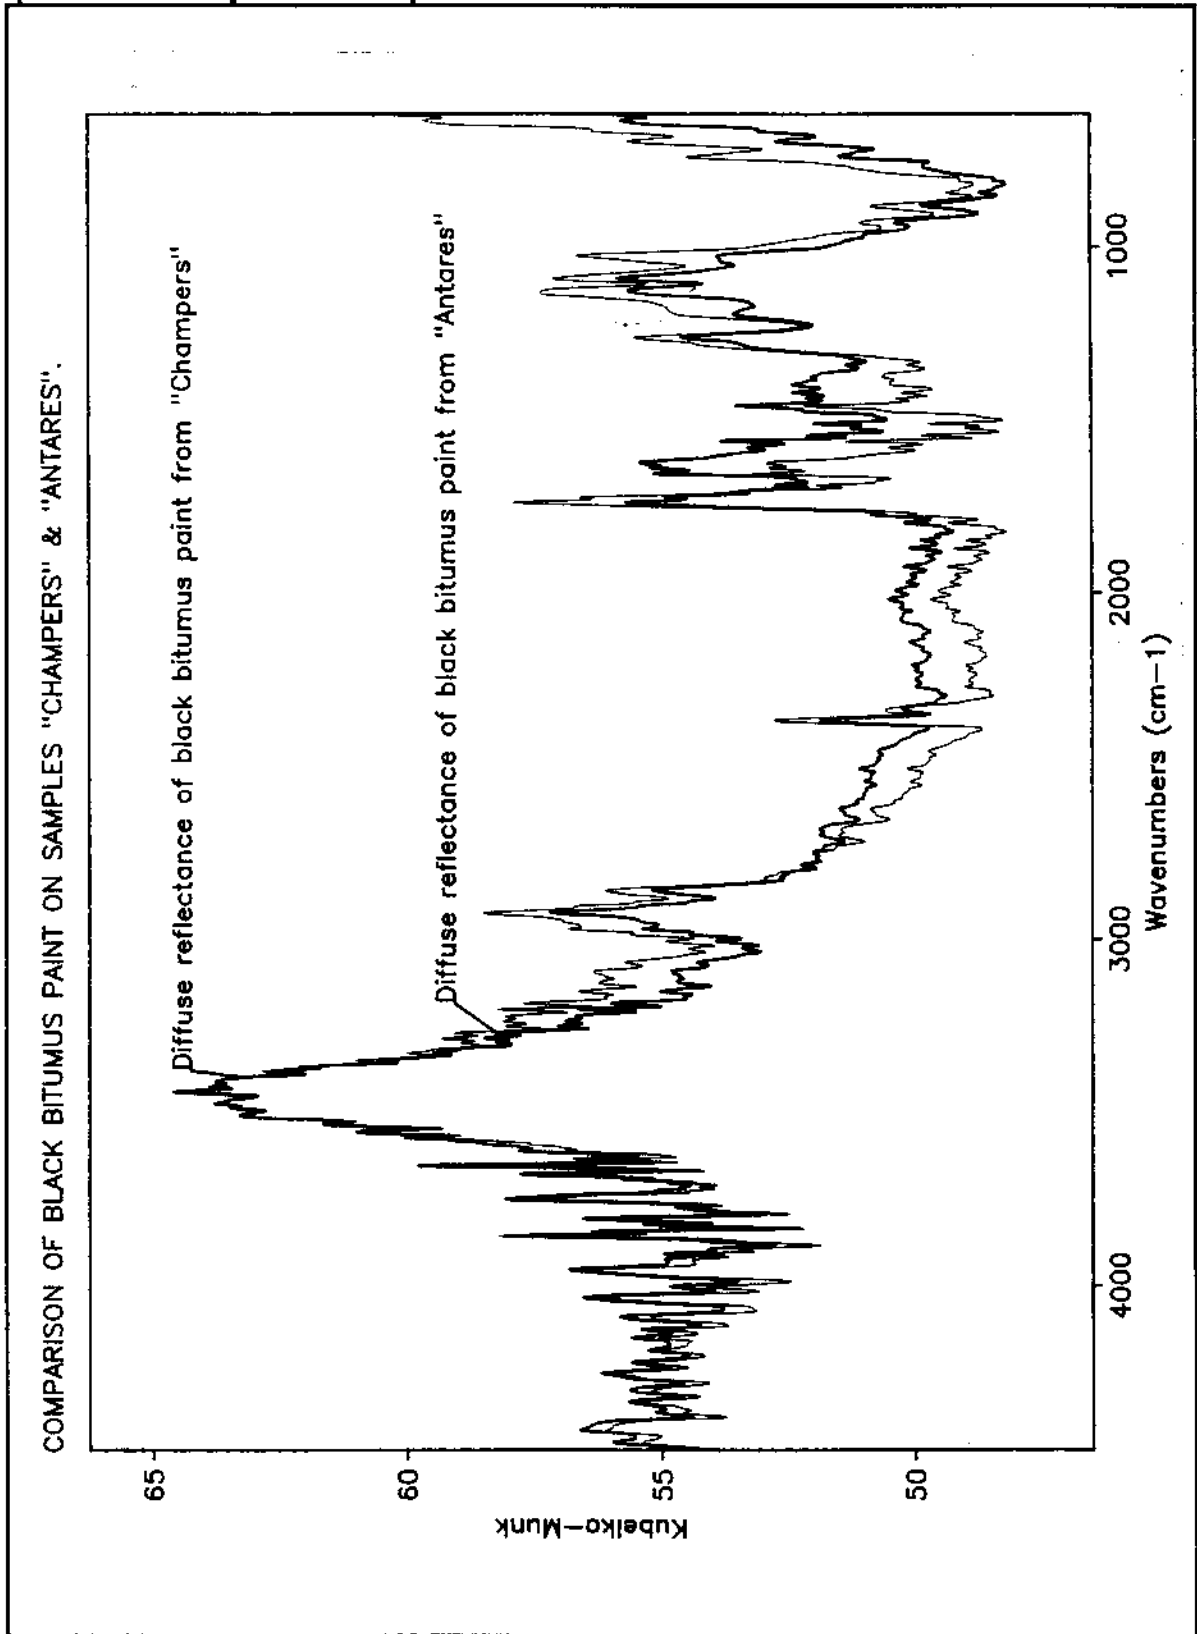
Spectrum Analysis of Samples

The samples of scale and paint taken from the ship's side and the sample of scale obtained from the skipper of Champers were examined by the Australian Federal Police Forensic Department. Both samples were found to contain a thin layer of a black bitumastic substance, which matched under spectrum test

(Attachment 1). The report from the laboratory (Attachment 2) opined that "the scientific evidence indicates that the scale found on Champers could have come from the ship Antares".

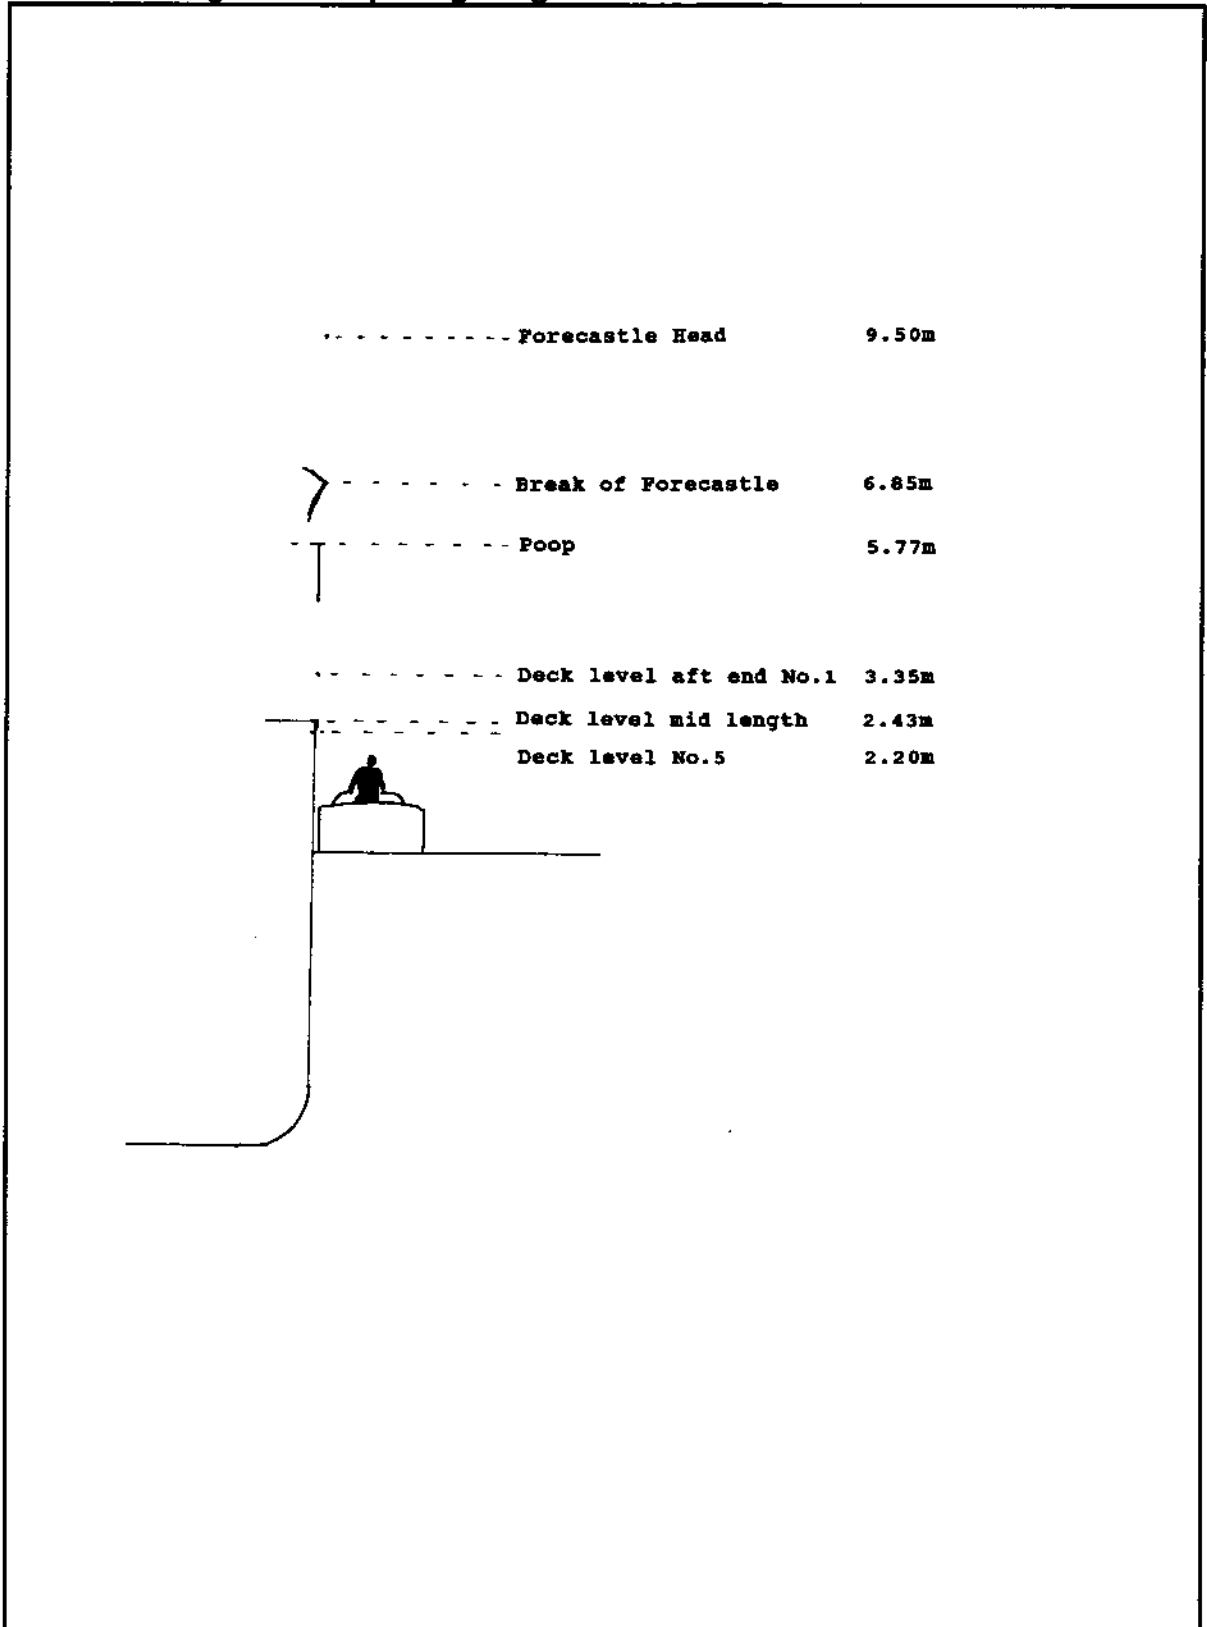
Sectional Diagram Comparing Heights of the Two Vessels

The scale found on Champers was found to contain black paint, a topside paint as against boot-topping. Had the ship with which Champers collided been riding high in the water, it is more probable that red boot-topping paint would have been scraped off.
