Summary

On 1 December 1992, while engaged in a navigational training exercise off the north-west coast of Flinders Island, Bass Strait, the Australian Maritime College training ship Wyuna struck a submerged object while navigating the passage between North and Mid Pasco Islands.

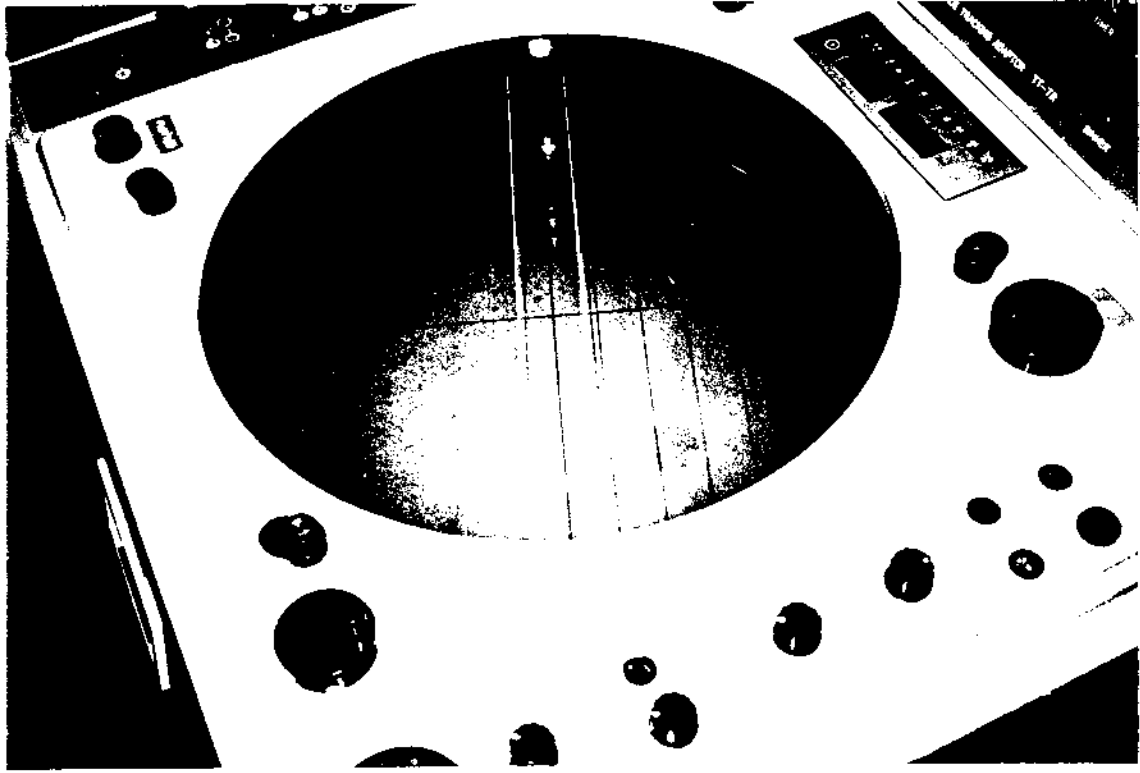
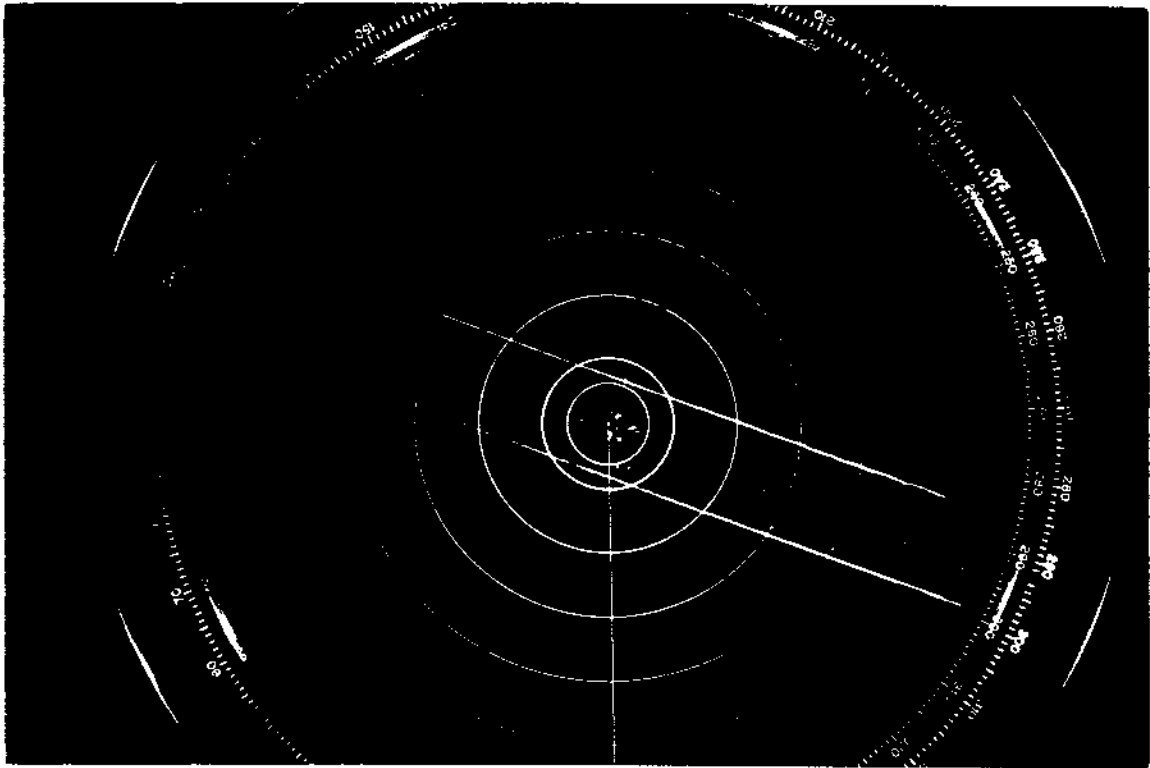
radar reflector screen, three cables both to port and to starboard of the intended track. By adopting a double parallel index approach, they would have been alerted immediately the Wyuna strayed off track by the echo of one or other of the islands encroaching within the relevant parallel index line. In fact the course had been altered from time to time in order to keep the ship on, or close to, the intended track—the purpose of the exercise. Both the Officer and the student were satisfied that the Wyuna was on the intended track, mid-way between the two islands and it is accepted that this was so.

*Parallel Index Lines set up on "Wyuna" Radar as for
Passage between North & Mid Pasco Islands*

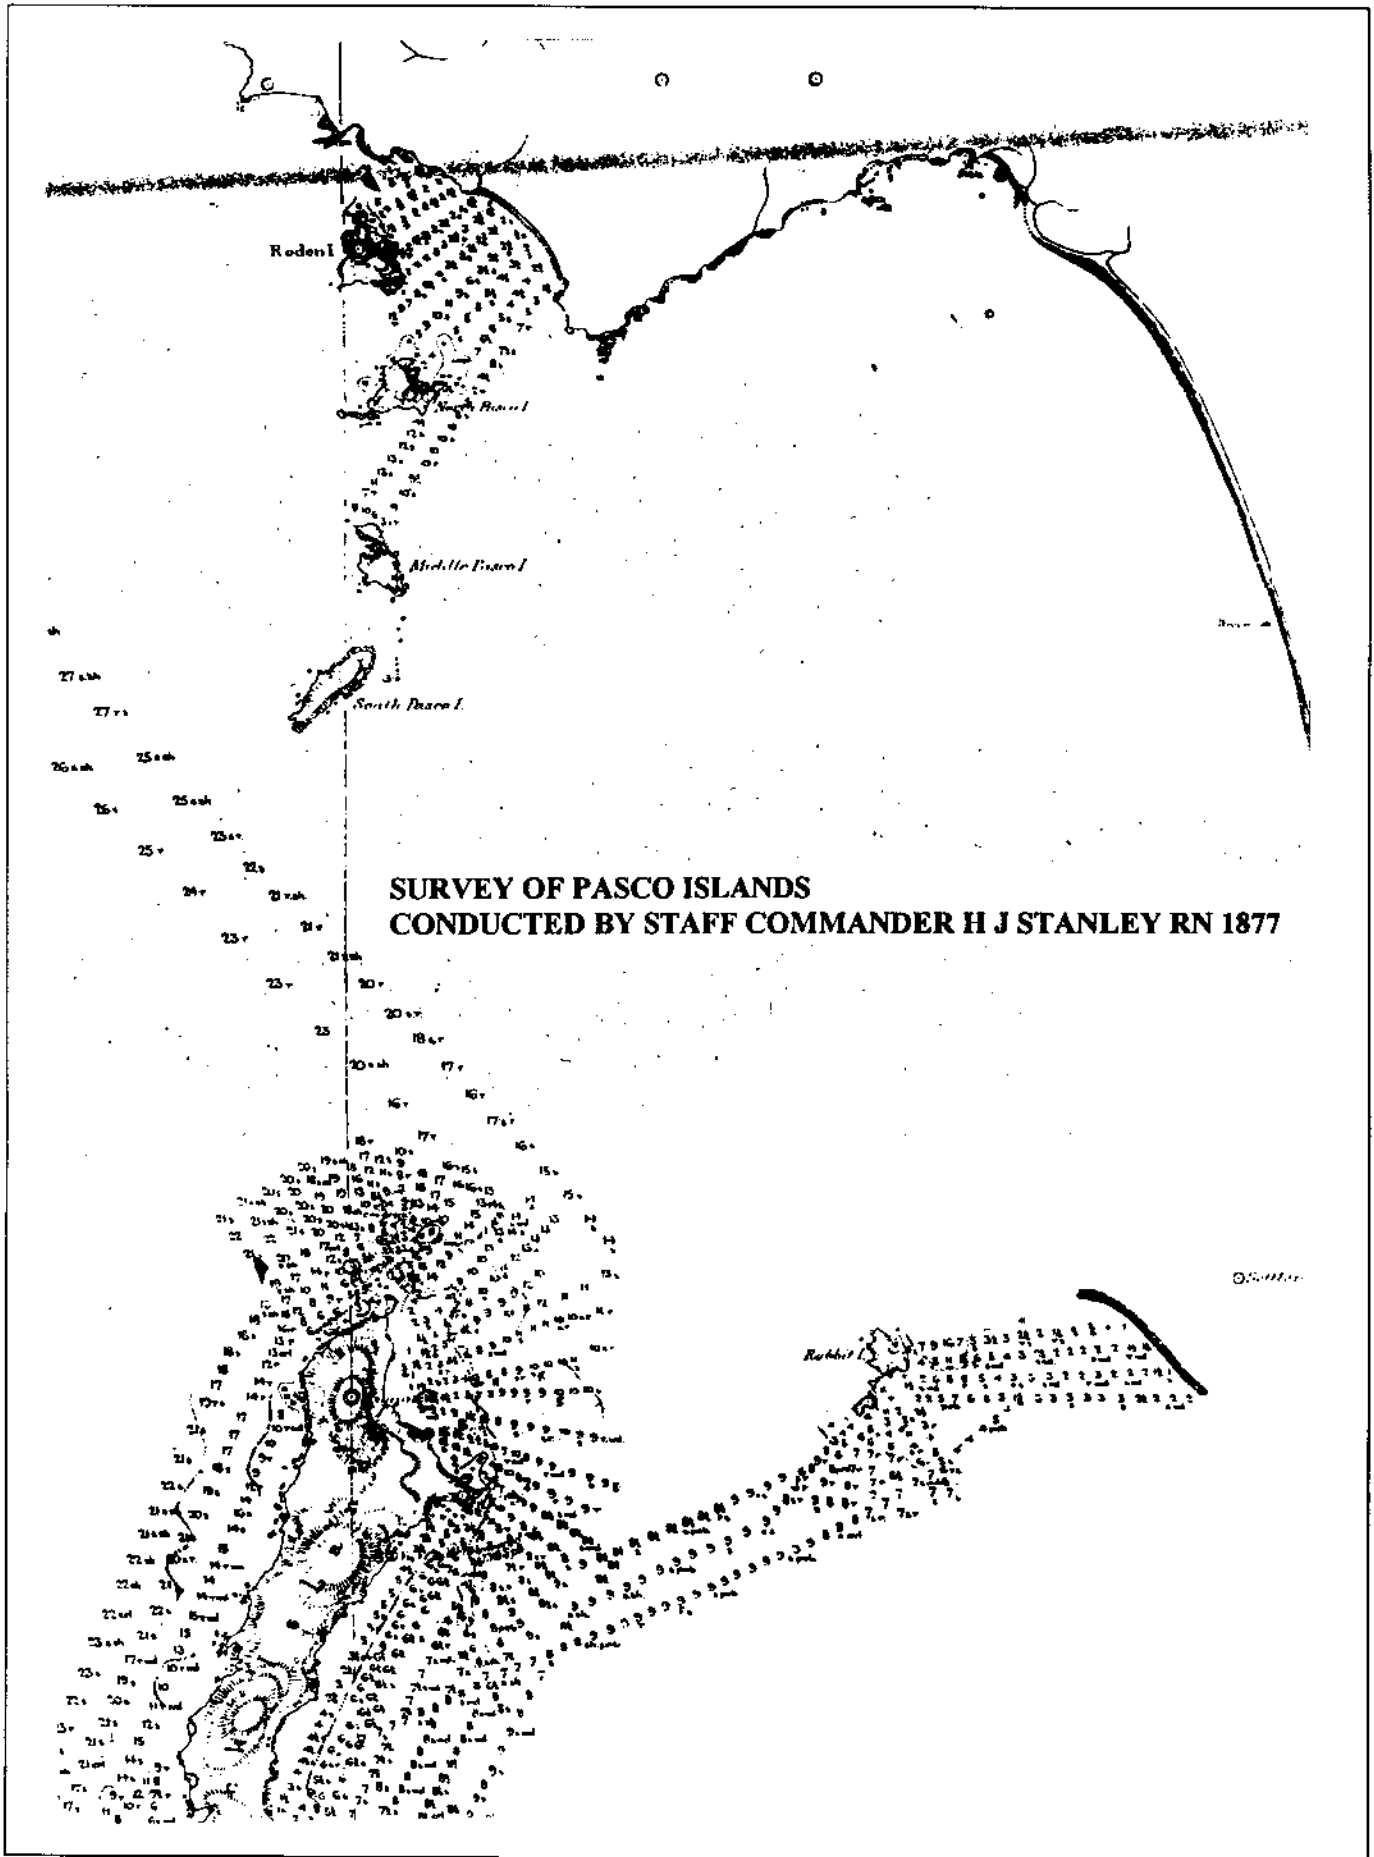
Survey of Pasco Islands conducted by Staff Commander H J Stanley RN 1877

The area of the Pasco Islands was surveyed by Staff Commander H.J. Stanley, R.N. in 1877 and by Commander R.F. Hoskyn, R.N., in H.M.S. Myrmidon, in 1886-7. The soundings would have been obtained by handlead, in all probability from an open boat, such as a cutter or whaler. The area in which the 8.5 fathoms sounding was located was surveyed by Commander Hoskyn, and from the survey chart it is evident that a closer network of soundings was carried out around that point, but without locating any rocks.

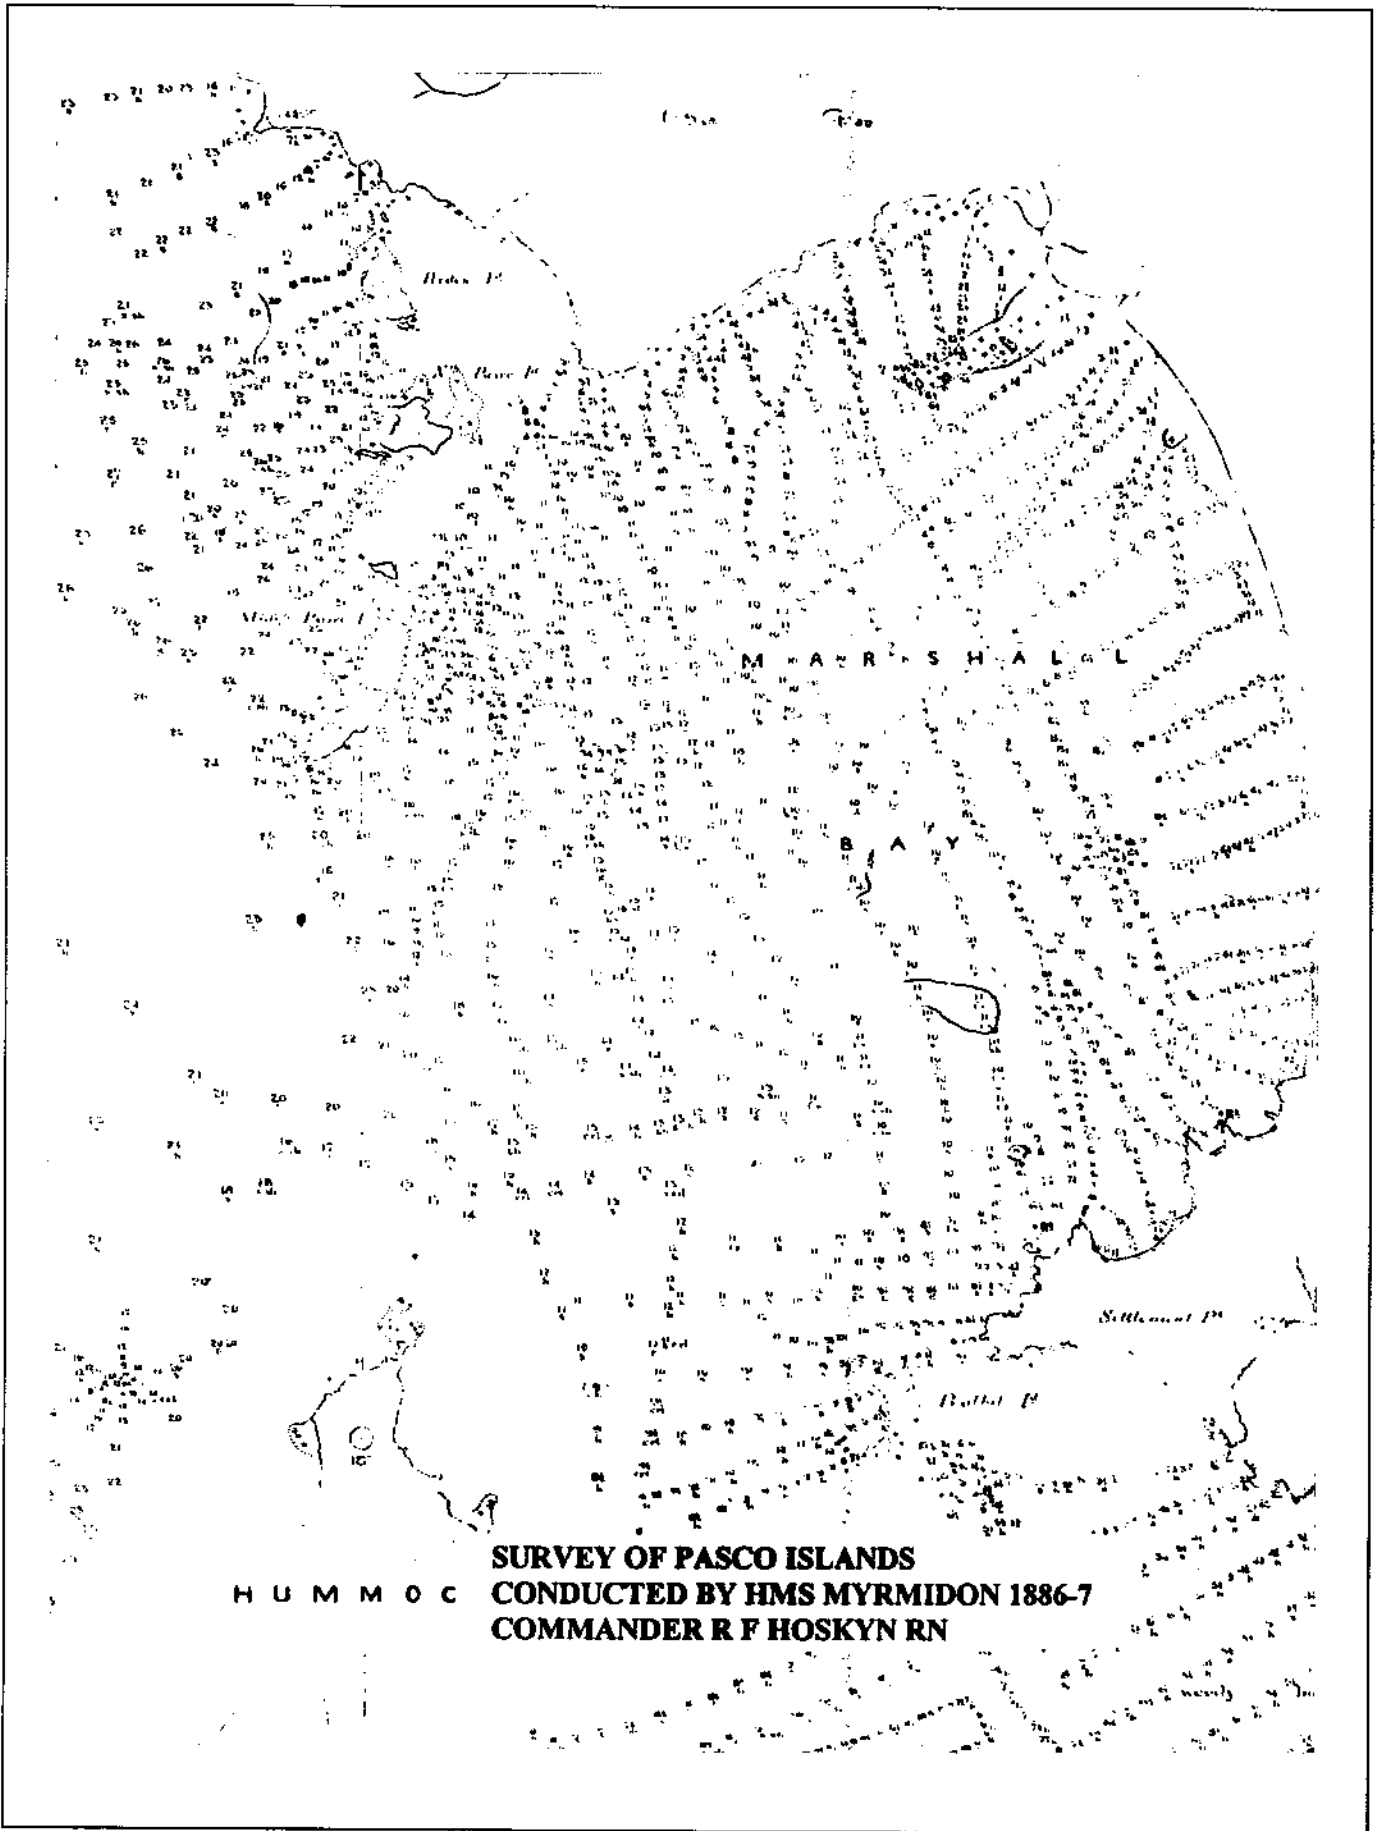
**Survey of Pasco Islands conducted by HMS Myrmidon 1886-7
Commander R F Hoskyn RN**

Although the early surveys conducted by officers of the Royal Navy were very accurate, obstructions could well lie undetected between the actual lines and points of soundings.

In the area around the Pasco Islands soundings appear to have been taken about every 500 feet (152.4m) along a line of survey, but the distance between the lines of survey varied a great deal. It is very important that mariners bear this in mind when navigating in areas that have not been surveyed more recently, with more modern equipment. A paper on chart reliability, published by the Hydrographer RAN in 1972, advised mariners that in most coastal surveys closest spacing of lines is 200 to 400m and that obstructions of a lesser dimension could go completely undetected. However, with modern hydrographic techniques, side sonar and airborne laser, there is less chance of isolated dangers going undetected.
