Summary

In the early morning of 3 December 1992, the fishing vessel Ronda Lene was trawling for prawns to the south-east of Middle Reef in the Great Barrier Reef. At 0220, the vessel was trawling in a north-westerly direction; one of the two deck hands was on watch while the skipper and second deck hand were sleeping below.

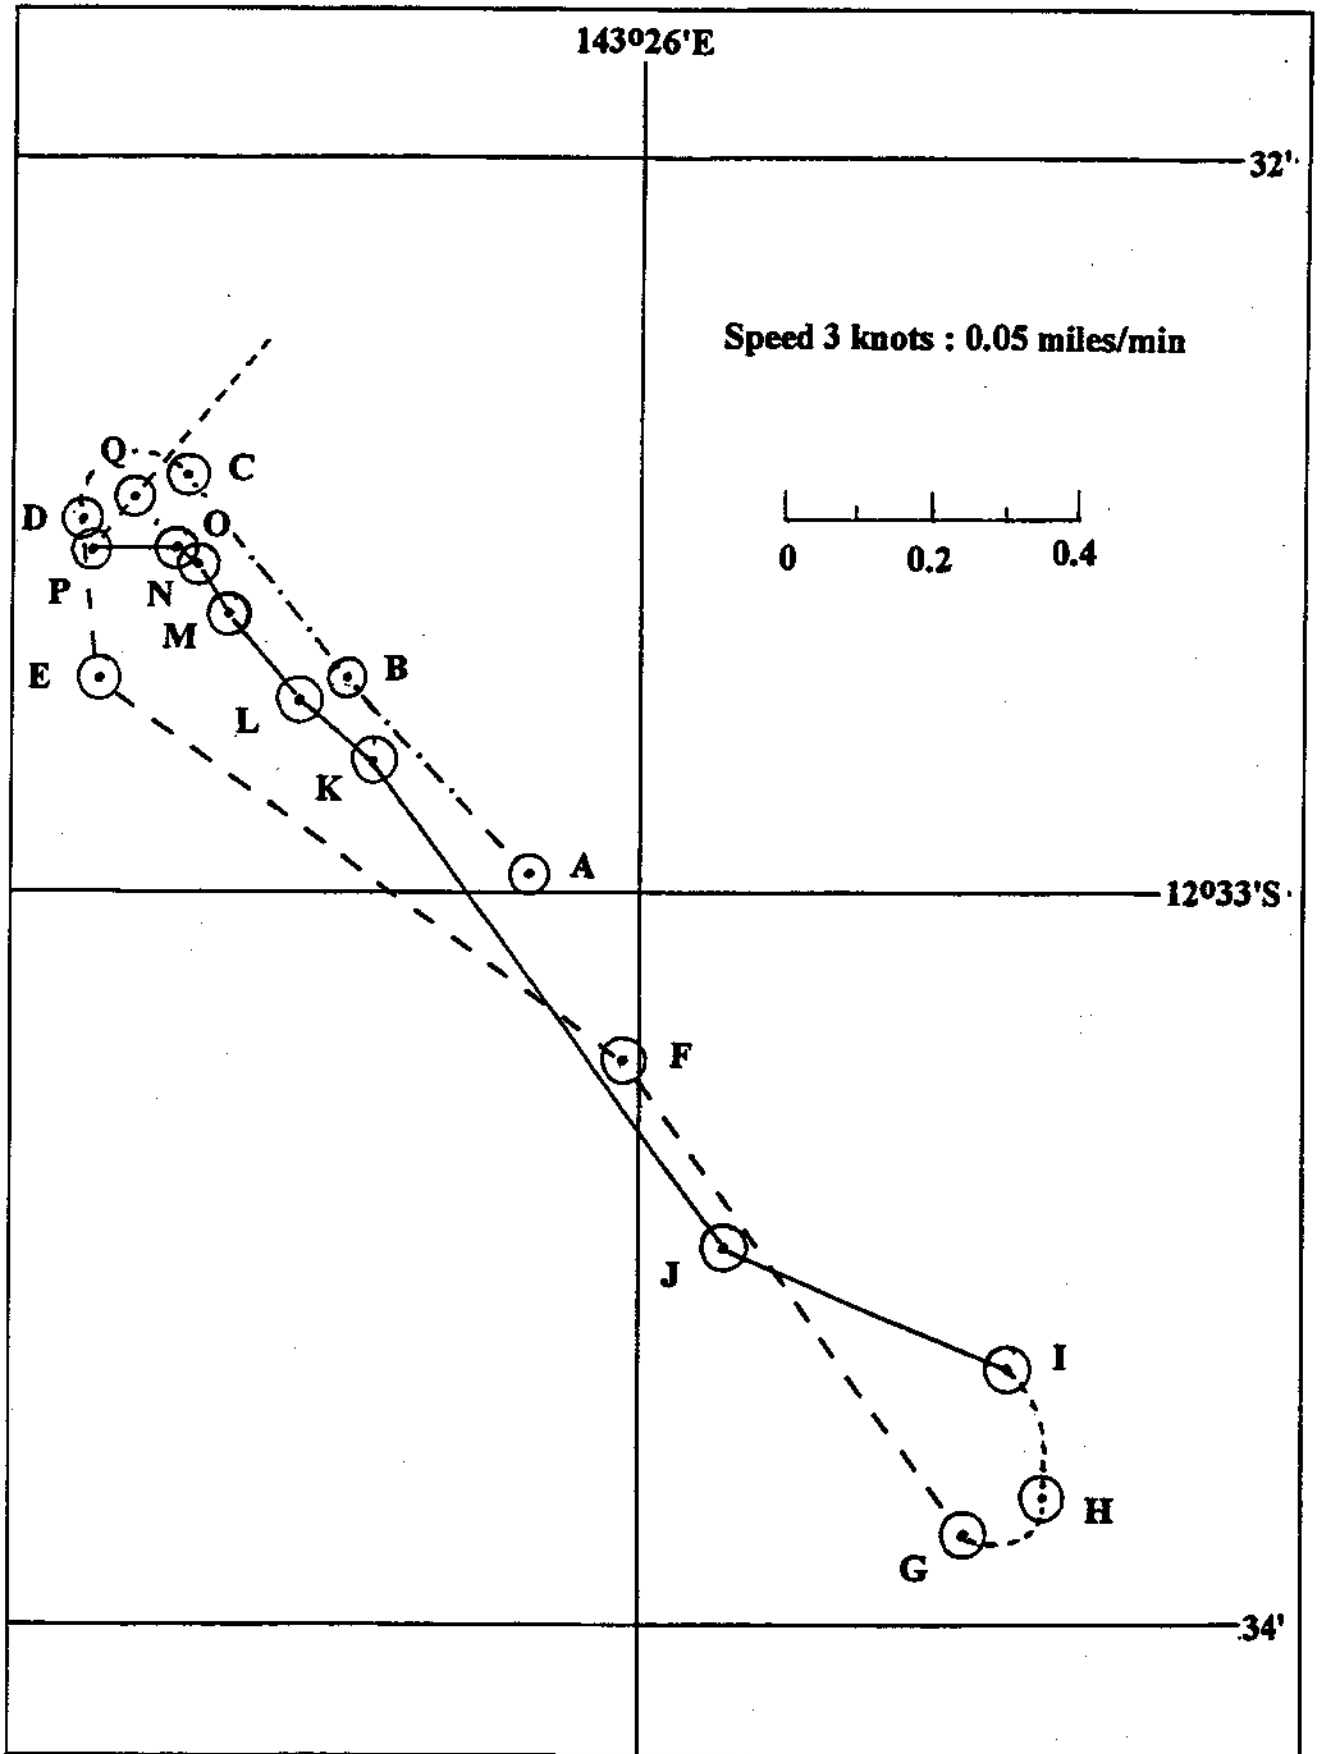
Positions taken from Ronda Lene's
Navigation Plotter

The track of Ronda Lene was recorded on the vessel's electronic plotter, from continuous direct input from the GPS Navigator, and was retained on disc. However, there is no time-base. Positions shortly before and after the collision (K - Q in diagram), positions of where the vessel had altered course on to reciprocal courses (A - D and G - I in diagram) and two intermediate positions (F and J in the diagram), were noted so that these could be transferred to the appropriate navigation chart. To agree with the navigation chart these positions, based on the World Geodetic System 1972 Datum, all had to be adjusted 0.09 minutes southward and 0.06 minutes westward. Even so, the position of the collision as recorded by Ronda Lene was about 1.1 miles north-west of the position as recorded by Fareast.

The Inspector considers that given the regular plotting by Fareast's deck officer, the position relative to the land is more accurate and to achieve a common datum at 0244,

all the Ronda Lene positions have been moved 1.1 miles in a south-easterly direction.

From the transposed positions it is apparent that Ronda Lene was making north-west and south-east runs of about 1.8 miles.

Working back from the collision position, Ronda Lene appears to have altered from a north-westerly to a south-easterly course between about 0116 and 0122, between positions C and D, and then to have been trawling in a south-easterly direction between about 0125 and 0200. At about 0200 the vessel altered course to port, to the east, to come around to a north-westerly heading and apparently adjusting to position west of the previous track (position J).

Between positions J and K, Ronda Lene made good a track of 324 degrees, between K and L a track of 310 degrees, between L and N a track of 323 degrees, and then, shortly after, a track of 310 degrees to position O. The track then shows a marked alteration of course to port at position O, to proceed in a westerly direction for 1.3 cables (240m), and then an abrupt change (at position P) to a north-easterly direction.

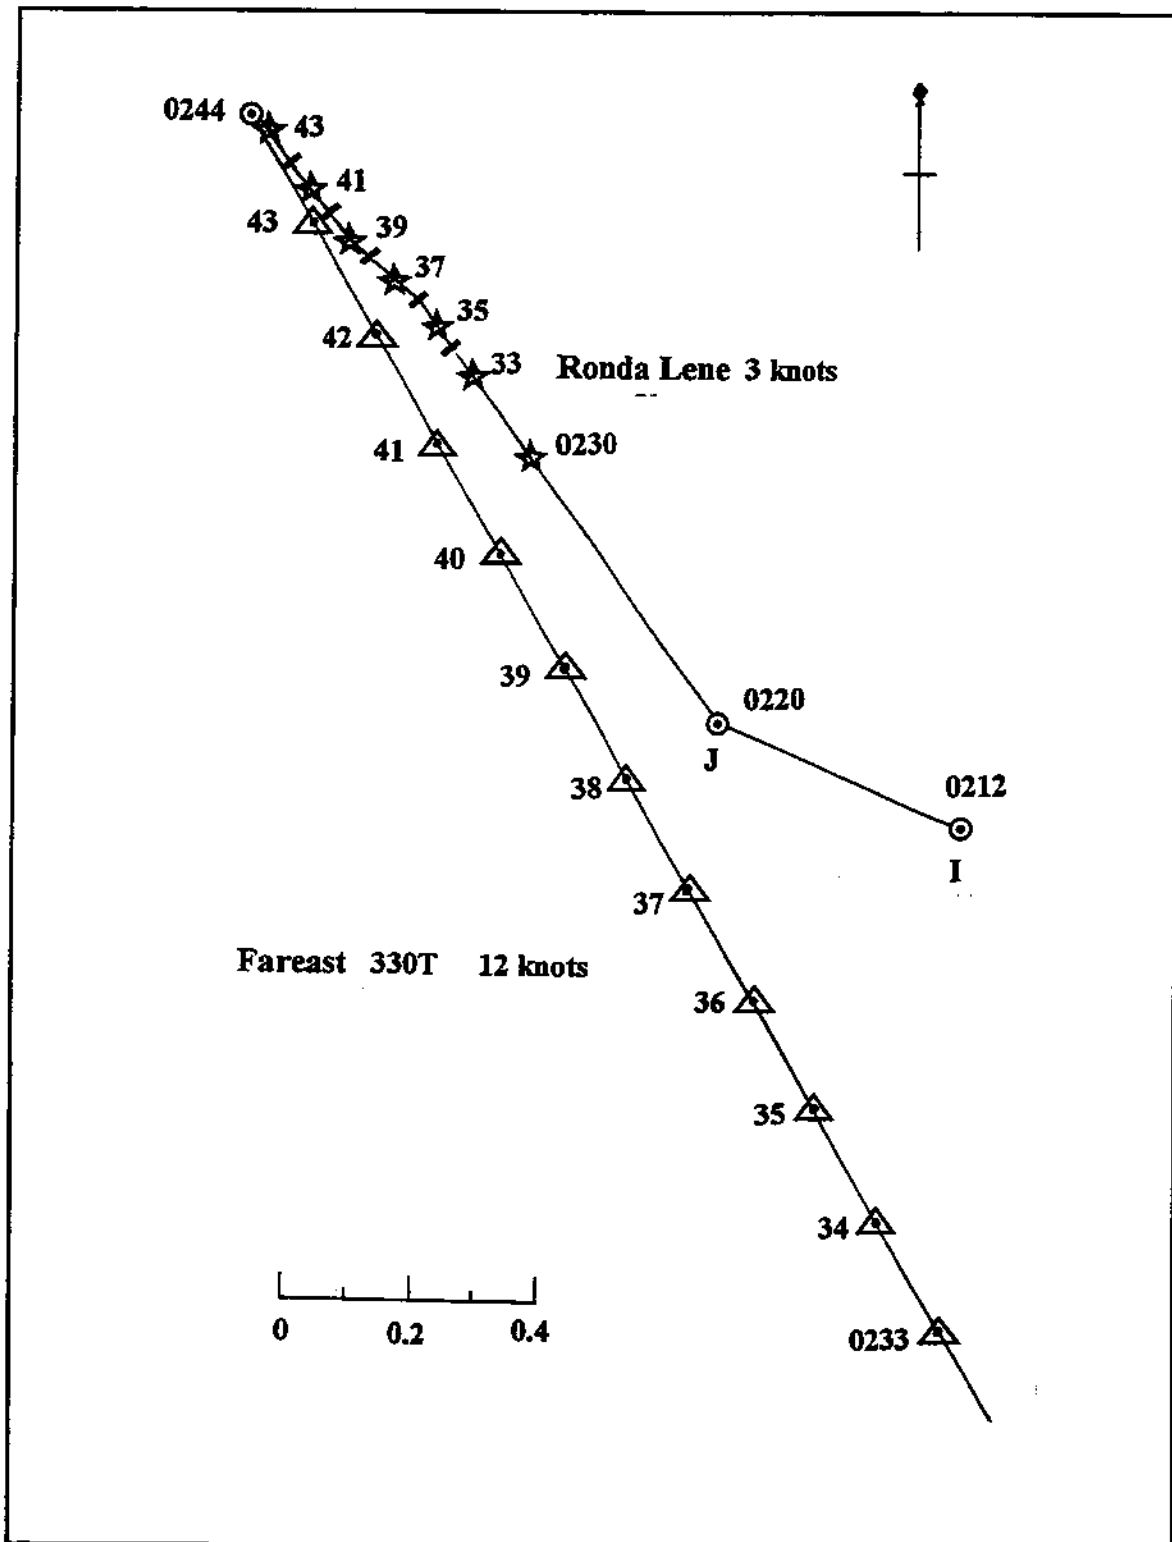
Collision at O on Ronda Lene's track

about 60 degrees across the track, the port side light being clearly visible. As Fareast was steering 330 degrees, this would equate to a heading for Ronda Lene of 270 degrees, as indicated on Ronda Lene's plotter. The Pilot's estimate that Ronda Lene was two trawler lengths off would place the fishing vessel about 15 degrees on the starboard bow, on a bearing of 345 degrees. On such a bearing, for the red sidelight to be visible to the Pilot, Ronda Lene had to be heading between 165 degrees and 277.5 degrees. Had Ronda Lene been on a more northerly heading, the red sidelight would not have been seen. This would all tend to indicate that Ronda Lene did alter course to 270 degrees at point O and that the collision occurred at point P.

However, the Ronda Lene's deckhand is adamant that he did not alter course to port and according to Ronda Lene's skipper, the point where the track changes to a westerly direction (O) denotes the collision position and a loss of signals from the satellites.

Comparing the tracks of the two vessels, on the basis that the collision occurred at point O, at 0200, Ronda Lene would have been right ahead of Fareast at a distance of about 6.38 miles. As a result of the combined effects of the westerly set experienced by

Fareast and Ronda Lene altering on to a reciprocal course through east, Ronda Lene would have opened out to starboard to a maximum bearing of about 334.5 degrees, or just 4.5 degrees on Fareast's starboard bow, at 0210. Over the next 10 minutes, to 0220, as Ronda Lene moved to position J, the bearing would have decreased to 332.5. At this time, Ronda Lene would have been just 1.65 cables eastward of Fareast's track line. After this, the bearing would have slowly increased again to 334 at 0236, but would have then decreased again over the next three minutes to 333 degrees, when Ronda Lene would have been 0.76 miles from Fareast and only 0.38 cables eastward of Fareast's track. The bearing would have continued to decrease to 332 degrees at 0241, but would have then started to open, although Ronda Lene would by this time have been only 4.5 cables from Fareast and within 0.2 cables of Fareast's track. With Ronda Lene on the course of 310 degrees from just after 0243, although the alteration of course to port would have been noticeable to those on the Fareast's bridge, Ronda Lene's port sidelight would not have been visible to them.

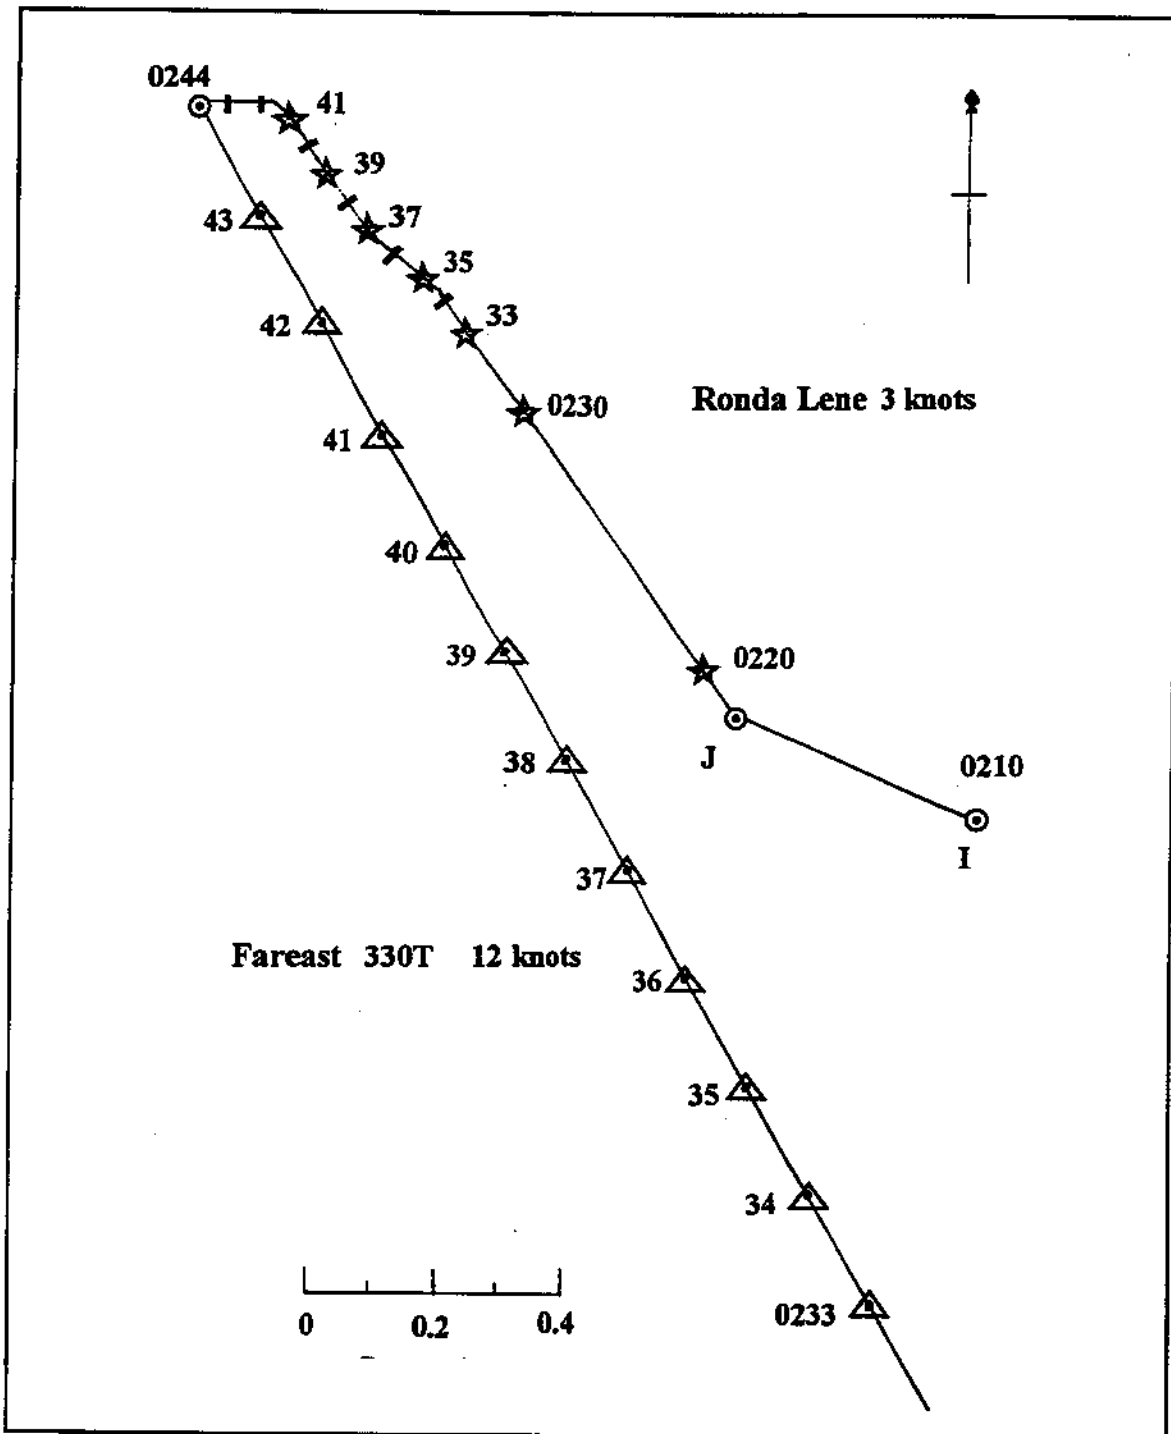
Collision at point P on Ronda Lene's track

On the basis the collision occurred at point P, at 0200 Ronda Lene would have been bearing about 331 degrees, one degree on Fareast's starboard bow, at a distance of 6.3 miles. The bearing would have then increased quite quickly to 336 at 0210, but would have then decreased again to 334.5 at 0220, at

which time, Ronda Lene would have been 2.65 cables eastward of Fareast's track. The bearing would have then increased again slowly to 337 at 0234, after which it would have remained steady for about three minutes (0234 - 0237), before continuing to open out to 342.5 degrees at 0241, when Ronda Lene would have been 4.25 cables from Fareast and 1.15 cables eastward of Fareast's track line. From about 0242 Ronda Lene would have remained on a steady bearing of 345 degrees, 15 degrees on Fareast's starboard bow, until the collision.

The tracks and relative positions based on a collision at point P are more in keeping with the evidence provided by those on Fareast.

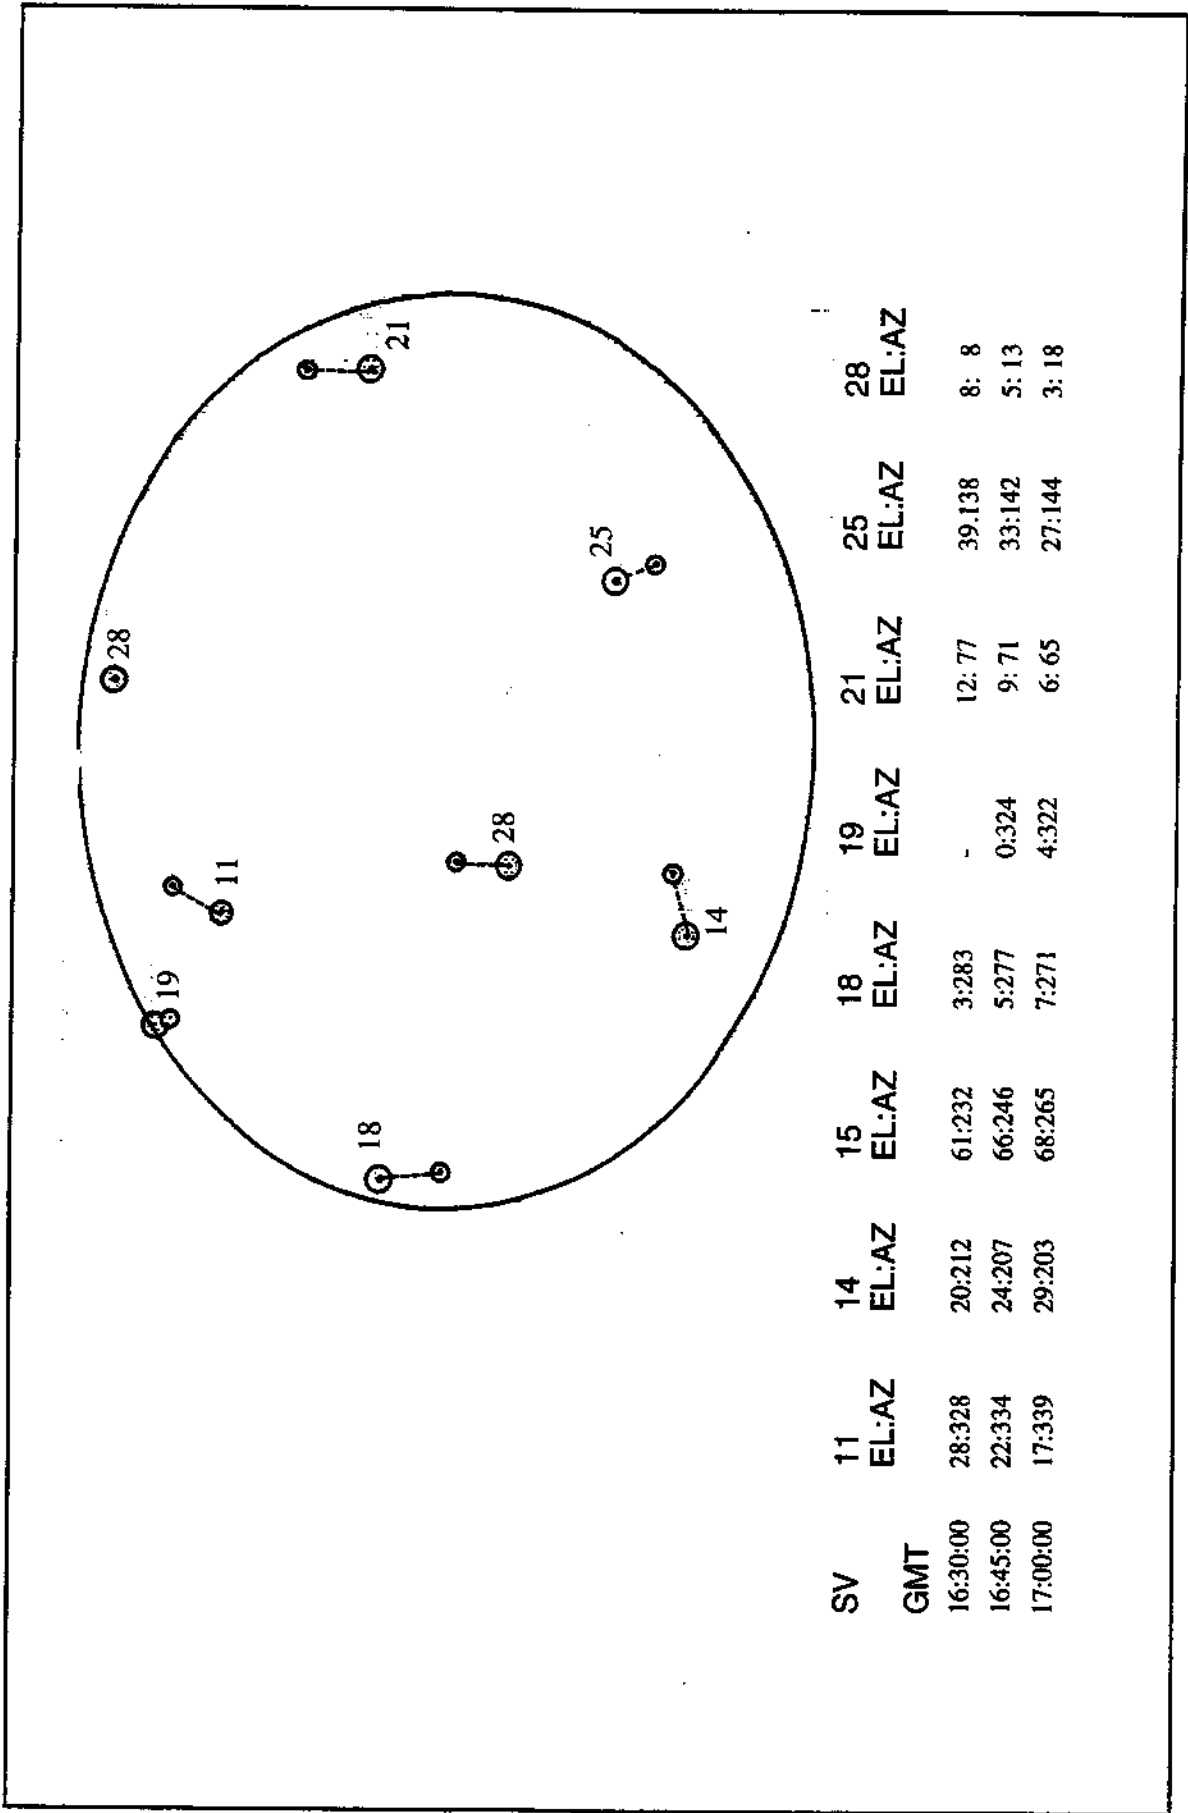
Satellite configuration at time of Collision

From information provided by AUSLIG Geodetic Operations Section, eight satellites were indicated as being above the horizon at the time of the incident, but four of these were at very low altitude - three at five degrees and one at nine degrees. At low altitudes satellite signals can be distorted, thus Ronda Lene's equipment was most probably utilising three of the four "suitable"

satellites, numbers 11, 14, 15 and 25.

From all of the advice received it is considered possible that at the time of the collision, either owing to the heel caused by the impact or the screening by Fareast, satellite signal reception could have been temporarily interrupted aboard Ronda Lene. If an interruption did occur, then dependant upon which three satellites were used for position fixing on resumption, it is also possible that a "jump" could have occurred.
