**Departmental investigation  
into the  
capsize of the crane barge  
TITAN  
off Smoky Cape, on the 25 December 1992  
and  
the subsequent sinking of the barge  
off Camden Head, on 29 December 1992**

into the capsizing of the crane barge

TITAN

Published: 18 October 1993

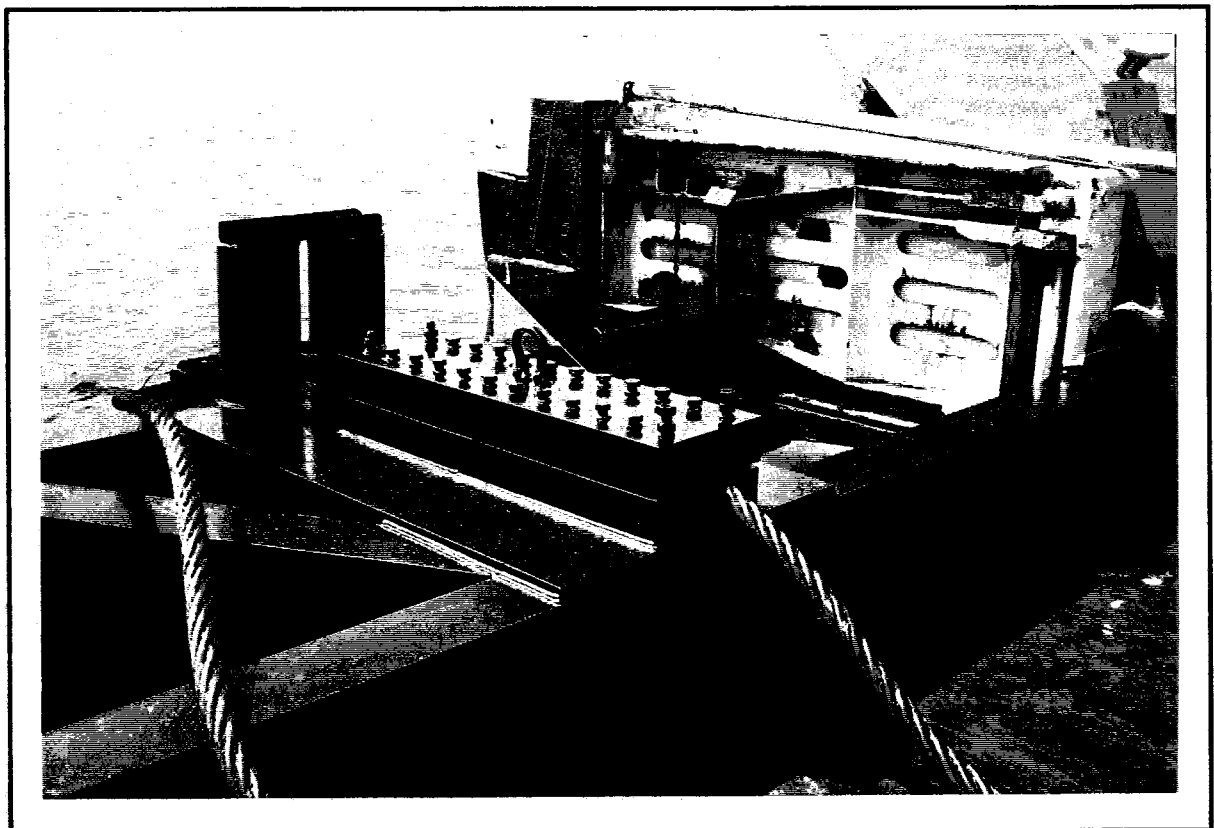
**Towing frame**

The towing frame, fabricated in Sydney, was adequate for the tow and the wire clamp seemed adequate for normal towing operations. Despite the great strain that was placed on the wire when the nylon stretcher parted, no distortion or fracturing of the frame, its welds or the associated deck structure could be found.

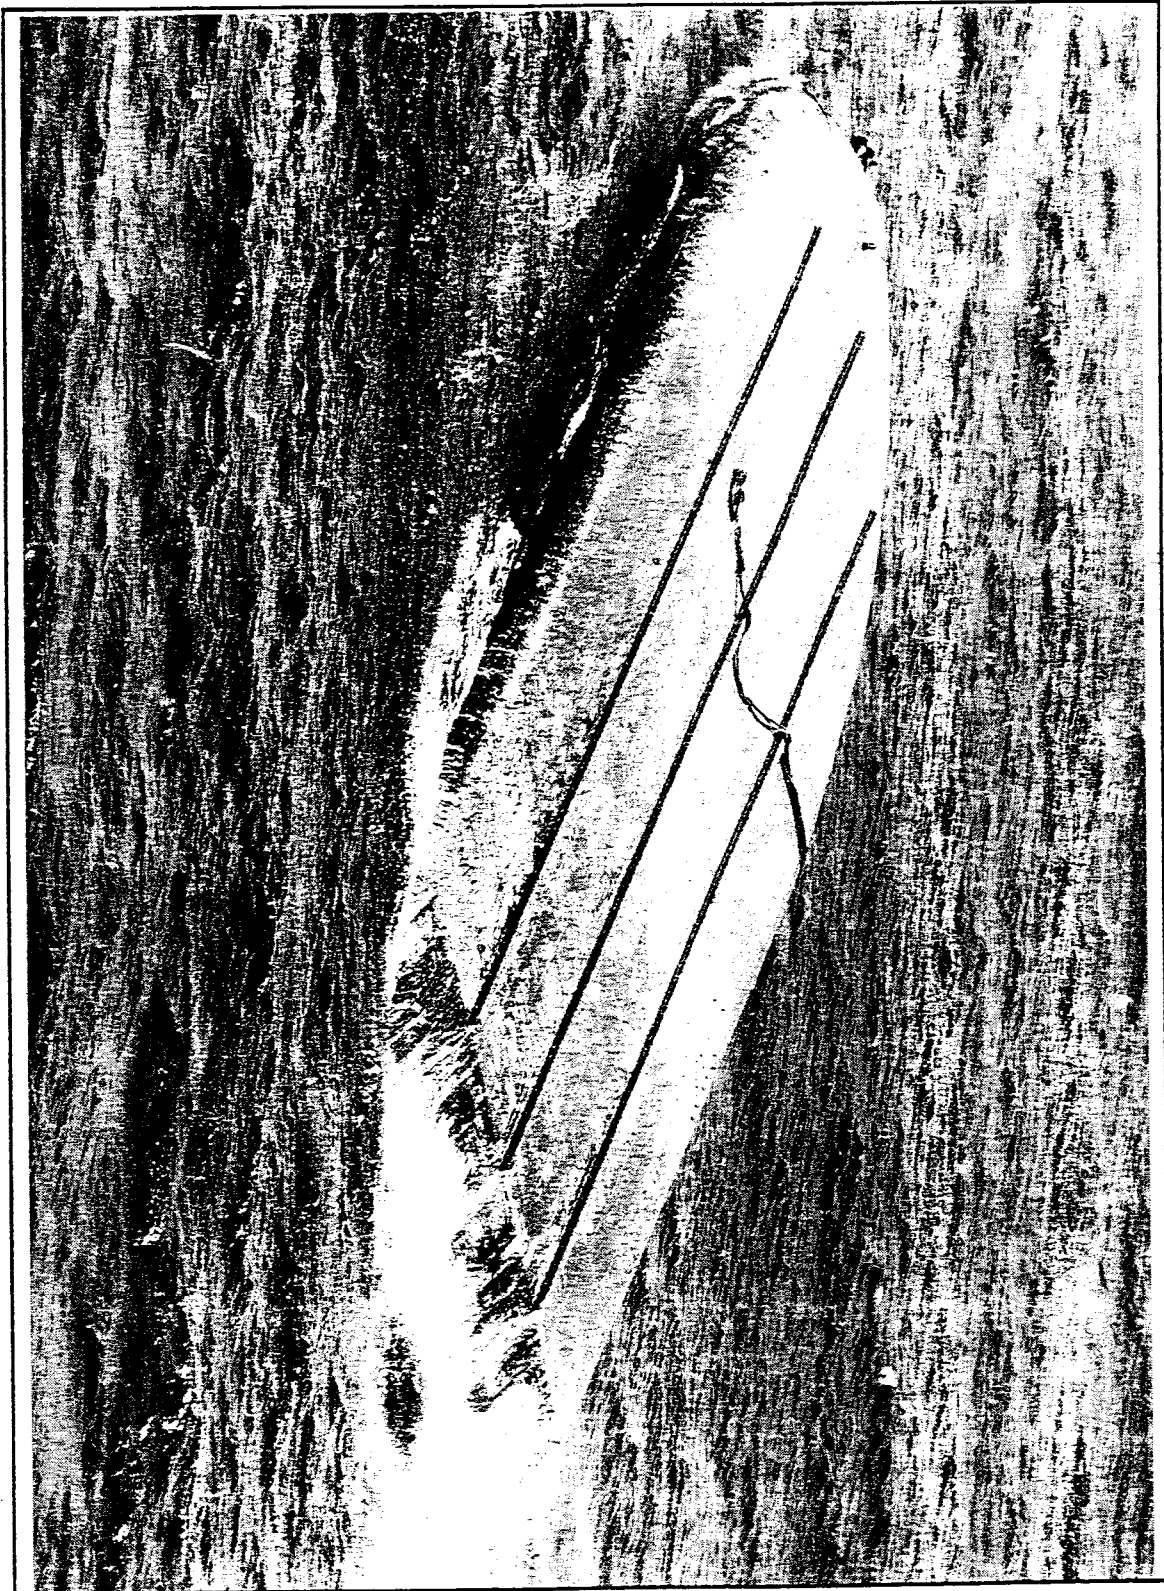
Photograph Capsized Titan

Rapuhia turned about to find the barge. A visual search could not locate Titan, but a radar echo showed a target close to Rapuhia and a sweep by searchlight showed the capsized hull of the barge.

The position of the capsized vessel was reported as  $30^{\circ} 52.5'$  South,  $153^{\circ} 15.5'$  East,  $9.5$  miles north-east of Smoky Cape in more than  $100m$  of water.

Underwater examination established that the crane had fallen off the central mast, which was bent at an angle and that the live ring was jammed on the mast at an angle of about 70 degrees to the horizontal. Skylight glass in the engine room skylight had been broken and the engine room plates, normally making up the working surface of the engine room, had fallen against the inverted skylight and interior deckhead.

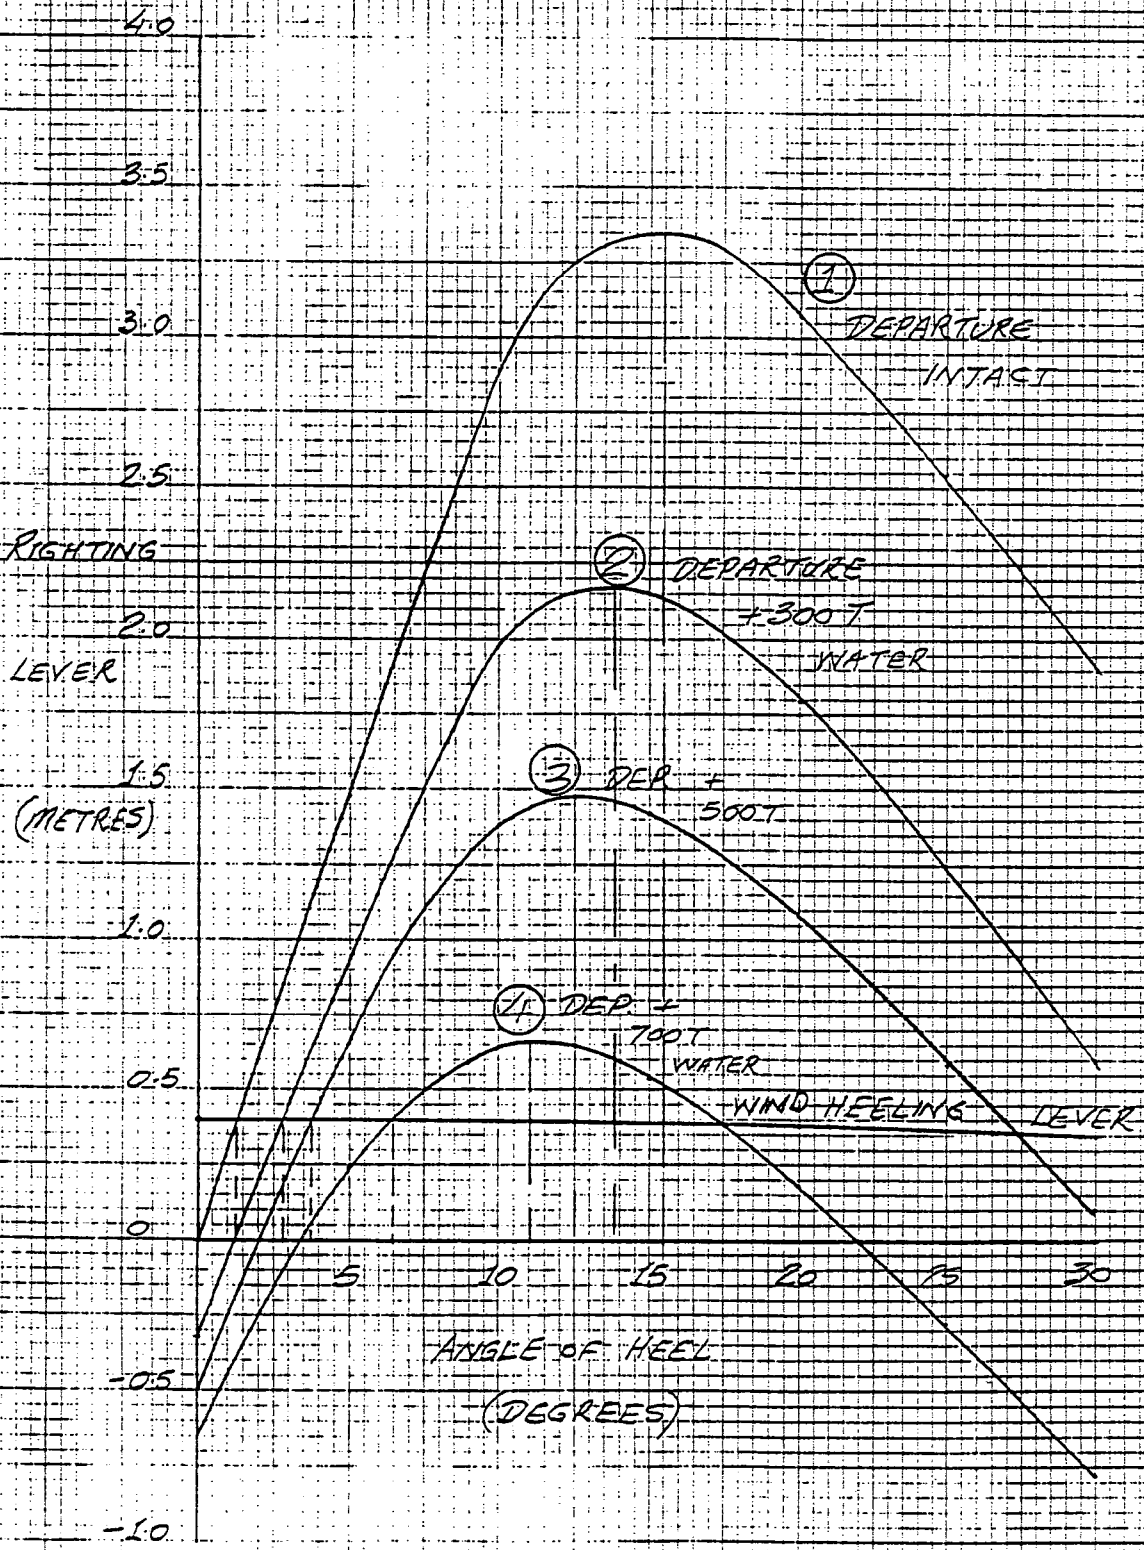
Dynamic stability curves as per USL Code

However, it was noted that the report of the 24 November, appeared to contain an incorrect analysis in evaluating the static stability curve rather than the dynamic stability curve. Notwithstanding this, Titan's resistance to a capsize at small angles of heel was between three and four times greater than the minimum required. The measure of a vessel's ability to overcome an external heeling moment is an imaginary righting lever known as the GZ.

The USL Code stability criterion for barges is based on a 15 degree angle of heel criterion. The consultants noted that the Titan's deck edge immersed at an angle of heel of 9.6 degrees. Once the vessel immersed its deck edge, the dynamics of its stability characteristics would have changed significantly. However, based on the intact stability data, even if the angle of heel had been based on the barge's deck edge

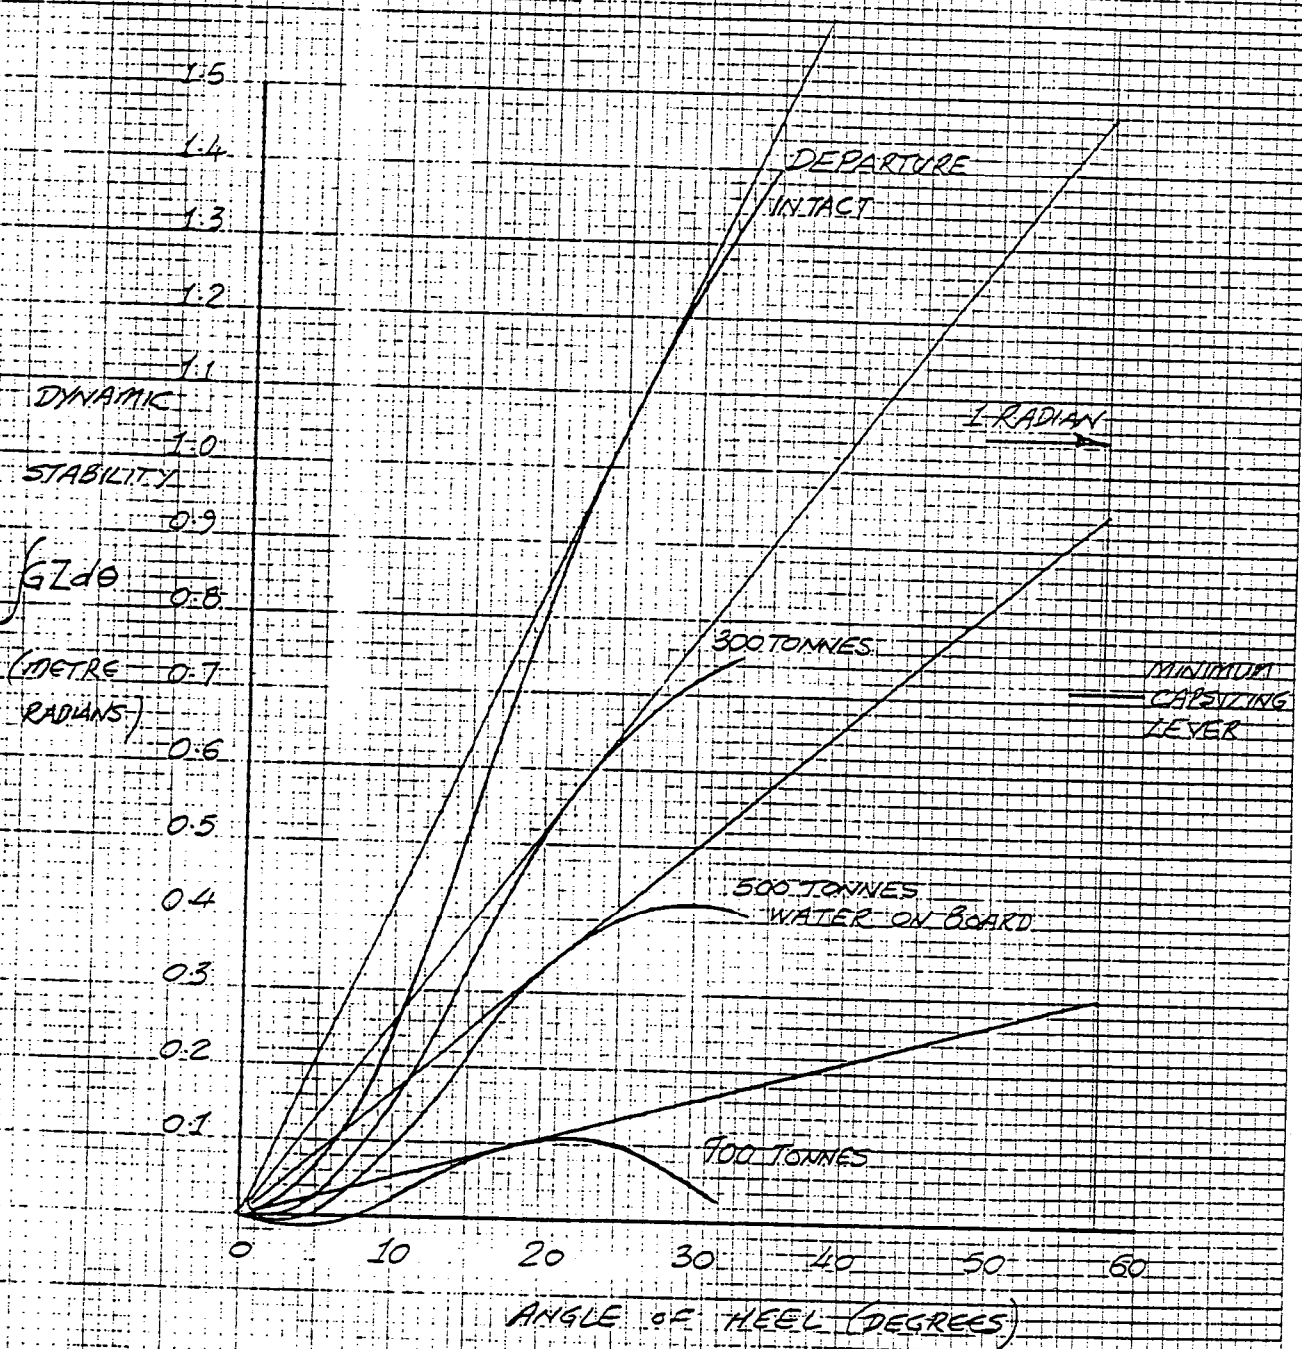
Evaluation of stability criteriaIMO MSC/Circ 503

<u>Intact vessel</u>		<u>required</u>	
Area to max GZ	30.06 metre deg	4.58	
Range of stability	> 40.0 deg	20.0	
Angle of heel in wind	1.3 deg	4.7	
 <u>Vessel + 300t. water</u>			
Area to max GZ	17.41 metre deg	4.58	
Range of stability	> 30.0 deg	20.0	
Angle of heel in wind	2.8 deg	4.7	
 <u>Vessel + 500t. water</u>			
Area to max GZ	10.38 metre deg	4.58	
Range of stability	29.0 deg	20.0	
Angle of heel in wind	3.7 deg	4.7	
 <u>Vessel + 700t. water</u>			
Area to max GZ	3.23 metre deg	4.58	FAIL
Range of stability	18.5 deg	20.0	FAIL
Angle of heel in wind	6.5 deg	4.7	FAIL

Actual Intact value	2.40 metres	
Vessel + 300 t. water	1.47 metres	
Vessel + 500 t. water	0.95 metres	
Vessel + 700 t. water	0.30 metres	FAIL
- Wind heeling lever not to heel vessel to more than 15 deg  
Angles of heel as per IMO evaluation are all significantly less than 15 degrees.
