Portion of chart Aus 4708 showing position of Oji Maru No.37

On 5 April 1993, Oji Maru No.37, a Japanese long line fishing vessel, was on passage from fishing grounds south-west of North West Cape to Fremantle. Just before midnight local time, it ran aground at full speed on Leschenault Reef, two and a half miles off the coast, about 39 miles north of Fremantle pilot boarding ground. The weather was fine and the visibility clear.

Portion of chart Aus 334 showing position of grounding

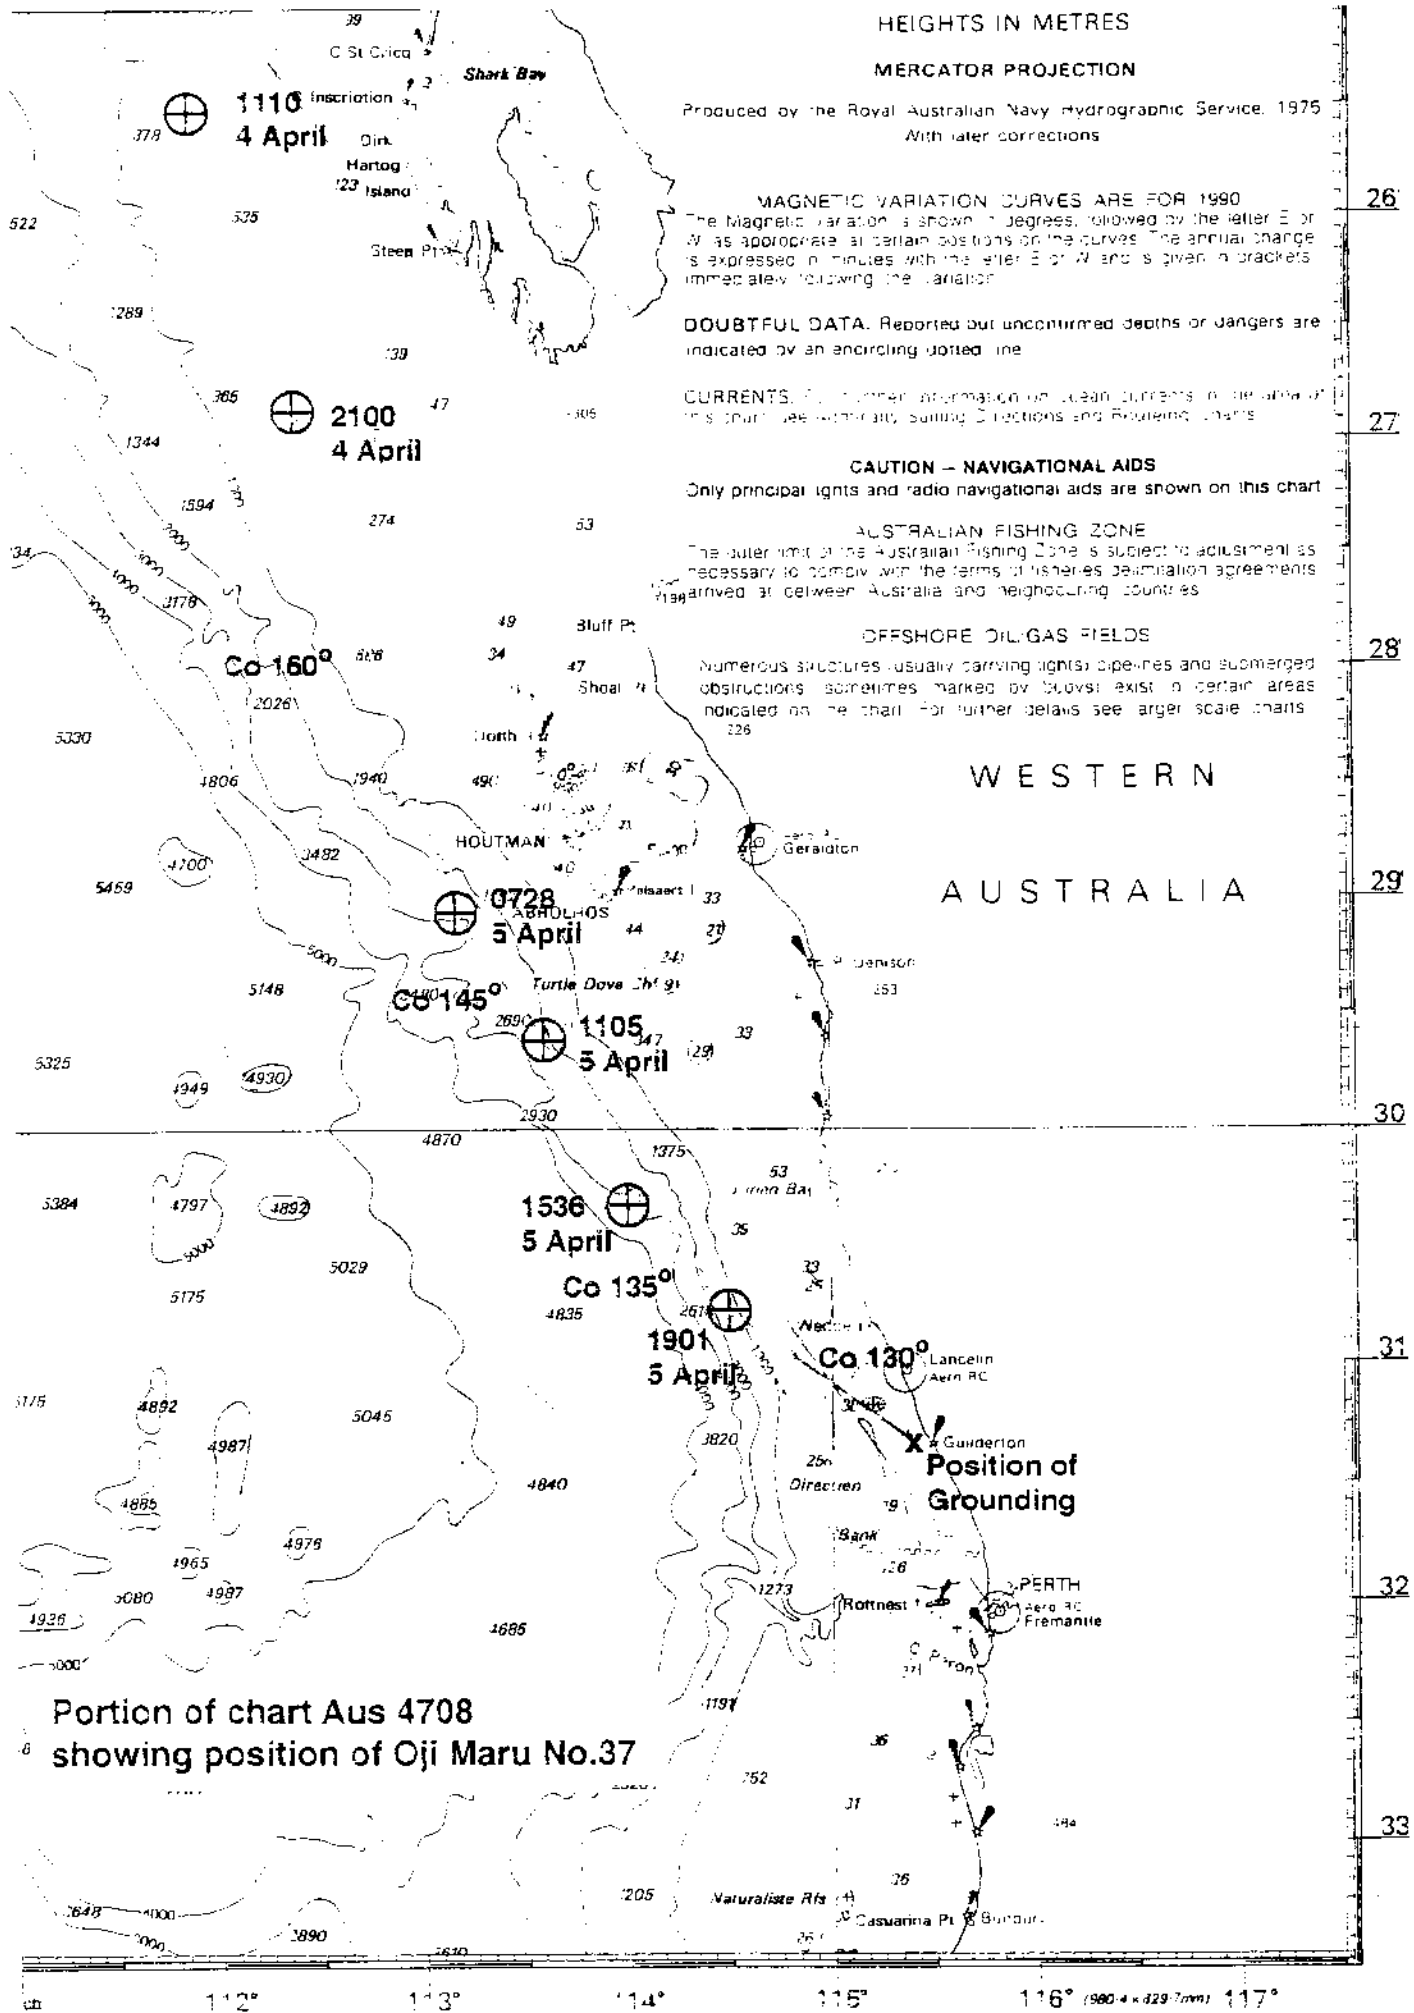
Position of Grounding

The position at 1901 was plotted as 30°47'S 114°32'E. The vessel had made good the course steered at a speed of eleven knots and had experienced minimal set and drift. From this position to the fairway bouy Oji Maru No.37 needed to make good a course of 146 degrees. The distance was 88 miles.

The Master, however, altered course 5 degrees to port, to 130 degrees, towards the coast, rather than eleven degrees to starboard to steer for Rottnest Island. The course of 130 degrees would have brought the Oji Maru No.37 to a position off the town of Two Rocks, 27 miles north of the Fremantle fairway bouy, at about 0100 on 6 April (see portion of chart Aus 334, page 11).

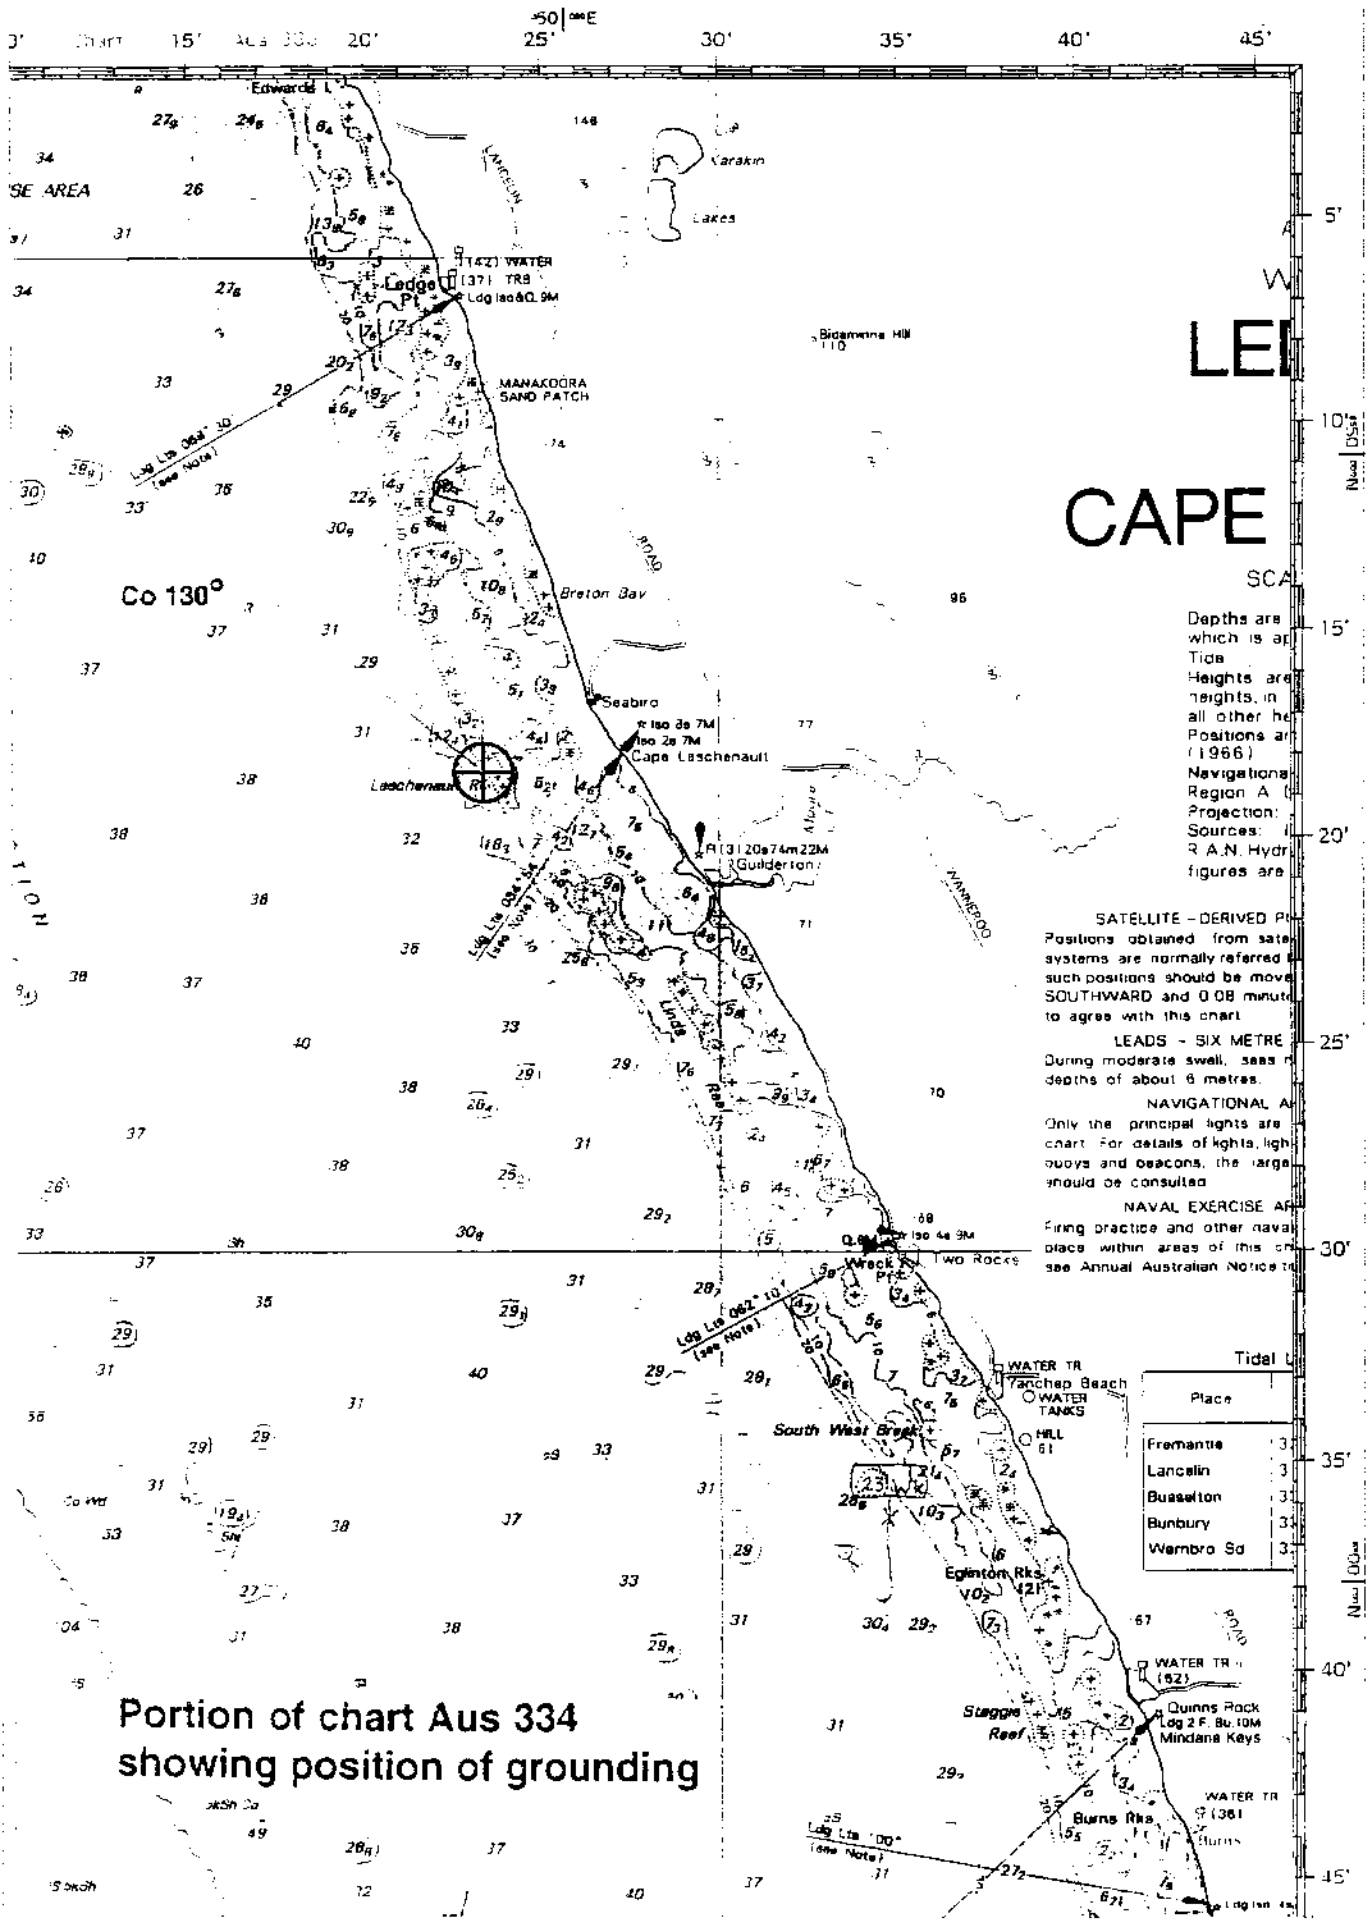
Oji Maru No.37 was in no danger until the Master took the decision to alter to 130 degrees and a course was made good of 125 degrees. The decision, if deliberate, seems irrational if he intended to make Fremantle or wait off the Port until daylight. He effectively set course direct for the beach.

The most probable explanation was that the course alteration was applied the wrong way. Had he altered course to 140 degrees, and had the vessel made good that course, Oji Maru No.37 would have arrived off the Fremantle Fairway buoy at about 0300 on 6 April 1993.

priority given to navigating the ship as against fishing operations. In fact, had Oji Maru No.37's position been transferred to chart Aus 334 at about 2100 on 5 April, when the fishing vessel reached latitude 31 South (the northern limit of chart Aus 334), the potential danger should have been readily apparent to the Master or a qualified navigator, had there been one on the bridge.
