Malinska

Summary

The Malinska, a Maltese flag bulk carrier of 34,752 tonnes deadweight, loaded a full cargo of manganese ore at the Grootte Eylandt loading terminal from 23 to 25 April 1993.

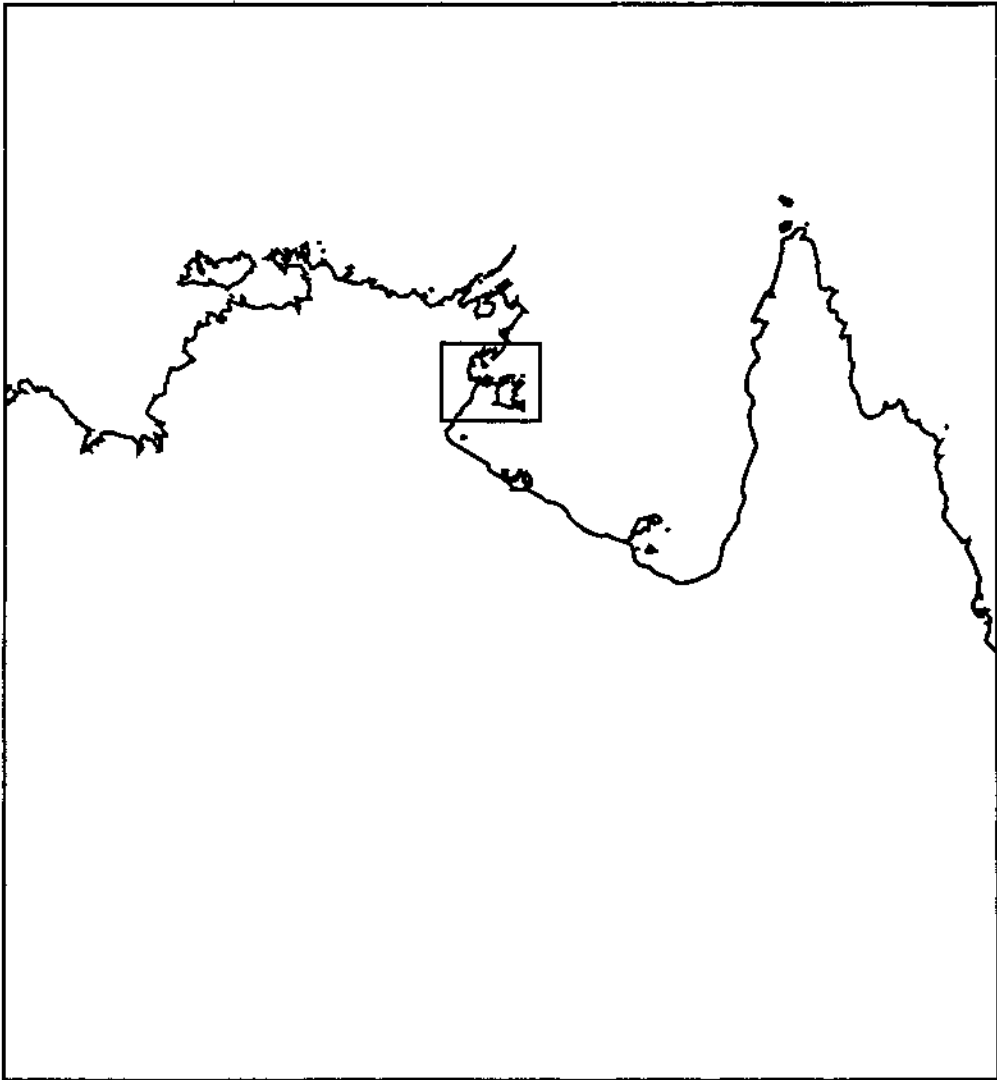
Area of Grounding

While sailing from the port, the ship, which should have cleared via a narrow channel of deep water through a bank stretching southward from Connexion Island, grounded on Burley Shoal, 1.5 miles north of "the gap". Initial attempts to refloat the ship were unsuccessful and 1100 tonnes of cargo had to be off-loaded before the ship was pulled off by tugs on 28 April 1993.

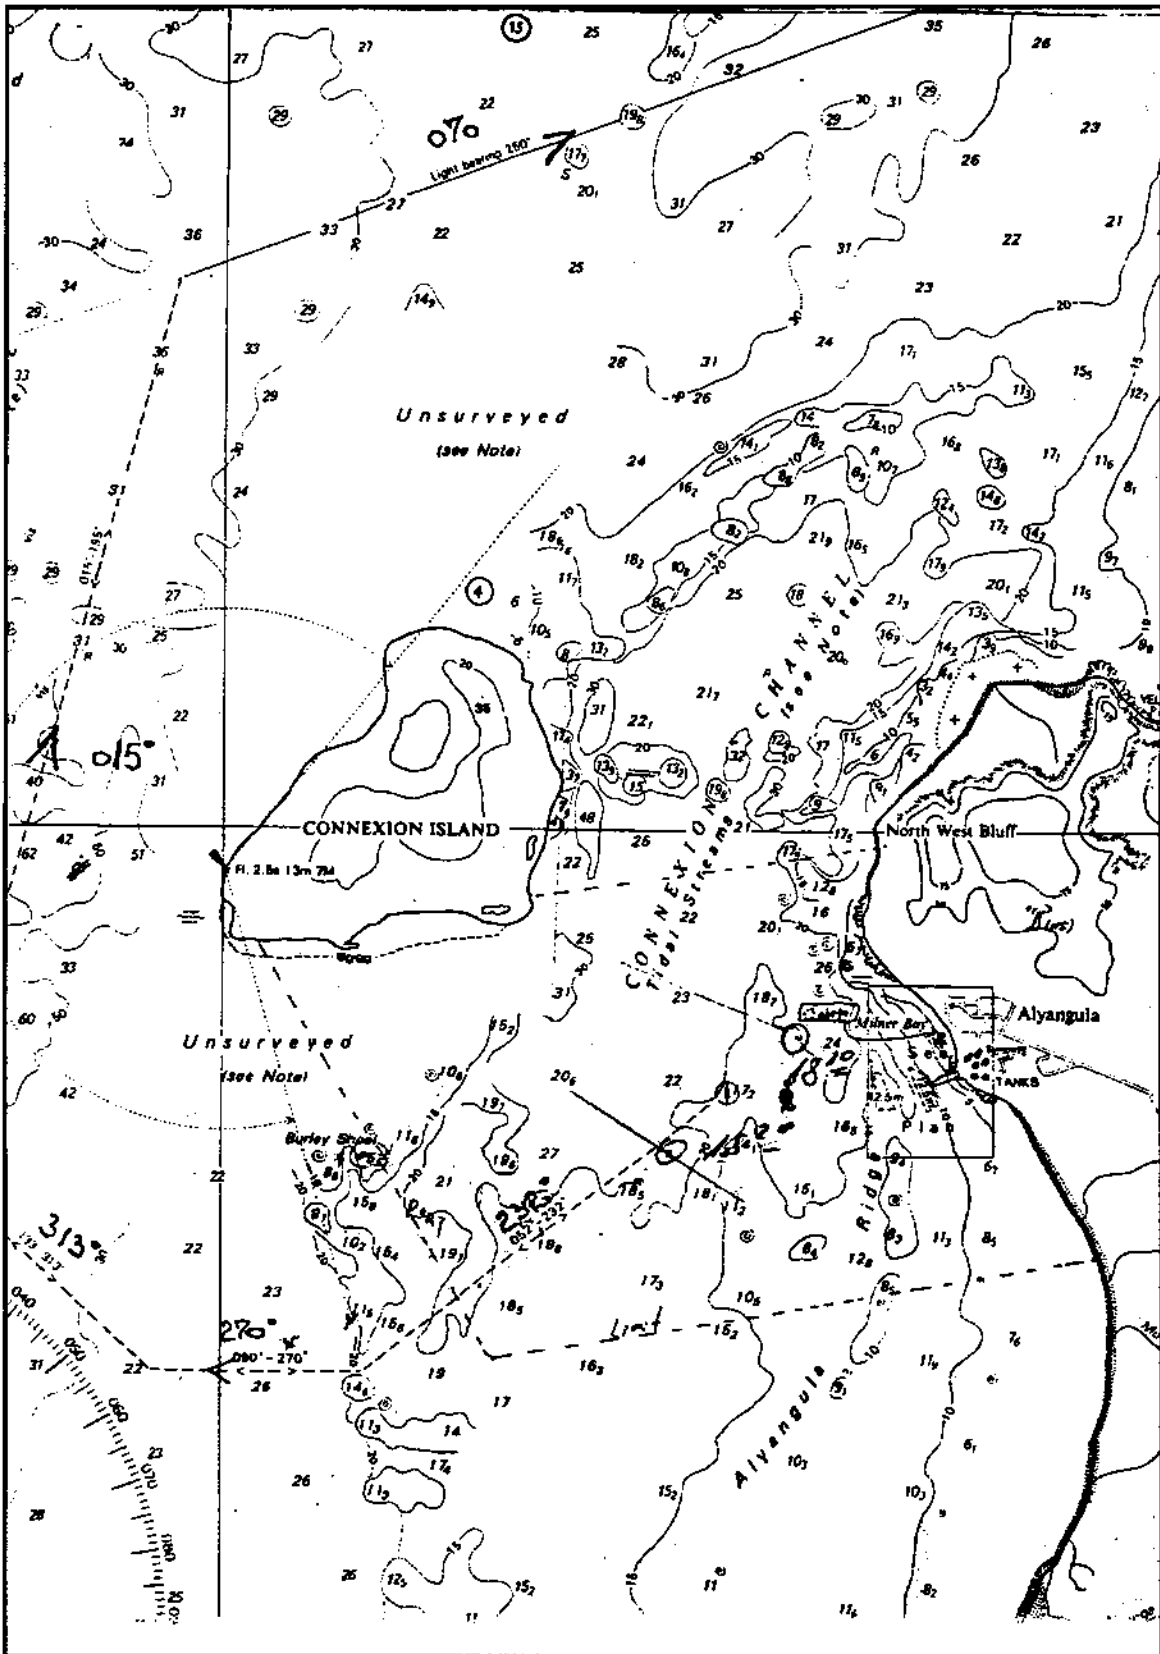
Photocopy of chart in use aboard Malinska
 Extract from chart Aus 14

Two positions were plotted on the Malinska's chart, at 1810 and 1820, the latter placing the ship just south of the recommended track and indicating that the course of 232 degrees had been made good and that there had been no tidal effect.

It is concluded that Malinska was set well to the north of the recommended track, and that the position plotted by the Third Mate at 1820 was not correct. It is

considered possible that the Third Mate, for whatever reason, laid off a distance of 2.5 miles, instead of 2.0 miles

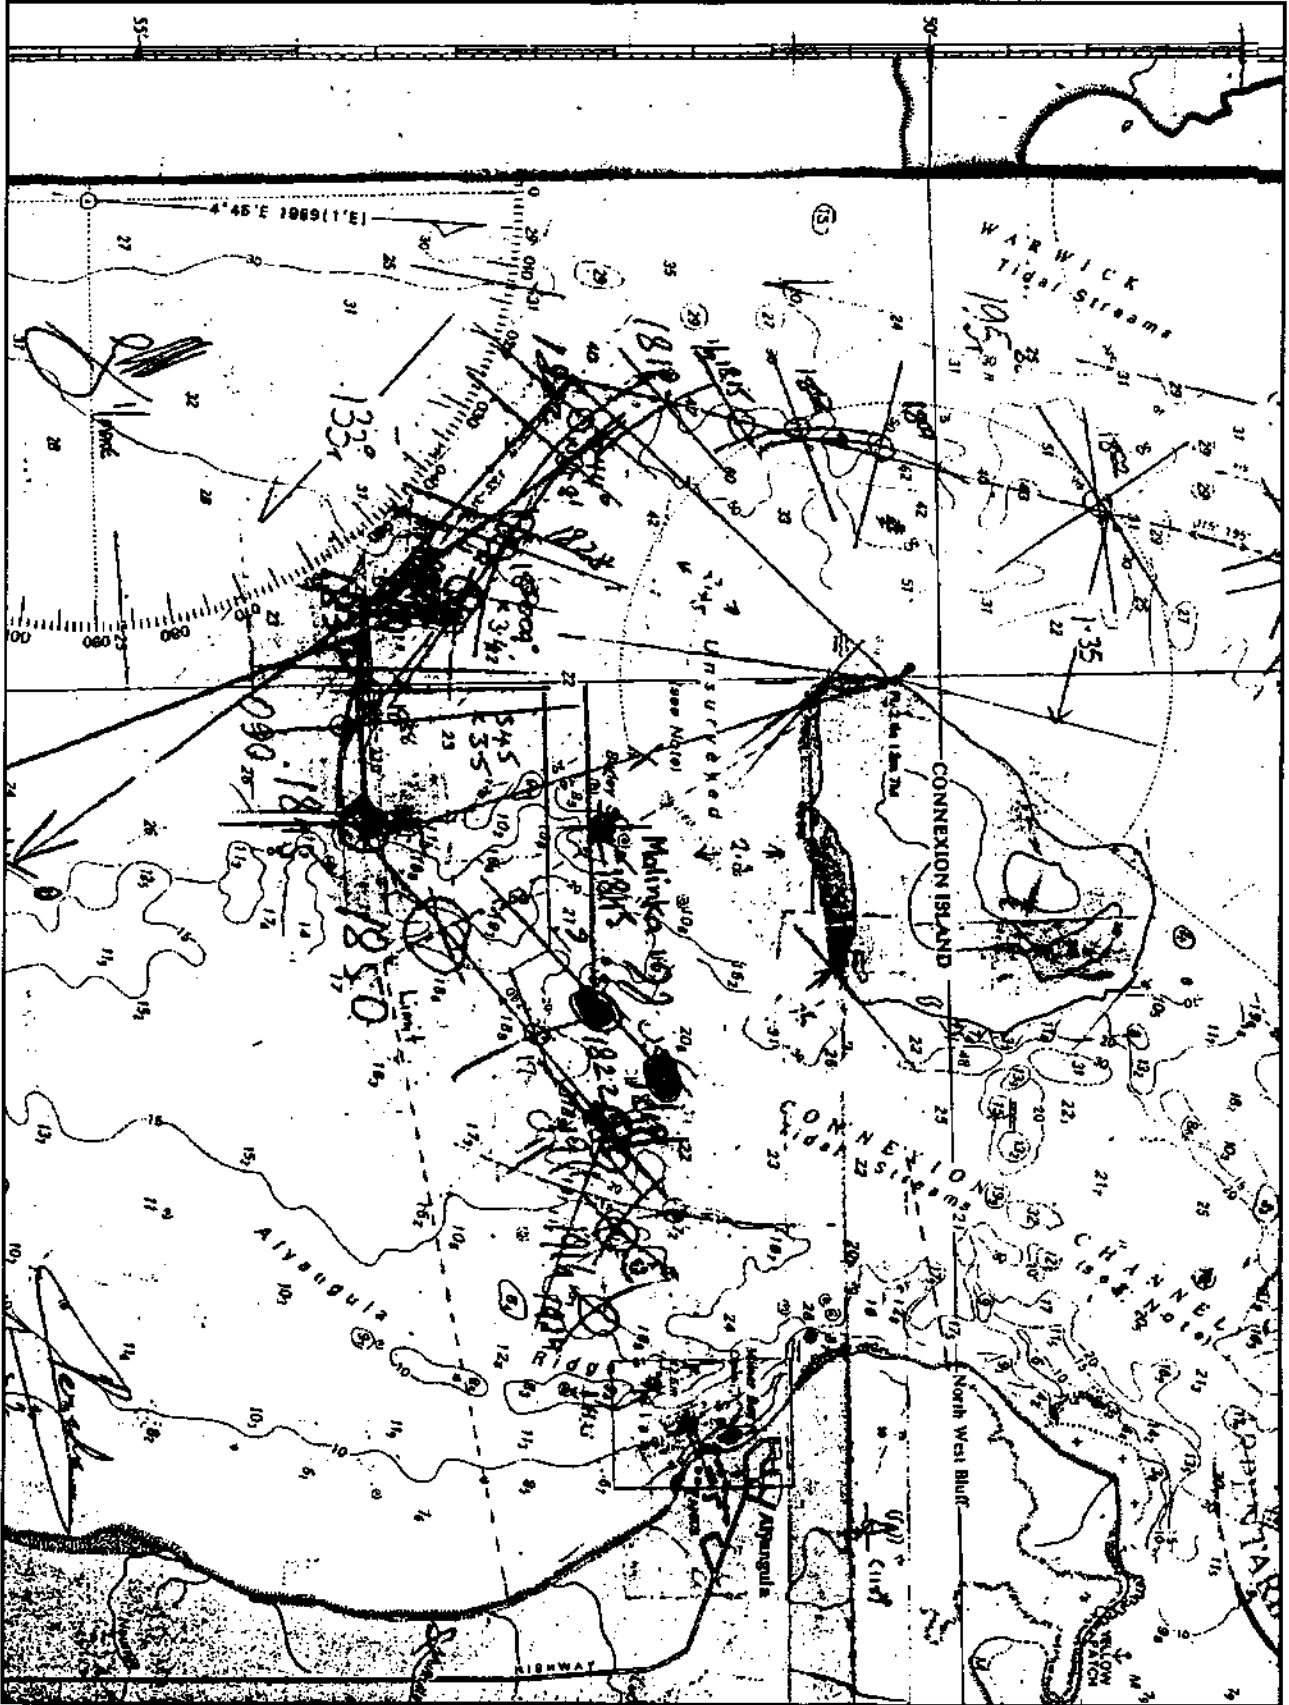
Photocopy of chart in use aboard Iron Carpentaria
 Extract from chart Aus 14

At 1820, Iron Carpentaria was in a position 228 degrees 2.5 miles from Connexion Island light and course was altered to 145 degrees, to take the ship south of the recommended track and to pass south of the 11.3m patches located south of "the gap". A second visual bearing (089.5) and radar distance (3.75 mls) were taken of Malinska at 1822, and while the Master was studying these on the chart, the Mate called out that Malinska was turning to starboard. The Master queried this, but the Mate confirmed, saying that he could now see the red side light.

Iron Carpentaria was found to be setting strongly to the north and was four cables north of the recommended 133 degree track, therefore at 1832, course was altered to 160 degrees. At about this time the Harbour Master was heard calling Malinska two or three times on VHF 16, but there was no response from the ship.

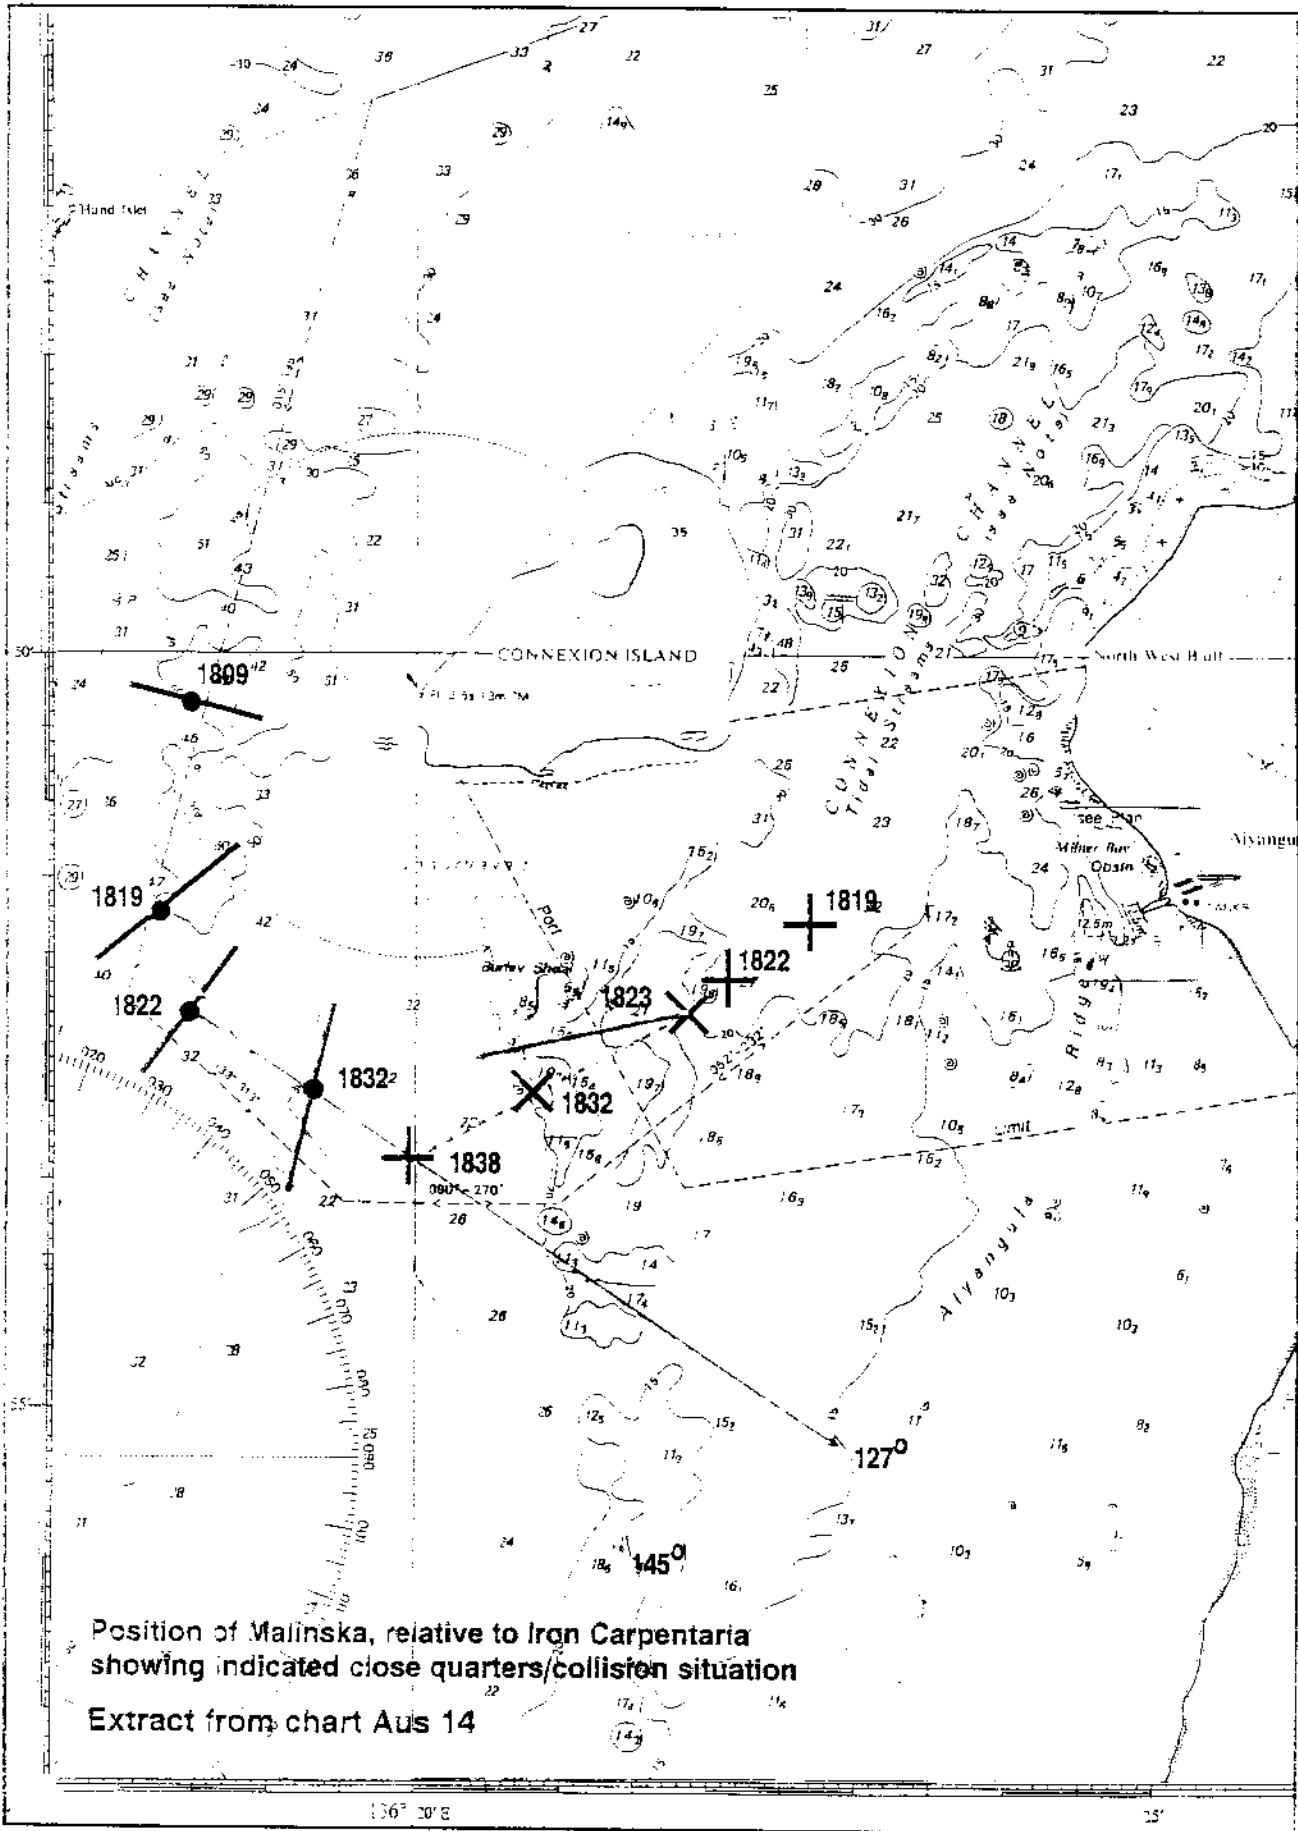
Position of Malinska, relative to Iron Carpentaria showing indicated close quarters/collision situation
 Extract from chart Aus 14

assess the situation. These two relative positions placed Malinska half a mile to the north of the recommended track.

The Master of Malinska stated that he checked the bearing of Iron Carpentaria and that it was 259 degrees. When Malinska was steady on the 260 degree course, at about 1826, according to the Mate, Iron Carpentaria was right ahead or very fine to port. This is supported by the fact that the Chief Officer of the Iron Carpentaria reported seeing Malinska's red side light at this time. From the plotted positions of Iron Carpentaria, these points would suggest that Malinska was even further north than as indicated by the relative positions plotted by Iron Carpentaria.

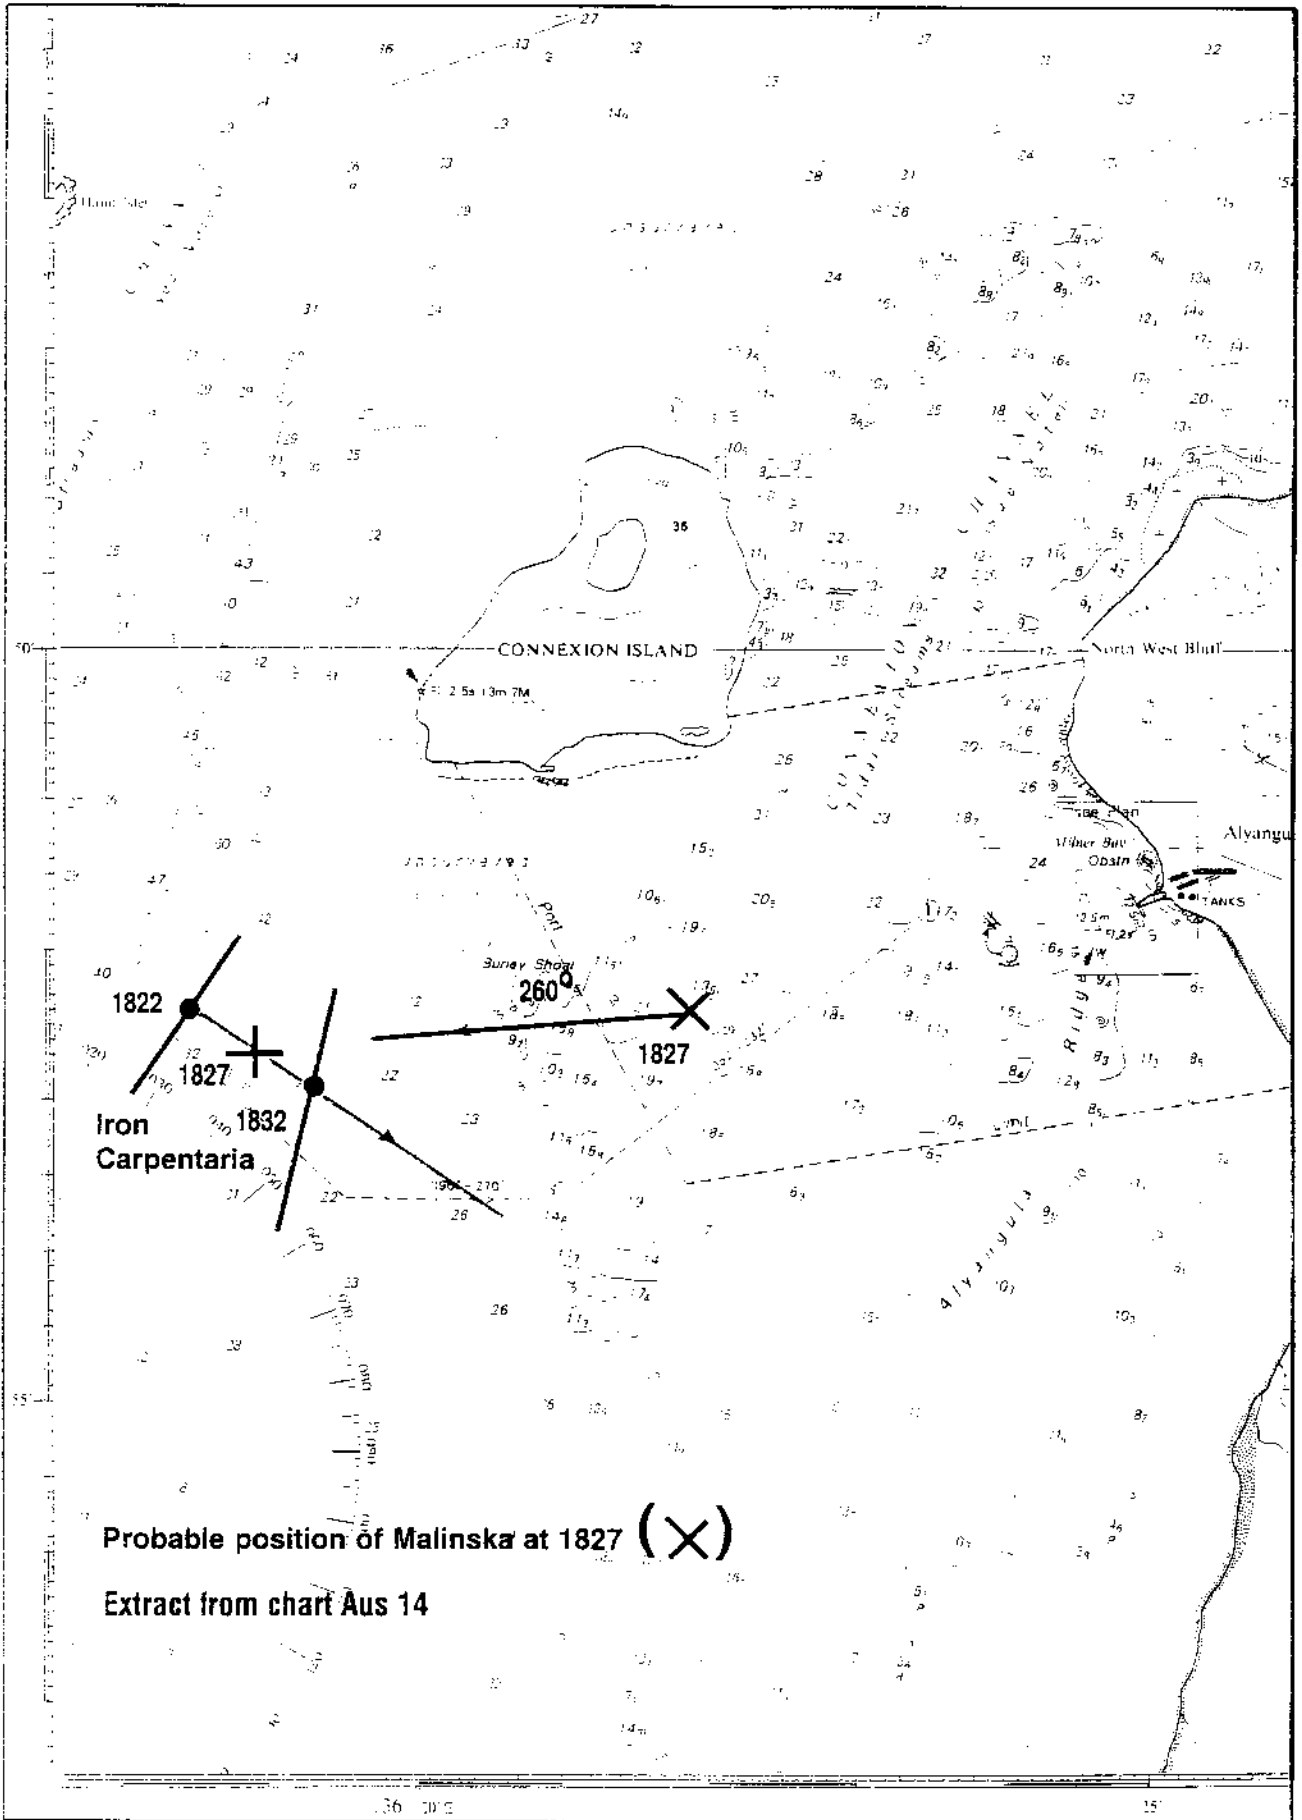
This failure to establish that the ship was being set to the north was a major navigational error. Not only did it result in the Master thinking that an alteration to starboard was safe, but even without the alteration of course to 260 degrees, the set experienced may well have resulted in the ship grounding on the 9.7m patch immediately south of Burley Shoal.
