Shortly before 0100 on 9 September 1992, the yacht *Libra*, on passage from Noumea to Brisbane, was involved in a collision with a large, unidentified, north-bound ship about 44 miles east-north-east of Cape Moreton.

Incident at Sea, Report No

54

"Departmental investigation
into the collision between
yacht **LIBRA**
and
MV SANKO HERON
off Cape Moreton
9 September 1992

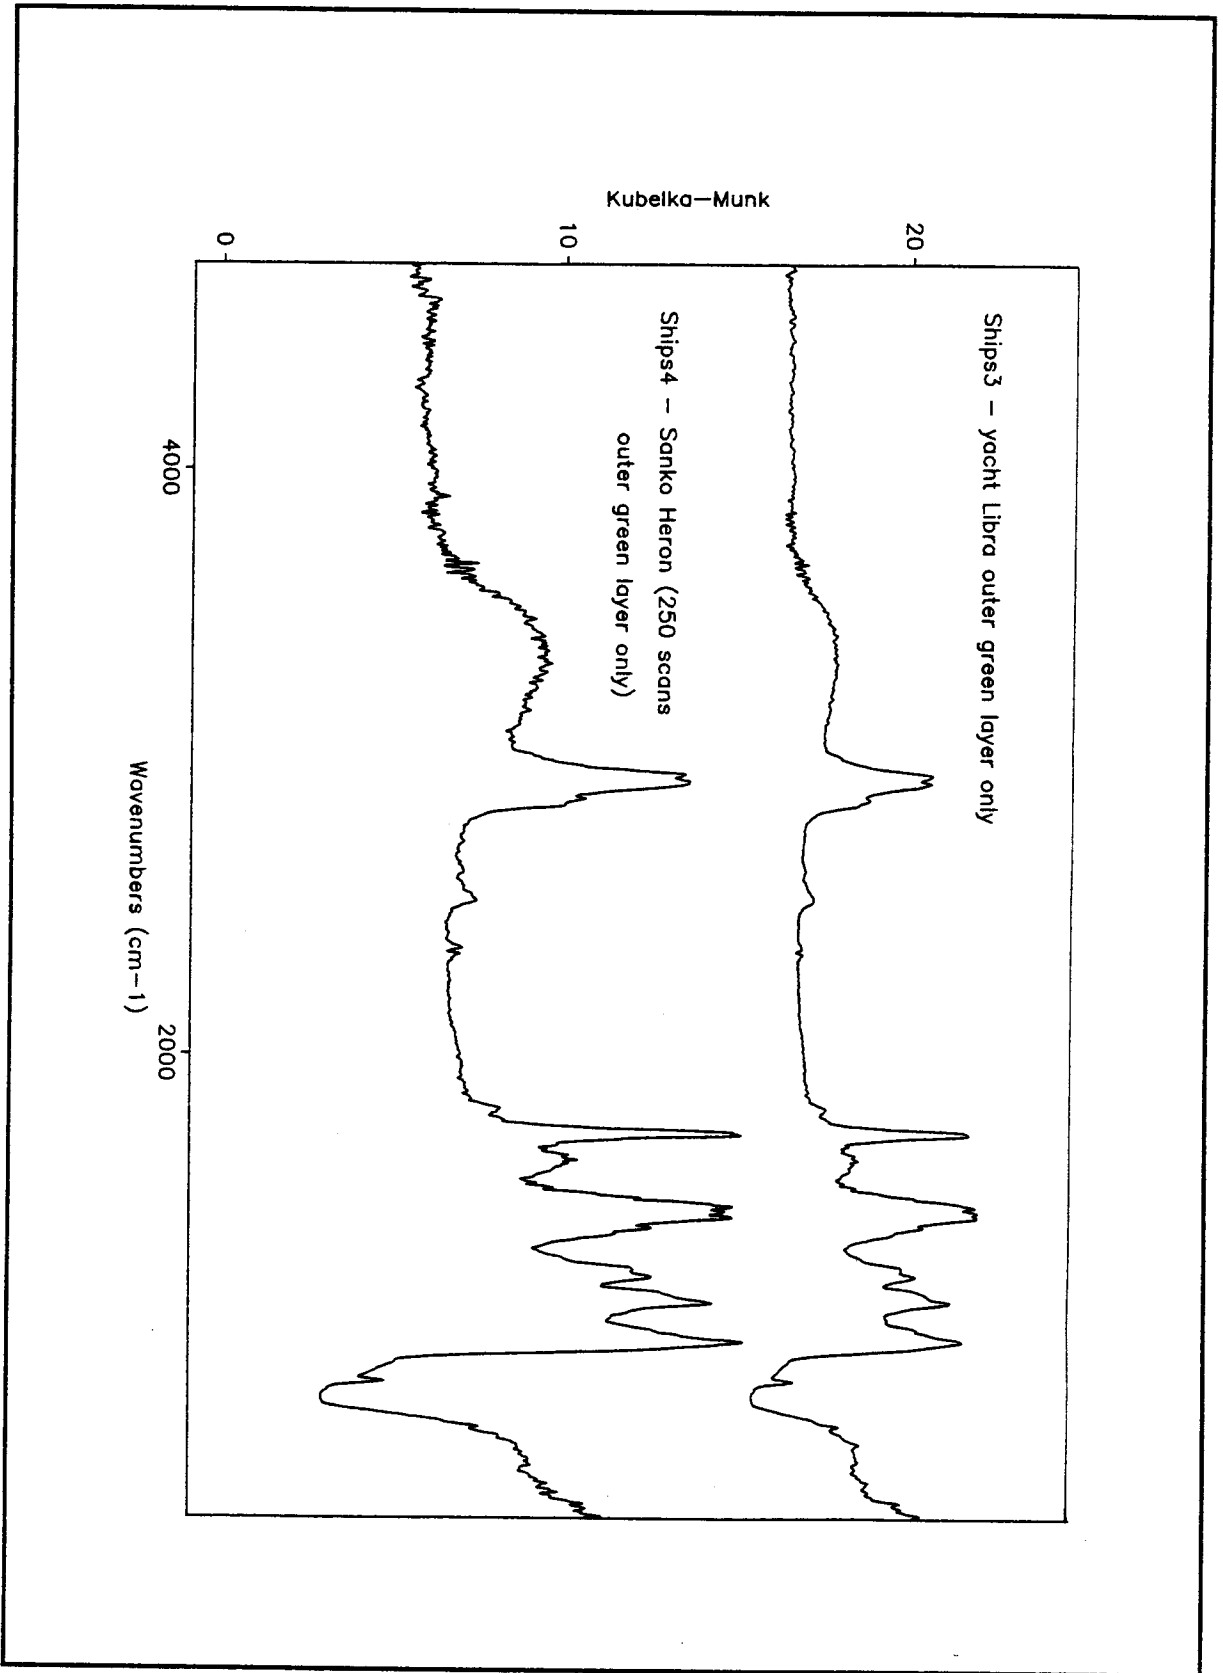
An instrumental analysis using Fourier Transform Infra Red (F.T.I.R.) spectroscopy was conducted to differentiate between the samples at molecular level. Infra-red absorption spectra were recorded for the outer green layers and for all layers and a very close correlation was observed.

The examination revealed a number of macroscopic and microscopic similarities and no significant dissimilarities. The instrumental analysis of colour and polymer character did not reveal any significant differences. On this basis

Infra-red spectra of outer green layer

the opinion was that it appears highly probable that the samples shared a common origin.
