MAERSK RUNNER

Summary

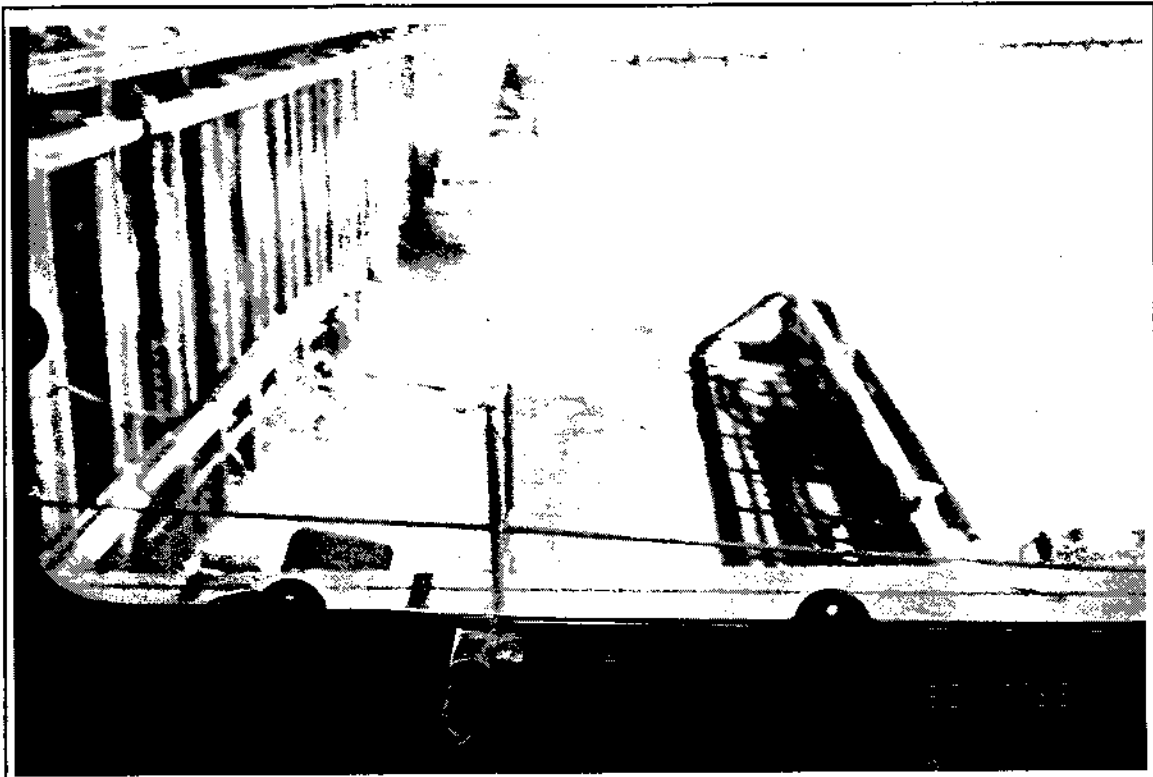
The design of Maersk Runner is such that the engineer at the controls cannot see the winch drums. Whereas the towing winches are equipped with hydraulic spooling gear, the

working winch is not. It is considered that it would have been appropriate, due to the absence of direct visual capability, for the working winch also to be fitted with hydraulic spooling gear.

Photograph: view from winch control position aboard Maersk Runner. Winches and "blind" area of working deck are covered by TV monitors.(Photograph: Captain D J Dillon)

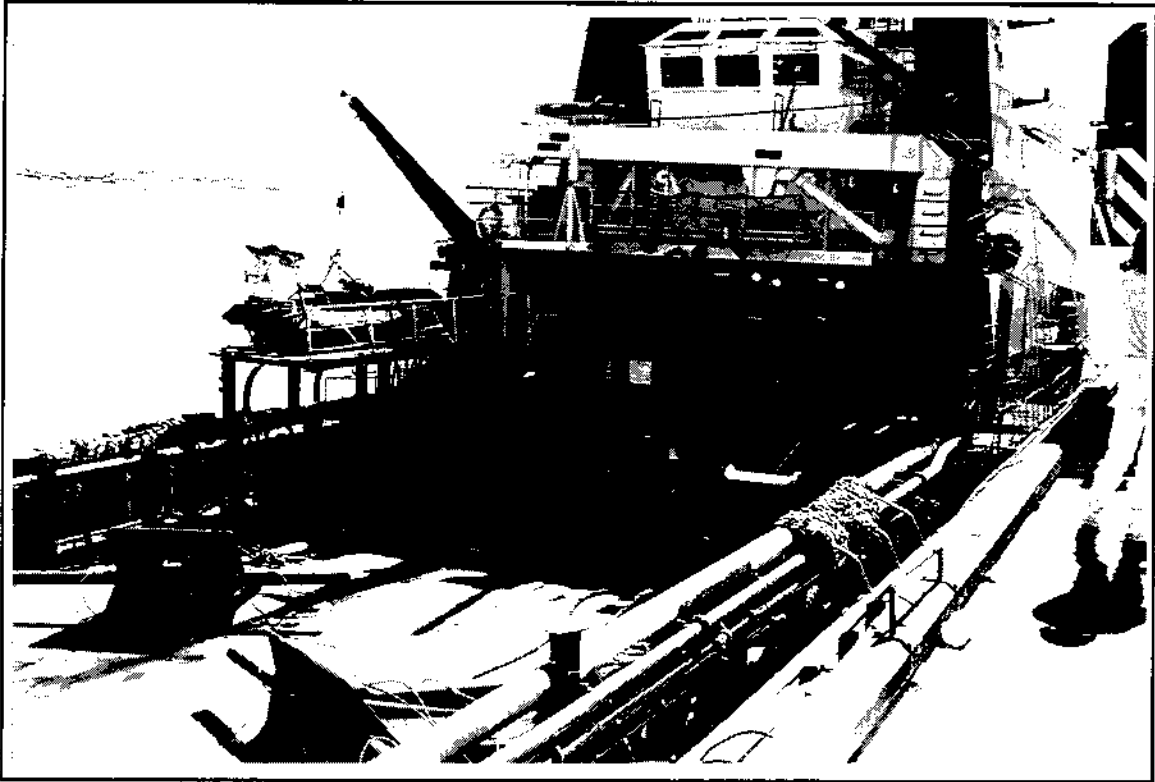
View of forward end of working deck

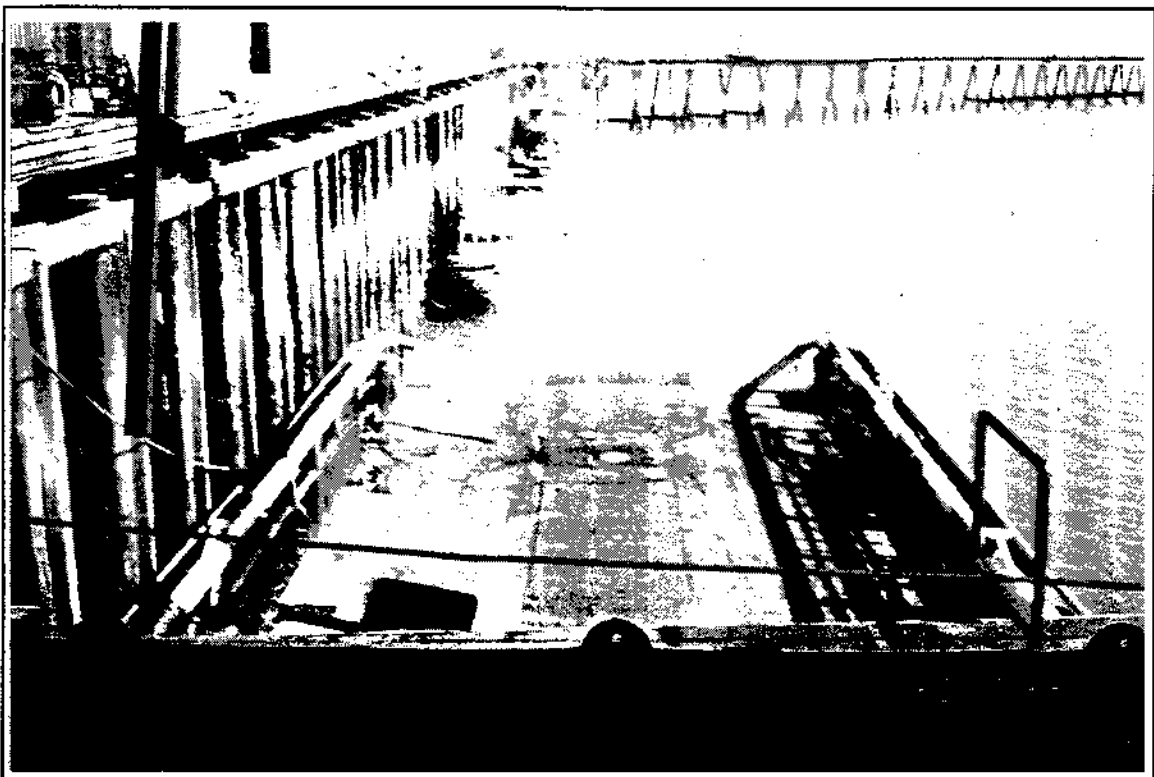
Due to the heavy steel framework immediately aft of the towing and working winches, which largely conceal them from view, to obtain a similar view from outboard of the safety barrier, the Mate would have had to position himself only about 8m from the stern, 33m from the winch drum. At this distance, because of the dimness of light caused by the framework and surrounding structure, it would be difficult to get a clear view of the drum.

View of working deck from control position

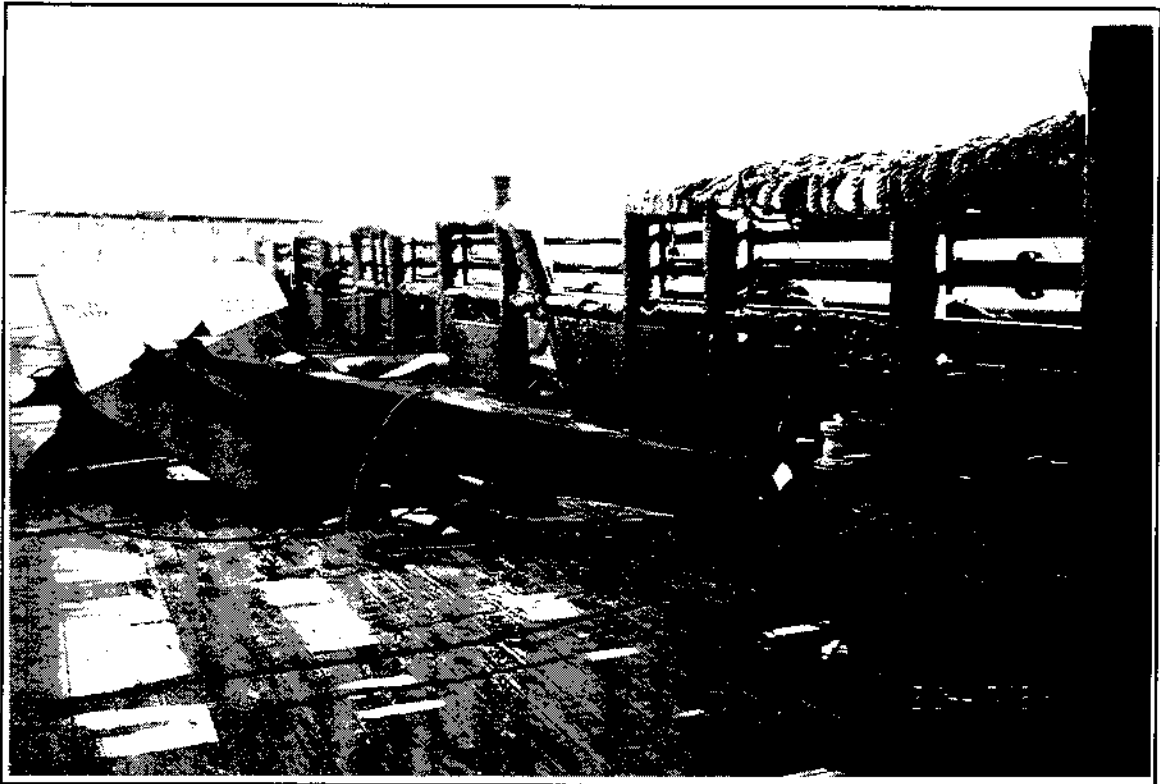
Anchor upon which the mate was standing, also showing dummy roller (right hand side) around which tugger wire had been lead.

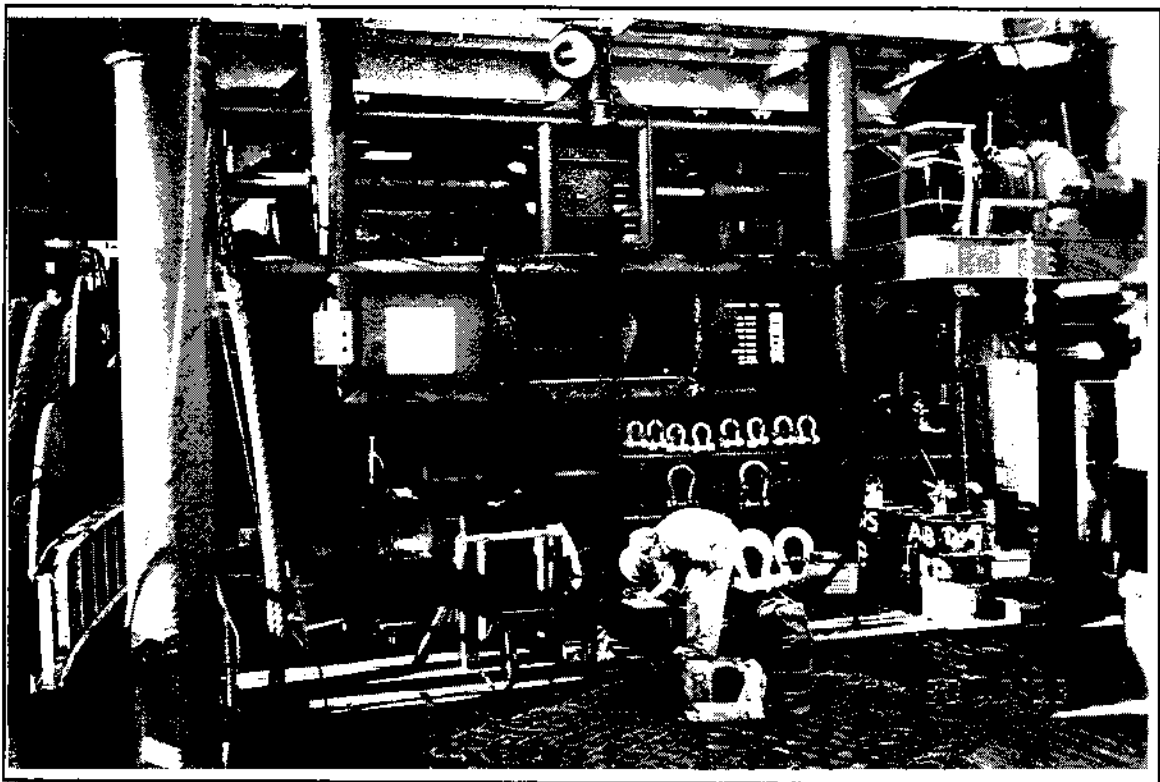
View of working winch from where the Mate was standing.

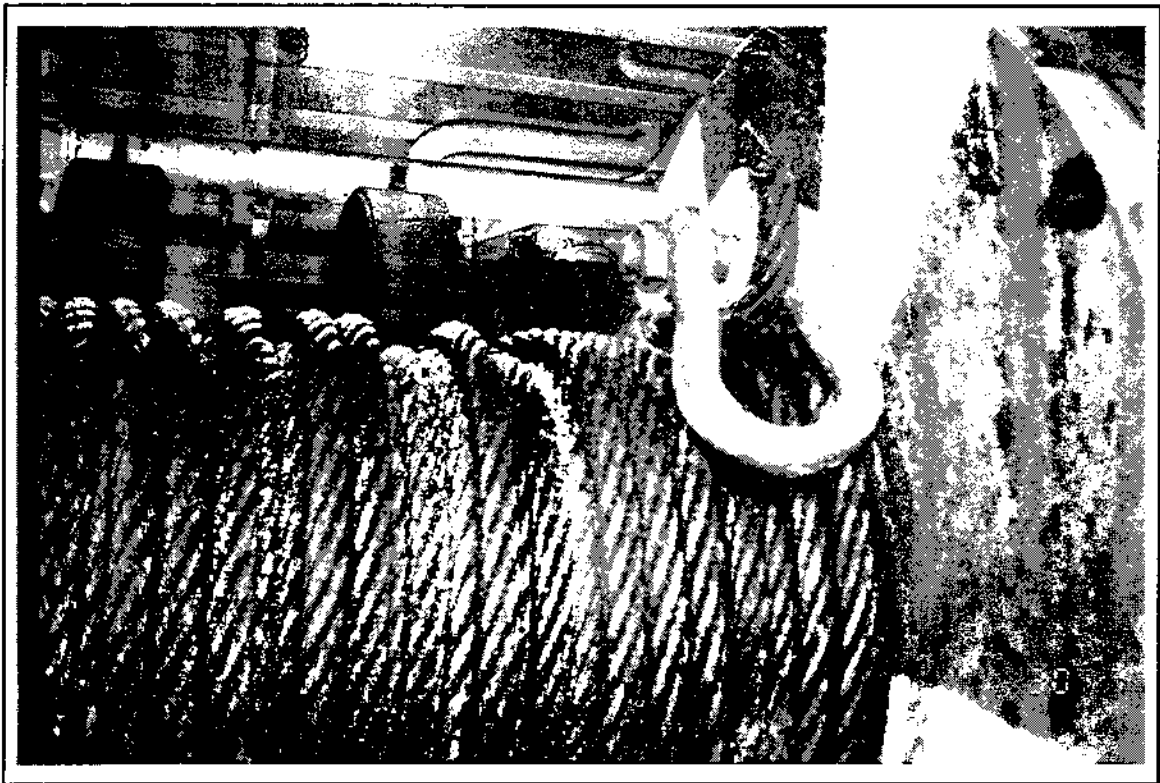
Position of shackle on working winch.

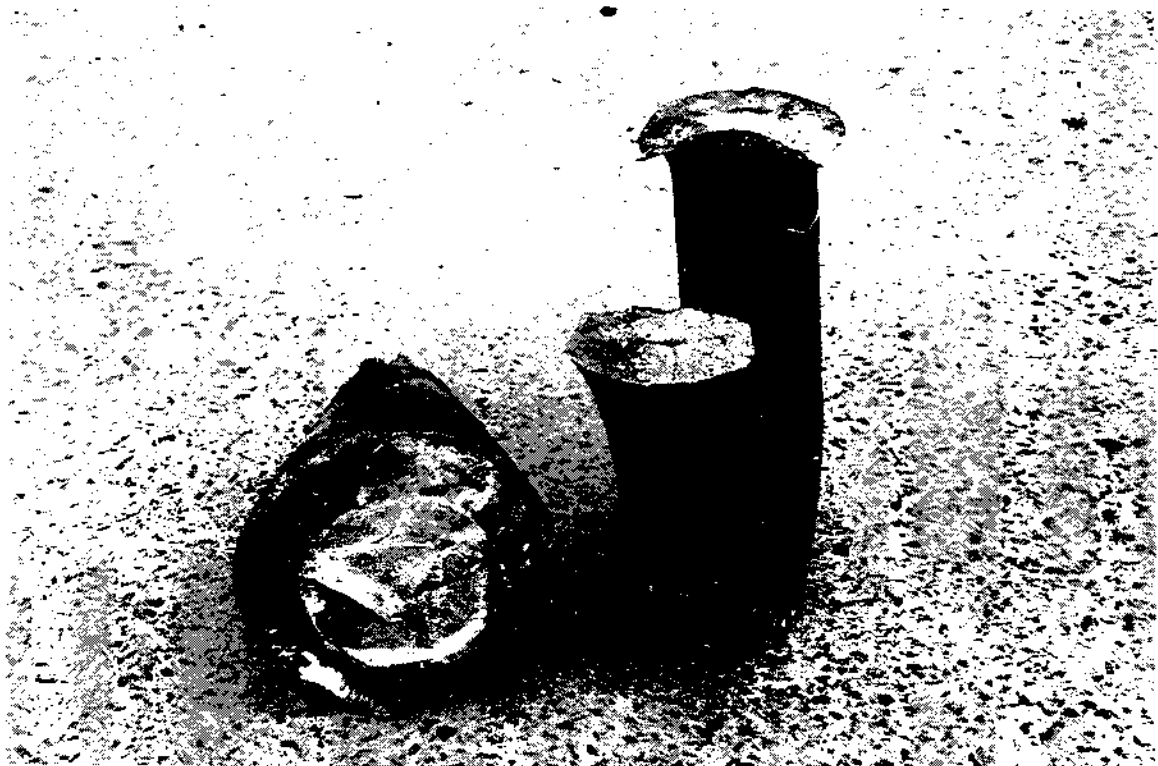
The socket had failed at the two (2) junctions of the 'U' shape to the conical section.

The overall appearance of the fracture surfaces and the bend in the leg which contained fracture B indicated that side A fractured first followed by bending of leg B and subsequent fracturing at B.

Figure 1: Showing the two halves of the fractured spelter socket.

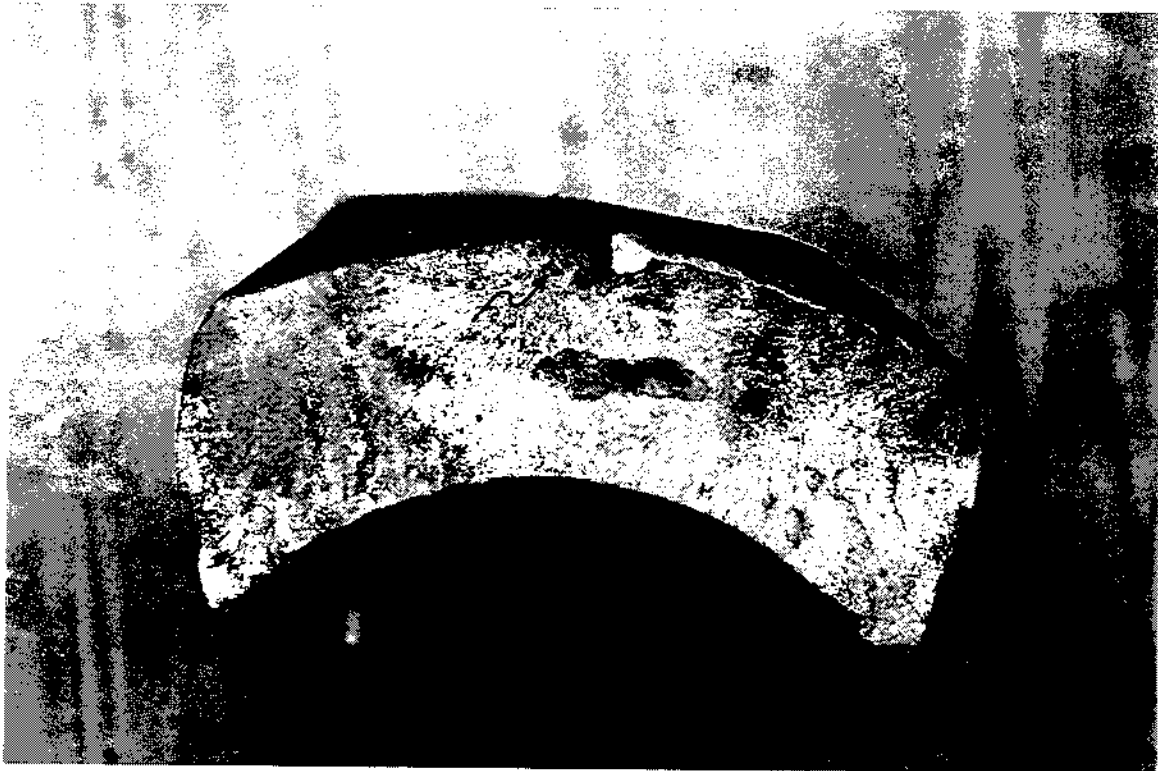
Fracture A exhibited a small casting defect on the outside surface. This defect was probably a shrinkage cavity, was approximately the size of half a two cent coin and extended to a depth of approximately 10mm. The general appearance of fracture A indicated that the fracture initiated at this casting defect and propagated through the cross-section to the inside surface of the 'U'.

The casting defect from which the fracture initiated will have acted as a stress concentrator, however it is quite probable that failure would have occurred if the defect had not been present.

Figure 2: Showing the fracture surface at A.

Note centreline shrinkage and the small casting defect towards the top at the photograph.

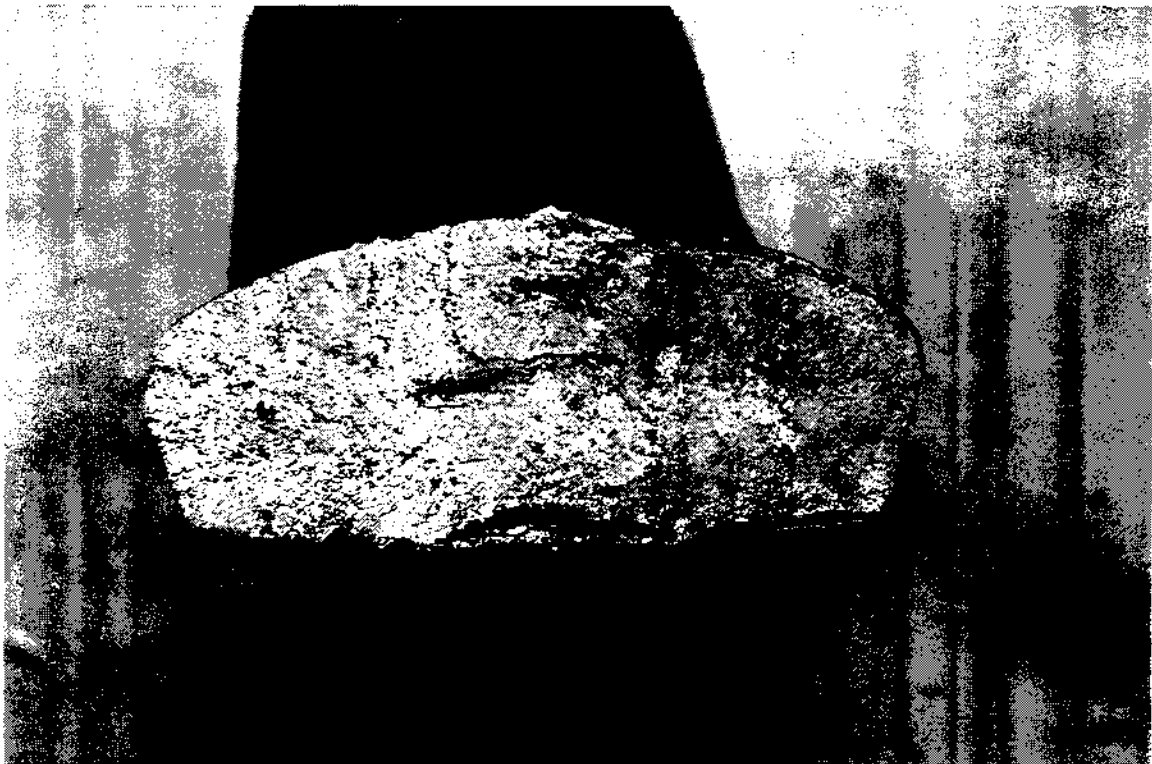
Both fracture surfaces exhibited centreline shrinkage which made up approximately 2% of the cross-sectional area.

The origin of the fracture on fracture B was not able to be determined. Most of the fracture surface exhibited cleavage type facets similar to those observed on fracture A.

Figure 3 : Showing fracture surface B.
Note the centreline shrinkage.

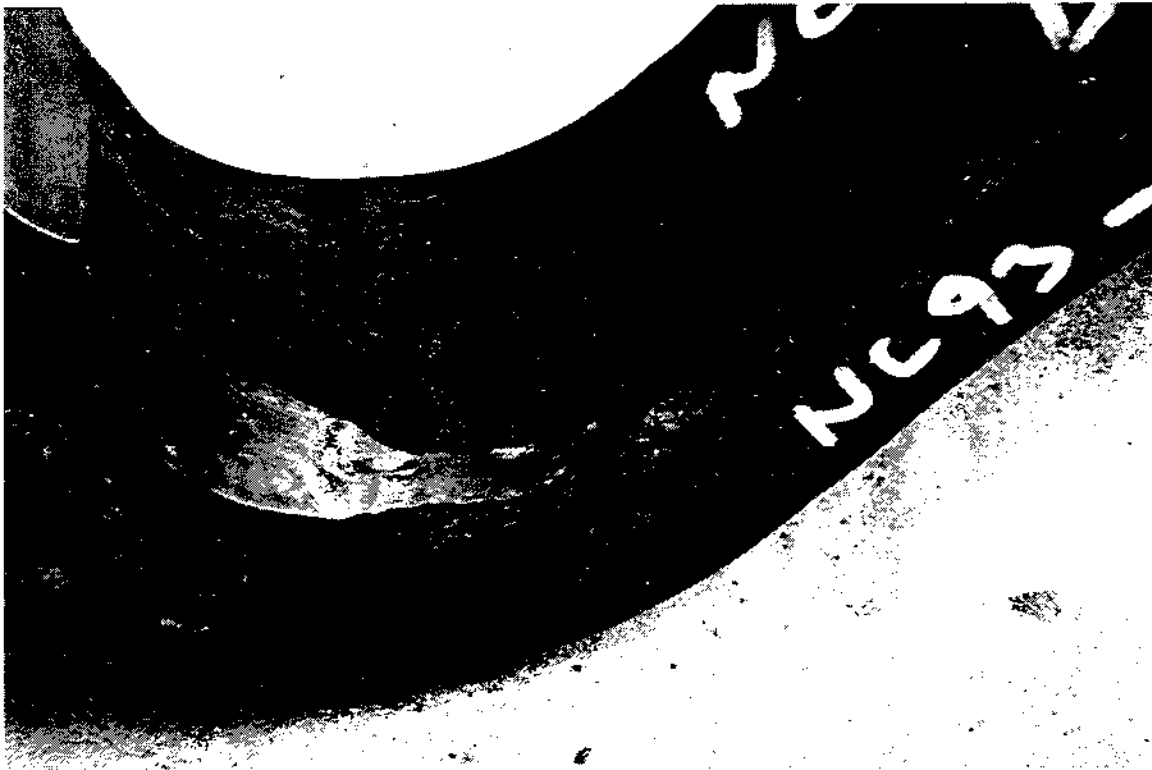
The severity of this bruising indicated that either the socket had been in service for a considerable period of time and the bruising was in fact a mixture of wear and bruising or that the type of load applied for the first time was greater than the design capability of the component.

Figure 4: Showing the bruising in the bottom of the 'U'.

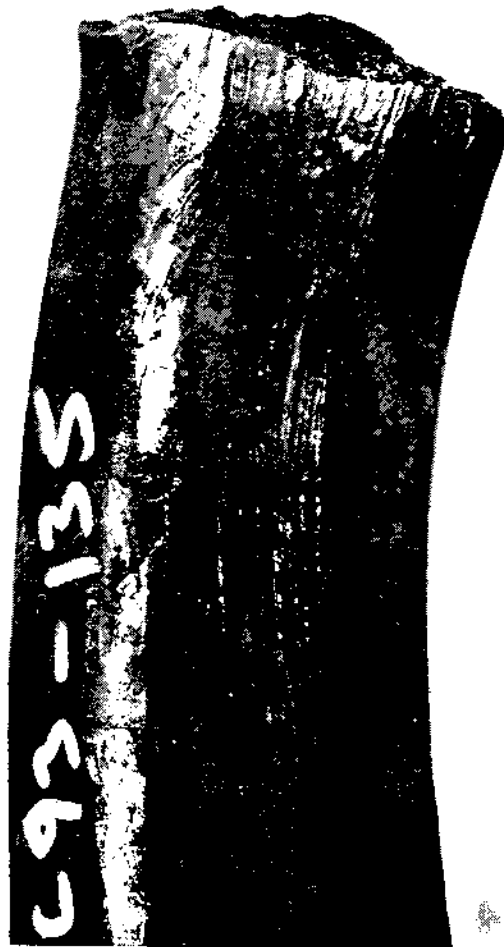
Several areas on the outer surfaces of the 'U' shape exhibited damage characteristic of a stranded wire being dragged across the surface.

Figure 5: Showing the abrasions on the outer surface of the 'U' caused by stranded wire.
