Pacific Commander alongside at Darwin November 1993

# Summary

In the early hours of 29 October 1993, the offshore supply vessel Pacific Commander manoeuvred stern-to the semi-submersible drilling rig Atwood Falcon to back-load some sections of casing. The Master was advised the cargo operation would be of short duration and, as a result, he chose not to use an anchor, making fast with two lines aft and maintaining position, at right angles to the rig, with the bow thruster.

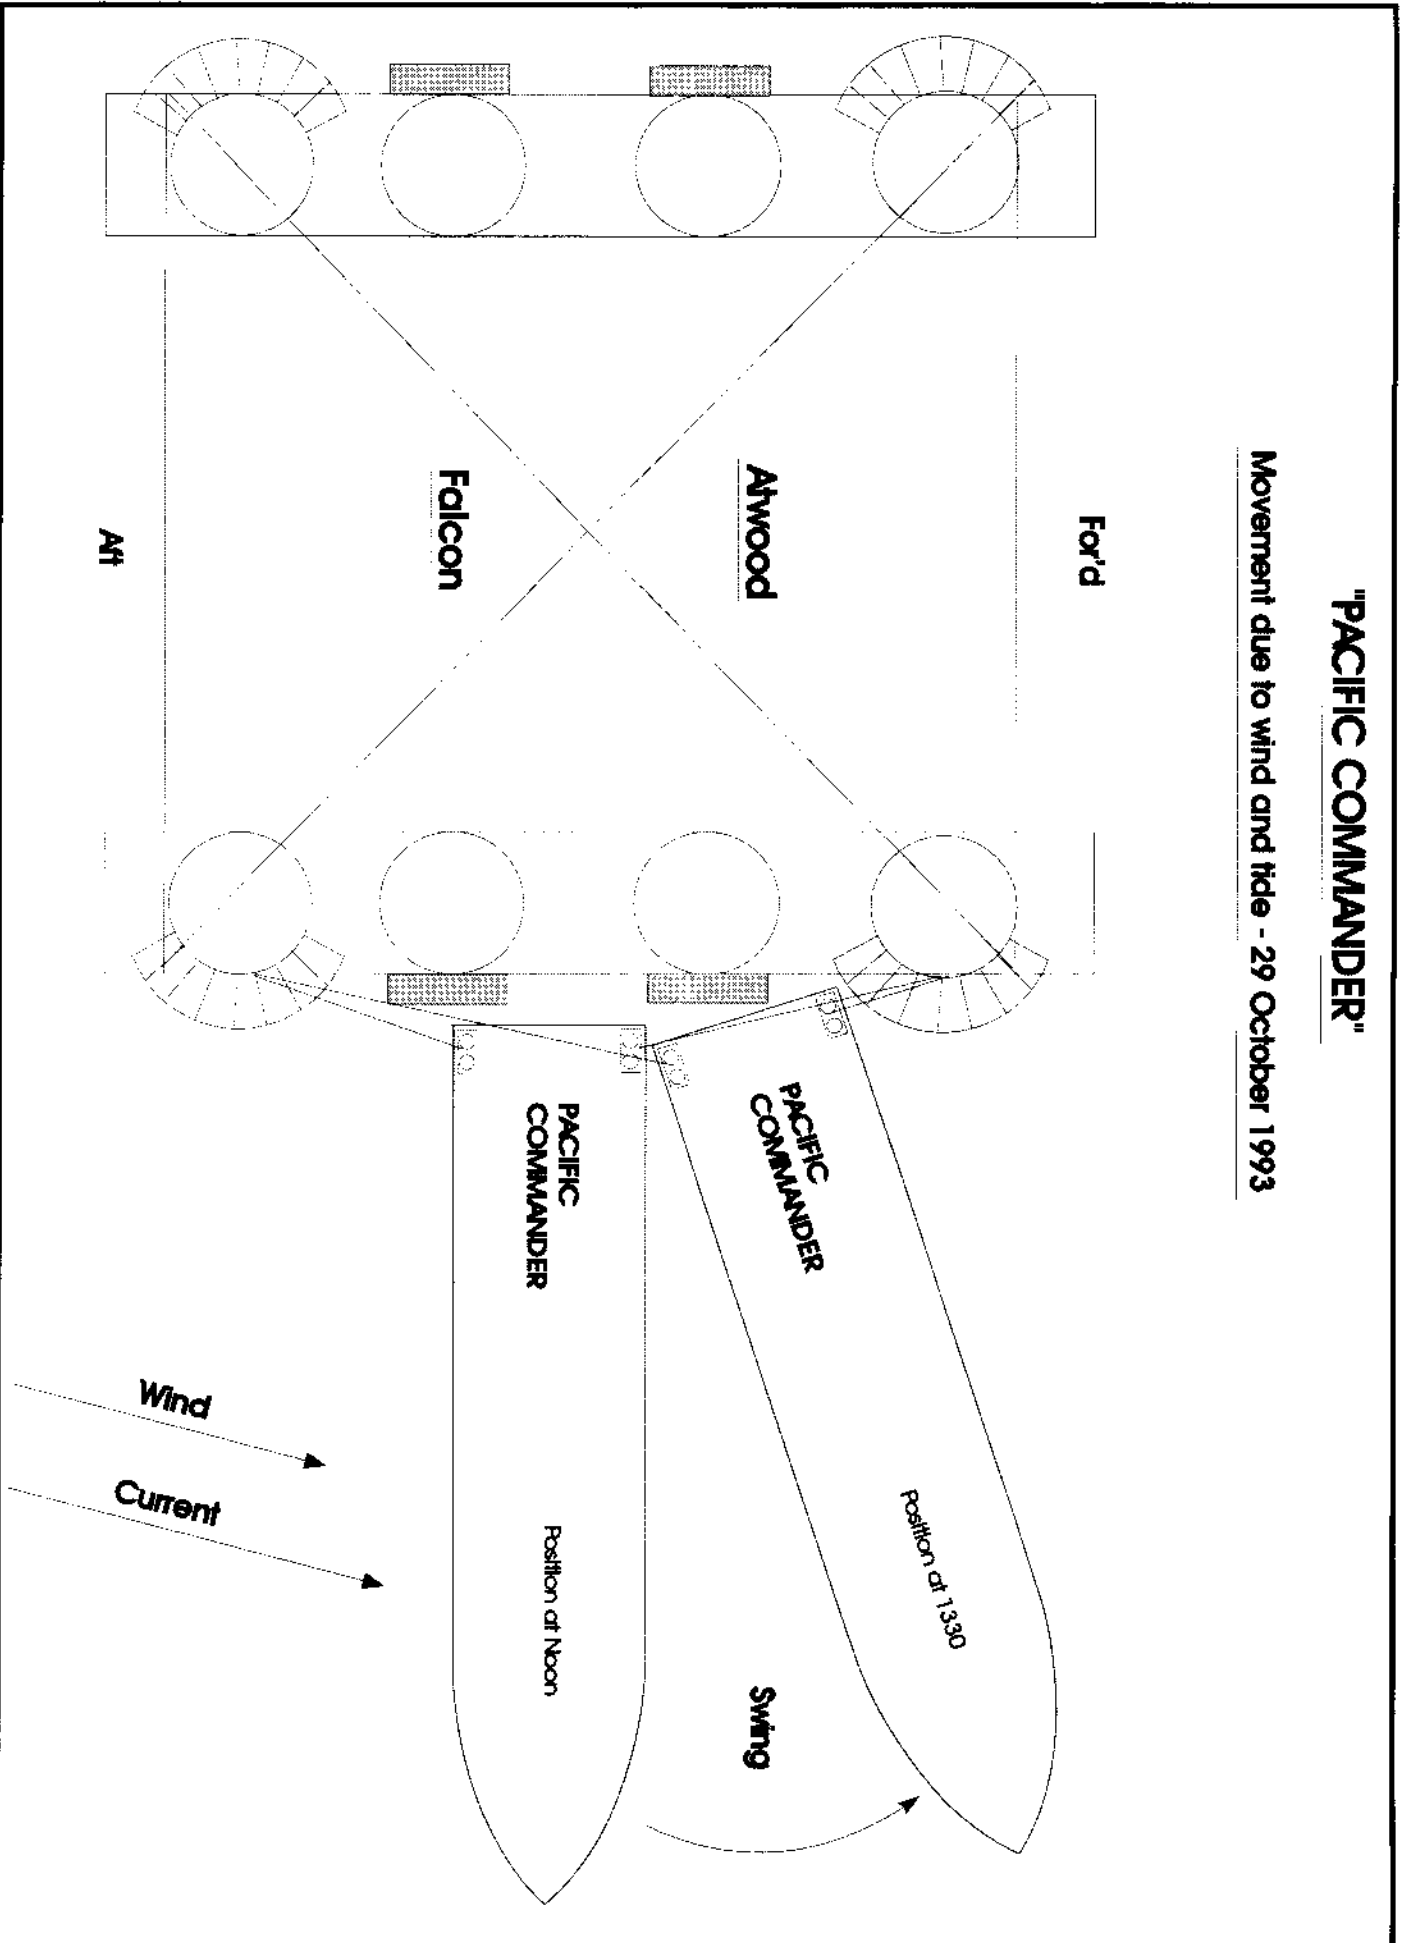
Movement due to wind and tide - 29 October 1993

The Mate found that he was having to use increased bow thruster power to maintain position against the wind and current and called the Master at 1315. Arriving on the bridge, the Master found that although the bow thruster was on full thrust, Pacific Commander had "fallen off" to port. The vessel had also moved bodily to port, putting great weight on the nylon starboard quarter line, which had stretched considerably. He therefore advised Atwood Falcon that he was going to let go and move out. The cement pump was stopped and the hose disconnected, the port quarter line was let go and the hose and line lifted clear by the rig's crane at 1324.

The wind too had increased during the morning, from 8 knots at 0800 to an estimated 14 knots at 1330. This would have had a significant effect on the high forward end of the vessel and, therefore, on the ability of the Master and Mate to maintain the vessel's position.
