Summary

On 10 December 1993, the Australian flag tanker Osco Star was loading a cargo of petroleum products at the Shell refinery Geelong (Corio). A little after midnight, as the officer of the off-going watch was checking the deck, he opened the sighting port to no.4 port cargo tank and heard the rush of liquid falling into what should have been an empty tank. On checking he found that the gas oil cargo in no.3 centre tank was flowing into no.4 port.

Oscos Star -

10/11 December 1993

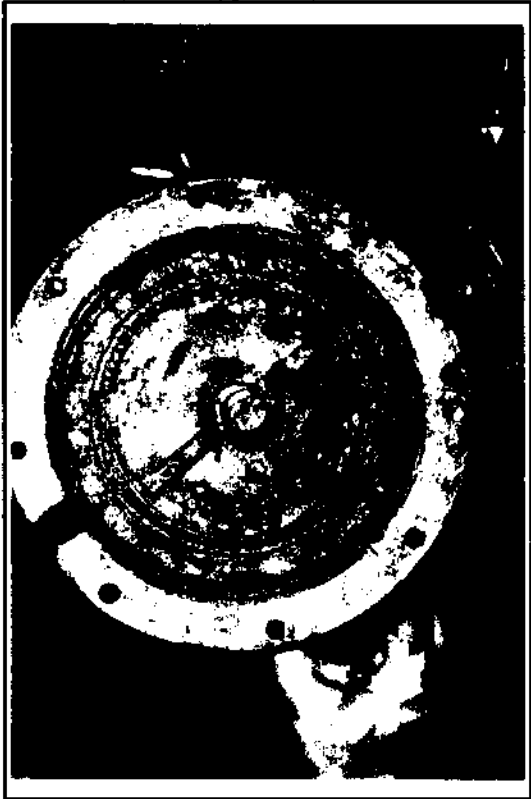
On 20 December, the P/V valve on no.3 centre was removed from the tank and opened up. It was found that the main spindle of the valve (for pressure relief) was seized solid (See photographs page 15).

Pressure release valve opened up -
view of underside of valve disc

Examination of the valve from no.3 centre tank revealed that a buildup of a lacquer-like residue, combined with corrosion, had reduced the clearance between the edges of the valve disk

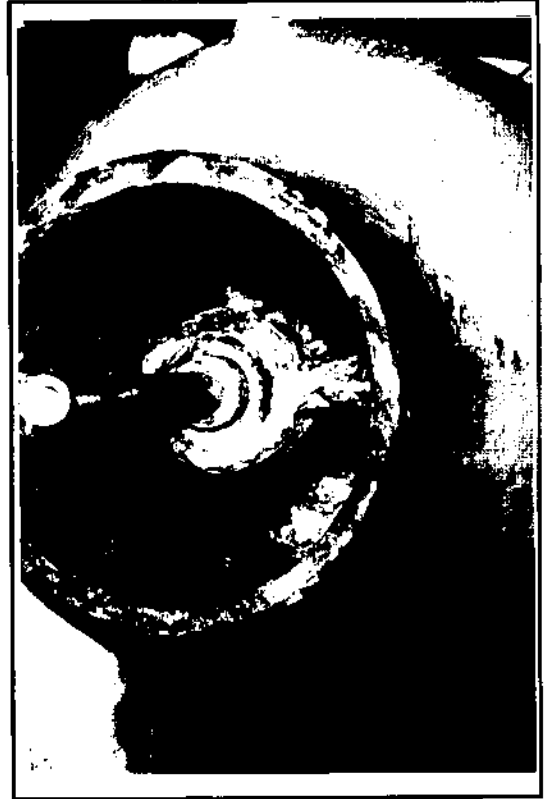
Pressure release valve opened up -
view of spindle in top guide bush

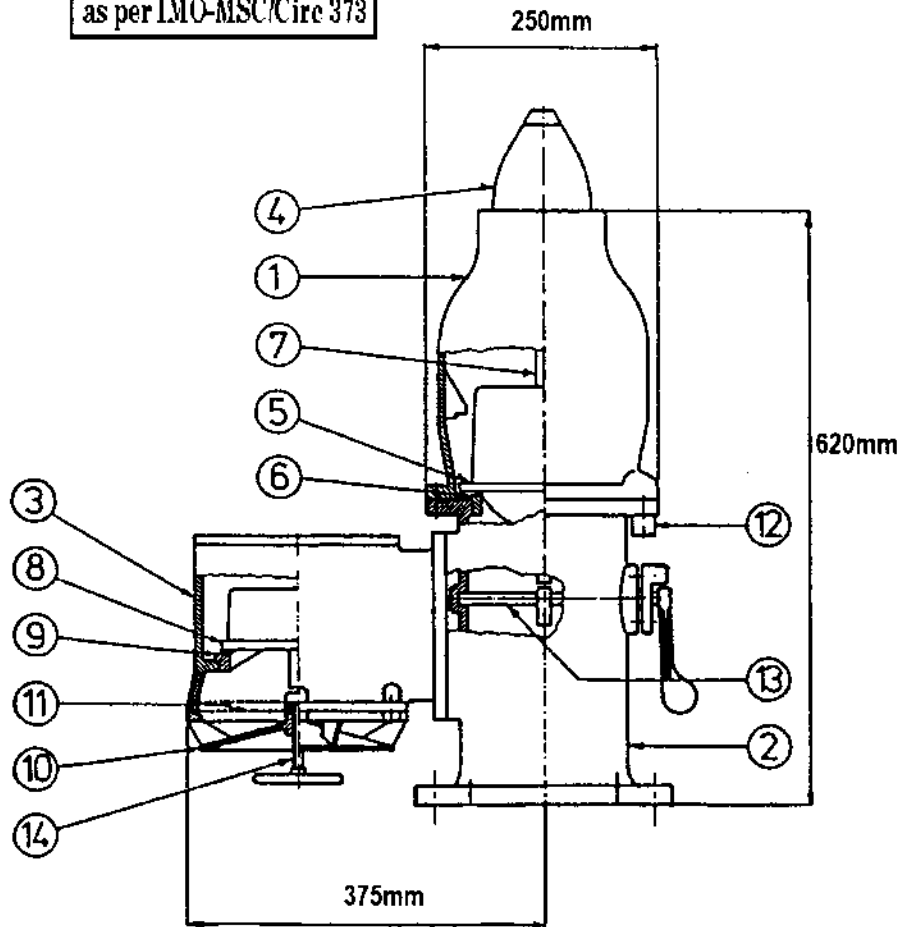
Pressure/vacuum release valve arrangement

The valves as fitted on the Osco Star are manufactured from materials as listed in 'Spec.5' of the illustration on the next page - with the exception that item 4 (Valve Top) is made of stainless steel and not bronze as listed.

When the valve on no.3 centre cargo tank had been removed and opened up, it was found that the cross-spindle, ("checklift" - item 13) carrying the cam, was seized in the valve adaptor (item 2) and the roll-pin securing the lever to the end of this spindle had sheared.

end of the spindle with the pieces of the sheared pin still in place. With the cam spindle seized, however, the valve would not lift and no movement of the valve top (Item 4) would be observed, although in the case of a cursory test, moving the lever and feeling the resistance might give the impression that the valve was lifting.
