**Departmental investigation
into a fatality
aboard the offshore supply vessel
SHELF SUPPORTER
off the north-west coast of Australia
on 29 December 1993**

Navigation Act 1912
Navigation (Marine Casualty) Regulations
investigation into a fatality
aboard the offshore supply vessel
SHELF SUPPORTER
off the north-west coast of Australia
on 29 December 1993

No 62

Published: 28 September 1994

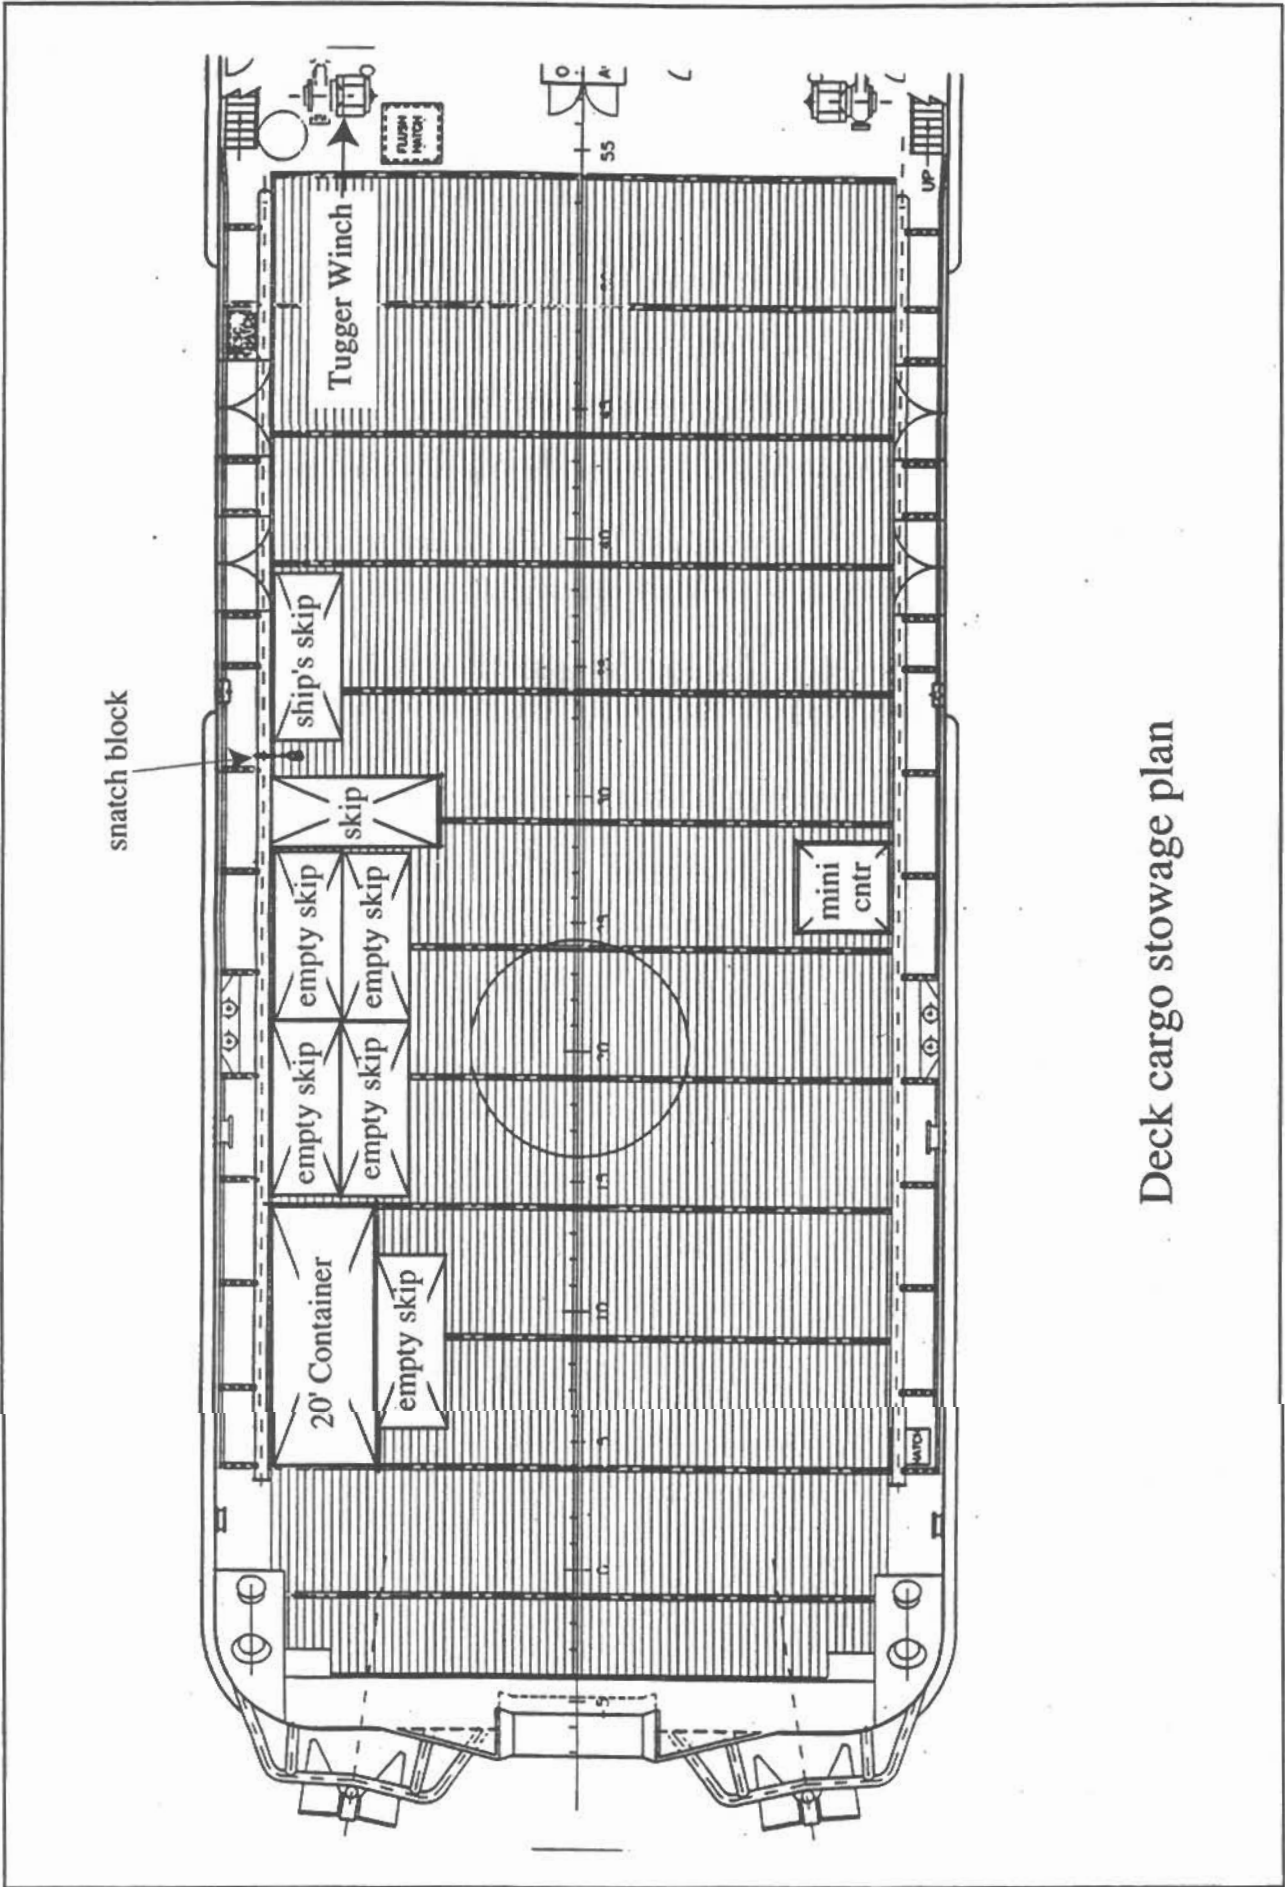
However, as one of the skips was stowed alongside the 20-foot container, the sixth skip became an odd one and was stowed athwartships, across the forward end of the stow. This neatly blocked off the stow and provided demarcation for the end of the cargo from the vessel's equipment.

Once the protection of the three inboard skips had been removed, the athwartships skip became vulnerable, any seas breaking over the deck striking against its side, rather than the end. The weight of the water striking the skip may have been sufficient to cause the skip to move, but the depth of the water may also have been sufficient for the inboard end of the skip to float slightly, which would have made the movement of it easier. In this respect it is considered that the angled end of the skip may have assisted the lifting effect of the water. It is worthy of note that following an inquiry into offshore industry cargo operations in Britain, the priority phasing out of boat-shaped skips was recommended because of this and other inherent factors.

Deck cargo stowage plan immediately prior incident.

Athwartships stowage, particularly of empty skips and other forms of bin, is considered by the Inspector to be undesirable, due to their greater vulnerability to movement by seas breaking on board. Where unavoidable for any reason, skips stowed in such a manner should be discharged first from the vessel. In this instance, it is considered stowage on the starboard side with the mini-skip, where there was ample space, would have been more appropriate.

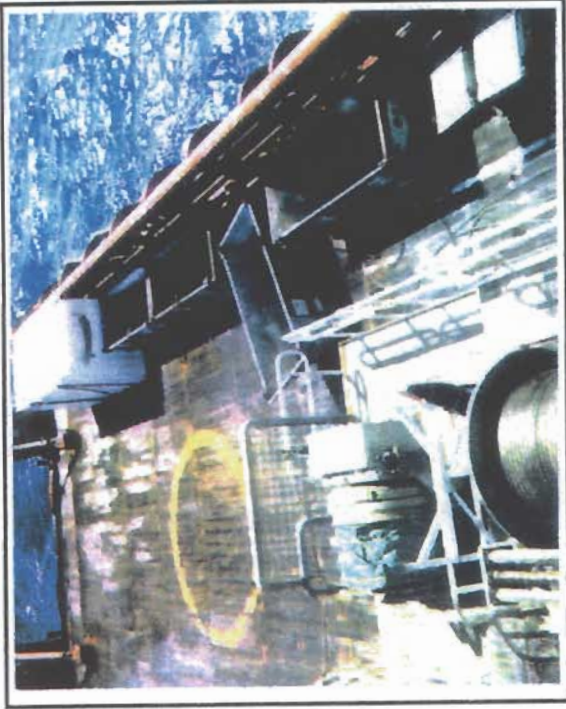
View from manoeuvring position

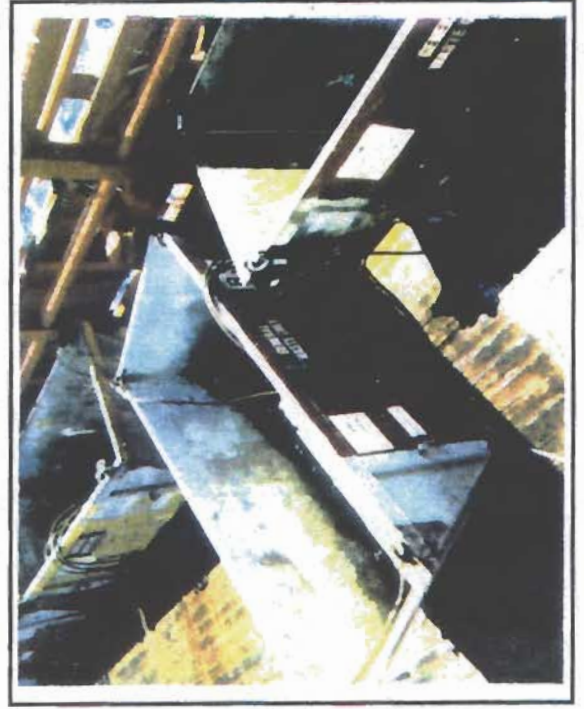
Whatever the AB's movements were, the movement and speed of movement of the skip forward on the deck, caused by the seawater travelling up the deck, apparently caught him unawares and pinned him with his back against the after inboard corner of the vessel's skip.

Shortly after the incident, the skip was found to contain about 30cm of seawater, which was most probably present at the time of the incident. This would have increased the weight of the skip by 1.5 tonnes, making a total weight of just under 2.5 tonnes, therefore requiring a greater force to move it.

Close view of moved skip

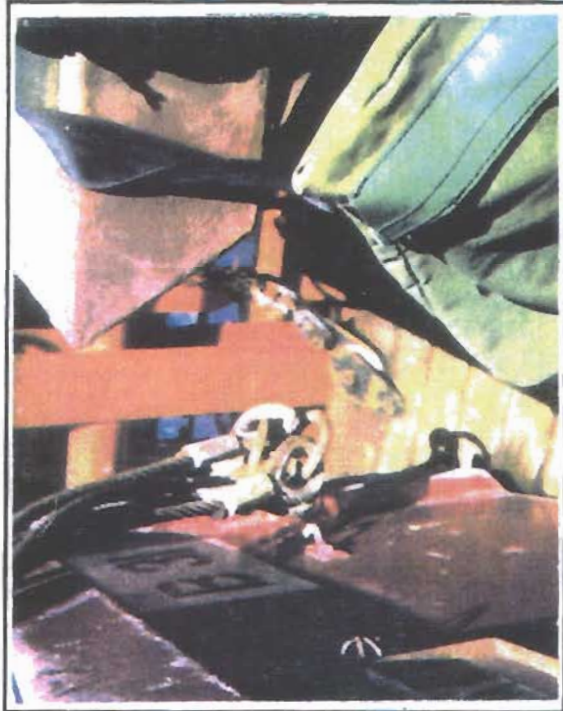
the vessel's crew, using the tugger wires and winches. On the port side, the wire was passed through a snatch block made fast to the safety barrier, just forward of the cargo stow, then passed aft inboard of the cargo, to be made fast to the safety barrier aft of the stow. When hauled tight by the winch, the wire secured the cargo in a tight block stow against the port safety barrier.

Opened snatch block

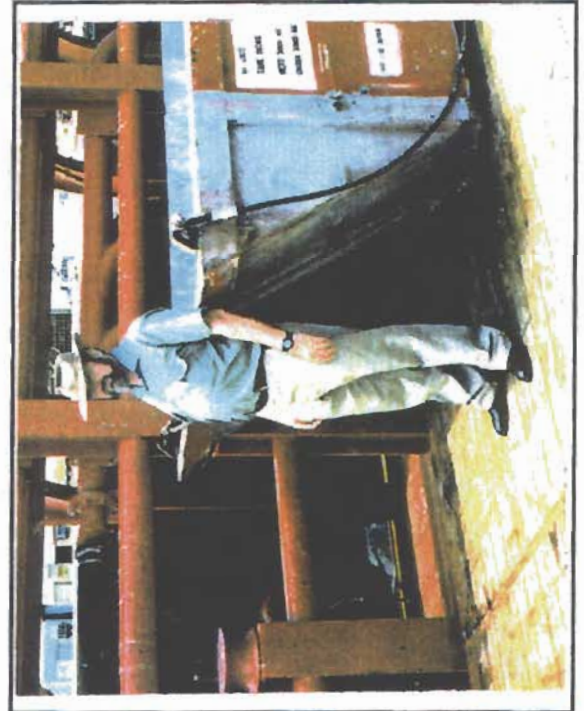
The AB was 181cm tall. The fact that his chin, according to the Greaser, was close to the lip of the skip, could indicate that he may have either been rising, or dropping at the time he was pinned. The crane driver, from his vantage point on the platform, was not immediately aware of him, indicating the AB may have been bending down. However, the Master was aware of him, apparently standing upright, just before the skip moved.

Comparative height of skip
