Summary

On the evening of 31 January 1994, the Port of Melbourne Authority's suction dredger A M Vella was operating at the eastern end of the South Channel, Port Phillip Bay. The cargo vessel Searoad Mersey, under the command of a "pilot exempt" master, entered Port Phillip Bay on its regular scheduled service. The vessel had received clearance to enter from Point Lonsdale Signal Station, which also advised of the A M Vella dredging operation.

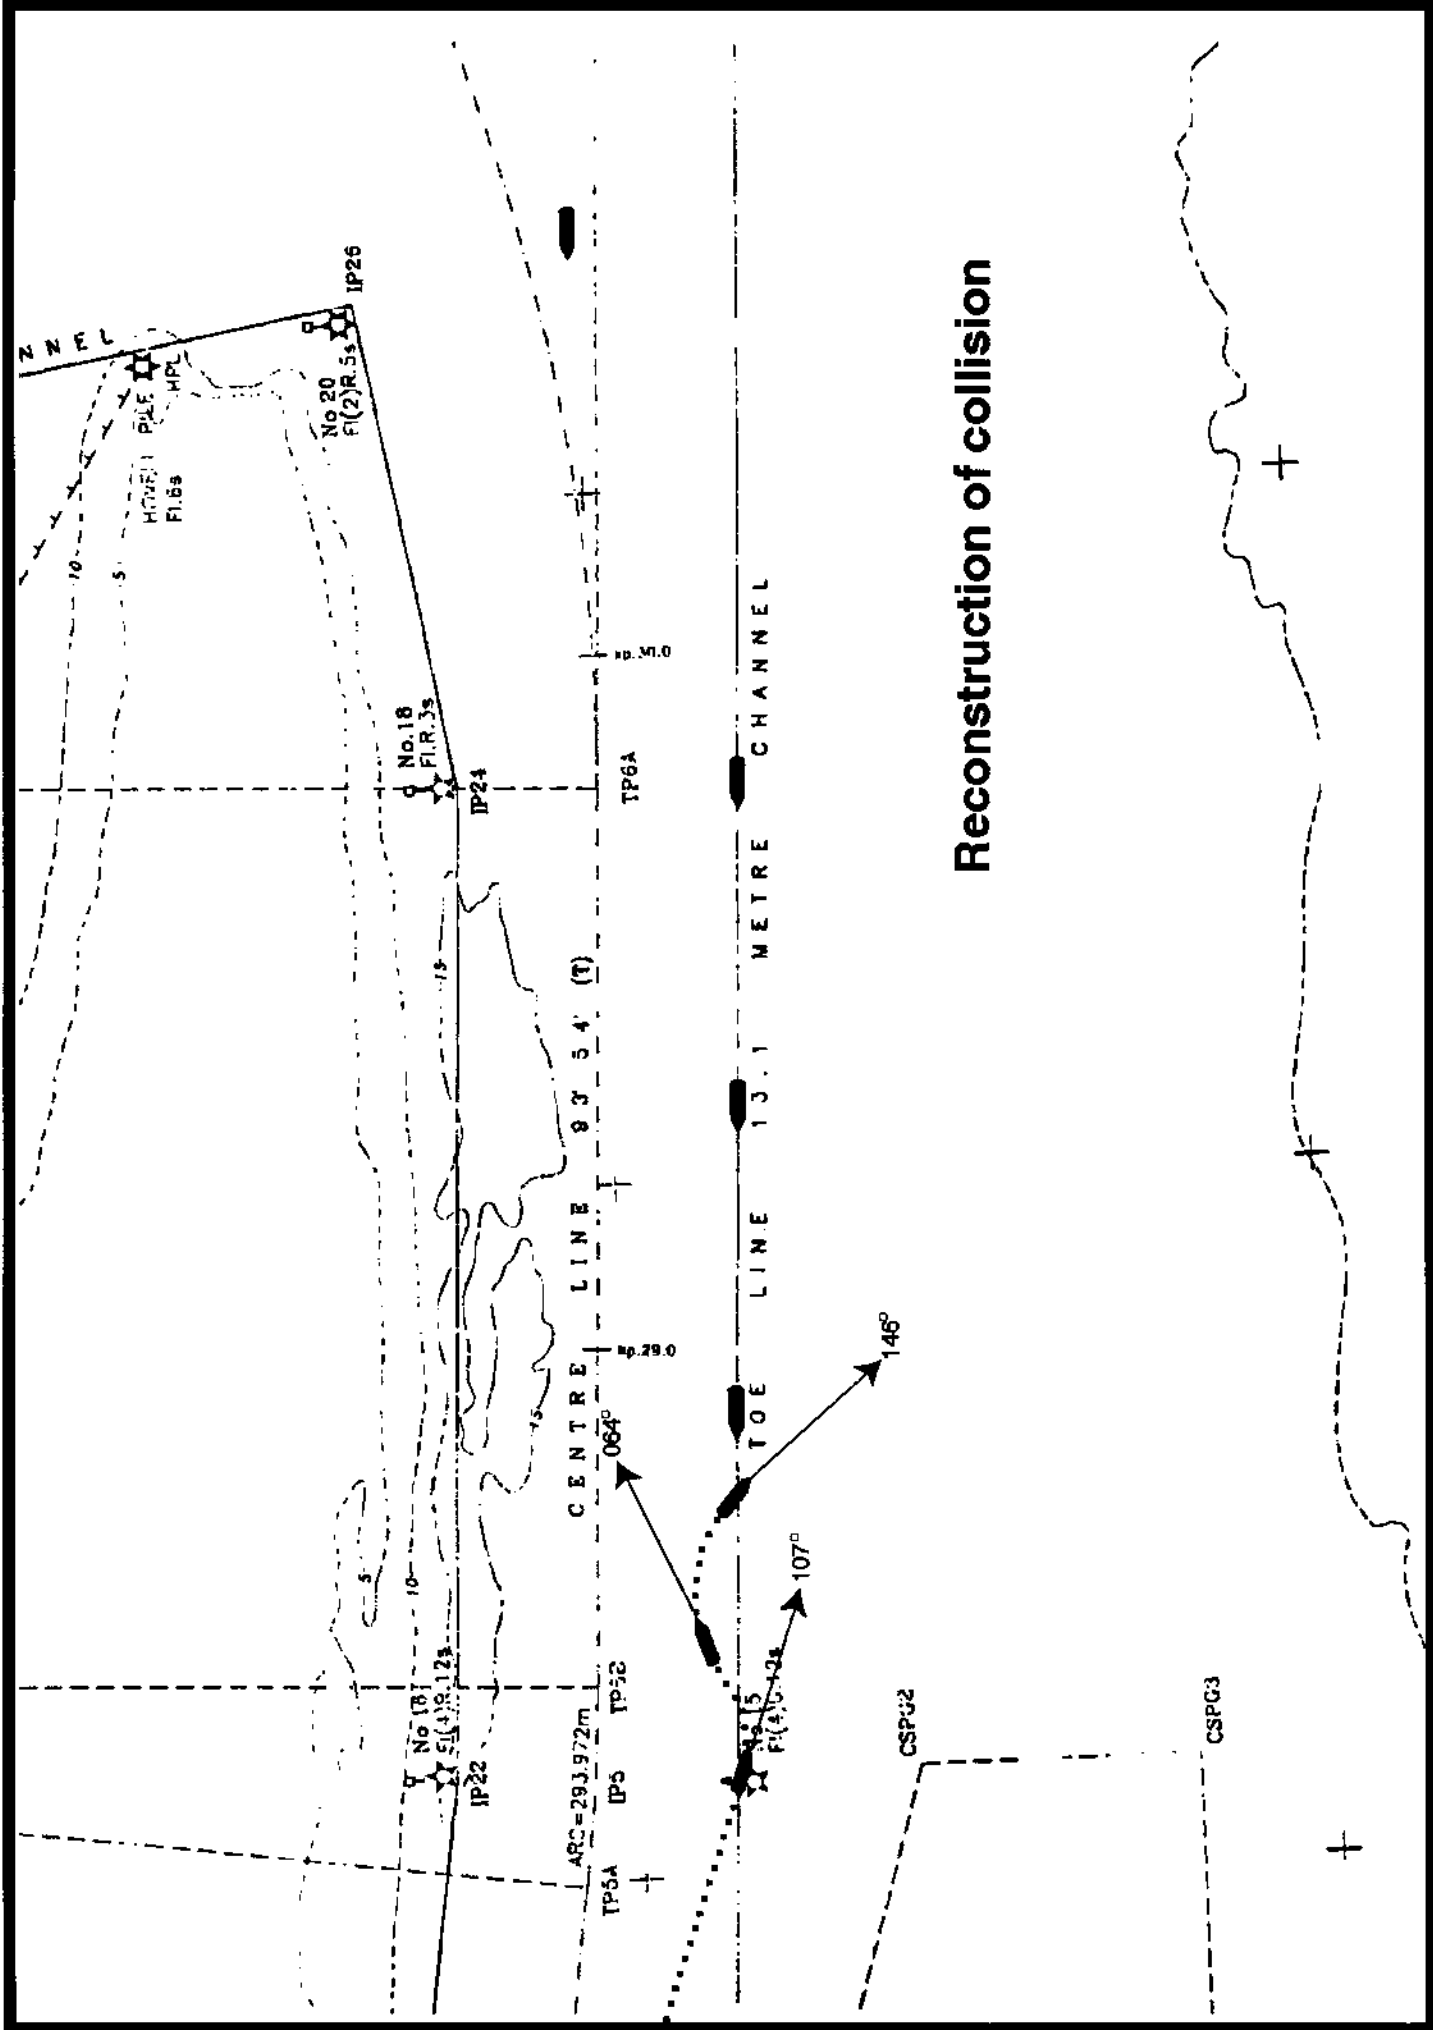
Reconstruction of collision

At 2131, A M Vella was in a position south of No.20 beacon, and assuming that it was on the northern edge of "Area 3", would have been bearing about 102° at a distance of 5.6 miles fine on Searoad Mersey's port bow. A reconstruction on what would have appeared on Searoad Mersey's radar screen indicates that A M Vella would have appeared to be in the middle of the channel, although in fact, because of the bend in the channel, it was south of the centre line (see "reconstruction of collision" diagram page 25).

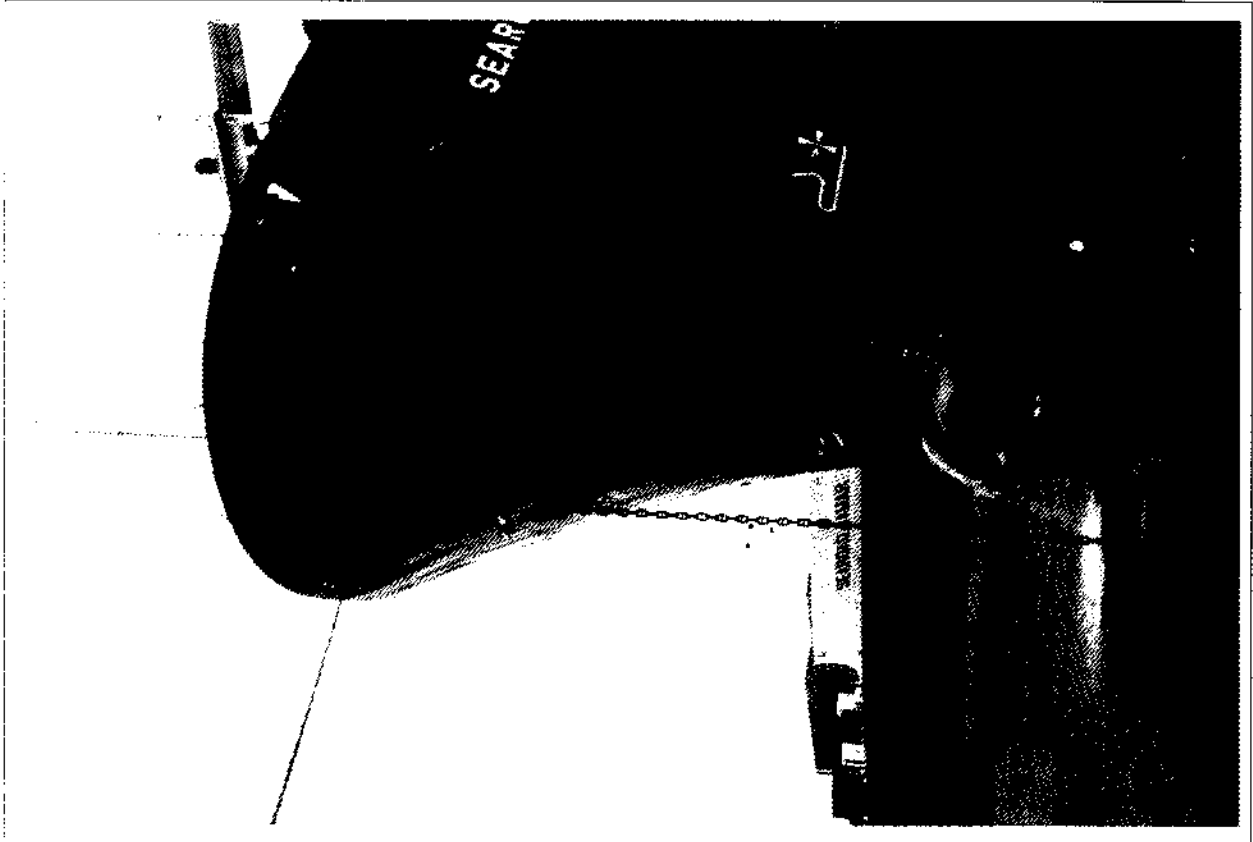
Inspection of the vessel revealed the forward section of the bulbous bow had been compacted back about 1.5m, scoring on the bow, and a horizontal score mark on the starboard quarter.

Inspection of the vessel revealed that, in addition to the damage to the dredging equipment, heavy indentation to the ship's side plating had been sustained, in the vicinity of the trunnion guides, vertical pipeline guide slots down to the shipside suction inlet.

**DAMAGE TO SEAROAD MERSEY BULBOUS BOW
AND BOW PLATING AND DAMAGE TO AM VELLA
SHIP'S SIDE PLATING AND DREDGE GEAR**
