Navigation Act 1912
Navigation (Marine Casualty) Regulations
investigation into the sinking of the off-shore supply vessel

BOA FORCE

on Saladin No.3 wellhead

on 24 February 1994

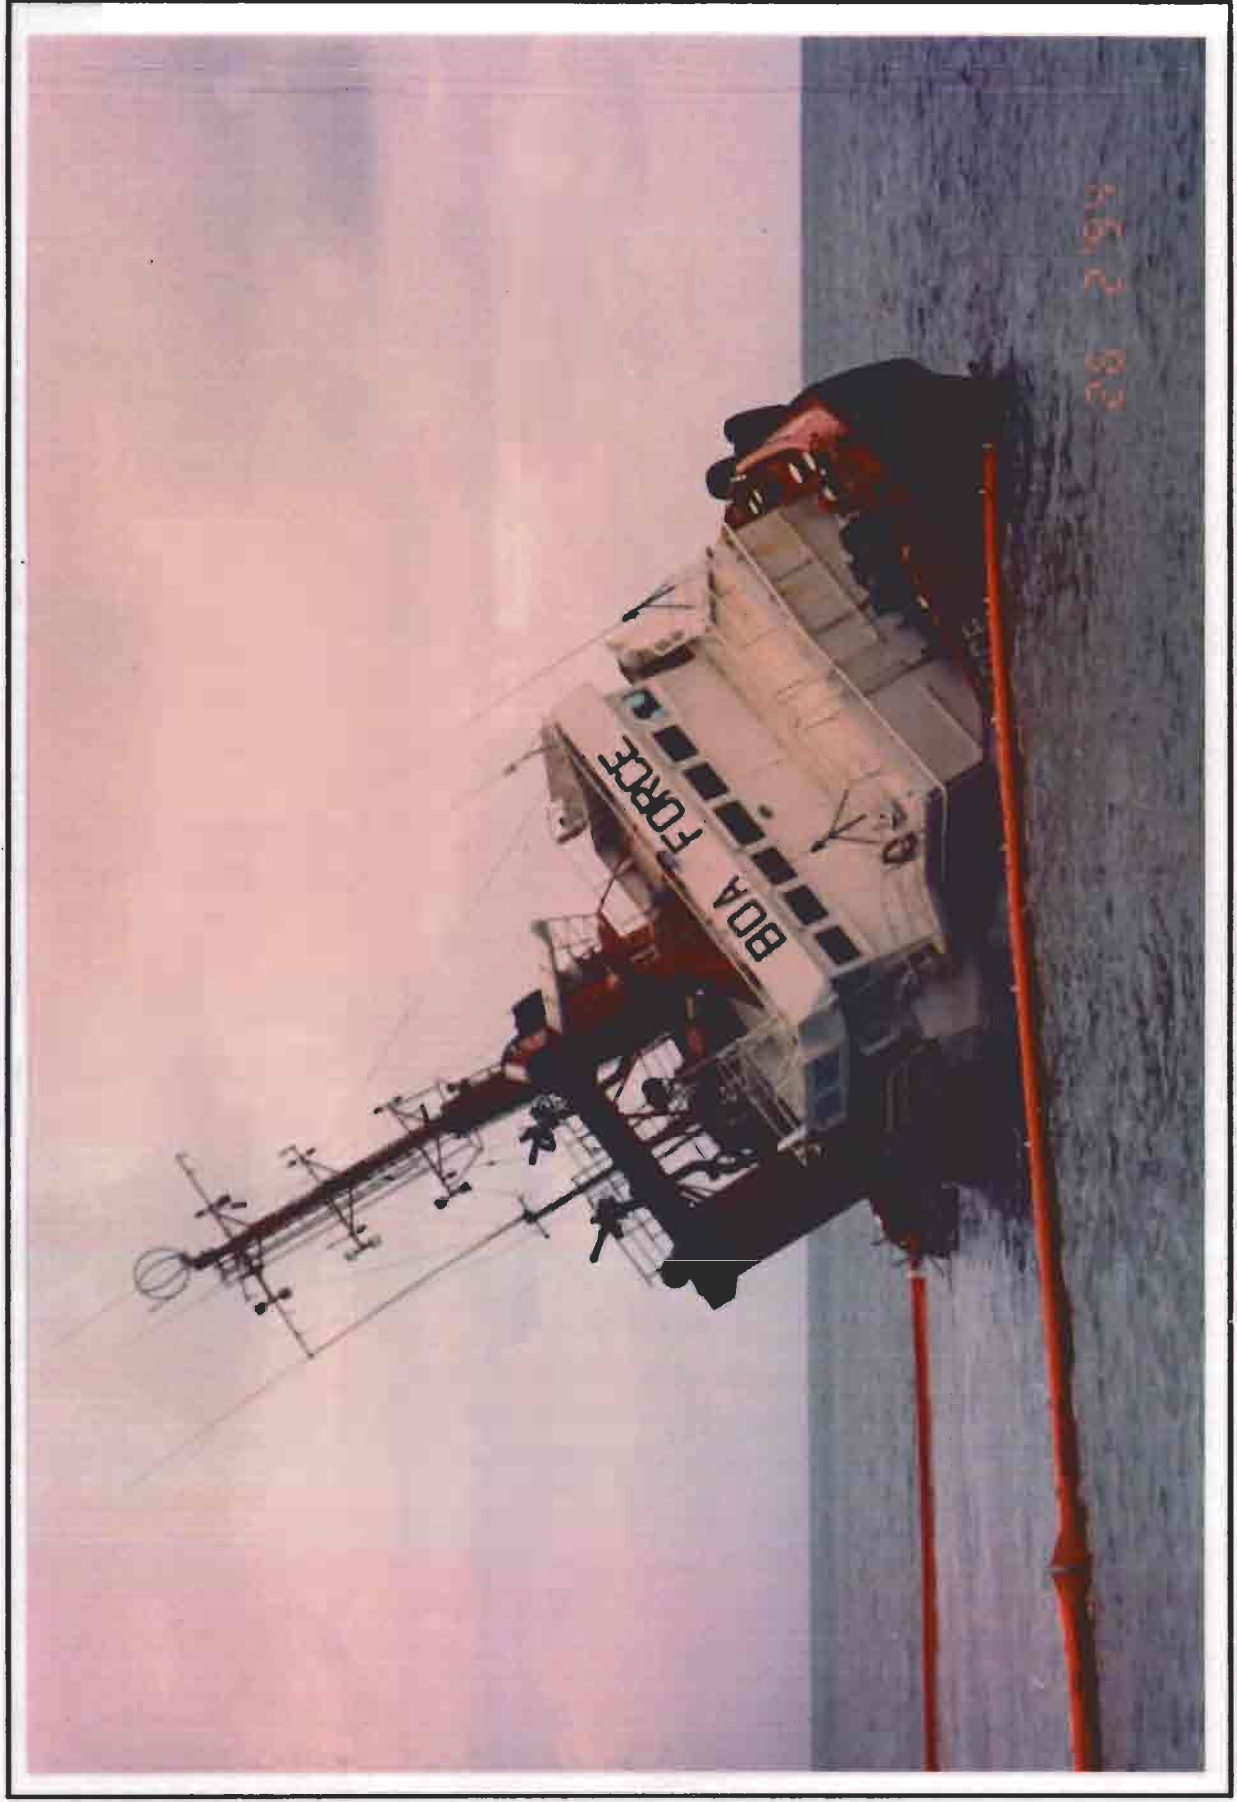
Boa Force after grounding near Thevenard Island

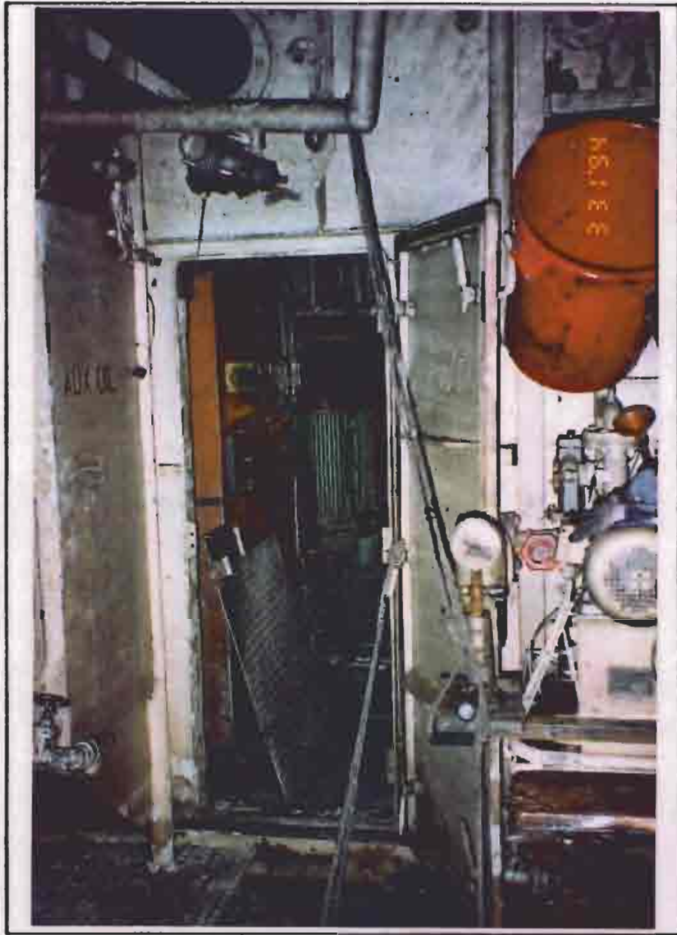
Forward bulkhead door, showing six securing dogs

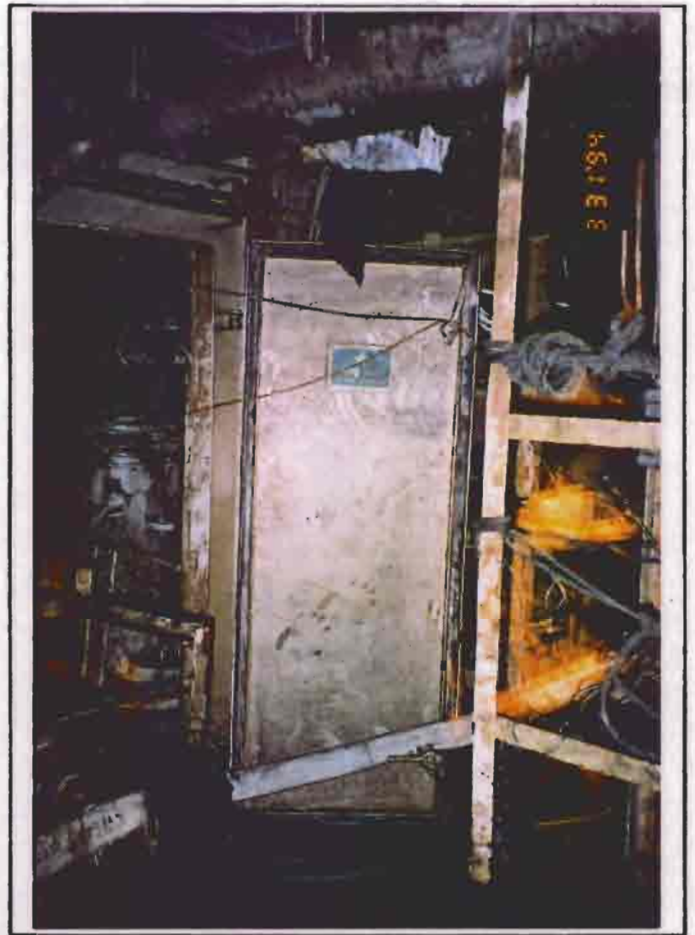
Aft bulkhead door showing two securing dogs

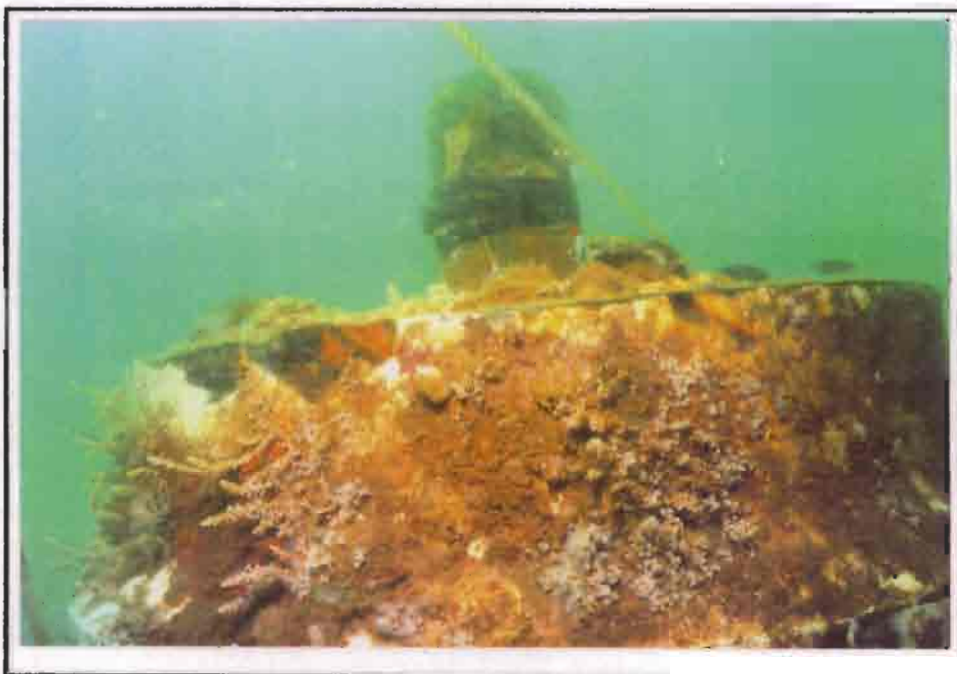
Well-head Cap

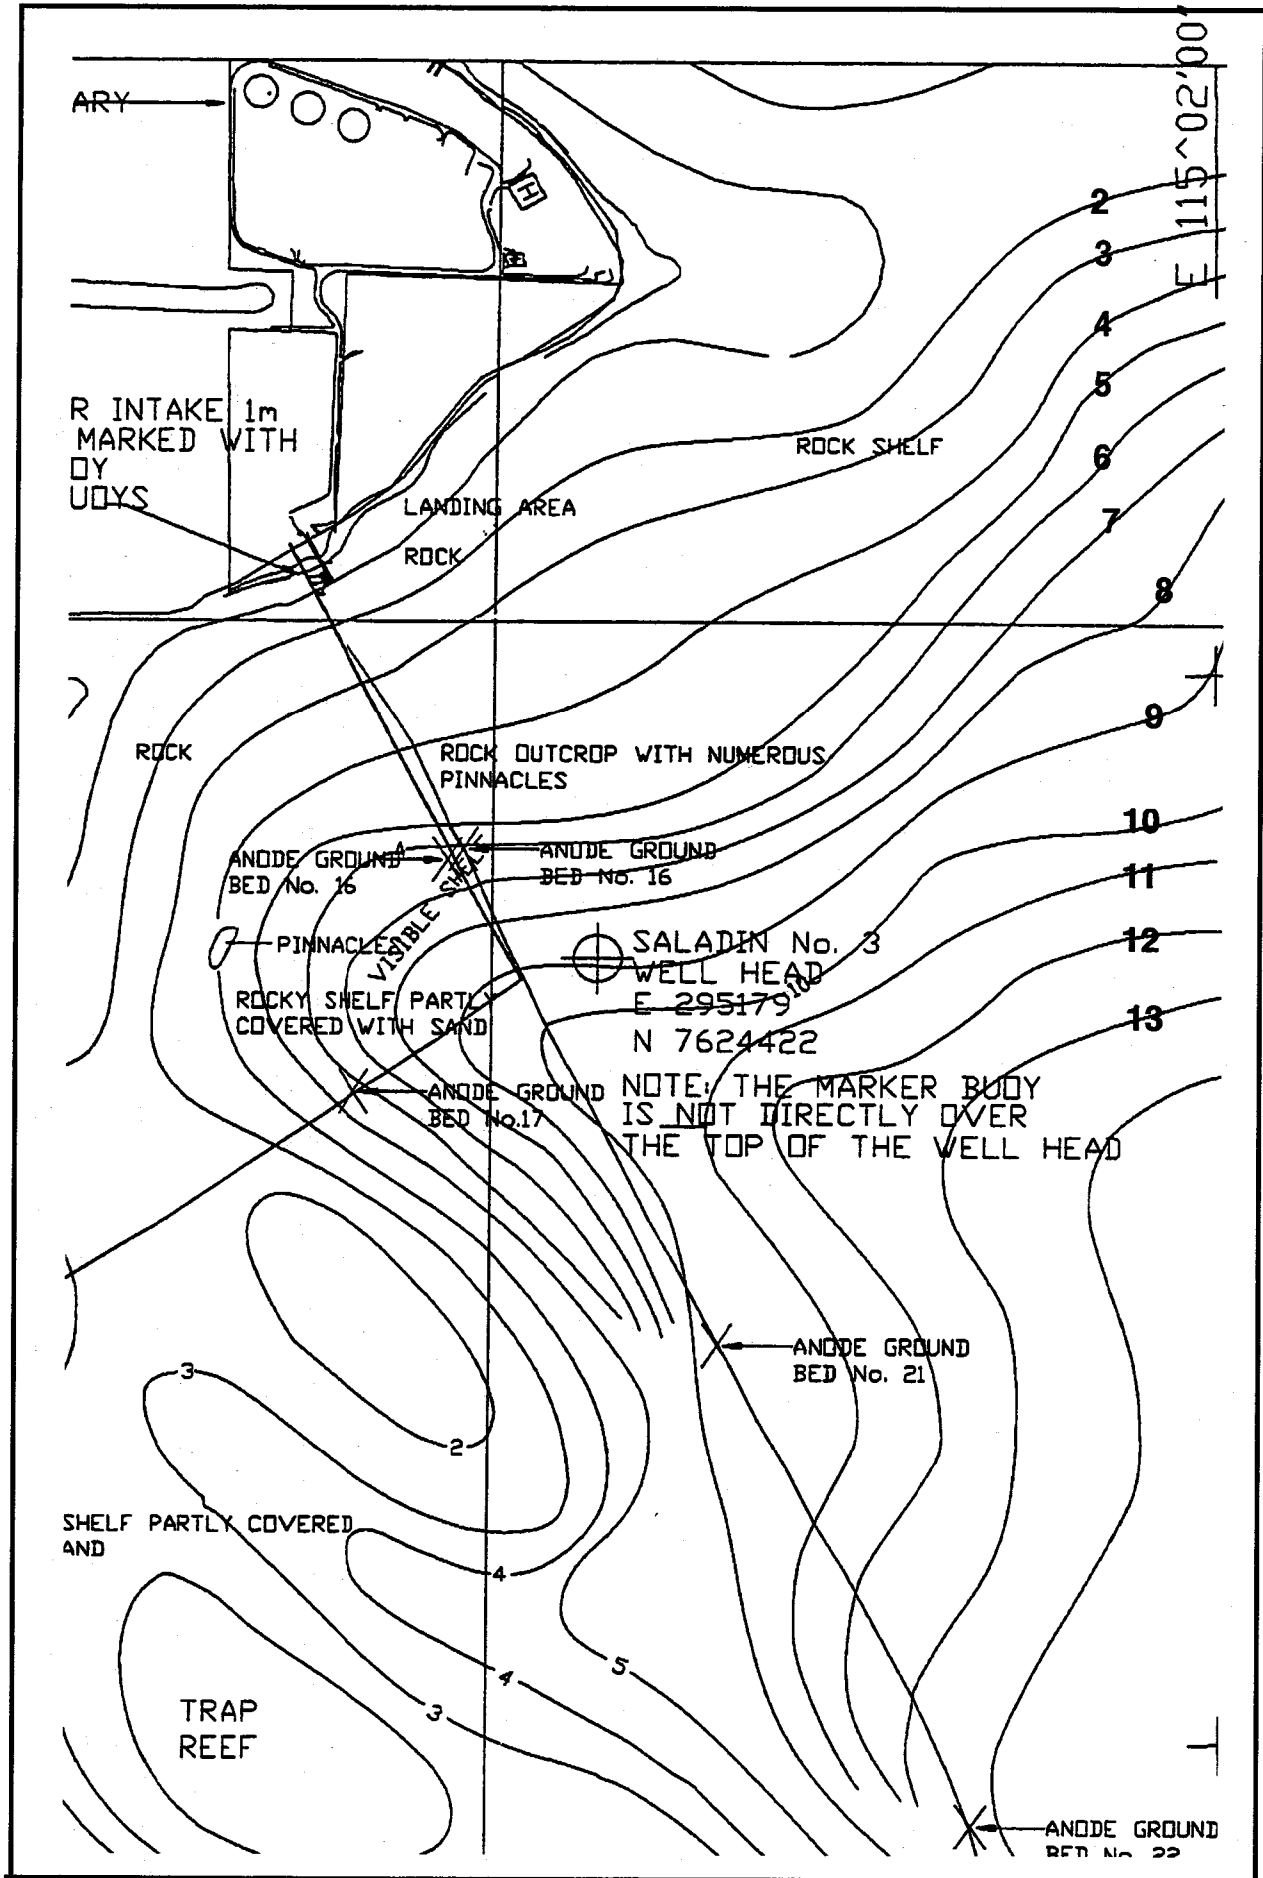
Enlargement of survey drawing 33765.210

The job safety analysis meeting failed to establish that drawing 33765.210 was intended for use close to Trap Reef and it was used, by both SSIII and Boa Force, as the working drawing when close to Thevenard Island, between 20 and 24 February.

The failure to mark the wellhead, together with the acceptance of drawing 33765.210, indicates a haste to complete the operation, consistent with a fixed price contract, resulting in incompatible goals to the detriment of a considered safety analysis. This should be seen in the light of the very high costs involved in the operation and the consequential monetary penalty brought about by delay.

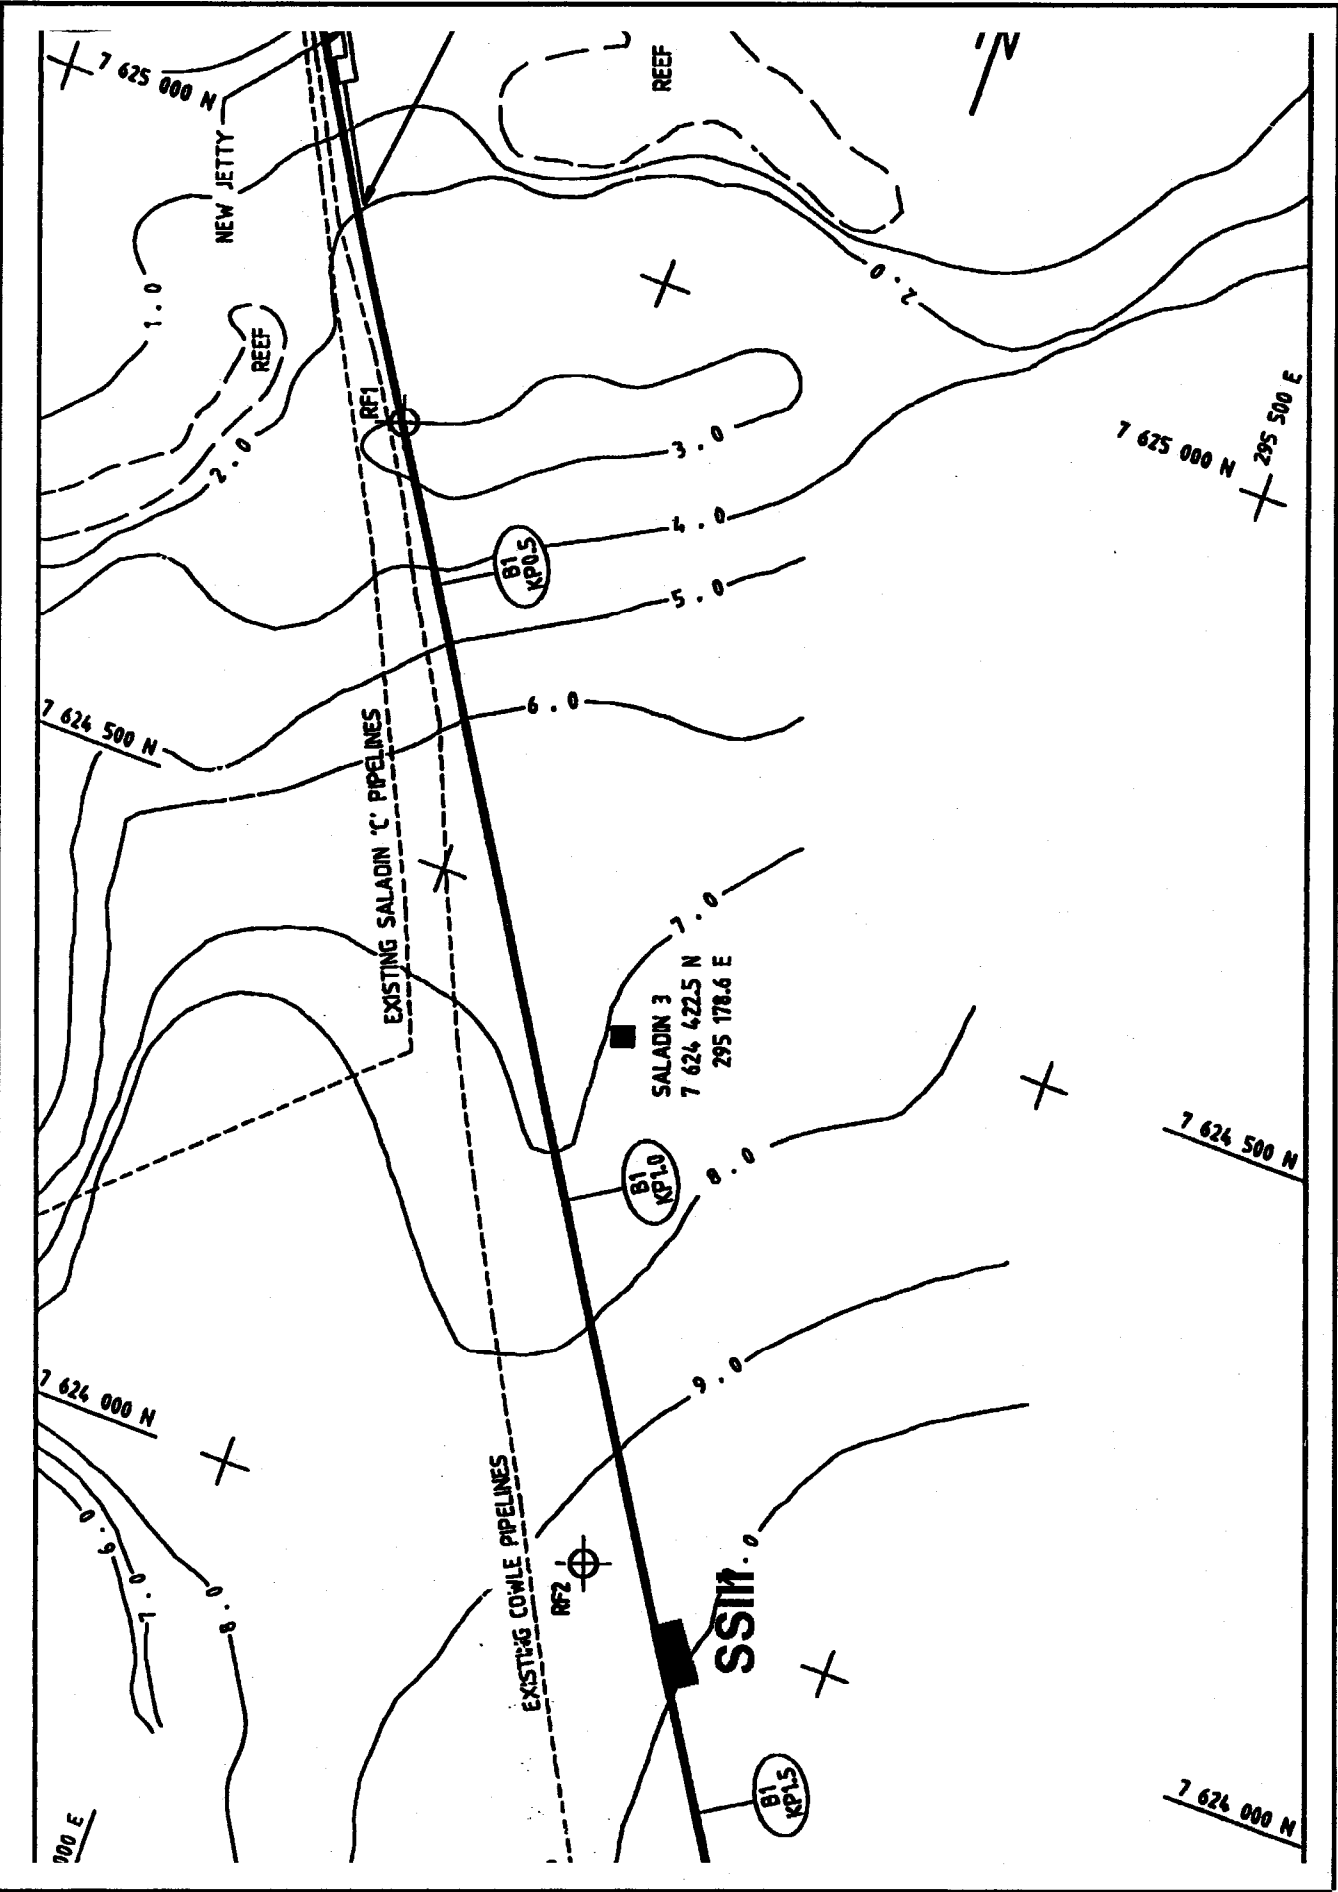
Enlargement of survey drawing B-72201-L

A document produced during the investigation, "Saladin No.3 - Suspension Status" shows the depth of the seabed in the area of the wellhead as 8.3m below mean sea level (MSL). Allowing that LAT is 1.5m below

MSL, a depth to the seabed of 6.8m would be indicated.

Examination by divers on the morning of 24 February, between 0945 and 1100, found that the seabed around the casing was scoured away, however away from the scoured area the general depth of water was 8.56m. Given a height of tide at 1000 of 1.7m, the general depth in the area of the wellhead was about 6.9m.

On balance, given the nature of the relationship between masters of support vessels and those supervising the operation on parent vessels in the off-shore industry, the Inspector considers that it was not unreasonable for the Master to accept the drawing 33765.210 at face value at the time of the job safety analysis meeting of 19 February. However, had he compared the depths he would have found a significant discrepancy in depth of about 1.6m.

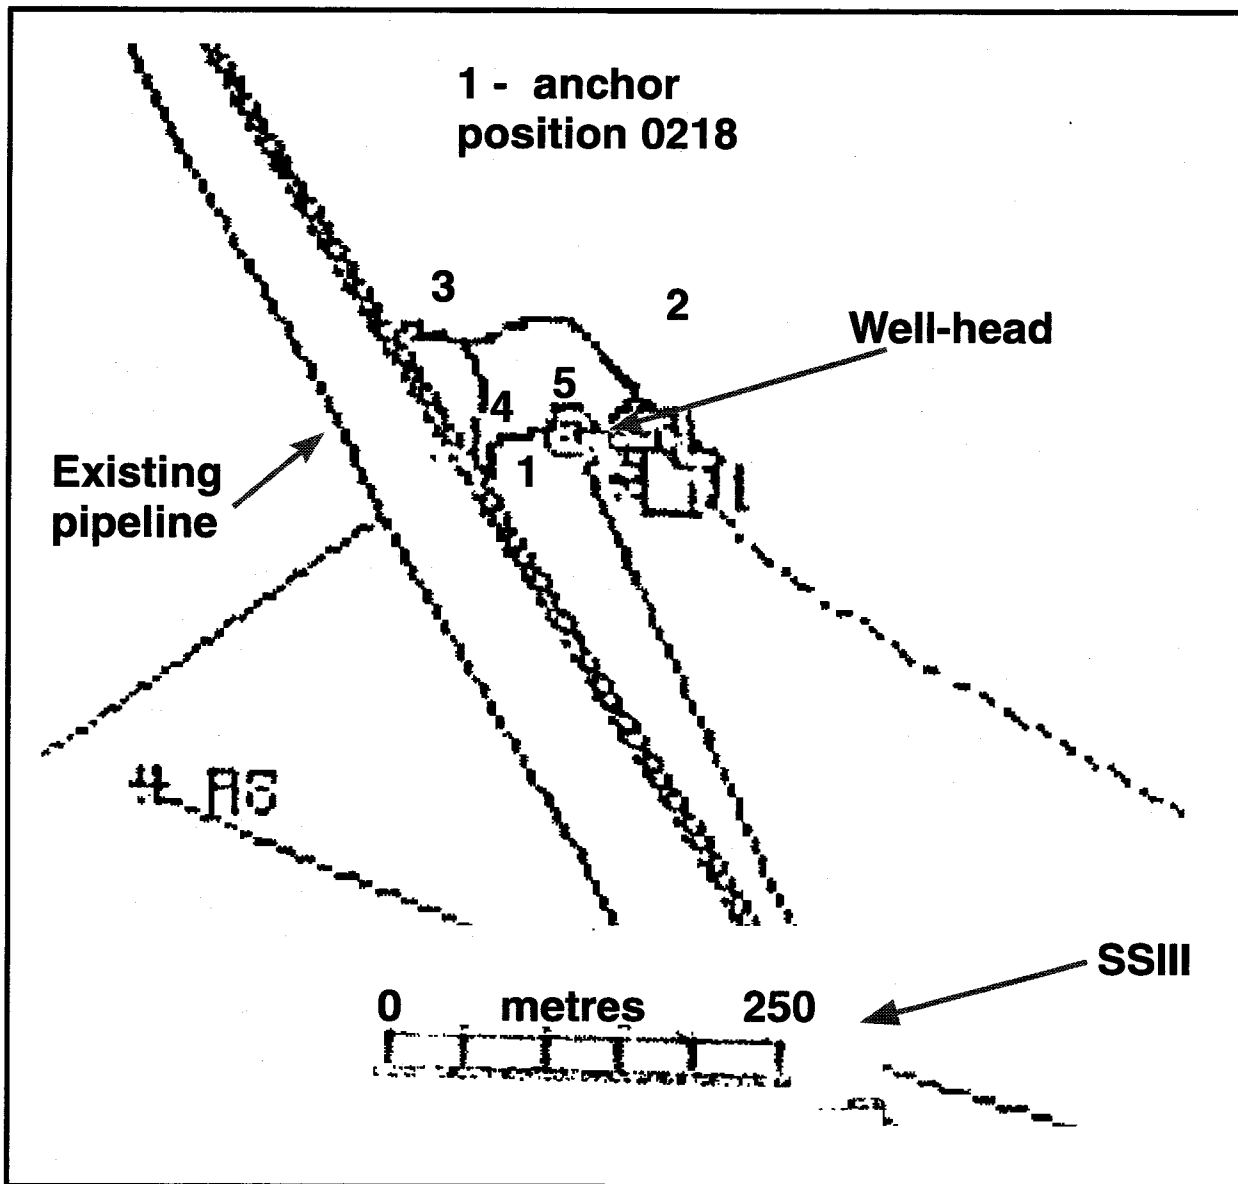
Enlargement of DGPS monitor printout

Enlargement showing movement of Boa Force from 0218 to 0255, from position 1 anti-clockwise to position 2, then north-west and west to position 3, then south to position 4 and grounding position 5.

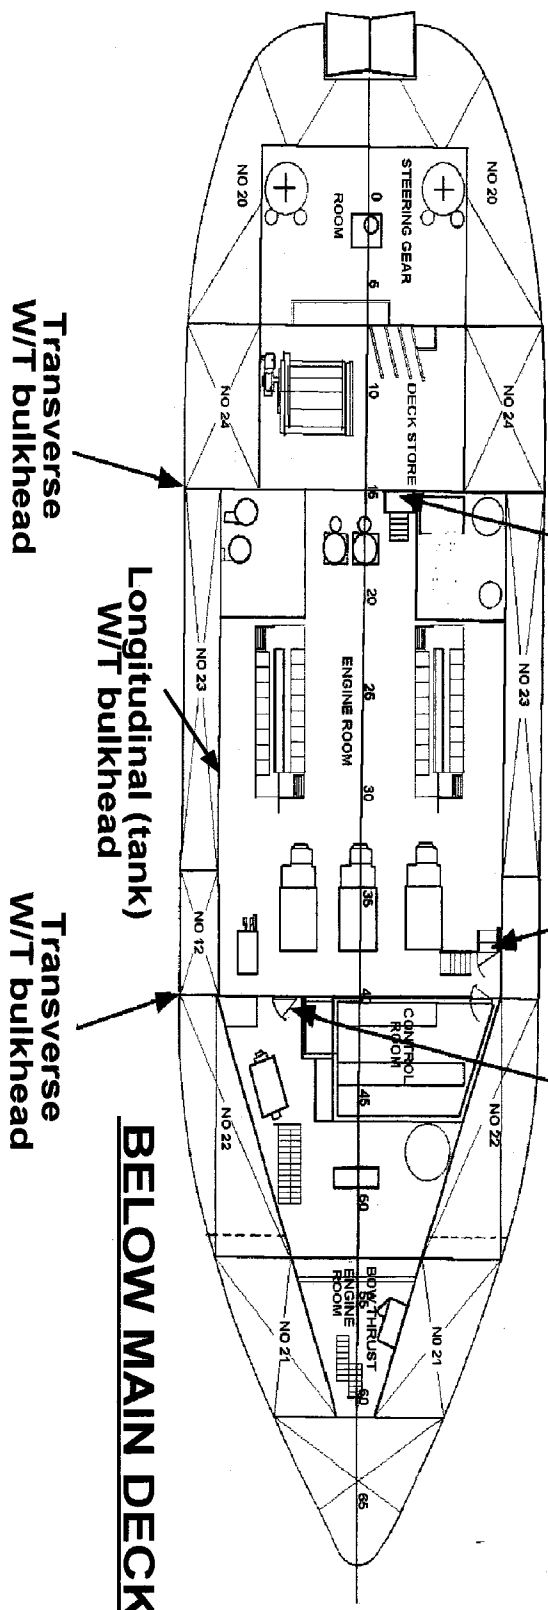
The damage stability book for Boa Force does not consider the possibility of flooding of either the engine room or the spaces forward and aft of it, despite the single skin in way of the engine sumps, either side of the centre tanks.

Hinged door

Transverse
W/T bulkhead

Longitudinal (tank)
W/T bulkhead

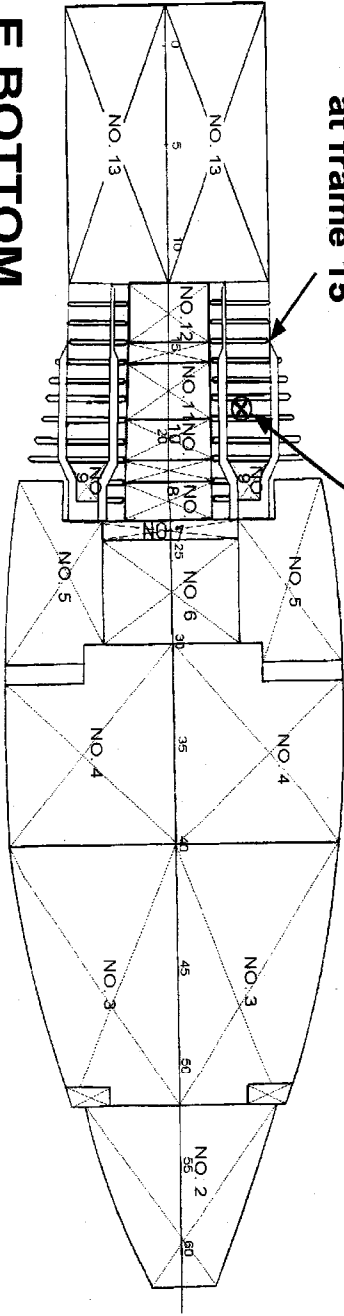
wellhead had punctured the port side of the bottom plating of Boa Force, in way of the engine sump between frame **18** and 19, 10.20m forward of the port rudder stock. They also reported to the Barge Master that the anchor was

Scoring of hull
at frame 15

Wellhead
punctured here

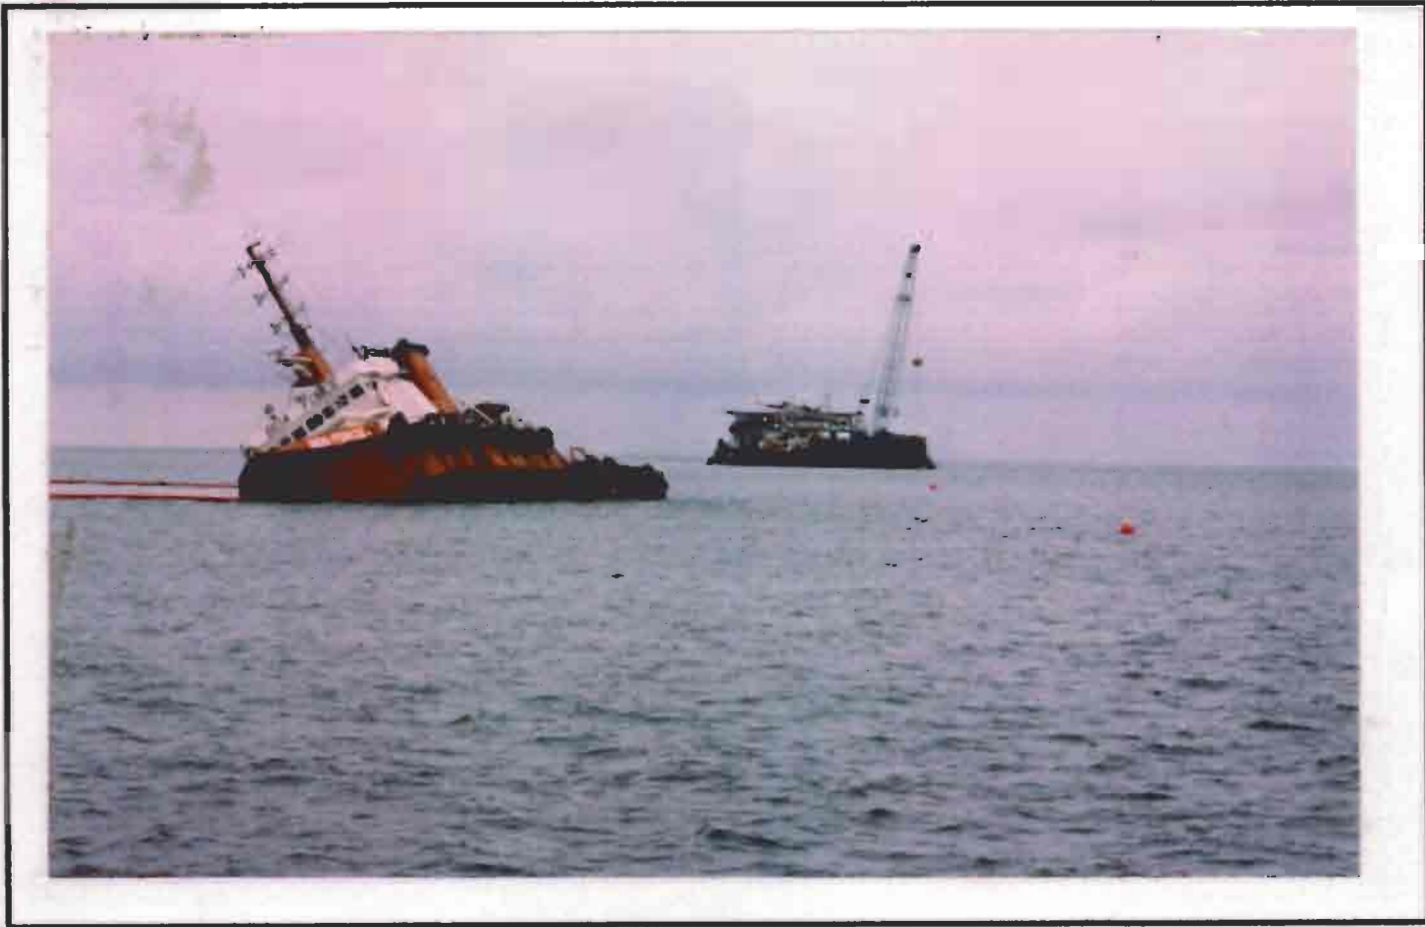
Boa Force - 26 February 1994

Photograph shows Boa Force with SSIII in background. The gap between orange "Norwegian" buoy and Boa Force shows the extent of clear water between Saladin No.3 well-head and the Roller\Skate pipeline.
