Summary

On Saturday, 1 October 1994, the Indian bulk carrier Chennai Nermai, while entering the Tasmanian port of Burnie under pilotage and being turned within the harbour, made heavy contact with McGaw Pier. The concrete pier was penetrated to a depth of about 4m and the ship sustained damage to the stem and bow plating.

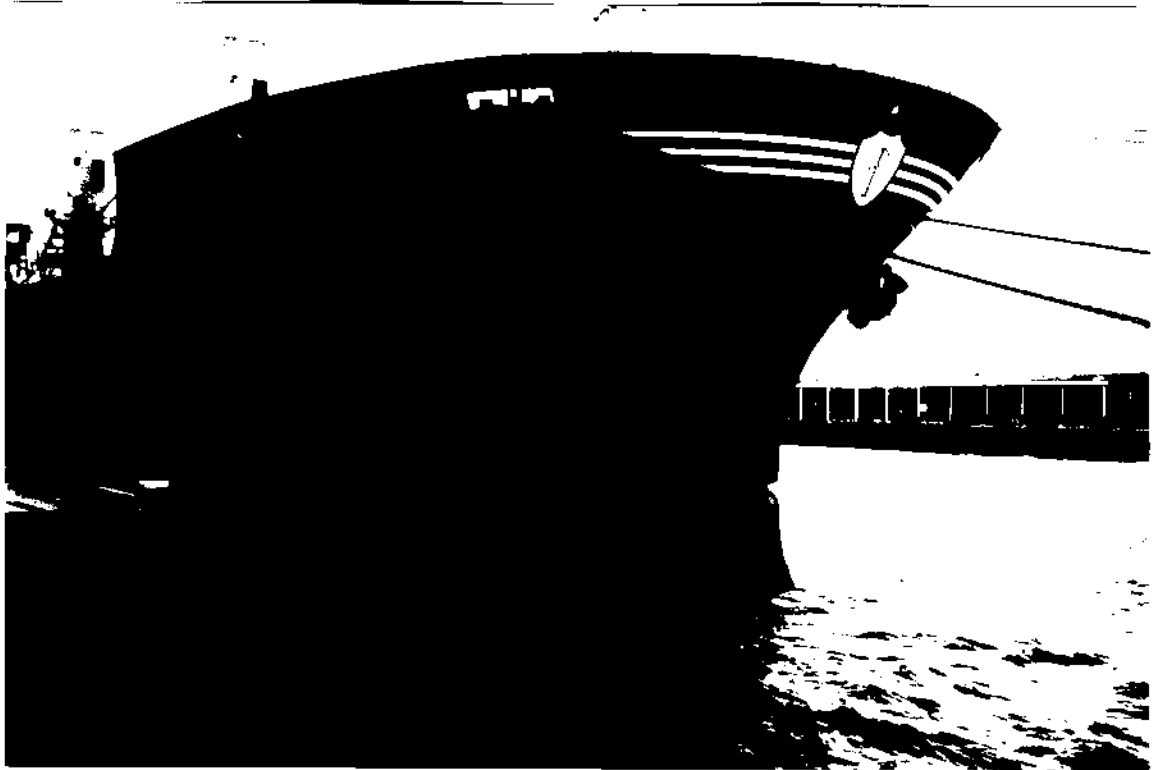
Inspection of the stem and bow plating revealed a 1.3m high horizontal gash 2m above the waterline and extending 4m aft on the starboard side and a 0.75m high gash extending 1.5m aft on the port side. Internal frames and stiffeners in way of the gashes were buckled, torn and fractured.

Damage to Chennai Nermai's stem and plating

The ship was off-hire for more than 12 days while temporary repairs were carried out to the stem and plating, before the ship was able to load its cargo.
