# Summary

The Turkish flag bulk carrier M Nuri Cerrahoglu, sailed from Hay Point on 2 November 1994, loaded with about 52,500 tonnes of coal, bound for Singapore and Turkey by way of the inner route of the Great Barrier Reef and Torres Straits. The vessel had a maximum draft of about 11.0m and required a suitable "tidal window" to navigate the Prince of Wales Channel and Varzin Passage of the Torres Straits.

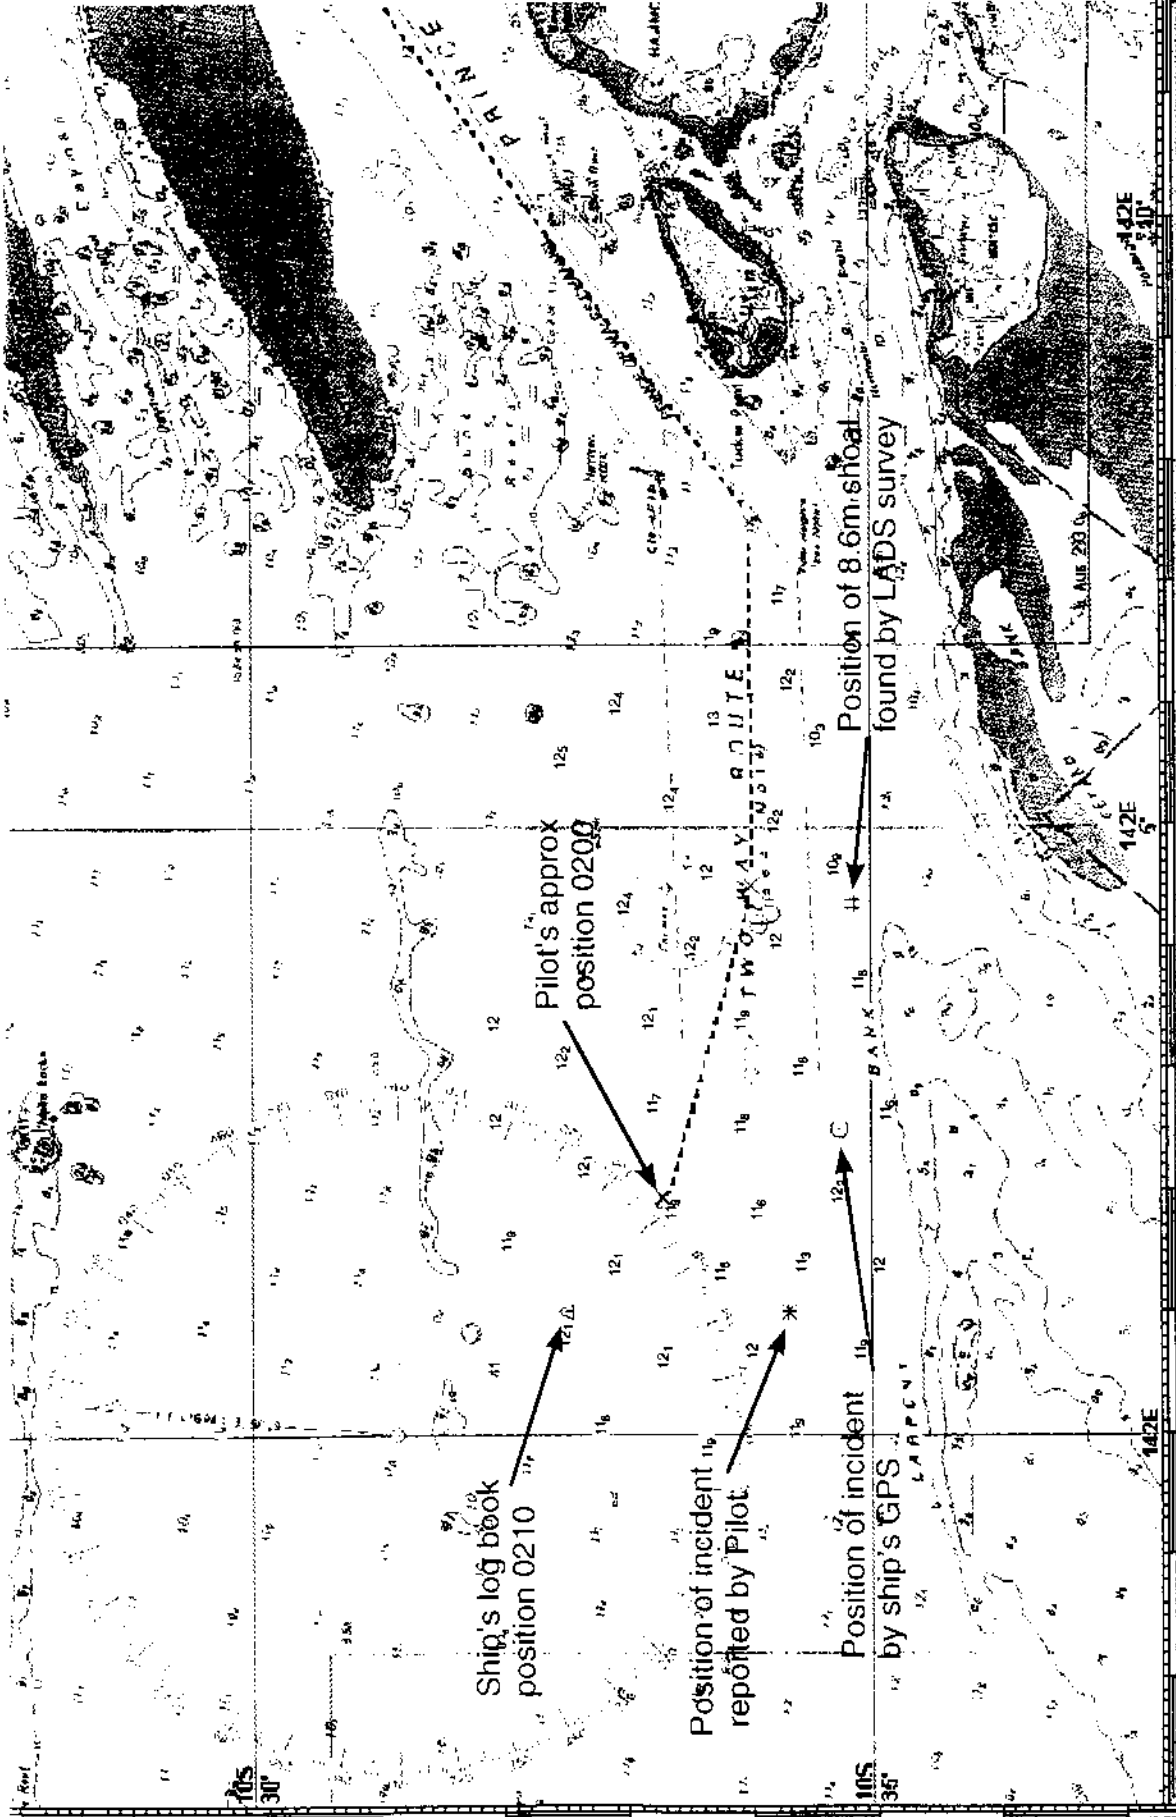
Section covered by chart Aus 296  
(Goods Island to Proudfoot Shoal)

Advice contained in the legend of chart Aus 296, Goods Island to Proudfoot Shoal, states:

*“Positions obtained from Satellite navigation systems are normally referred to WGS Datum; such positions should be moved 0.09 minutes SOUTHWARD and 0.06 minutes WESTWARD to agree with this chart.”*

The reported ship's position by GPS, was 10°34.7'S 142°02.5'E, which adjusted gives a position of 10°34.8'S 142°02.46'E. The position was also checked by radar bearings and distances taken from Goods Island (Tucker Point, 082° at 6.2 miles) and Friday Island (north extreme of Potts Point 098° at 6.3 miles). The radar positions are consistent with the GPS position.

The bow of the ship was about 205m from the radar scanner and the ship's heading was about 117°. When the vessel appeared to stop in the water it was about 450m from the shoal water off Larpent Bank. Had the vessel not stopped, but maintained a steady rate of turn, the closest point of approach to the 10m contour off Larpent Bank would have been approximately 420m. The least depth indicated on or close to the track of the turn to port was 11.6m.

When M Nuri Cerrahoglu appeared to stop at about 0220, the charted depth of water was about 11.6m. The tide at Booby Island was about 1.0m above datum and there should have been at least 1.0m clearance under the keel, given a ship's maximum draught of 11.62m while underway. There was no detectable swell that would decrease the effective depth of water.

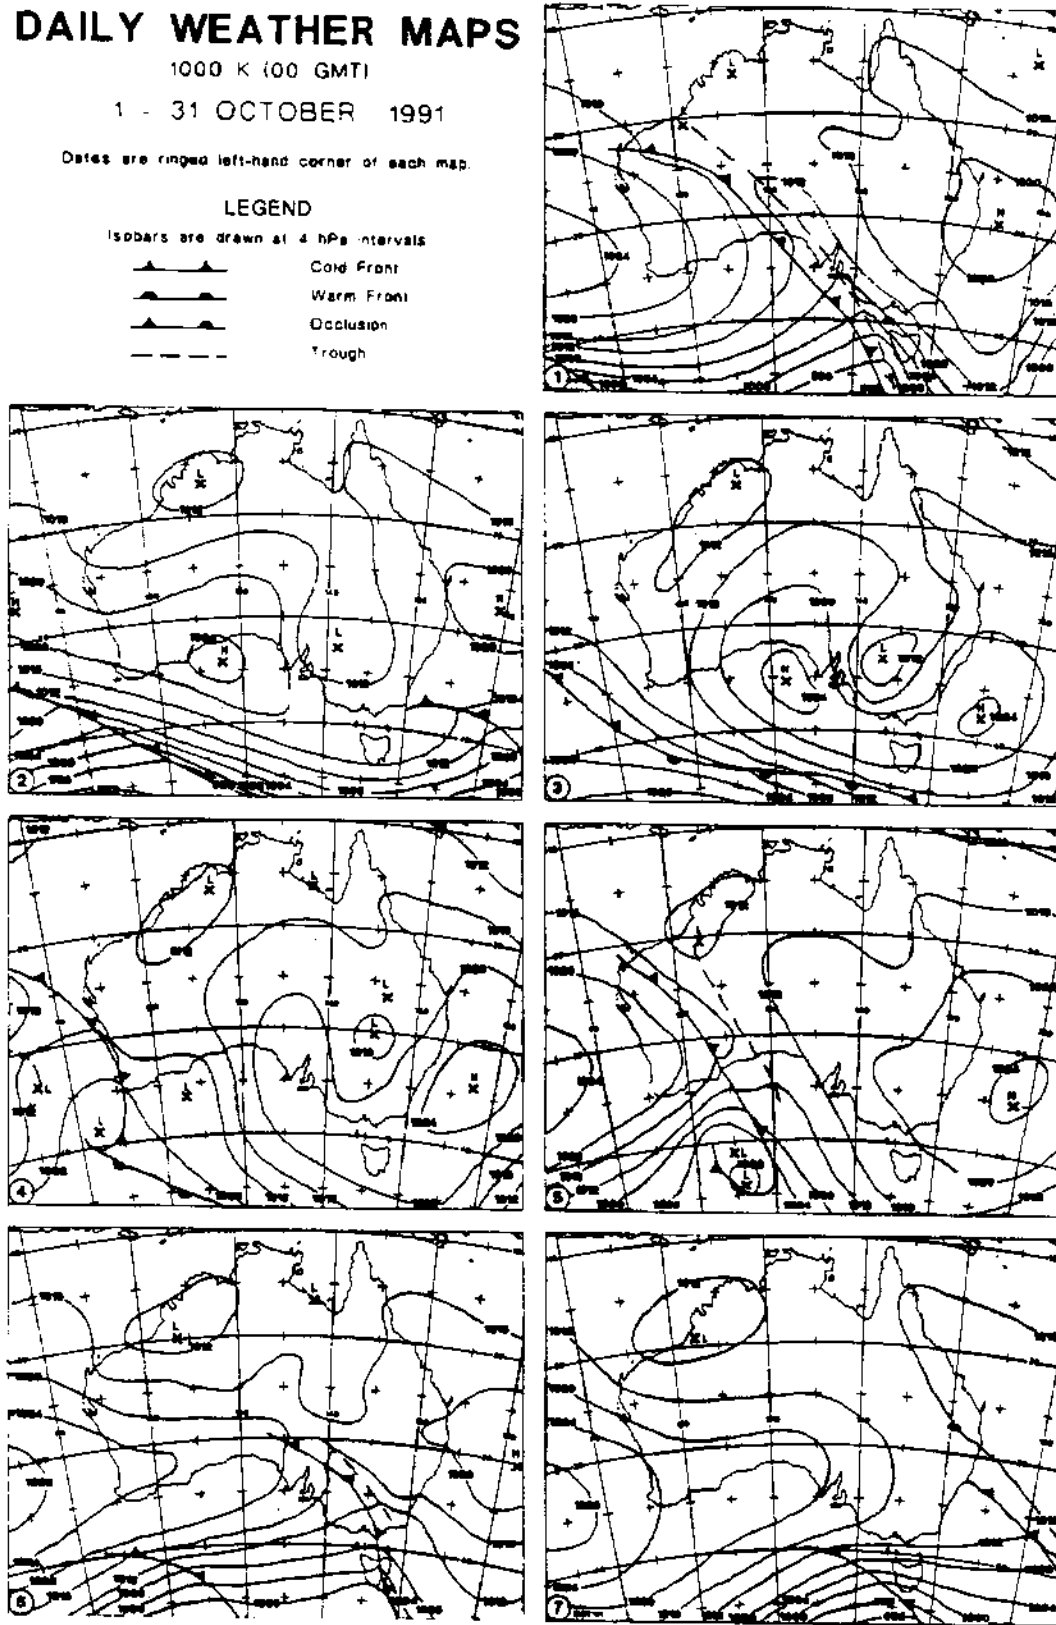
Figure 1 Synoptic Charts for 9 am 1st to 7th October 1991

The Inspector engaged the Bureau of Meteorology to compare the weather pattern of 4/5 November 1994 with 4 October 1991, when a fully loaded bulk carrier became tide bound between Varzin Passage and the Prince of Wales Channel, with insufficient water to either retrace its course through Varzin Passage or continue through the Prince of Wales Channel. On this occasion, also, tidal heights were significantly below those predicted.

*Higher than normal atmospheric pressure would have contributed to a depressed sea level during early October 1991 and early November 1994. The effect of wind stress as a contributing factor in these incidents are unknown, however, [as indicated above] wind stress may have also contributed to the depressed sea level during these periods.*
