Far Sword

Summary

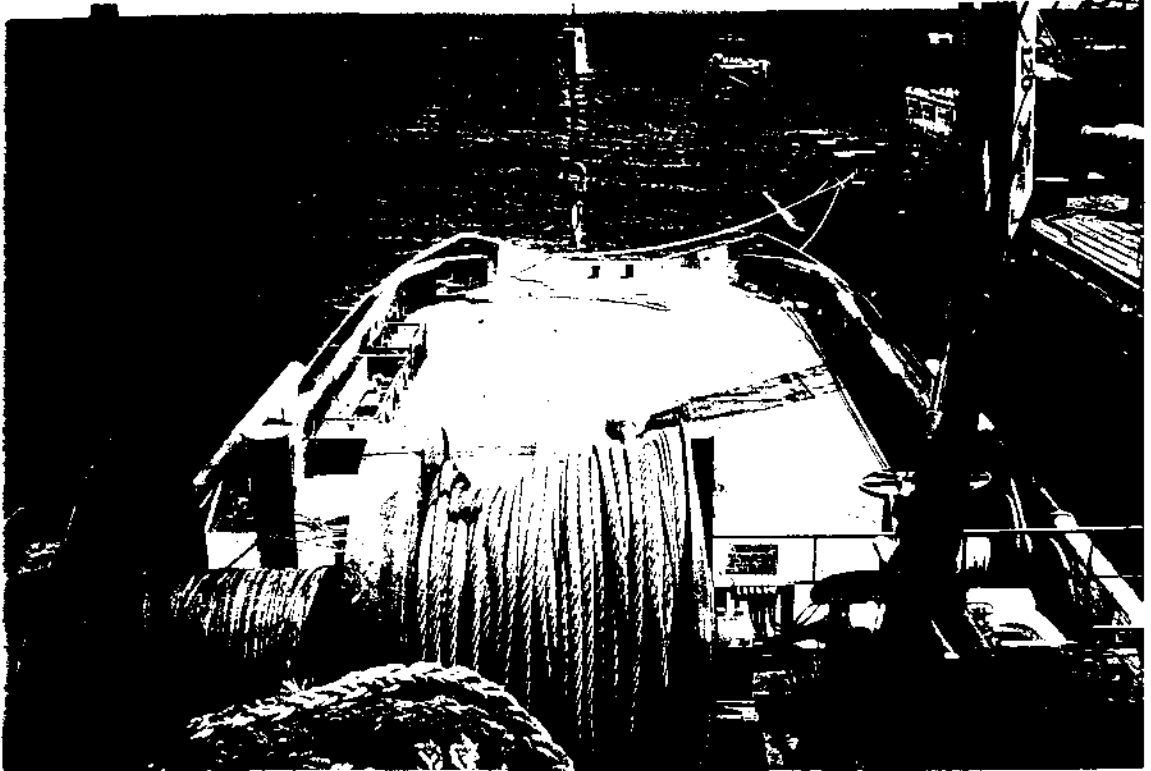
Aft deck viewed from bridge

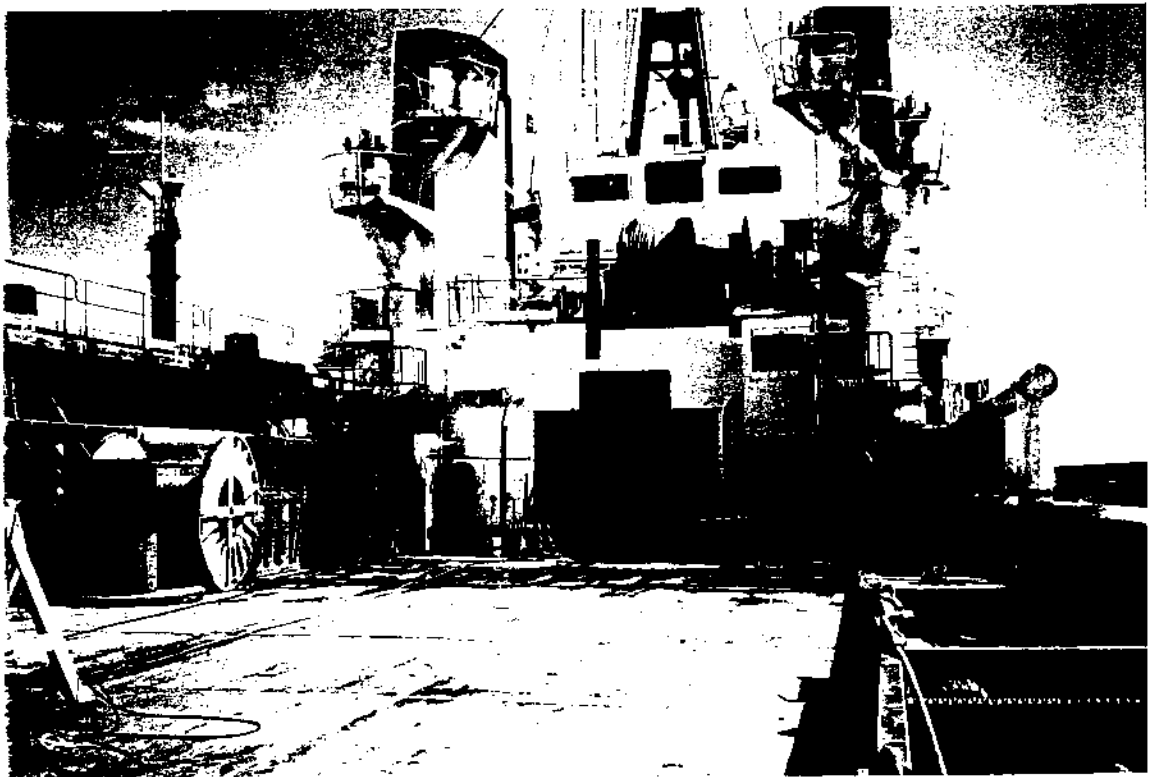
The solid plate design of the Far Sword safety barriers, together with their height, means that crew members working on the aft deck are very restricted in their ability to move to safety when a wave breaks over the stern. With virtually nowhere to go, the natural instinct to climb up on to the safety barrier rail is replaced by one to grab hold of the closest object and to hang on. This is neither an effective, nor a desirable situation.

Aft deck viewed from stern

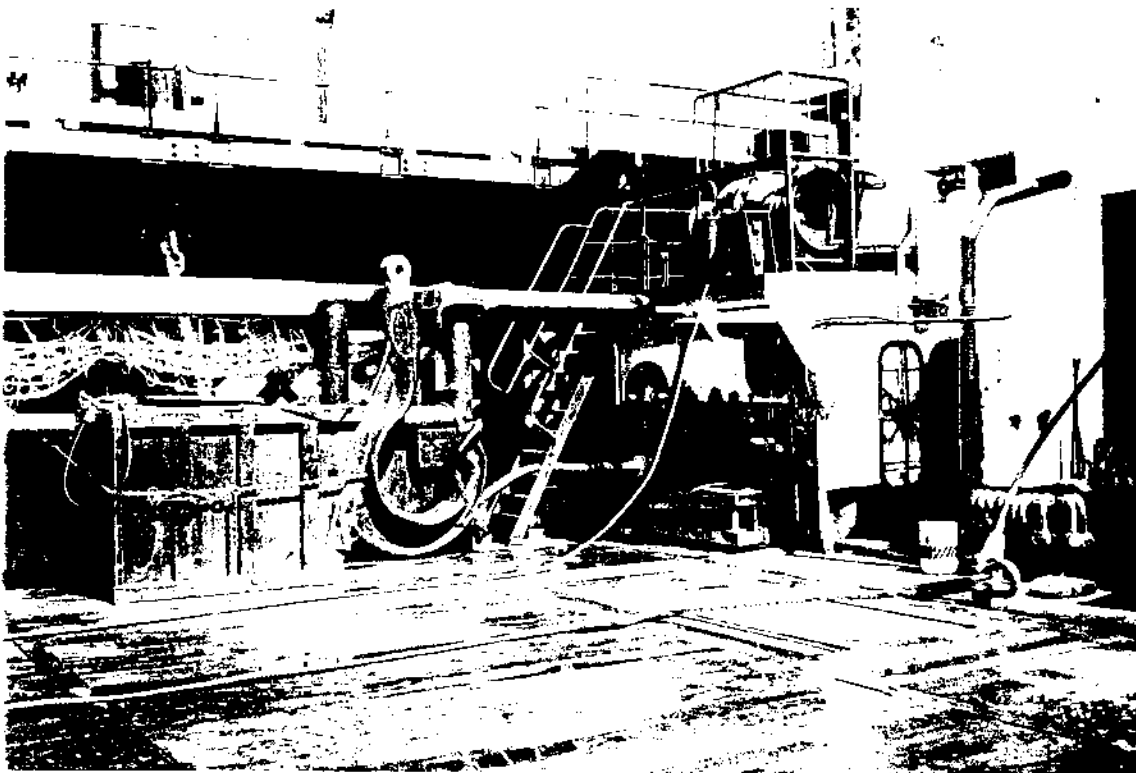
After completing his watch, the younger AB found that he had bruising on his right elbow and knee. In fetching up against the 'J' hook, the additional Master had received a 100 mm gash along his right shin, severe bruising to his right thigh and lower right leg, and bruising to his left thigh.

Aft deck port side showing location of stowed 'J' hook

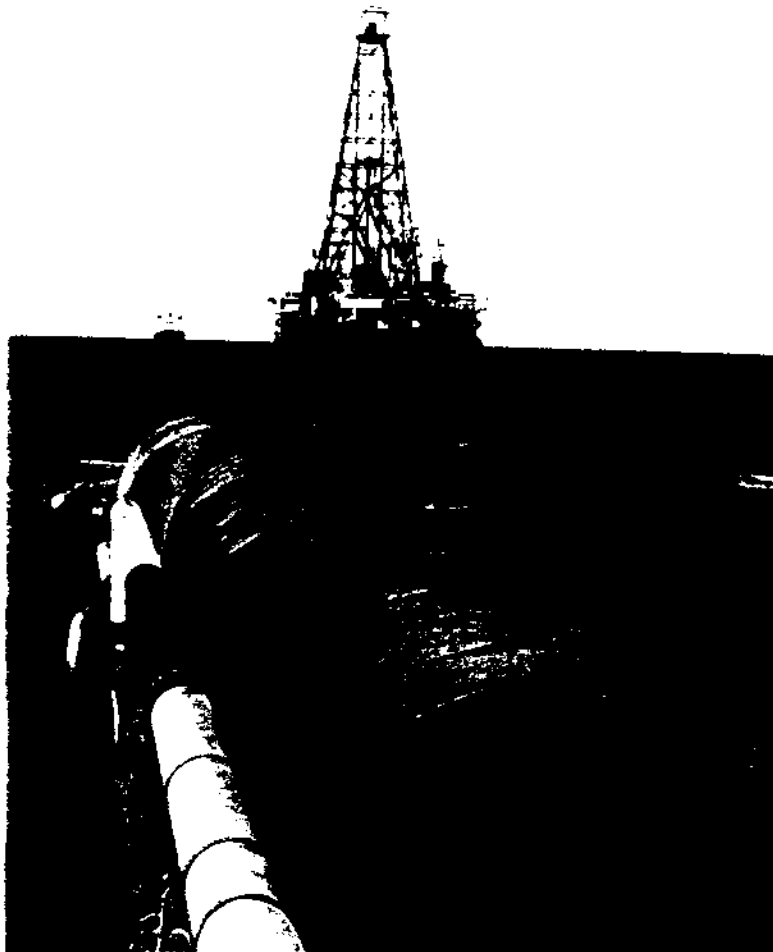
Anchor buoys stowed on deck during relocation move of Glomar Robert F Bauer
