# Summary

On 22 February 1995, tropical cyclone 'Bobby' was moving in a west-south-westerly direction off the north-west coast of Australia, gradually increasing in intensity.

The Maltese flag, 61,297 deadweight tonnes bulk carrier Bulkazores, one of six vessels at anchor, was the first vessel to clear the anchorage. The Master took the vessel two miles beyond port limits and then hove-to, to ride out the developing storm.

At 0722 on 24 February, the Master of Bulkazores advised Dampier Port Control that Bulkazores was being set towards the shore and, at 1026, the

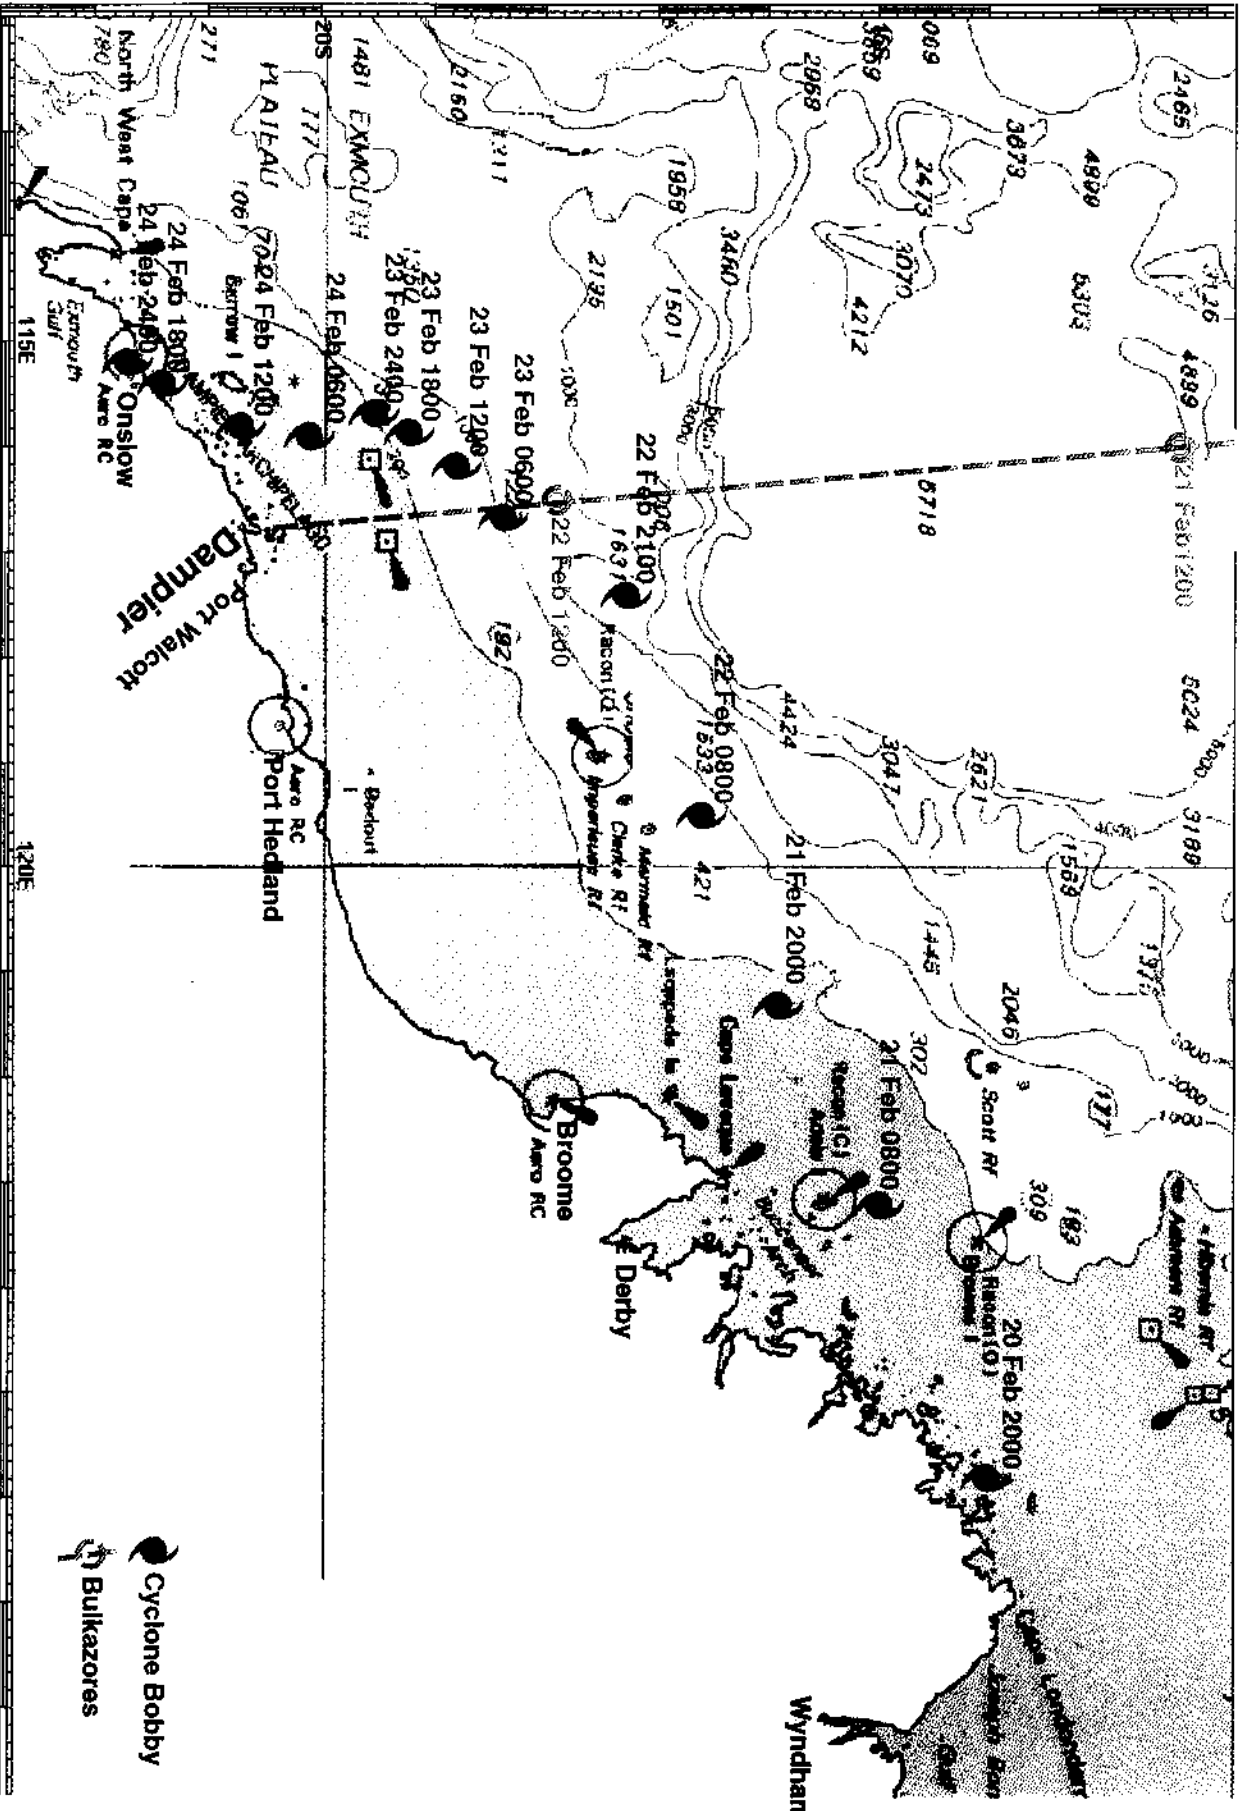
Tracks of Bulkazores and cyclone Bobby

At 0940, Bulkazores lost steerage, failing to respond to hard to port rudder, and the bow fell to starboard, off the wind. The vessel again started to be driven south, towards shoal water and Kendrew Island, a small island to the west of Rosemary Island. Bulkazores touched the bottom at 1025 and was hard aground on a heading of 045° at 1030, in a position half a mile south-west of Kendrew Island.

It is apparent that Bulkazores' difficulties started shortly after 0200 on 24 February. Up until that time, the vessel had been set roughly eastwards and westwards, but from about 0200 on 24 February the vessel started to be set south-westwards. Realising the problem, the Master increased engine speed to full ahead at 0440 and to full sea speed at 0500, but despite this, Bulkazores started to be set almost due south. At this time, Bobby was located just 57 miles west-north-west of Bulkazores and was moving south-south-easterly.

However, at about 0900, Bulkazores again started to be set to the south. Bobby had paused in its track, but was now moving south, just over 40 miles to the west of Bulkazores. The hurricane force winds, now blowing from the north-north-east, drove Bulkazores onto the shoals to the west of Rosemary Island, just half a mile from Kendrew Island.

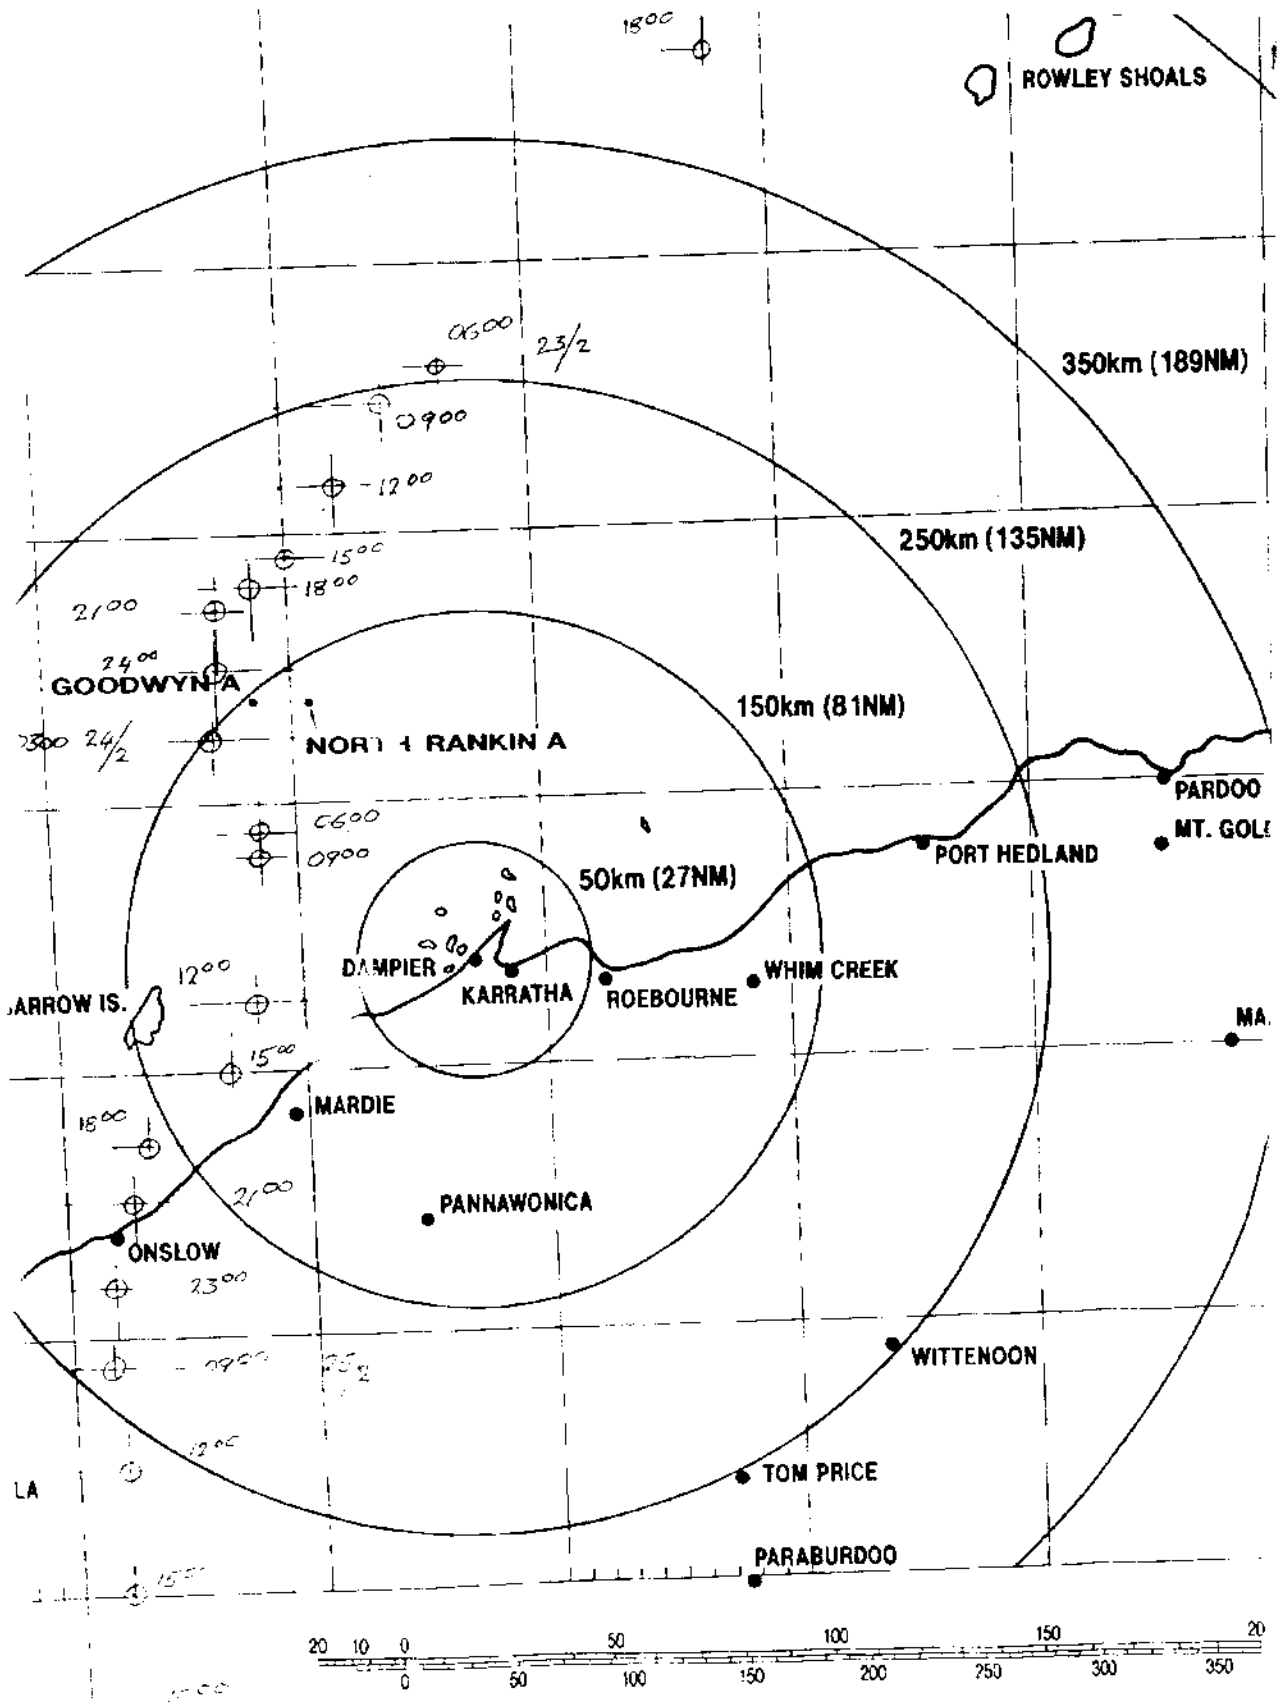
Section of Dampier Port Control plot of cyclone Bobby

At about 0300 on 24 February, 'Bobby's' direction changed to the south-south-east, but at about 0600, when it was just 60 miles north-west of Dampier, its movement changed back to the south. Bobby maintained a southerly direction until about 1200, by which time it had moved to a position 54 miles to the west, and slightly south of Dampier. It then moved south-westerly, parallel to the coast, for about six hours before again changing direction to the south, and crossed the coast just to the east of Onslow, at its greatest intensity (930 hpa), at about 2200 on 24 February. Thereafter it continued to move south, and later south-east, diminishing in intensity.
