# Summary

The 182 m long, Australian flag bulk carrier River Torrens arrived off the Port of Newcastle, New South Wales, at 2100 on 31 May 1995, loaded with about 27,000 tonnes of wheat from South Australian ports. At 2107, a licensed pilot for the port boarded the ship to take the vessel to no. 3 berth, the Western Basin Grain Terminal. The night was fine, partly cloudy, with a light north-easterly wind and a swell of about 1.6 m at the harbour entrance.

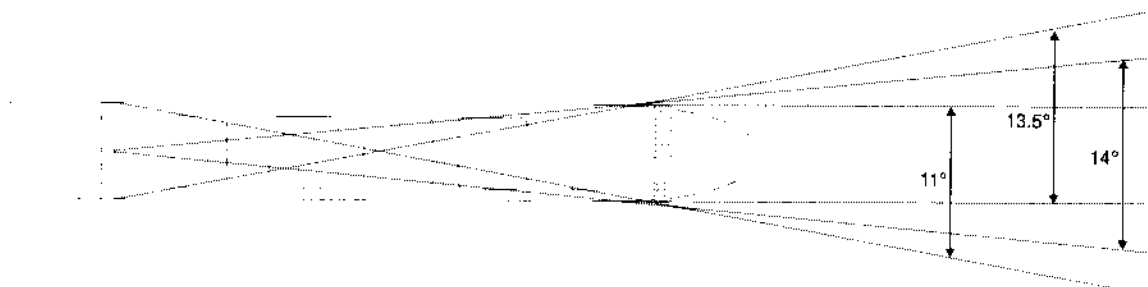
The self-discharging tower limits visibility from the centre line (the steering position) and all other parts of the bridge. Conning the ship into Newcastle is therefore normally conducted from the port side of the wheelhouse, or the port bridge wing. From either, visibility is effectively obstructed from dead ahead to about  $11^\circ$  on the starboard bow, effectively cutting out any point of reference in that arc and affecting the perspective of those on the bridge.

**Diagram showing arcs of obscured vision**

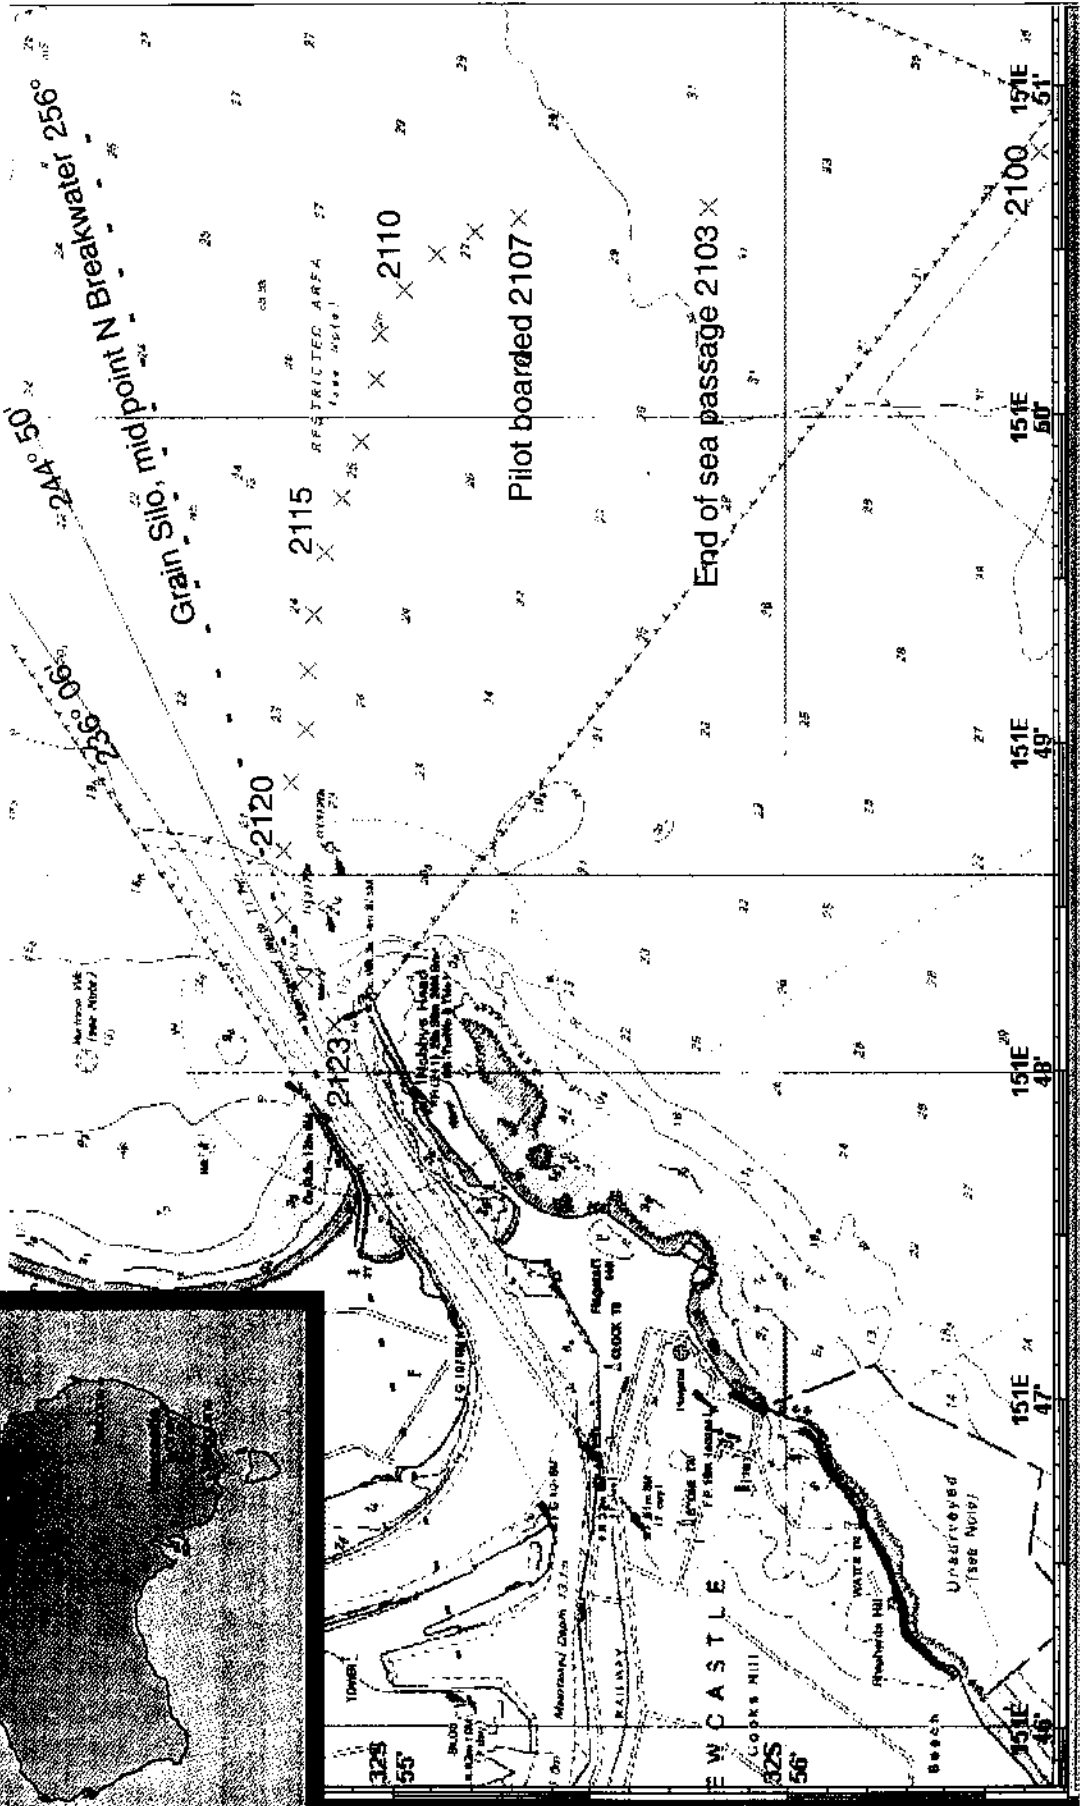
Section of chart Aus 207 – Reconstruction of approximate course followed from 2100 to 2123.  
 (Based on course recorder and engine revolutions)

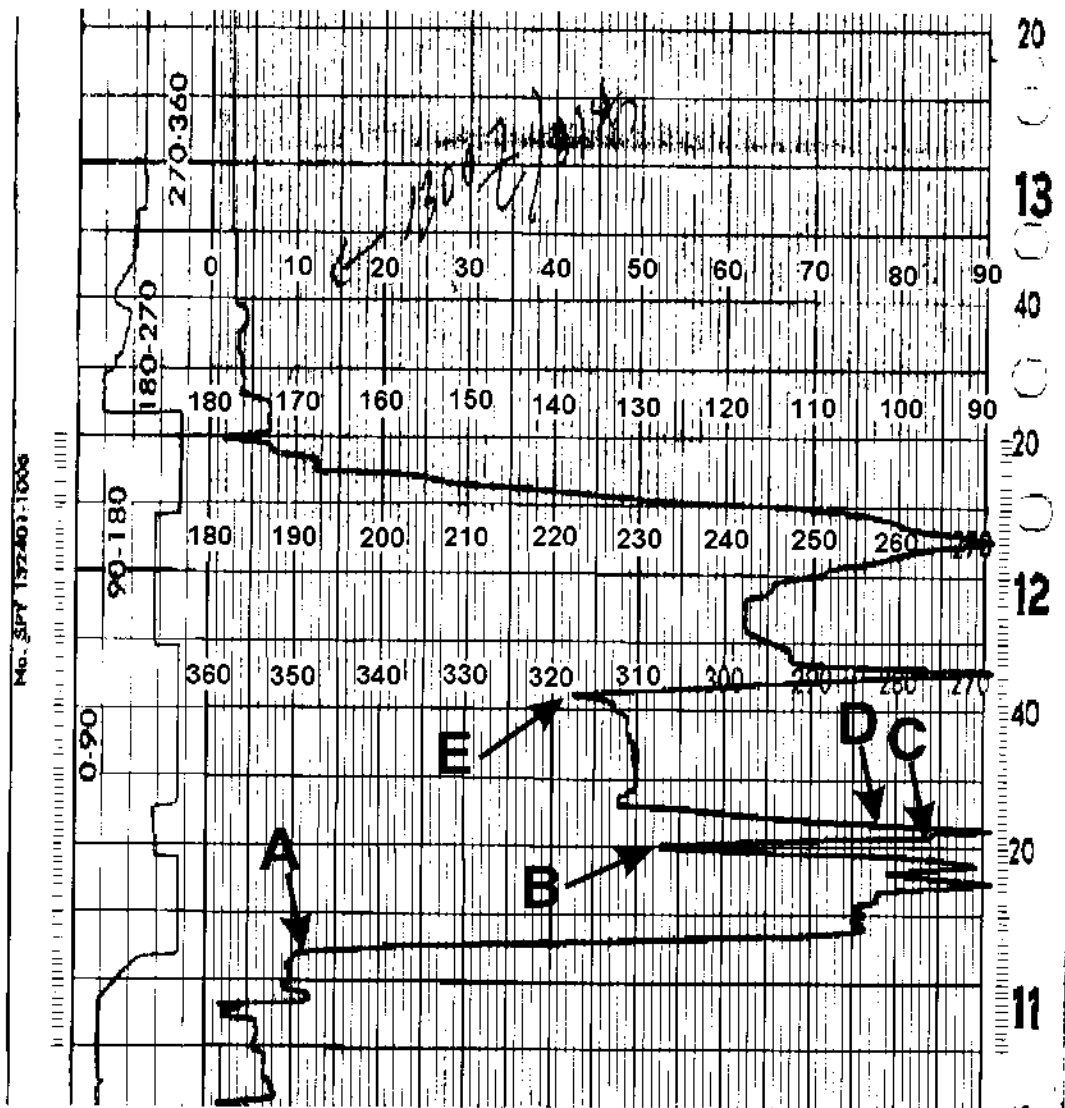
Examination of the course recorder trace shows that there was a one degree error in alignment (*the trace showing one degree high compared with the ship's gyro compass*), and that there was a difference between the quadrant pen and the trace pen of about 1.25 mm.

**Course recorder trace 1100 – 1230 UTC (2100 – 2230 EST)**  
 (course recorder approximately 3 minutes slow of ship time)

- A Pilot on board
- B Passing southern breakwater
- C Probable contact on southern side of channel
- D Probable grounding on northern side of channel
- E Vessel refloat
