Summary

On Saturday 17 June 1995, the Australian bulk carrier Iron Prince collided with the fishing vessel Pisces to the west of Cape Nelson, Victoria at 0644 Australian Eastern Standard Time. The weather at the time was clouded sky with passing showers and gale force winds with a heavy sea and swell.

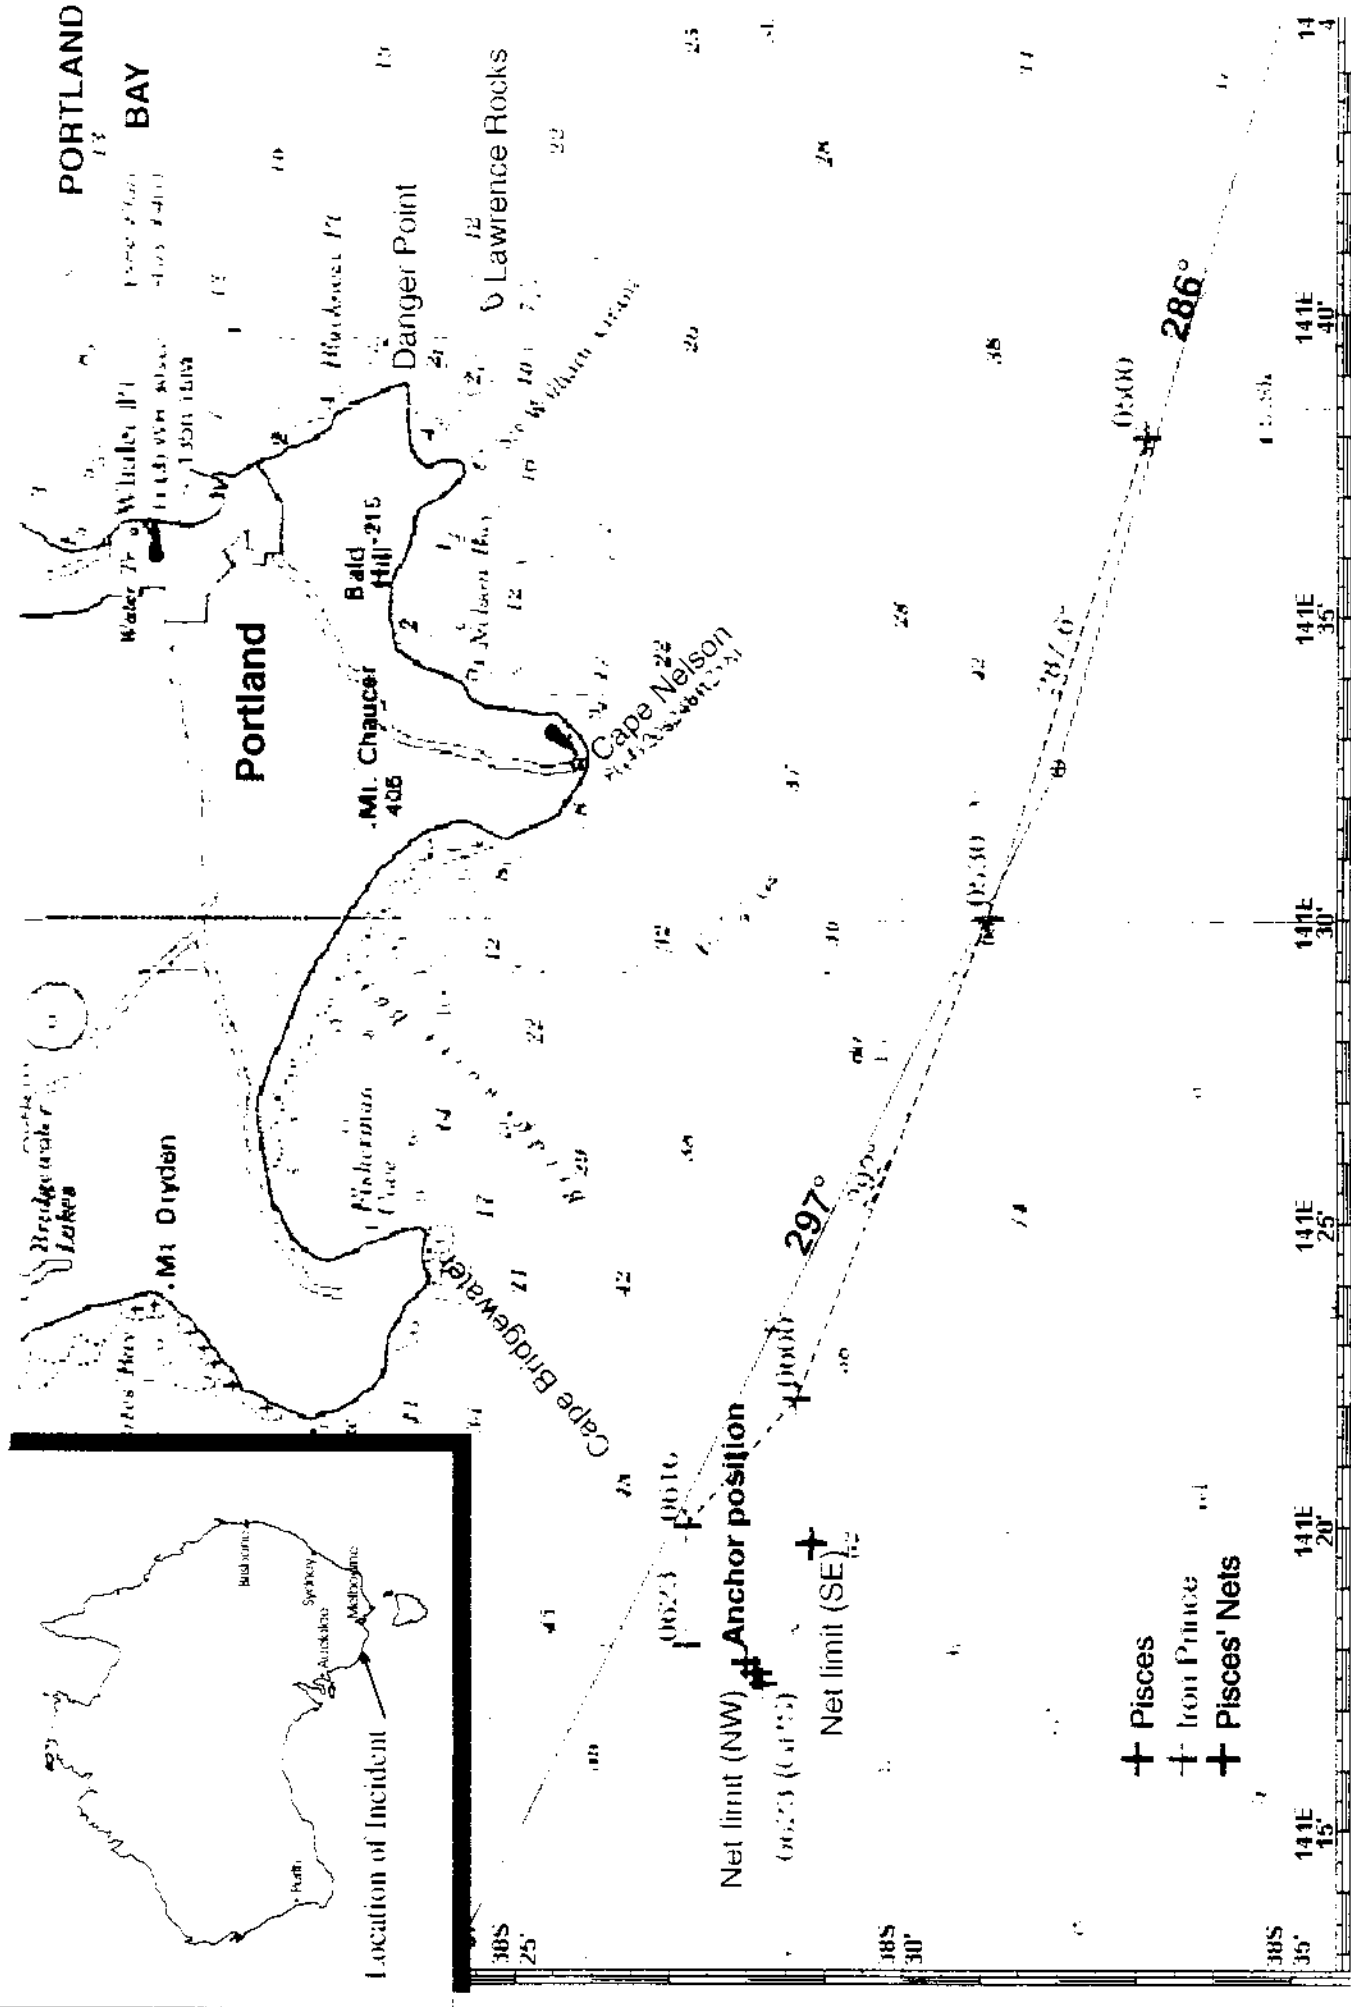
Portion of chart Aus 348 showing positions of vessels

The Pisces skipper had marked the GPS positions of the end marker buoys and his anchor position on the Furuno electronic plotter. These indicate that the nets were deployed along the 50 metre depth contour and that Pisces was anchored in position 38° 27.99'S 141° 17.72'E (corrected to Australian Geodetic Survey).

The Mate aboard Iron Prince was utilising visual bearings, radar bearings and radar distances for plotting the vessel's position on the chart. The 0600 and 0616 (ACST) positions place Iron Prince about nine cables, or about 1670 metres inshore of Pisces and its nets. The visual bearing (083°) of Cape Nelson light and distance off by radar (11.4 miles) plotted on the chart at 0623 (ACST) is also north of the Pisces position.

However, the GPS position given to MRCC Canberra by the Master at 0623 (ACST), 38° 28.1'S 141° 17.5'E, seven minutes after the collision and after Iron Prince had turned about to port, was very close south-west of the Pisces GPS position. Also, Iron Prince's track made good between 0500 and 0530 (ACST) projected, passes between Pisces and the western most net marker buoy.
