Navigation Act 1912  
Navigation (Marine Casualty) Regulations  
investigation into the capsizing of the  
landing barge

KEPPEL TRADER

and the subsequent fatality  
off the mouth of the Victoria River

7 August 1995

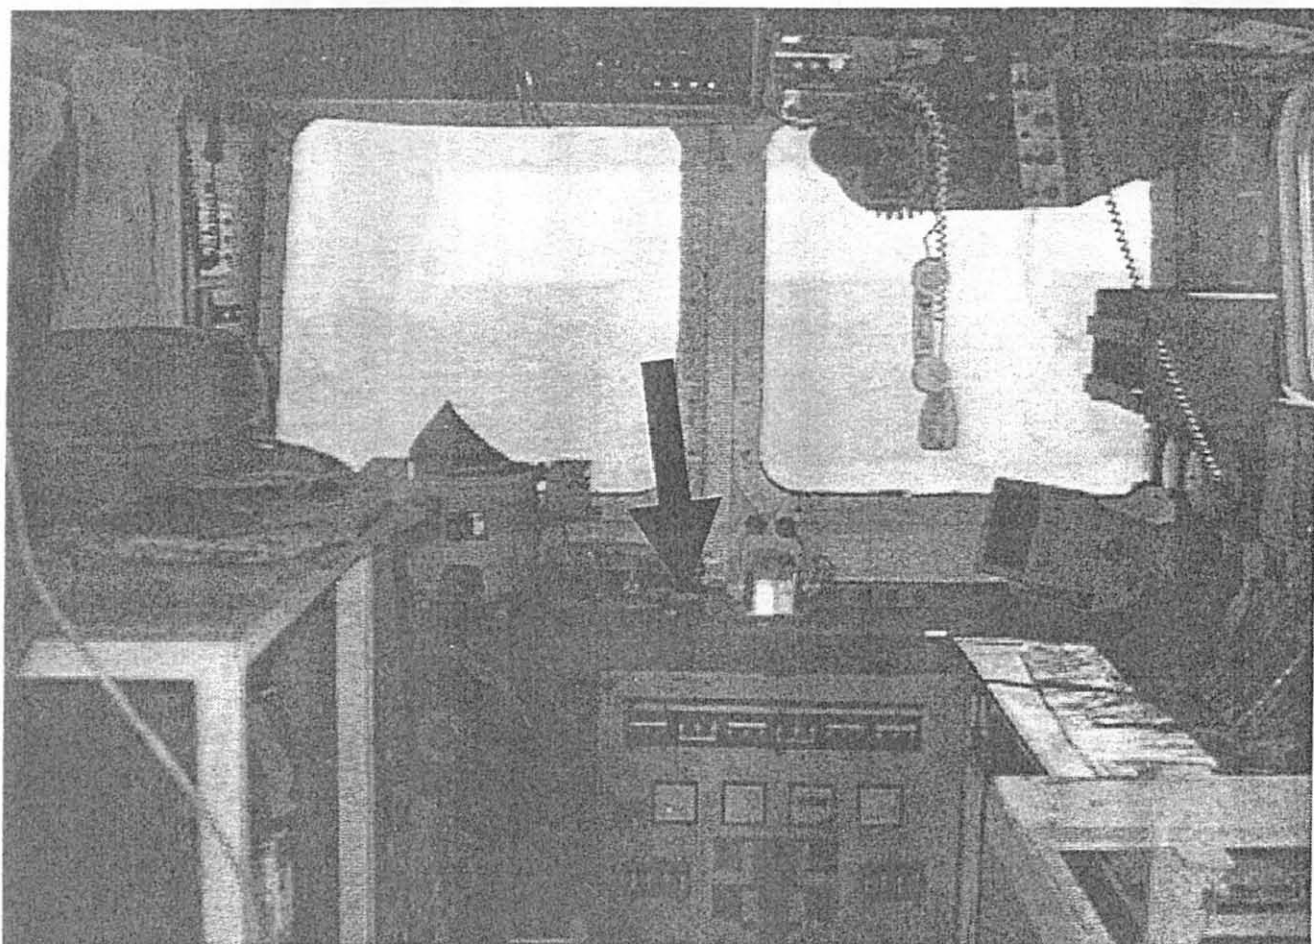
Interior of wheelhouse after salvage  
Engine temperature gauges immediately to the left of the engine control  
levers (as marked)

Temperature gauges, for the cooling water of the two main engines, were situated on the wheelhouse instrumentation panel, as well as on the engines themselves. The gauges on the wheelhouse panel, however, always had their pointers in the red sector, at the 'hot' end of the scale, when the engine temperatures were, in fact, quite normal. This was a defect of long standing which required the deckhand to make regular comparisons of the

5. It is considered that the long-standing defects in the wheelhouse panel temperature gauges contributed to the incident, in as much as the Master felt compelled to check the engine temperatures on the local gauges at a time when the vessel was in difficulties.

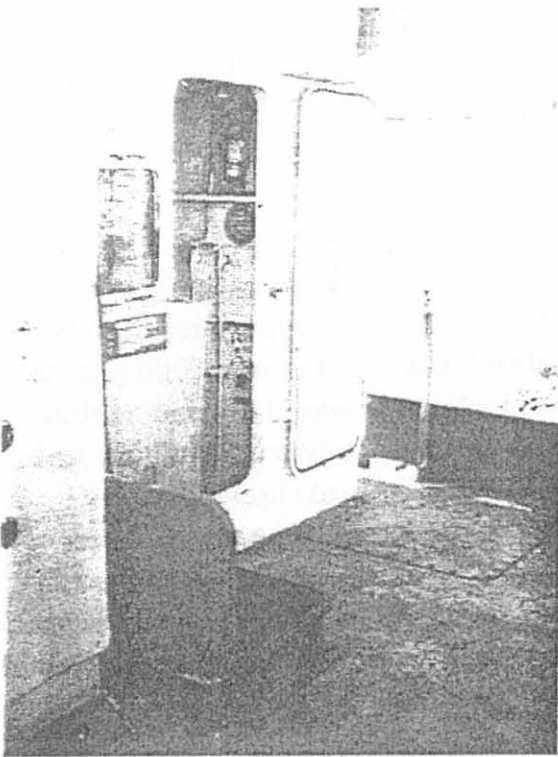
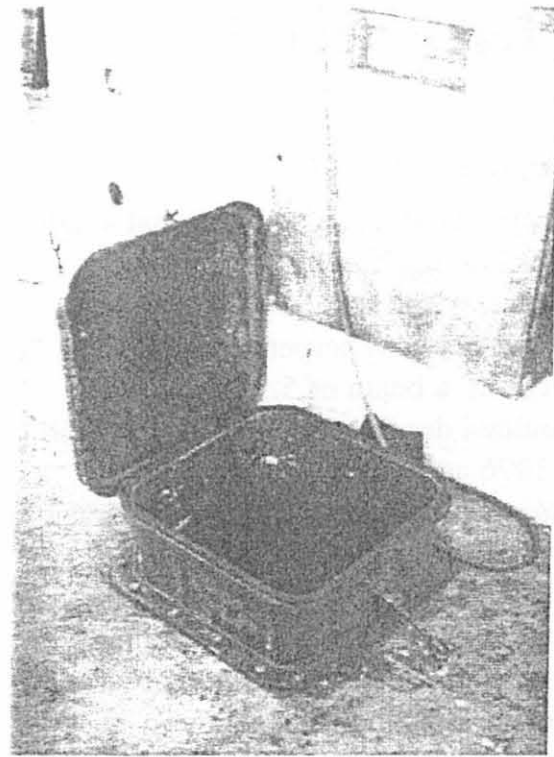
An external access to the machinery space is through a hatch on the main deck, with a 250 mm high coaming, adjacent to the deckhouse and slightly to starboard of the centre line. Another hatch to the machinery space is provided under the benchtop in the galley, giving internal access to the machinery space from within the deckhouse.

**Access hatch to engine room from main deck**

The maximum value of the righting lever GZ, in the condition of loading when Keppel Trader sailed from Darwin, was 0.216 m and occurred at an angle of heel of 16.332°. With the engine room hatch in the deck closed, the angle of flooding (immersion of the engine room vent) was 41.5°, approximately 4.5° past the angle of zero righting lever. With the engine room hatch on the main deck open, the angle of flooding (immersion of the engine room hatch) was reduced to 27.89°.

Had an exemption under Section 421 of the Navigation Act 1912 been sought from AMSA before the voyage was undertaken, it is probable that the vessel's failure to comply with the stability requirements of the USL Code would have come to light. At the very least, the fact that no stability calculations had been undertaken should have been revealed, as there is an obligation on the surveyor, in AMSA's *Instructions to Surveyors*, to ascertain that the relevant criteria are met. It is also possible that an inspection, carried out under 2.14.2.2 may have indicated the need for a warning notice on the engine room hatch in the deck, concerning the need for it to be kept closed at sea.

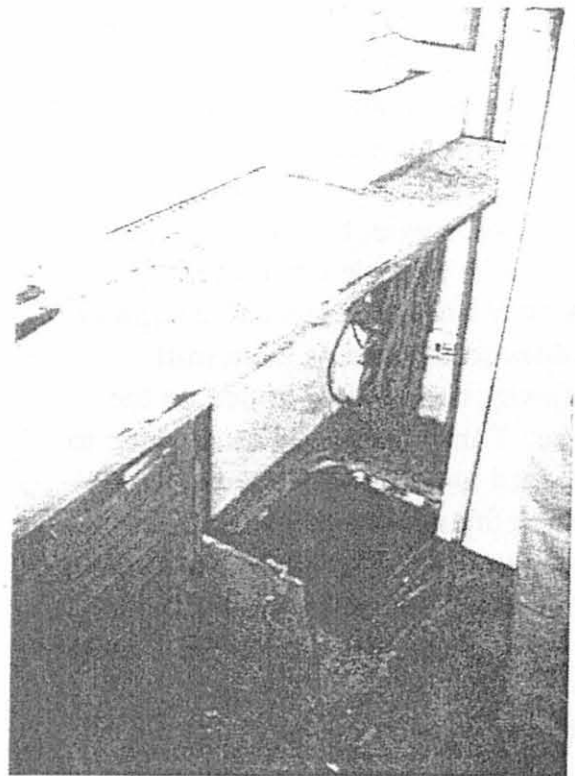
Internal access to engine room from under galley bench

4. The internal hatch, which should have been used for access to the engine room under the prevailing conditions, had been stacked with cartons of soft drinks when the vessel was stored with provisions, indicative of the fact that this hatch had fallen into disuse, even in heavy weather.

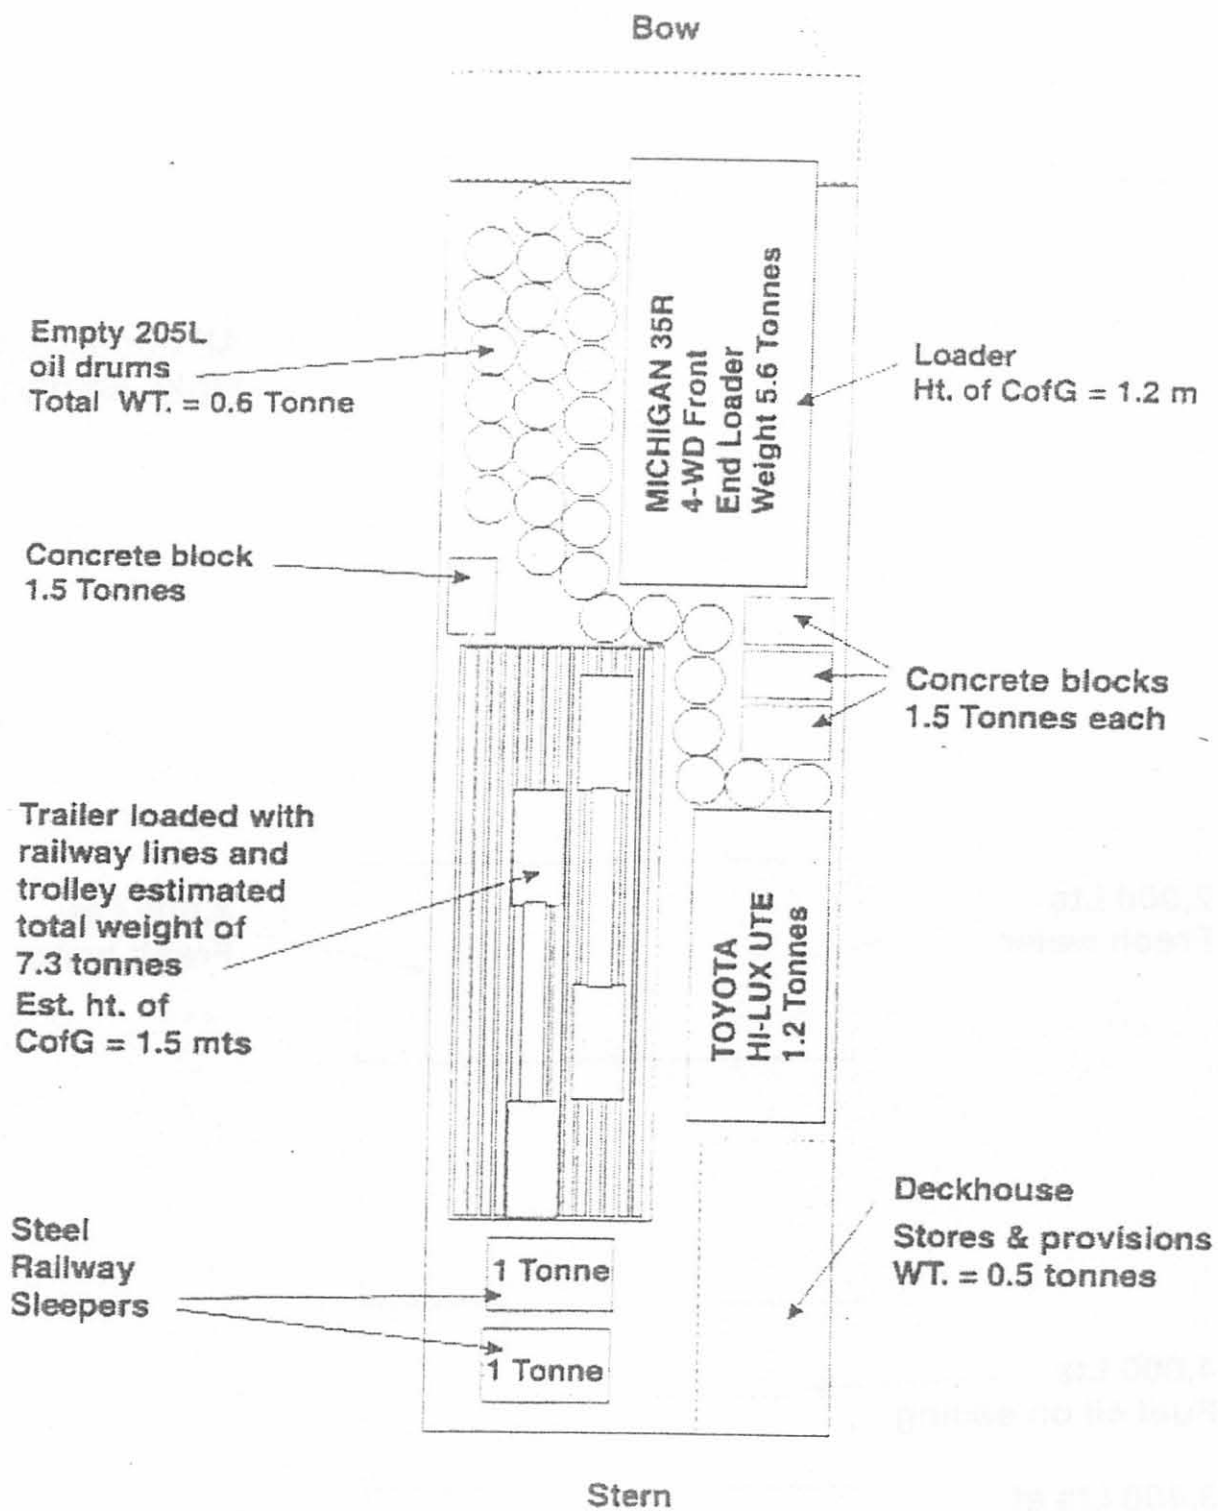
Cargo plan—7 August 1995

Keppel Trader was loaded with a deadweight total of approximately 32.6 tonnes, including 3.2 tonnes of fuel and 6 tonnes of fresh water.

The maximum departure condition as shown in the approved Trim and Stability booklet gives a deadweight total of 26.594 tonnes, based on a deck cargo of 22 tonnes with its centre of gravity being 0.5 m above the deck. The actual deadweight of Keppel Trader, before any ingress of the sea into the engine room, included an estimated 23.4 tonnes of deck cargo with the centres of gravity of the heaviest items of cargo, the front-end

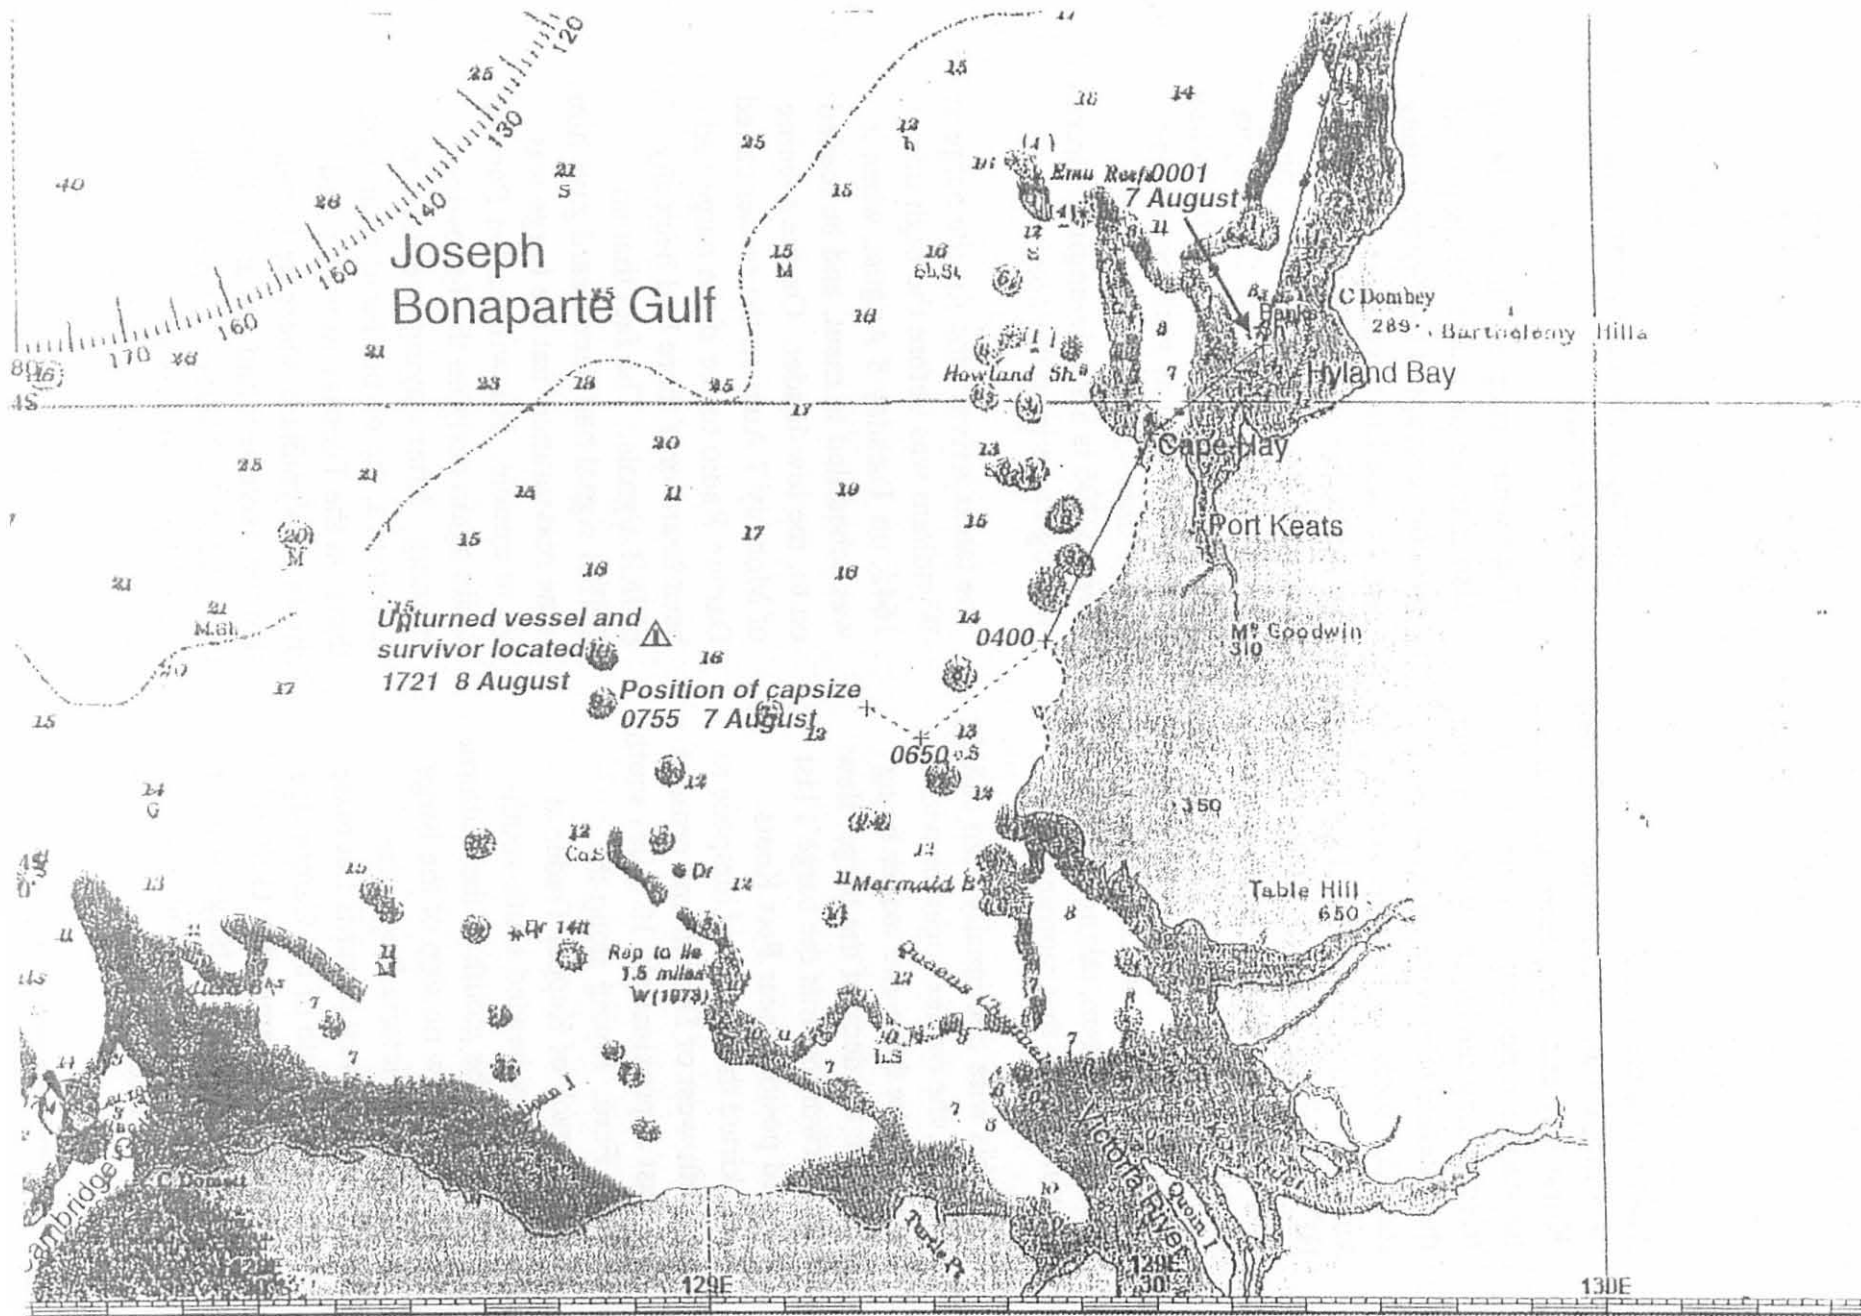
Portion of chart AUS 413 showing approximate track of Keppel Trader

At the time the Master was awakened by the violent motion of the barge, it is possible that it was being affected by the overfalls in this area. However, it seems unlikely that an overfall would have affected Keppel Trader at the time of its capsizing, as, by then, it was approximately four miles further to the north-west. Nevertheless, the overfalls are indicative of the hazardous conditions in the general area.

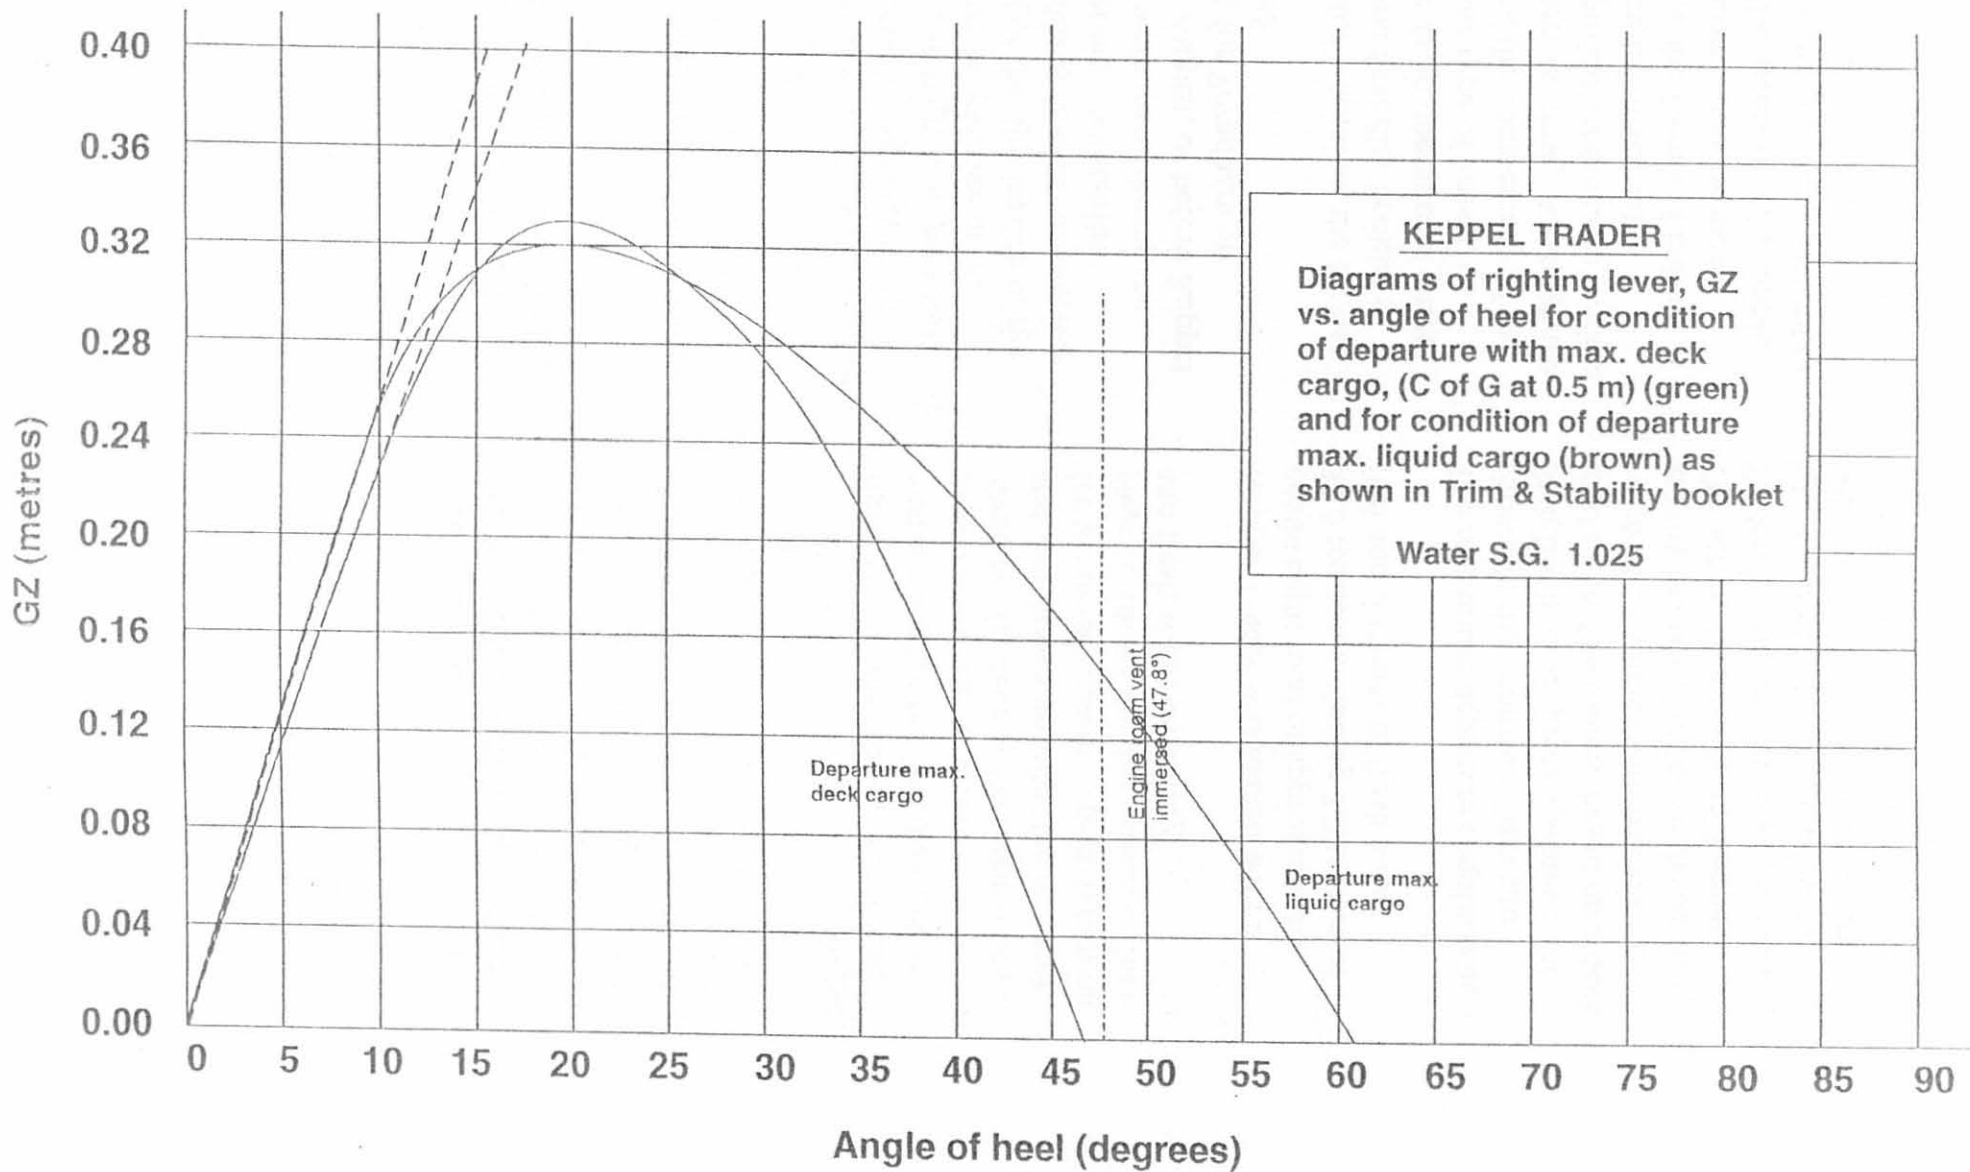
The vessel in the departure condition met all the requirements with the exception of the area under the GZ curve where it was significantly deficient. This area is the most important of all the criteria. It is an

A diagram showing the GZ curve for the condition of departure with maximum deck cargo, from the Trim and Stability booklet, is shown opposite.

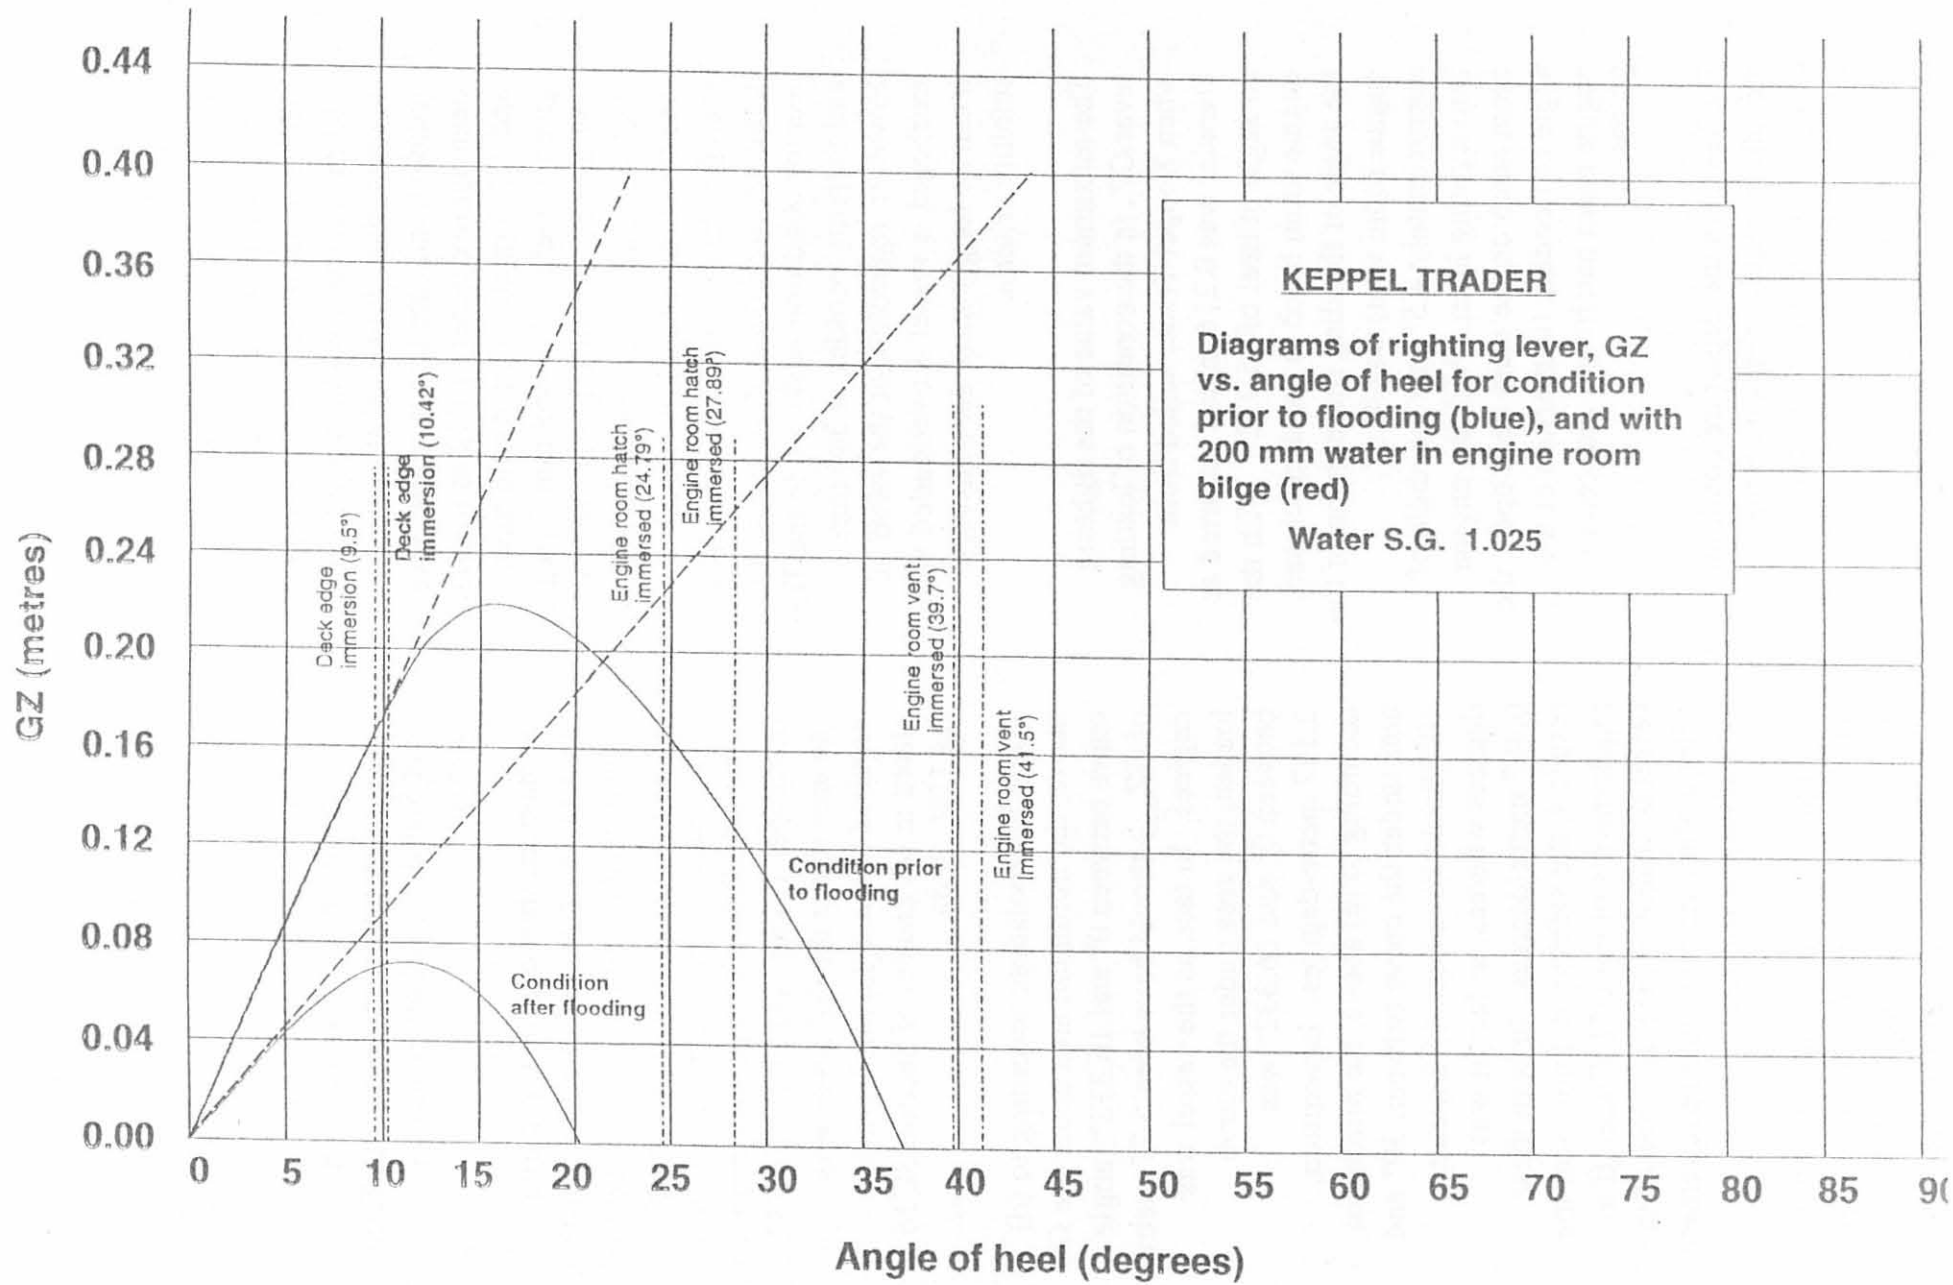
A diagram showing the GZ curve applicable to the vessel in the situation which existed prior to any flooding of the engine room, is shown on page 32 (blue curve). Because the maximum value of GZ for the departure condition of Keppel Trader occurred at 16.332°, the area under the GZ curve was required to meet the minimums as stated in (d) and (e) of Section 8C16 of the USL Code.

Using interpolation, according to (d) above, the minimum area under the GZ curve between 0° and 16.332° (angle of  $GZ_{max}$ ) should have been 5.77 metre-degrees. In fact, as the vessel was loaded, the area under the curve between 0° and 16.332° was 2.157 metre-degrees. In addition, according to (e) above, the minimum area under the curve between 30° and 40° should have been 1.72 metre-degrees whereas, in fact, it was 0.407 metre-degrees. In both these respects, the stability did not meet the requirements of the USL Code. If a vessel is unable to meet any one of the criteria, then the minimum requirement for stability is not met.

It is significant, and should be noted, that the maximum GZ was required by the Code to have a minimum value of 0.200 m and, in the condition as

loaded, Keppel Trader met this requirement with a value of 0.216 m. The relationship between the value of  $GZ_{max}$  and the area under the GZ curve can, however, be misleading. The minimum value of  $GZ_{max}$  of 0.200 m is based on the  $GZ_{max}$  occurring at an angle of heel of between 25 and 30 degrees. This minimum value of  $GZ_{max}$  criteria becomes irrelevant where the angle of heel of  $GZ_{max}$  occurs below 25 degrees. In fact, meeting this criteria of 0.200 m will present a false sense of security.

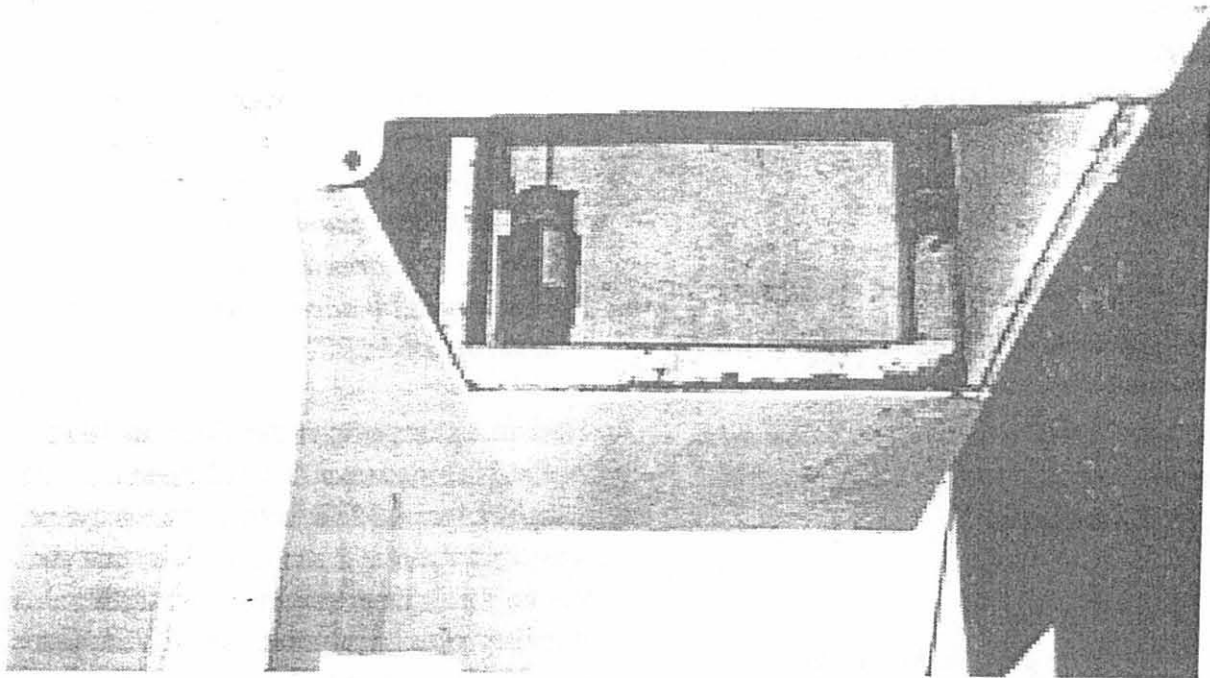
The upturned barge was being carried further out to sea by both the south-easterly winds and the current running from the mouth of the Victoria River. During the morning of Monday 7 August, the Master was battling to retain his hold on the upturned hull, frequently being submerged as the seas washed over him. In an attempt to gain body warmth without becoming totally exhausted, he alternated between being on top of the hull and being in the water, secured to the hull by his strop made from the plastic fuel pipe. He was wearing only a T-shirt and a pair of shorts. So quickly had the vessel capsized, he had no chance to grab either a life-jacket, warm clothes or the EPIRB, stowed in a bracket inside the wheelhouse.

Wheelhouse access showing stowed EPIRB
