Goonzaran

New Noble

# Summary

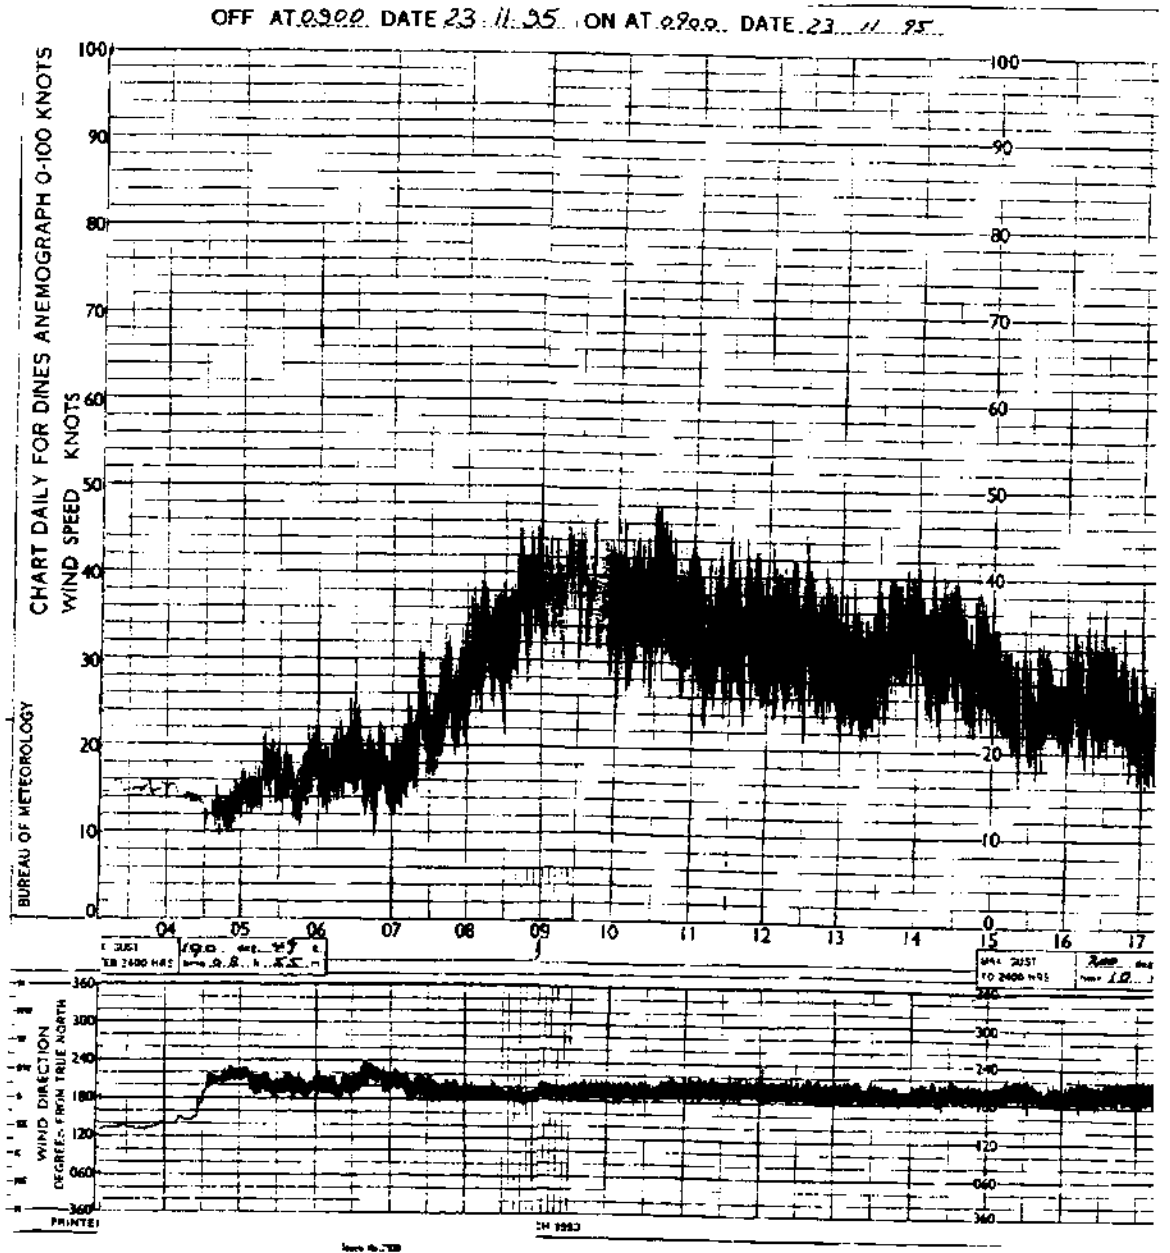
### Nobbys Signal Station Wind Speed (Knots) and direction record

During 22 November, the wind moderated to about 10 knots and veered to a south-easterly direction a little before 2300. At about 0430 on 23 November the wind veered the south-south-west and increased in strength to about 20 knots. By 0730 the wind was gusting to 30 knots and by 0900 gusts of 46 knots were being experienced with a mean of about 38 knots.

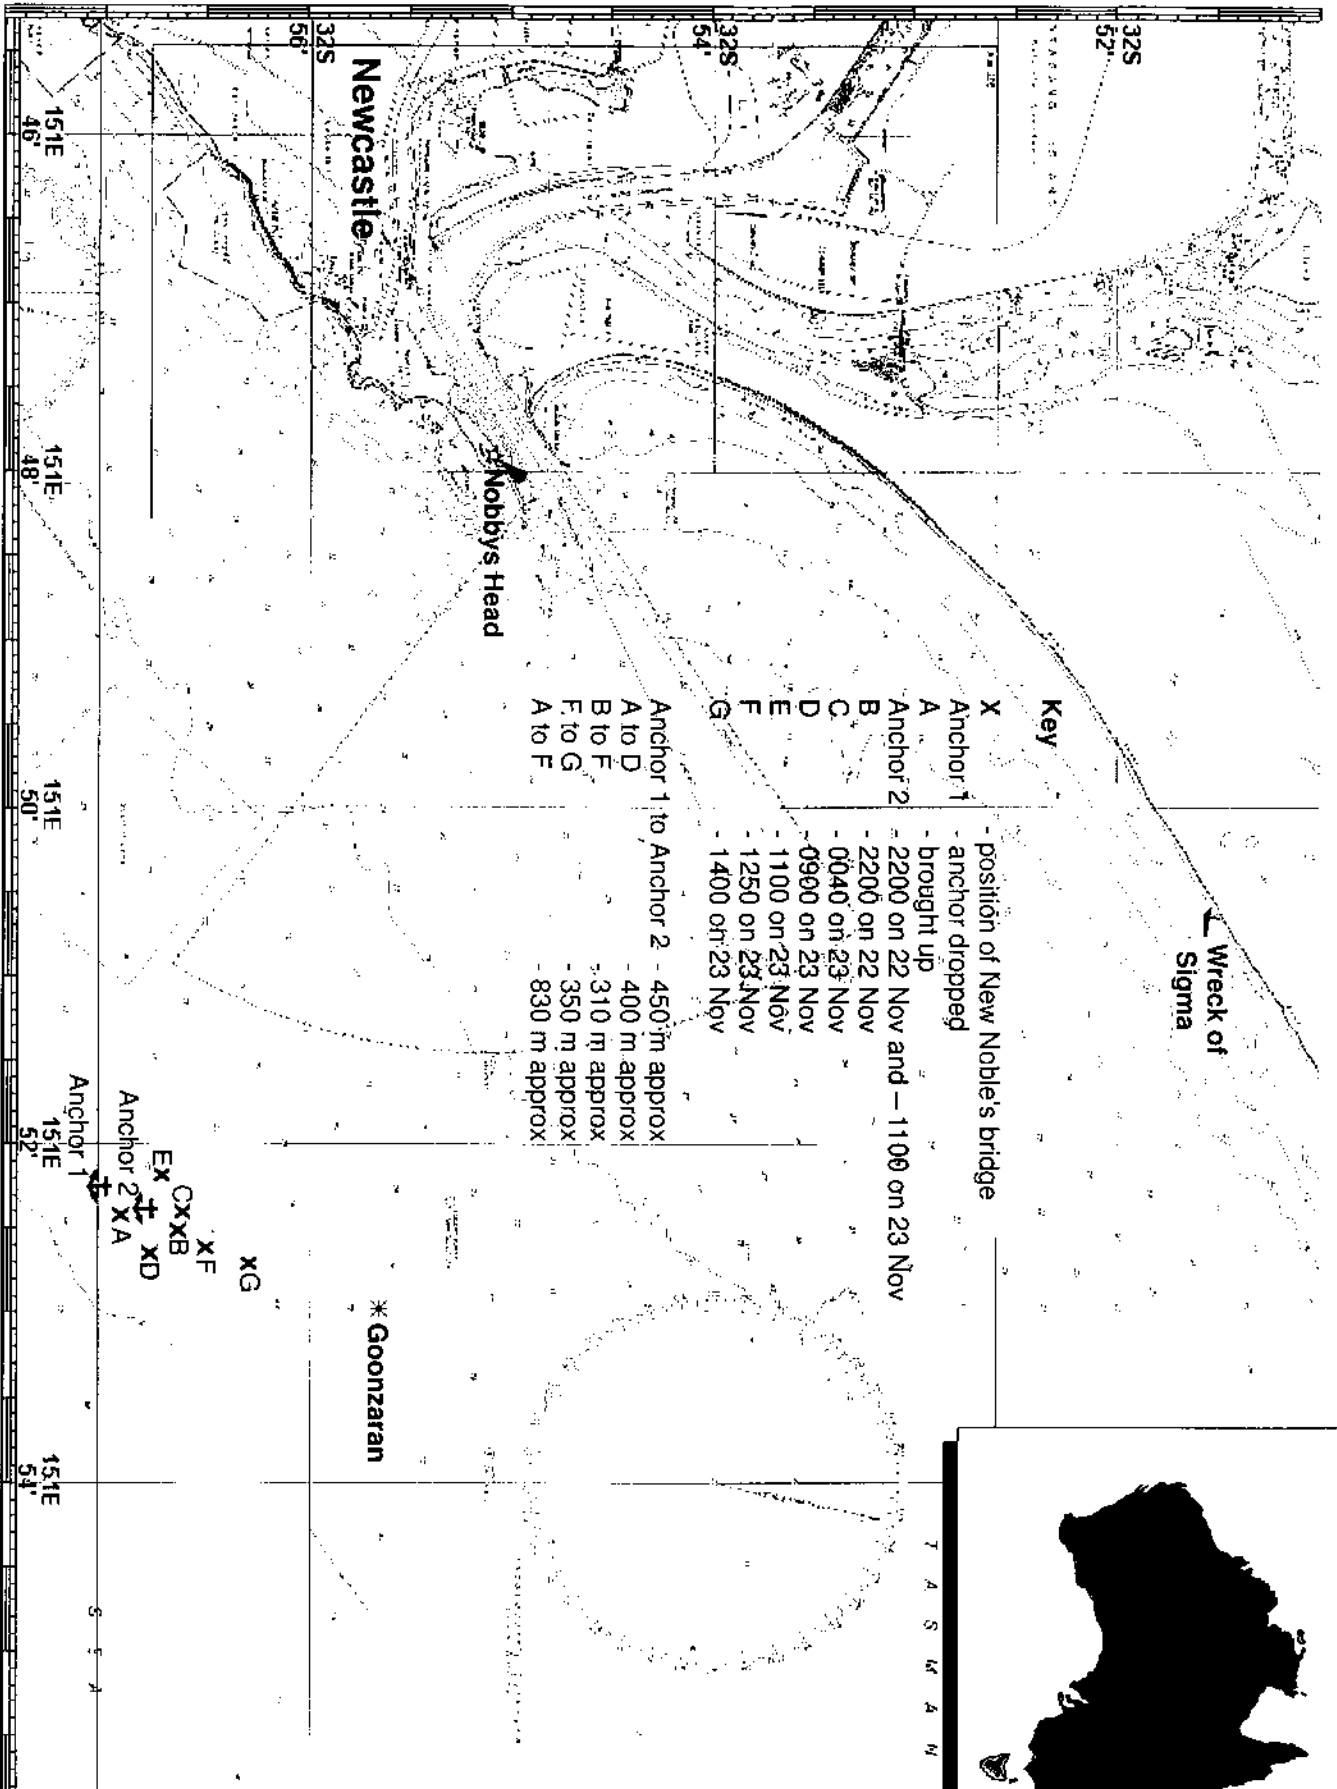
Portion of chart Aus 207 showing positions at anchor

New Noble anchored in a position about 1.4 miles south of Goonzaran. The reported position of New Noble's anchor was with Nobby's Head bearing  $298^\circ$  x 4.1 miles. New Noble also dropped 8.5 shackles in about 42 m of water, a ratio of depth of water to cable used of about 1:5. A position (of the ship's bridge) was marked on the chart with Nobbys Head bearing  $296^\circ$  x 4.2 miles, with the ship, lying windrode 300 m to the north-east of its anchor. The maximum radius of swing from the anchor was about 380 m, as measured from the bridge.

Nobbys Head bearing 292° x 4.17 miles, and, if accurate, this indicated that the ship had moved its position about 450 m north of the position in which the ship brought up on the morning of 22 November. This means that the anchor itself must have dragged at least 400 m. However, the log book entry for 2400 on 22 November, and the subsequent entries for 0400, 0800 and 1200 on 23 November, all noted that there was 'no sign of dragging'.

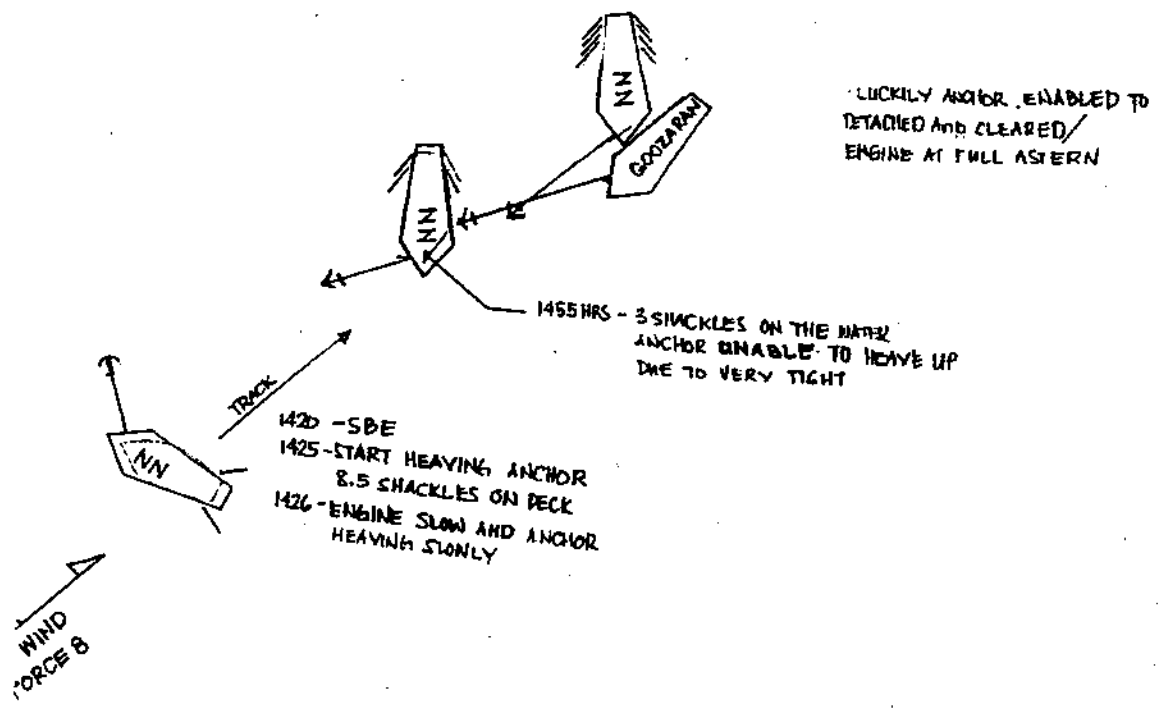
Sketch of incident by Master of New Noble

At about 1500¼, the ships collided, New Noble's bulbous bow and the flare of the bow contacting Goonzaran in way of no.3 hold and then no. 5 hold and no. 10 hold.

1500 HRS - ENGINE FULL ASTERN

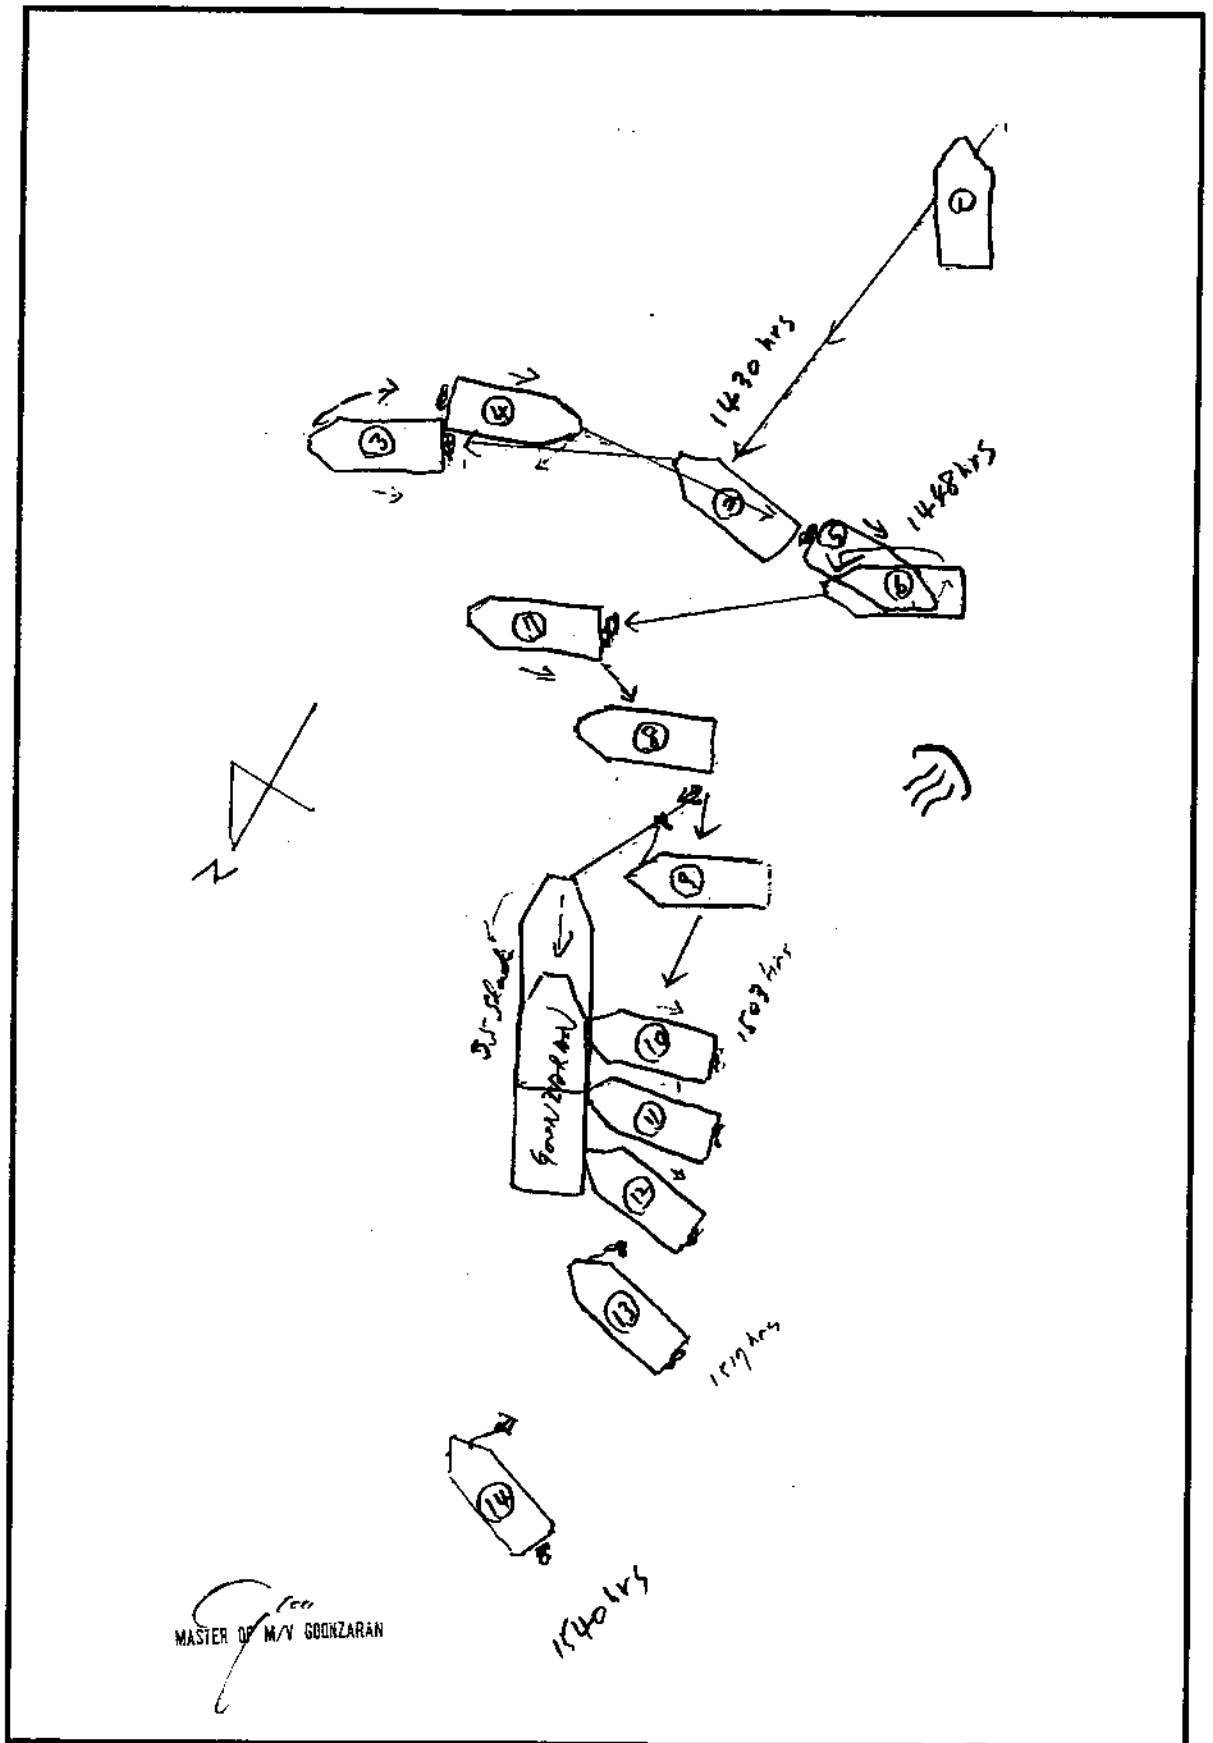
Sketch of incident by Master of Goonzaran

At about 1458, New Noble had recovered a little more cable and with about three shackles in the water, New Noble's anchor fouled the anchor cable of Goonzaran. It seemed to those on New Noble that Goonzaran's anchor cable tightened and the two ships were drawn towards each other. The Master used a burst of full astern and the Mate slacked the anchor before heaving on it again and the anchor seemed to clear the other ship's chain. By this time the ships were very close and New Noble was heading at right angles to Goonzaran. New Noble's Master called Goonzaran, initially on channel 6 and then on channel 16, establishing VHF contact at 1458¾.
