Departmental investigation
into the
grounding of
the Singaporean bulk carrier
SEA CRANE
on Tiparra Reef, Spencer Gulf
on 2 December 1995

Report No 87

Navigation Act 1912
Navigation (Marine Casualty) Regulations
investigation into the grounding of
the Singaporean bulk carrier
SEA CRANE
on Tiparra Reef, Spencer Gulf
on 2 December 1995

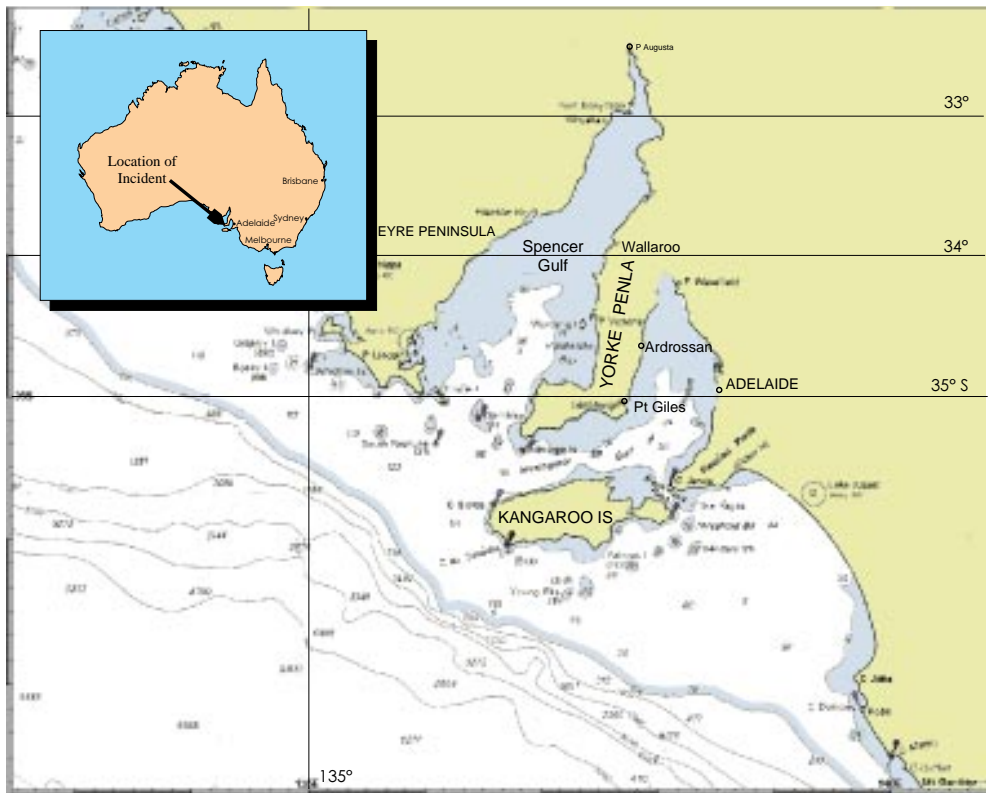
Portion of chart Aus 4709 showing Spencer Gulf.

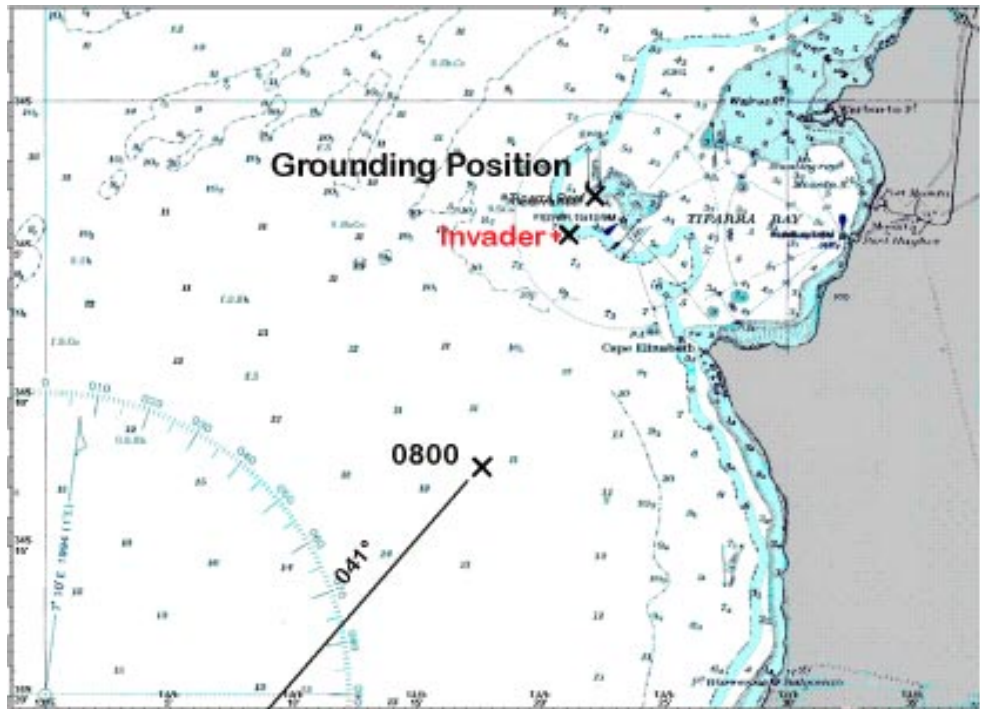
Portion of chart Aus344 showing positions of Sea Crane.

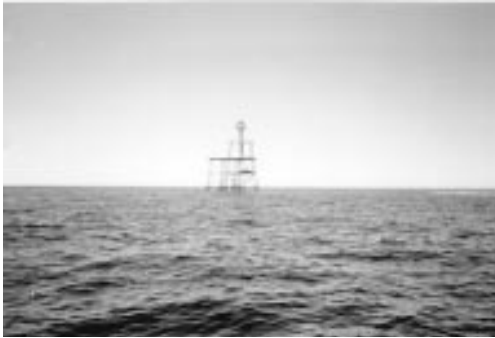
Tiparra Reef

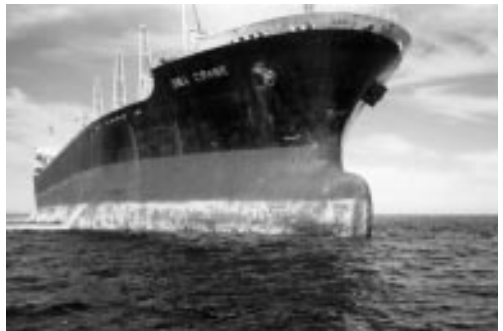
Sea Crane dumping ballast 2 December 1995
